Cruise Report No. 03

RRS Discovery Cruise 360

19 JAN-02 FEB 2011

Trials of the Autosub LR AUV, HyBIS, PELAGRA,
Ellsworth Camera and MYRTLE-X Lander systems

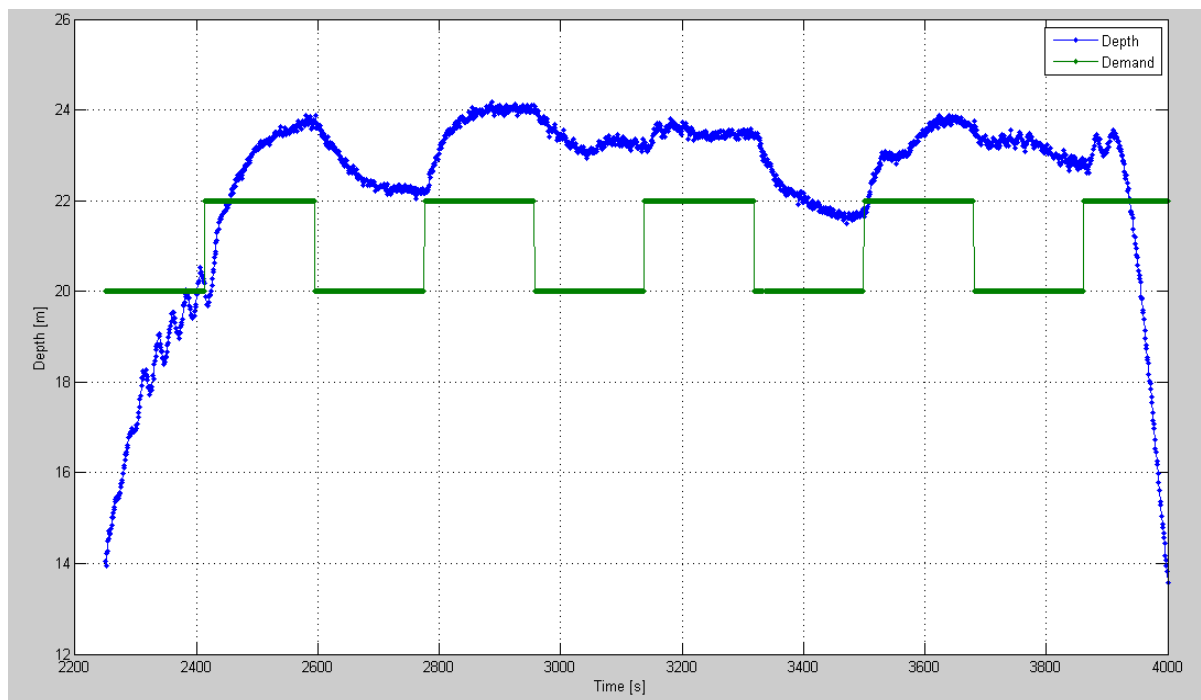
Figure 2. Depth Demand (green), and achieved depth for mission 9. Due to fault, the AUV lost control at 3900 seconds, and the mission was aborted.

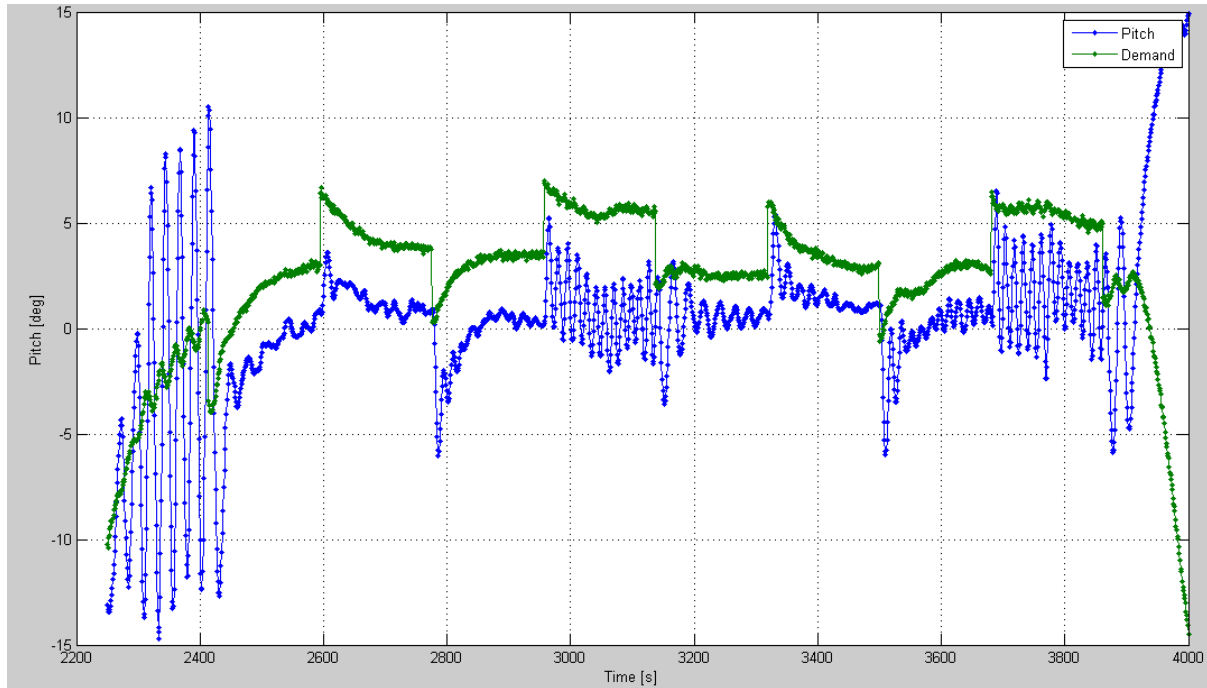
Figure 3. The Pitch demand (green), and pitch achieved for the set of control coefficients. The best control was achieved for the first three sets of control parameter at the start of the run. Best results are for $I = 0.05$, $P = 0.6$, where P and I are the control coefficients (2nd demand, 2600 to 2750 seconds). The start of the test begins at 2400 seconds.

For mission 9, run at 0.62 ms^{-1} the most effective control settings were: $I=0.05$, $P=0.6$.

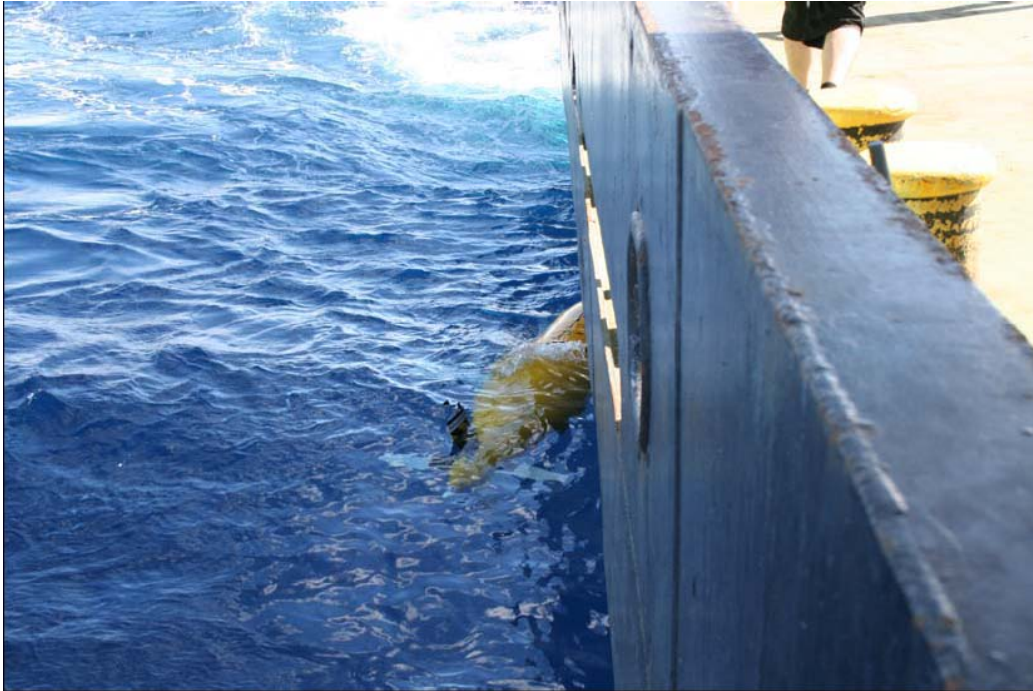
Figure 7. Autosub LR disappearing under Discovery's starboard quarter. The command to stop the ships propeller was issued

The AUV was launched as usual from the starboard side, but difficulties with release of the sea catch (it taking several attempts over several seconds) , meant that the AUV was not orientated ideally (at right angles to the ship , or slightly forward pointing), when it entered the water. In addition the tail handling line was released before the sea catch, hence we lost control of the AUV orientation at that point.

With the AUV drifting towards the starboard quarter, the ships side attempted to swing the ships head to starboard with starboard rudder and moderate propeller RPM. Unfortunately , with the AUV now close to the ship, this only had the effect of sucking the AUV under the counter and towards the propeller. At this point the request was made by the PSO to stop the ship's main propeller. This (fortunately) was executed almost immediately, preventing much more serious damage to the AUV.

The AUV surfaced on the starboard side. Initially the severity of the damage was not noticed. Following recovery, however, it was noticed that the propeller motor end cap assembly had been hit partially off, and the only thing preventing the propeller assembly being lost was the magnetic coupler

attraction. Flooding of the motor assembly destroyed that system, and consequential to that, voltage from the main power bus were able to short circuit onto the I2C bus, causing irreparable damage also to the sternplane and rudder controllers.

We had enough spares to effect repairs, and the vehicle was operational 2 days later.
