Survey of Broad Haven Primary School and adjacent land, Haverfordwest, Pembrokeshire, Wales

Open Report OR/08/063

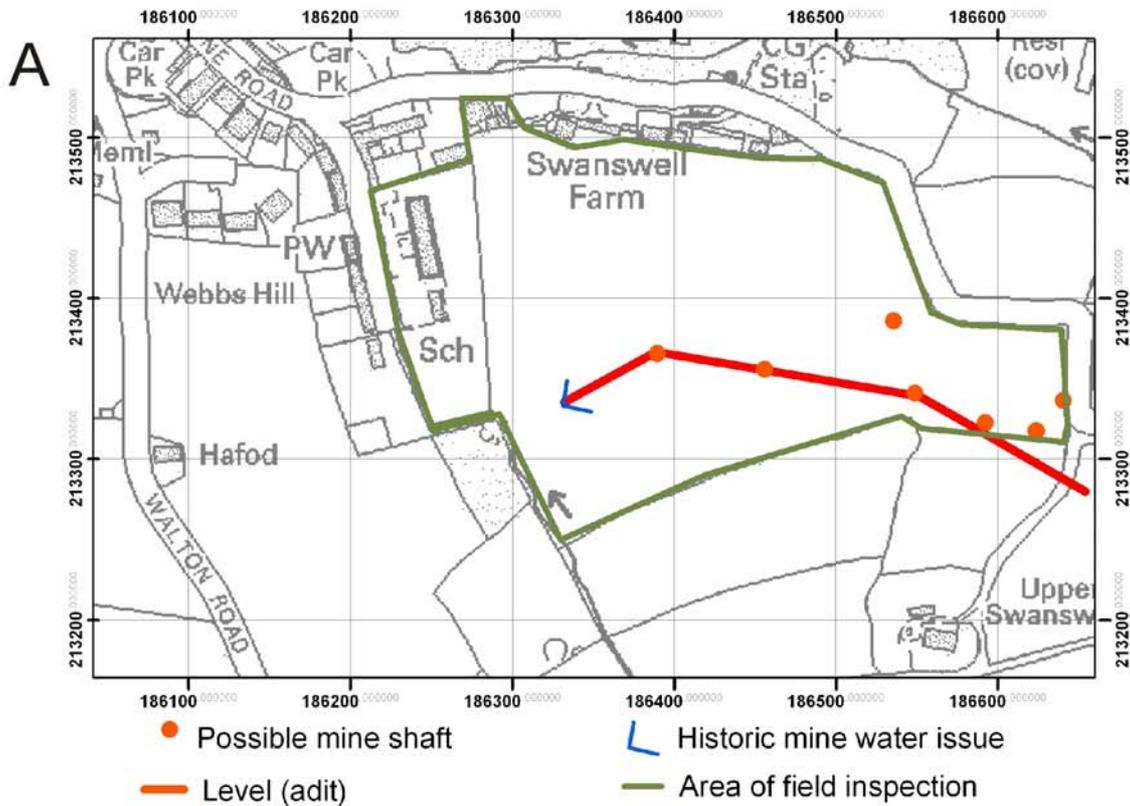
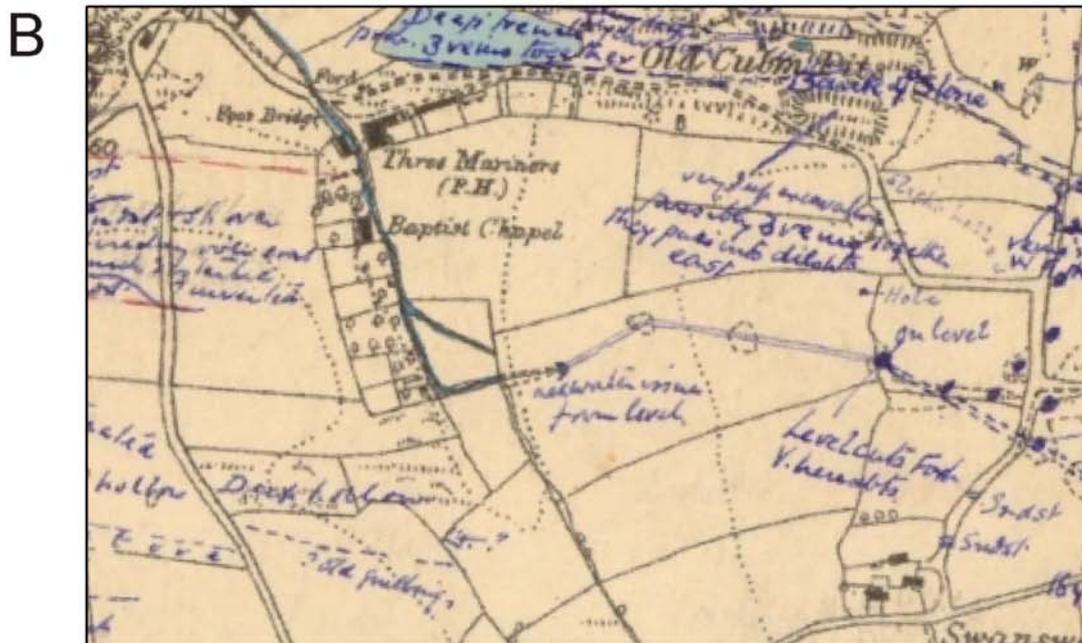
The mines east of Broad Haven were drained by a 'level' shown in Figure 1B which was driven from a point [¹86336, ²13333] within Mr Clark's field eastwards towards Foxhill Farm [¹87258, ²13075] and then north-eastwards towards Broadway. Figure 1A shows the estimated position of the level and shafts highlighted on the 1907 geological map (shown in Fig 1B), these have been reproduced on the current 1:10,000 OS map for clarity. At depth, in the upper part of the field, the level intersects the Foxhill Vein. At the time of the last geological survey (1907) the mouth of the level was open, draining westwards into the stream via a shallow culvert. A number of shafts are situated along the line of the level, and at least four of these are shown on the 1907 geological map (Fig 1B) within Mr Clark's field [¹86391, ²13365], [¹86459, ²13354], [¹86550, ²13339], [¹86594, ²13332]. The two westernmost airshafts are shown as dashed circular features on the 1889 OS map (the base map for the 1907 geological survey, Fig 1B), and it is possible that these had collapsed or were partially filled by this time. The map also shows two further mineshafts in the upper part of the field, close to its south eastern boundary [¹86625, ²13316], [¹86642, ²13336] and more occur nearby within adjacent fields. Small areas of spoil that previously surrounded these features are also shown on the geological map (Fig 4). They are now recognisable by areas of dark soil within the upper part of the field. An area of tipped and partially re-excavated material at [¹86613, ²13315] may represent the remains of one of the spoil heaps. The survey of 1907 also shows a 'hole', which was probably a 'crown hole' (a circular depression caused by collapse above a void) in the upper part of the field at [¹86538, ²13385]. However, none of the features identified on the geological map (drainage level, shafts or crown hole) are visible at surface at present, and it is likely that they have been filled in and ploughed over.

Figure 1. (A) Current 1:10 000 scale Ordnance Survey map with the location of the mine level and shafts shown on the 1907 geological map. (B) Extract from the 1907 geological map (field slip) made by O.T. Jones, marking ‘red water issue from mine’, ‘level cuts Fox v. (vein) hereabouts’, and several air shafts and mine shafts.

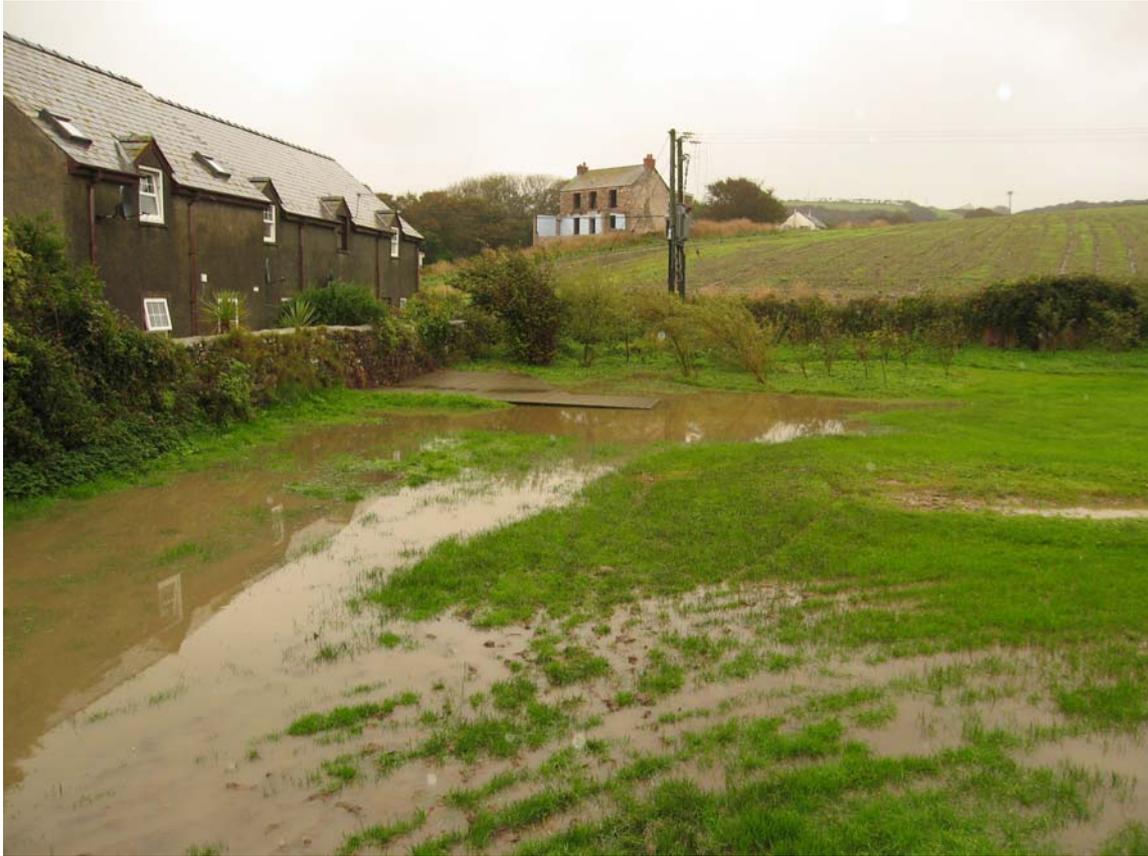
The flooding within the school precinct (Fig 2) is considered to have resulted from severe rainfall onto ground already saturated during a prolonged period of wet weather. In these circumstances, groundwater levels would be generally high and the infiltration capacity of the soil was consequently limited. Overland flow and interflow conditions (lateral movement of water through the soil zone) probably occurred (Fig 4). The run-off inevitably found its way to the lowest point within the valley, i.e. along the former stream course within the school grounds. The location of the school, on deposits of colluvium and/or alluvium in the bottom of the valley (Fig 4), is in an area where a naturally high water table level would be anticipated, even in periods of dryer weather. The combination of geographical and geological conditions makes the primary school susceptible to flooding, particularly over the wetter winter months.

Figure 2. Photograph of the northern boundary of the school field with free-standing water after a high rainfall event. Taken 11th October by Dr J R Davies, looking northeast from [BNG ¹86248, ²13865].

4. The school site is susceptible to flood hazards. Flooding is likely to be a recurring problem on the site if no action is taken to improve the current drainage provision within and outside the school. A vegetative cover on the field would reduce soil erosion during periods of high rainfall. Improved interception of sediment could be achieved by improving vegetation cover at the boundary between the field and school grounds.

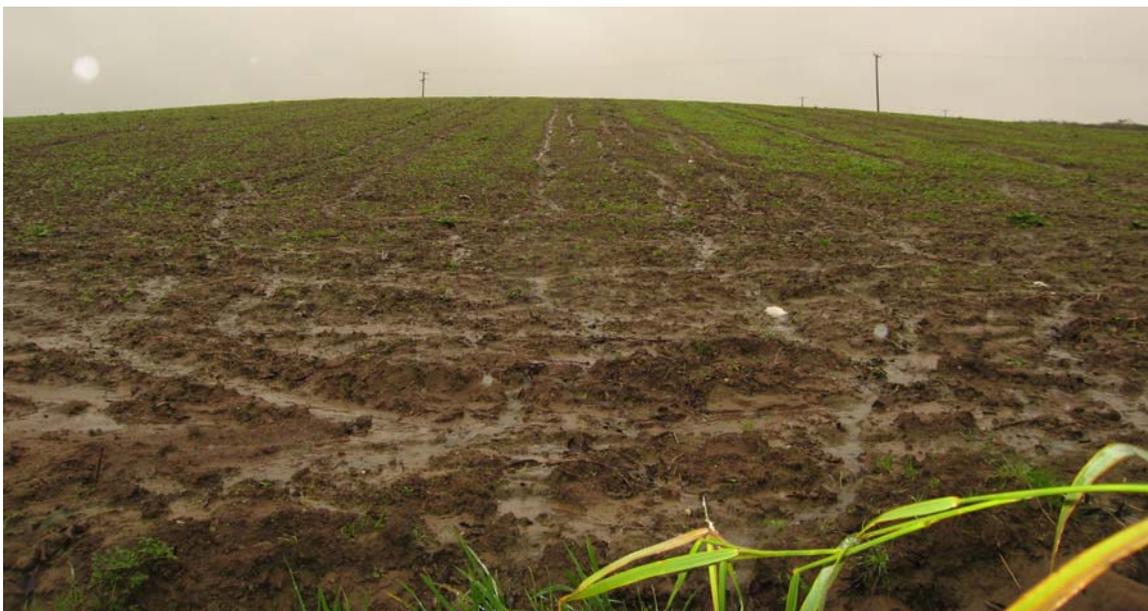
The walk-over survey noted that the field had been recently ploughed in a down slope direction (Fig 3). The ploughing and tyre tracks created artificial gullies along which rain water run-off was preferentially diverted, scouring out rivulets and exacerbating soil erosion. The absence of vegetative cover resulted in the erosion of large quantities of silt and sand from the field. The accumulated sediment blocked drainage inlets, and filled hollows, thereby adding to the severity of flooding.

2. The high rainfall, overland flow conditions and lack of vegetation on the field resulted in rapid soil erosion that transported large amounts of silt and sand down slope. There is no drainage provision or barrier to water between the school grounds and the field, and little vegetation to intercept sediment at the base of the field. Therefore, water and sediment entered the school grounds directly.

Figure 3. Photograph of field east of school showing sediment accumulation at base of the field, and rivulets formed on the slope, locally cutting depressions made by tractor tyres. Taken on 10th October by Dr J.R. Davies, looking east from [BNG ¹86287, ²13414].
