**ENVIRONMENTAL BASELINE STUDY
OF
DAMAGED GROUND
AT
CAIRNGORM ESTATE**

by
Dr Adam Watson

April 1994

Produced for Highlands & Islands Enterprise, 1994

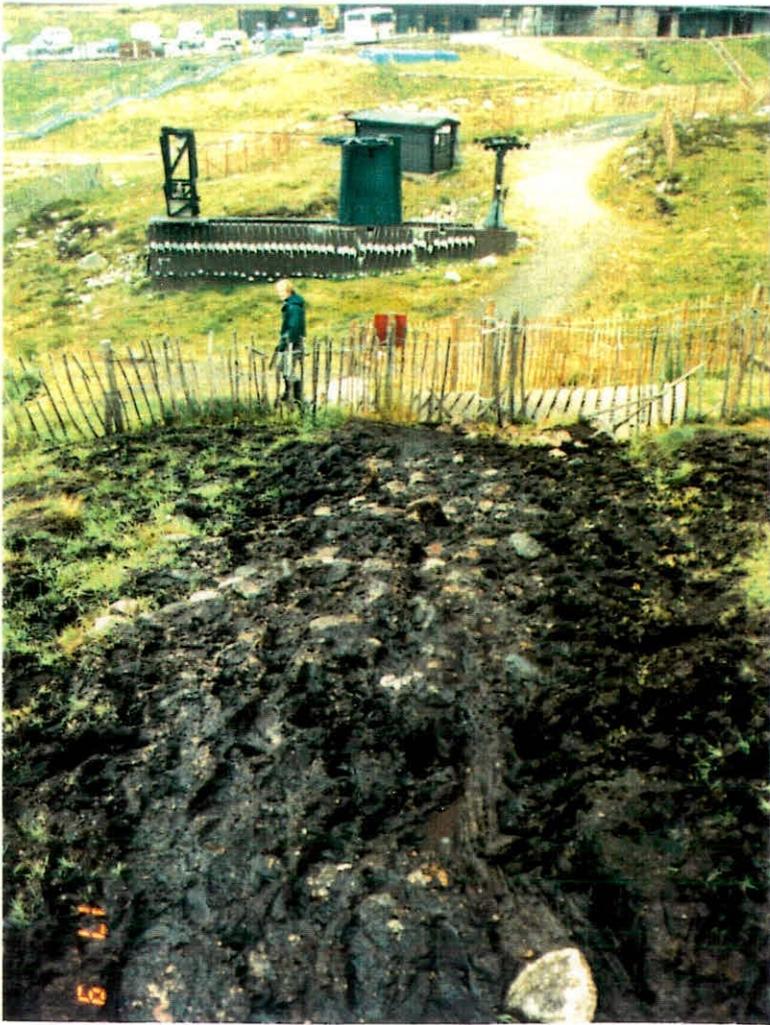
1

Wide stretch of churned-up wet peat at the start of the Northern Corries path, September 1987, prior to repairs.

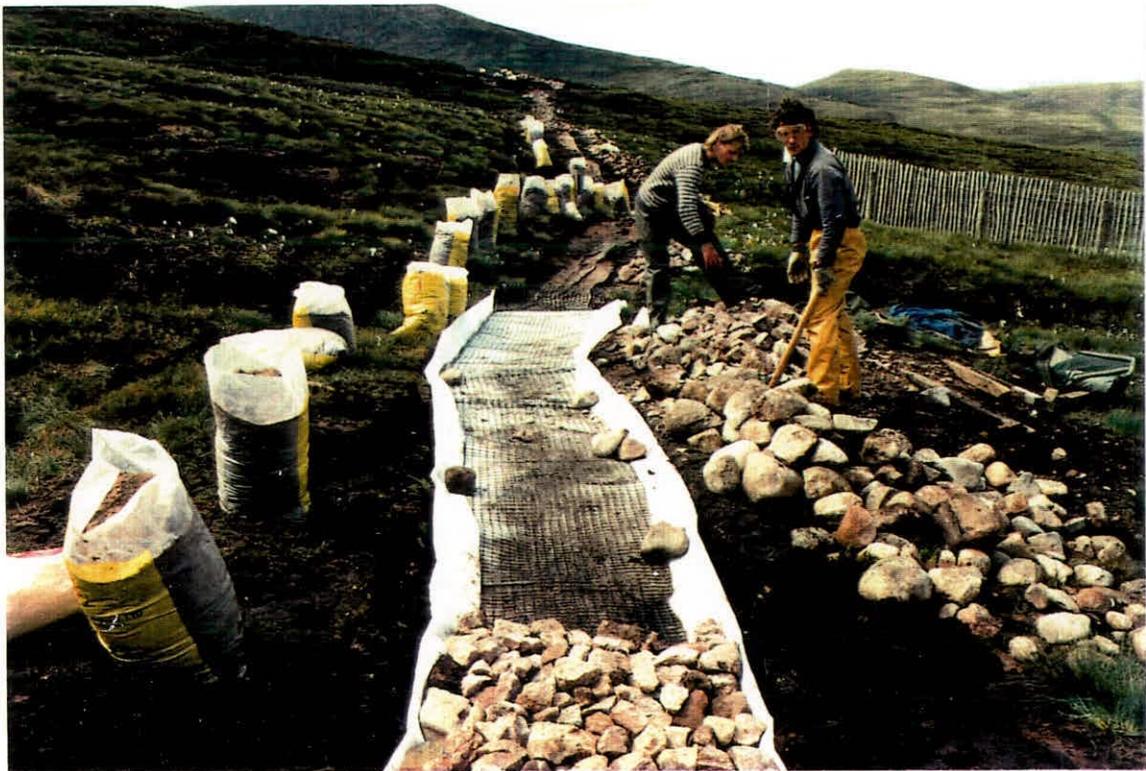
2 Same location looking in the opposite direction as 1 in July 1988. Much of the peat has been excavated and black geotextile matting is being laid by the path repair team, with broken-up local rock placed on top. Finally the surface is finished with a layer of fine well-drained gravel.

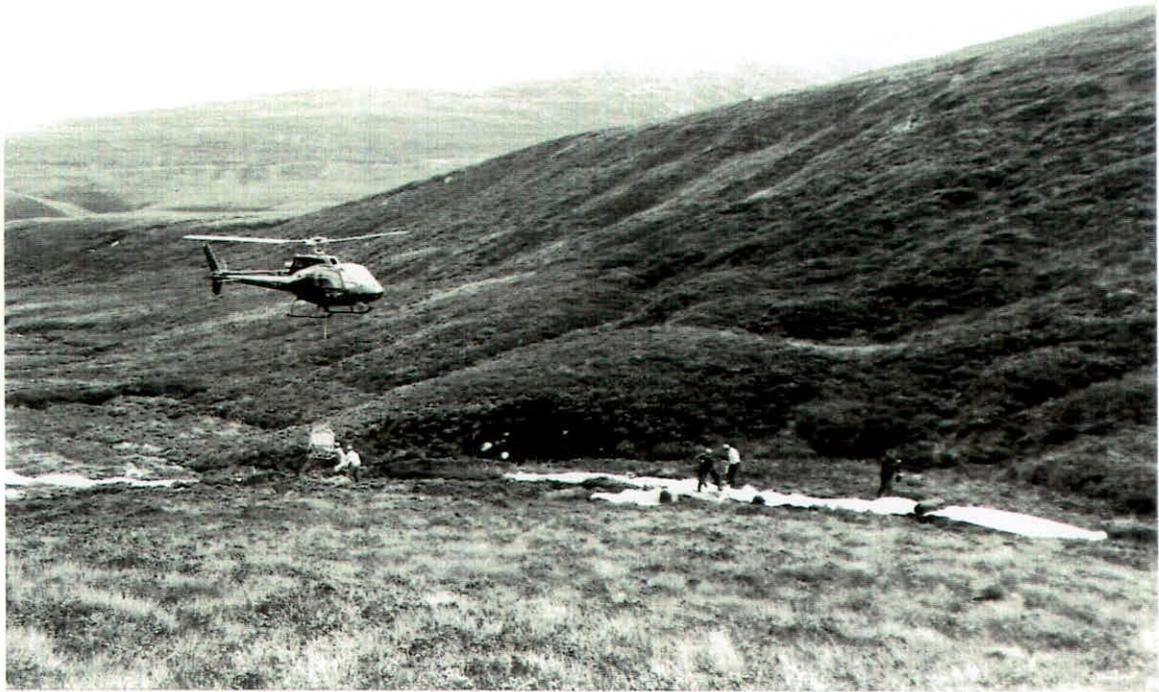
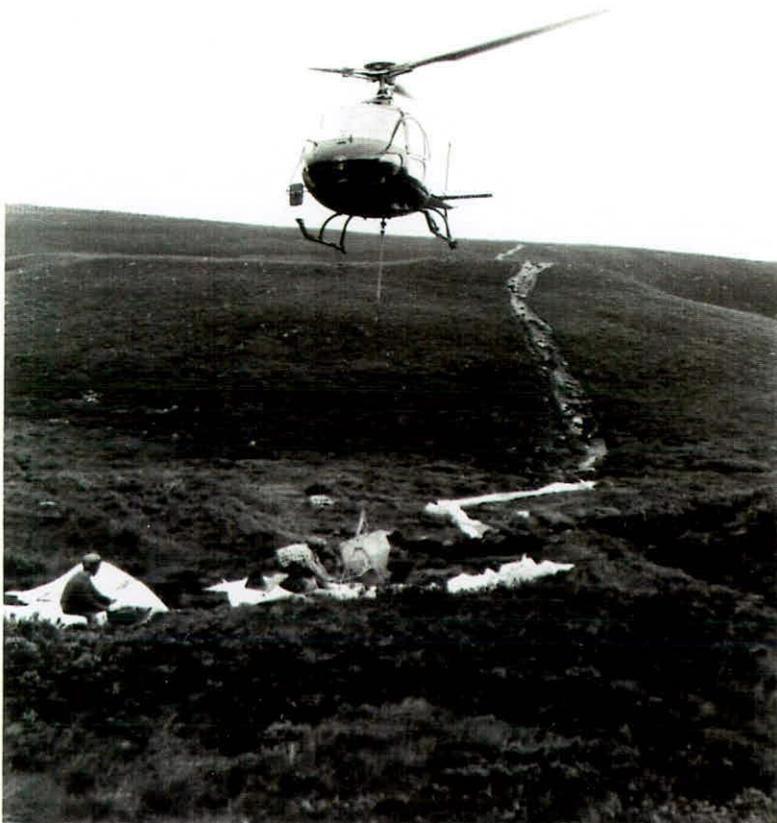
3 & 4

A helicopter is used to transport heavy material to remote sites, as here on the path to Chalamain Gap, west of Caochan Dubh a' Chadha in August 1989. Each skip carries 750kg of material. The road to Coire Cas can be seen going up the far hillside above the helicopter in Photo 3.

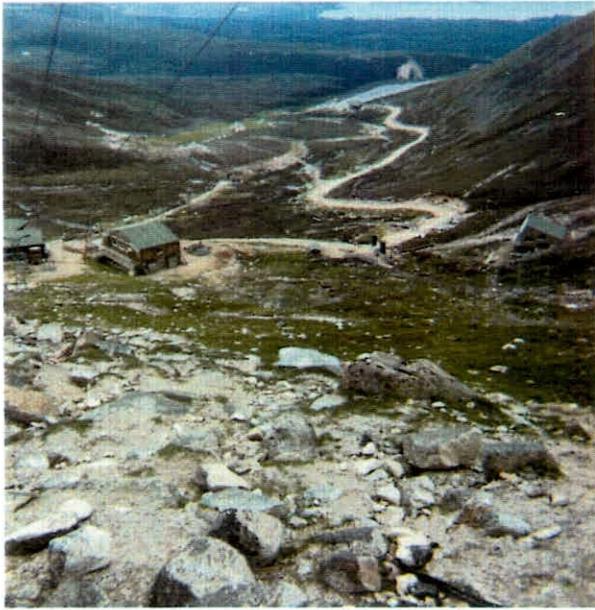
5

Looking downhill from lower section of White Lady piste, mid 1975.

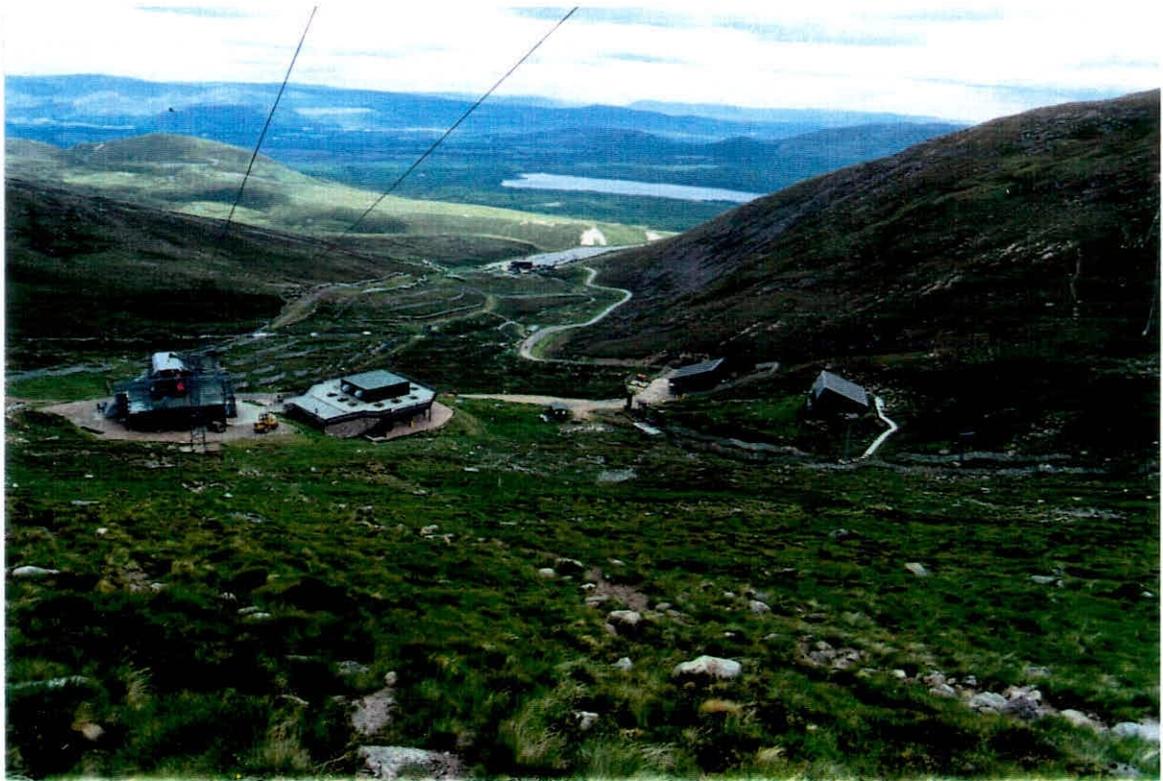
- 6 Taken slightly above 5, July 1993, shows (a) marked revegetation in foreground, (b) disappearance of a pale track (horizontal line beyond the stony ground in the 1975 photo), (c) revegetation around building second from left and (d) around the Scottish Ski Club hut on far right, including disappearance of track above right building, (e) revegetation of tow track and other tracks from top of building second from left down to the lower part of the sinuous road to the car park and (f) of bared area above building second from left. Note that the largest landslip on the Allt Mor (top right, behind car park) shows no obvious change.

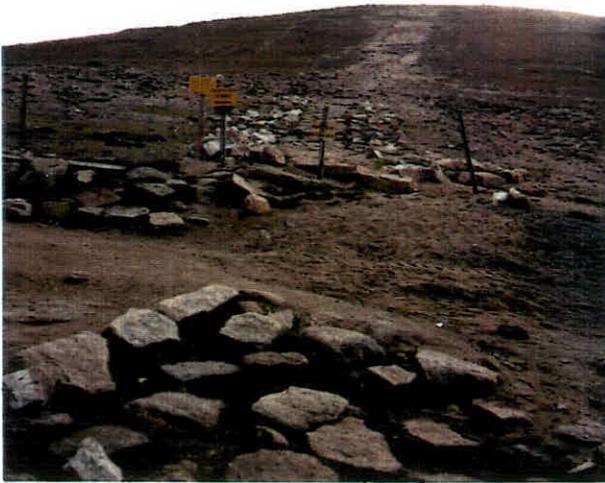
7

Shows direct path from Ptarmigan restaurant to Cairn Gorm summit, mid 1975.

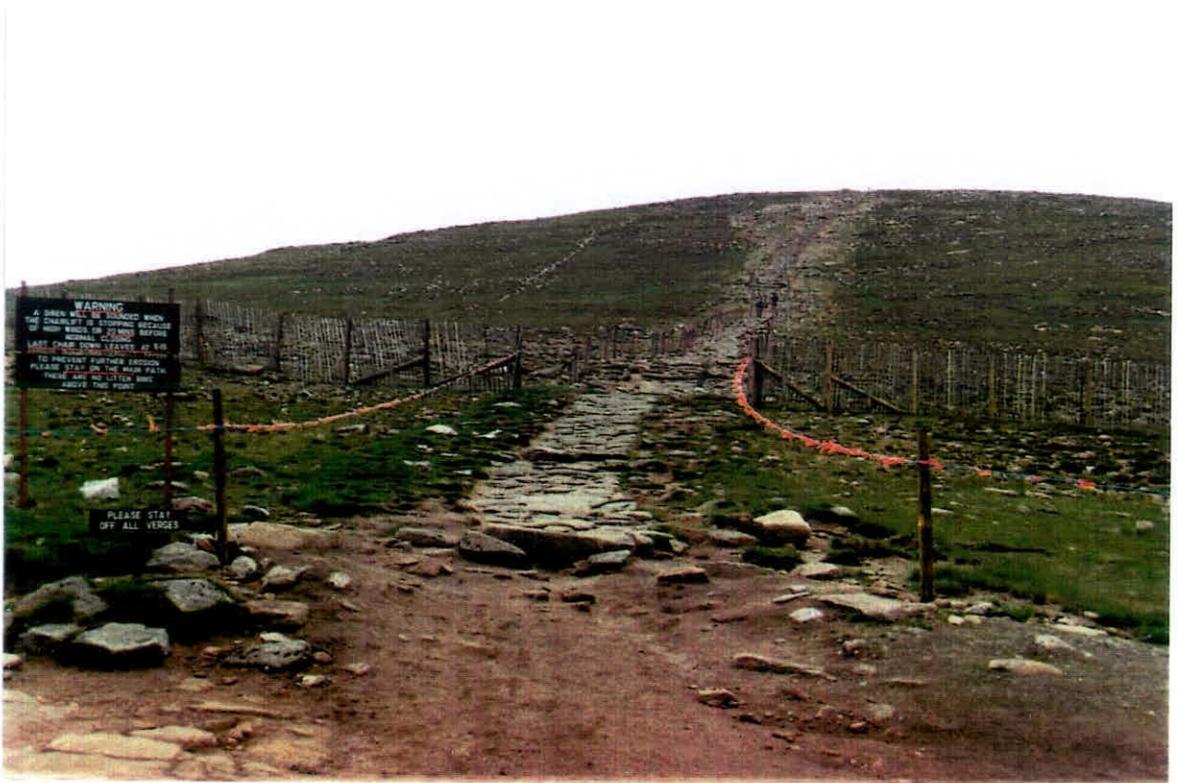
8 Shows same view June 1993. Note the narrowing of the bared ground by the path, and better vegetation cover, especially on the lower slope. 1975 photo shows white quartzite boulders on either side of bottom end of path and thin reseeding there and on either side. 1993 photo shows good cover of vegetation in same place (some of quartzite boulders have been removed to allow skiers to pass in winter).

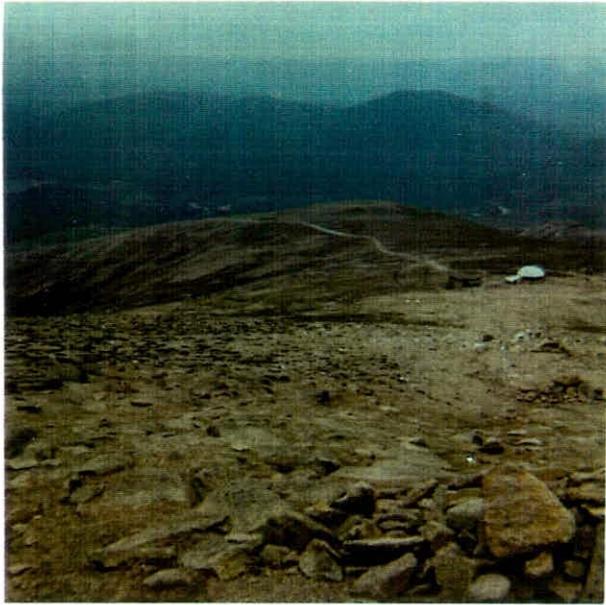
9

Looking down direct path to Ptarmigan restaurant, mid 1975.

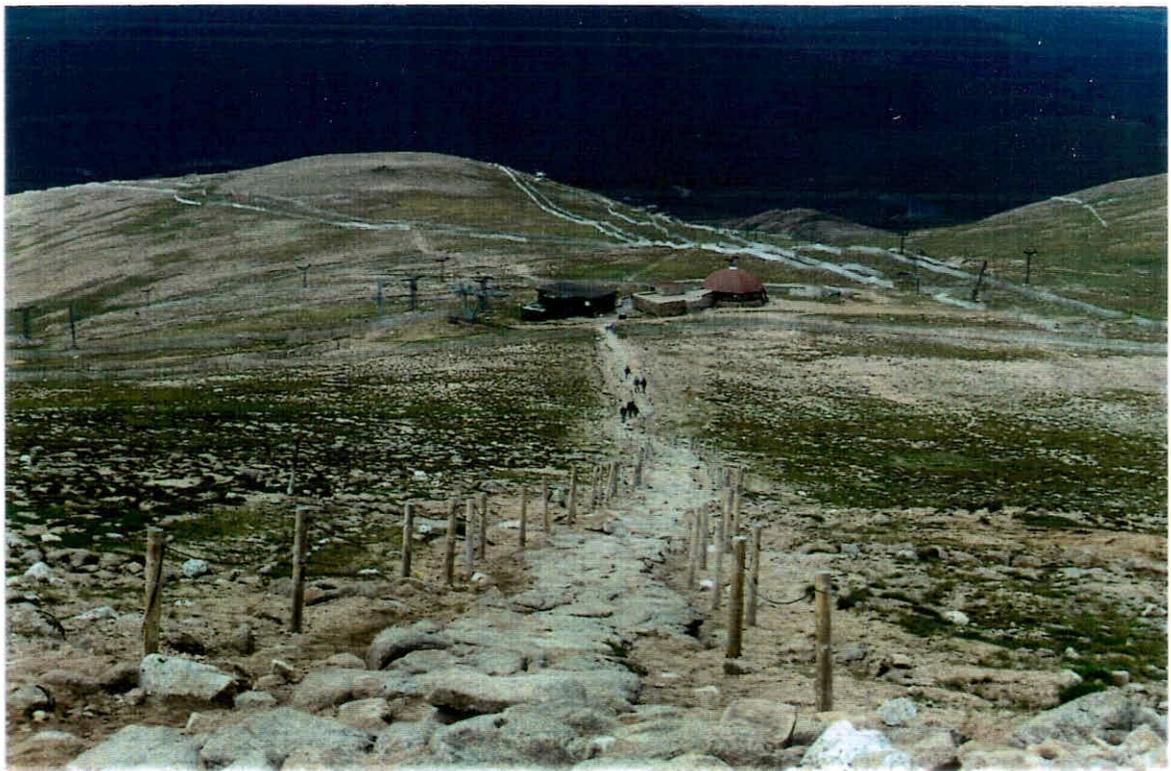
- 10 Same view, July 1993, illustrating major vegetation recovery mainly due to channelling walkers and to a lesser extent reseeded. Biggest recovery is seen under the two buildings on the 1975 photo. Old path to Cairn Gorm (left of chairlift top station) is far less obvious in 1993 photo, due to less usage by people. Very pale strips beside old path are snow fencing, not there in 1975.

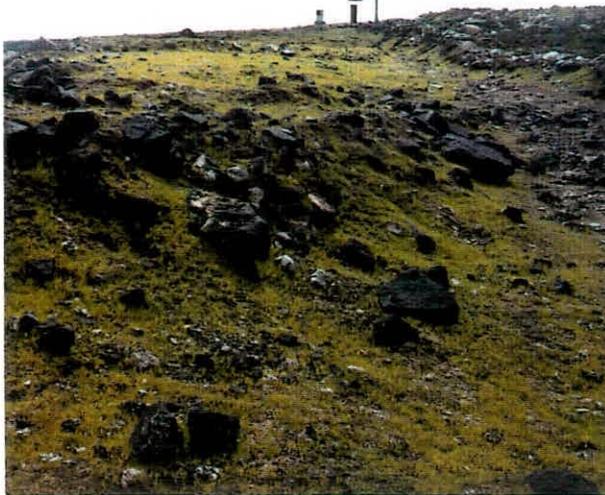
11

Reseeded area east of and about 200m below top of Fiacail tow, July 1975. A typical bulldozed area one year after it had been reseeded, showing thin grass cover and much bare grit.

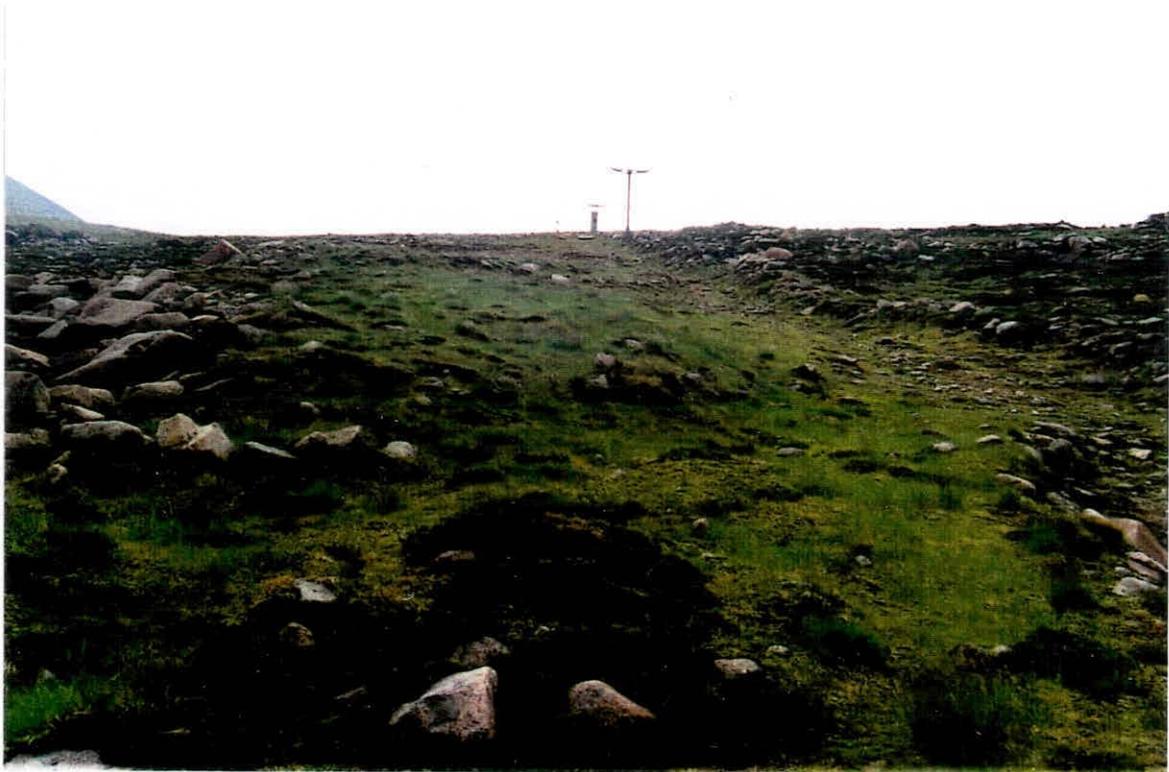
12 Same location, July 1993, with complete revegetation and much invasion by mosses and hill grasses despite this area being subject to heavy pressure each year as it is on a main piste. The boulders in the 1975 photo are black due to bitumen emulsion which has disappeared in the 1993 photo. On the original print more bare ground is evident below the skylining pylon in the 1993 photo due to use as a path.
