**British
Geological Survey**

Slope Monitoring at the Glan Ebbw Landslide, Blaina, South Wales: January to April 2016

Internal Report IR/16/015

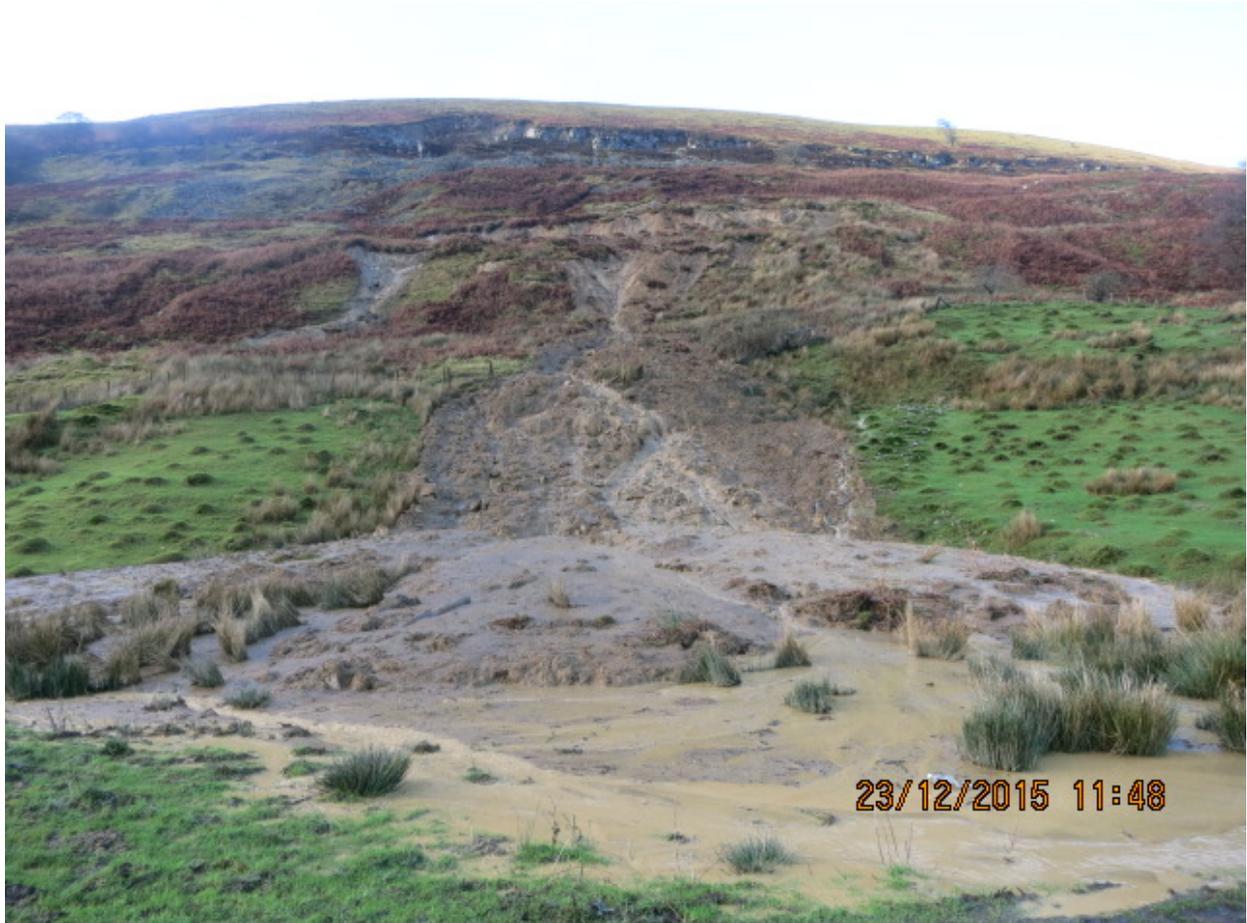
Figure 1 Photograph of landslide-affected slope taken on 23 December 2015, shortly after the initial movement took place. Note the accumulation of saturated landslide debris forming debris cones (wet clayey sand) over the flat area, which is the toe of an ancient landslide. Note how the alluvial fan is prograding out to the east, blocking the field drains and diverting sediment-laden water across the path and towards the houses below. (Photo Courtesy of BGCBC).

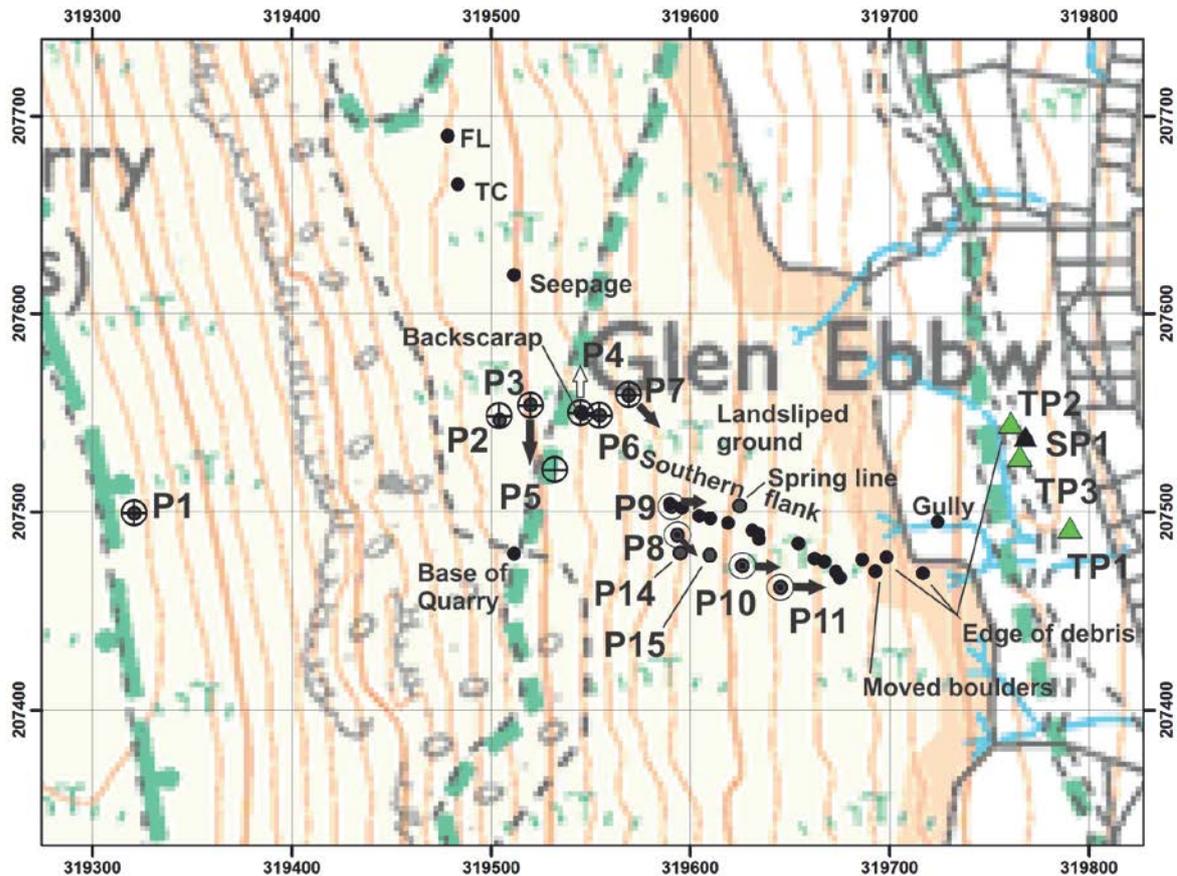
Figure 6 Map showing location of points re-surveyed on 4 Mar 16 (Survey 2). Two old steel pins were discovered and surveyed in, named P14 and P15. Arrows indicate relative movement direction based on difference between Survey 1 (28 Jan 16) and Survey 2 data. *Contains Ordnance Survey data © Crown Copyright 2016.*

Pin 1 – The dGPS survey data suggests this pin moved vertically upwards by 630 mm in the time period. The upwards direction and large magnitude of movement is not reasonable given the geological context and a lack of any very recent ground deformation features in the hill top area. The pin was installed in ground considered by the authors to be relatively stable. The discrepancy between Pin 1 Survey 1 location and Survey 2 data was later considered to be an error, caused by a problem with the RINEX data in the processing stage. This pin was

Pin 3 – new pin, moved south by 150 mm in the period.

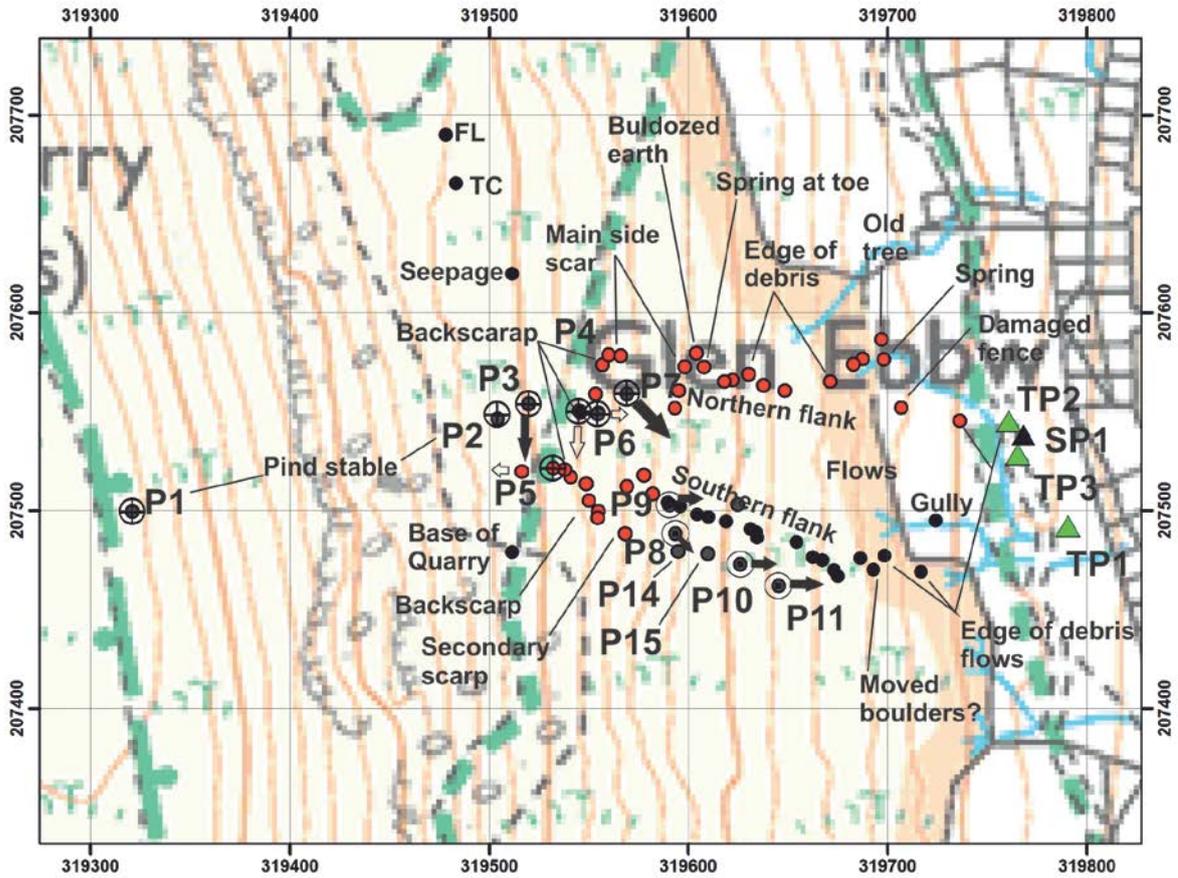
In summary, between 28 January and 4 April 2016, there was clear down-slope movement in the order of 10s to 100s of mm in five of the seven BGS ground pins. There was also clear ground movement in three of the four old steel pins resurveyed. The main backscarp was 9 m high at its highest point in the south.

Figure 7 Map showing location of points resurveyed on 8 Apr 16 (Survey 3) and main field observations. Arrows indicate relative movement direction based on comparison with Survey 1 and 2 data. *Contains Ordnance Survey data © Crown Copyright 2016.*

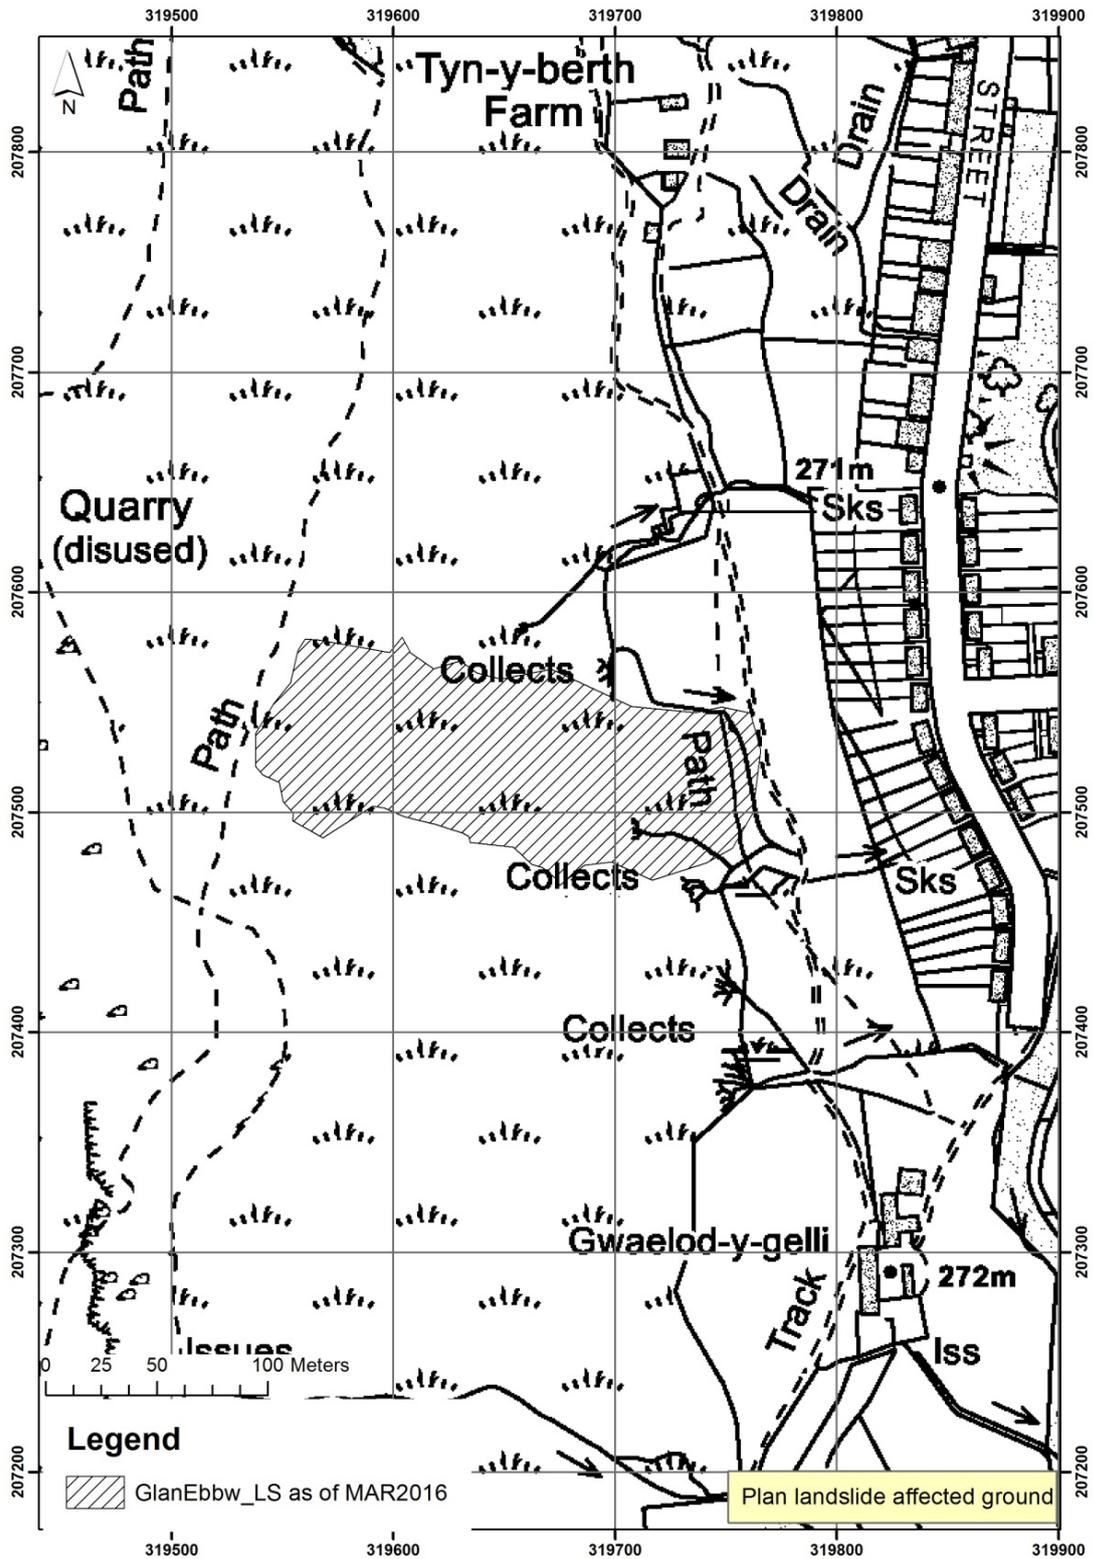
Figure 9 Plan showing area of recent ground movement (hatched), which covers 1.6 ha. The base map is the modern 1:25 000 OS B&W Topographic. Contains Ordnance Survey data © Crown Copyright 2016.

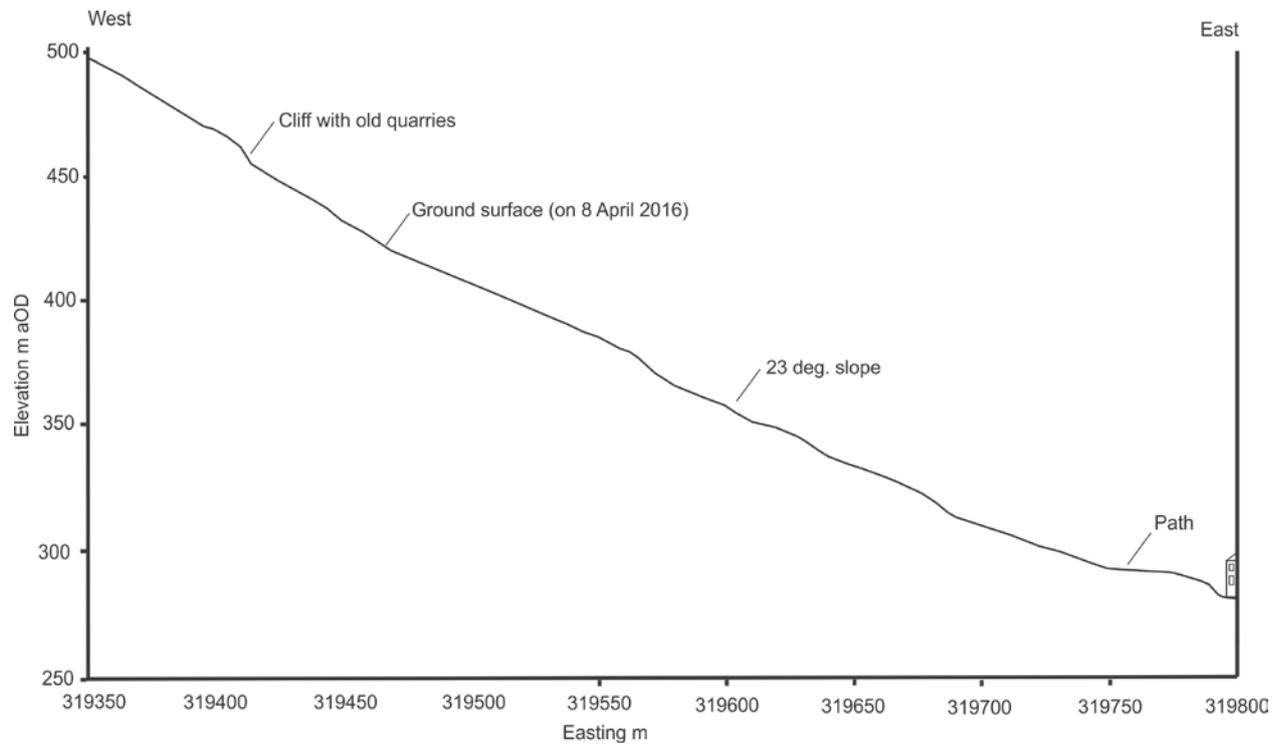
Figure 14 Slope profile orientated roughly through the centreline of the landslide, extracted from 28 January 2016 TLS data (see Figure 11 and Figure 13). Average slope angle of the failed slope (from crown to toe) is 23.2 degrees to the horizontal.

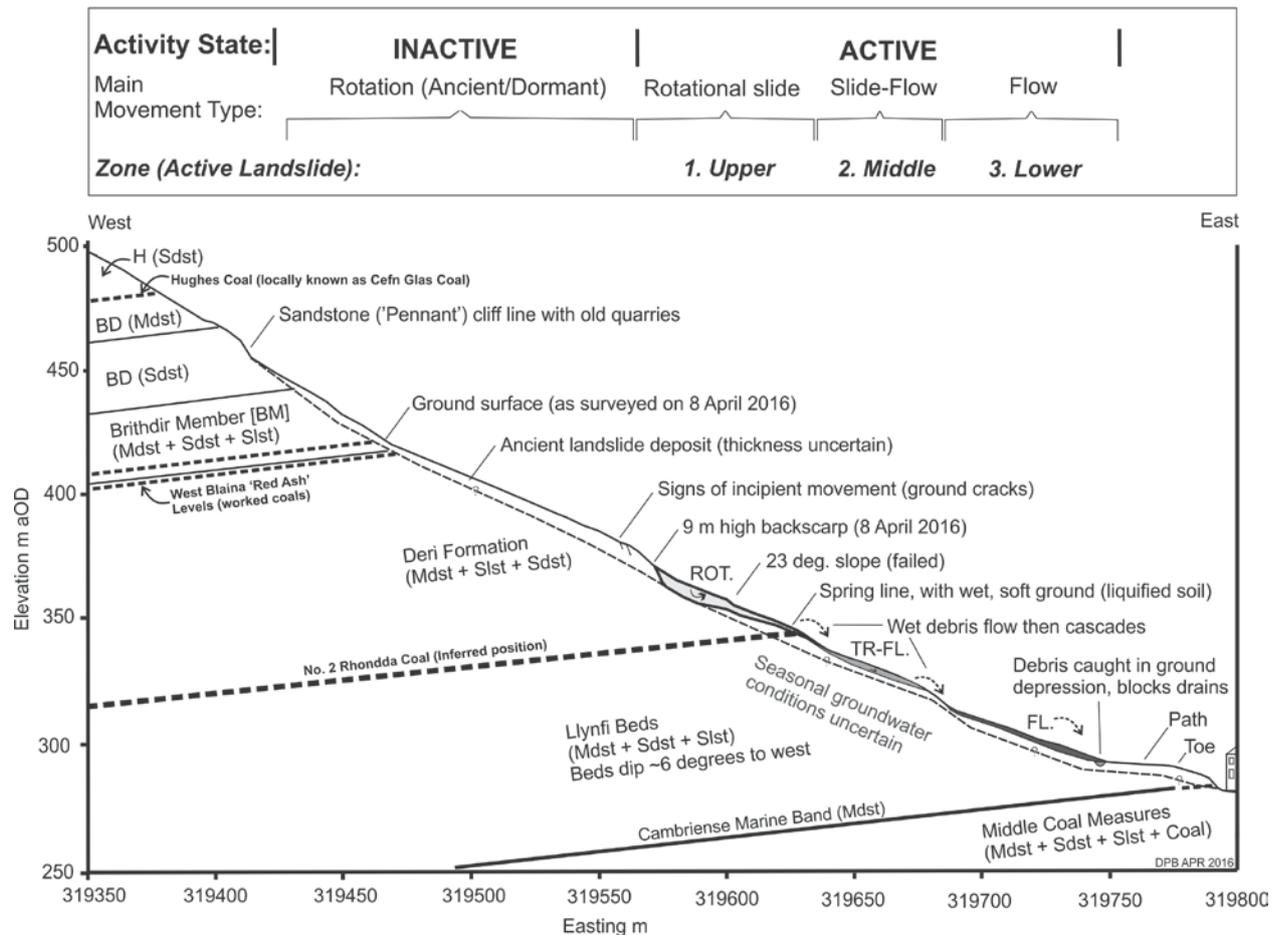
Figure 15 shows a cross section through the slope illustrating the likely failure mechanism and relationship with the main geological units. The observational data that has been collected underpins an initial interpretation of the failure mechanisms. It is a complex landslide that can be divided into three main zones: **1. Upper slope:** contains a rotational landslide (ROT. in Fig. 14) within relict landslide and head deposits and possibly affecting weathered bedrock (Deri Member) below. This is likely sliding on a deep-seated (>5 m) basal slip surface coincident with the Rhondda No 2 coal seam or weathered clay-rich seatearths; **2. Middle slope:** the liberated mass cascades down over a positive break of slope (bedrock feature) forming a cluster of interacting deep-seated translational slides (TR) which if saturated become flow slides (FL). These form the main body of the landslide. **3. Lower slope:** water flowing from springs and coal seams combined with effective rainfall saturates the debris, increasing pore pressure and weight of material, which then fluidises (causing undrained loading) and cascades out over a second break of slope, focused via surface water-scoured gullies. This process generates shallow (<5 m) debris/earth flows that accumulate in debris cones on the flat ground on the lower slope.

Figure 15 Conceptual Engineering Geological Model (2D) for the slope at Glan Ebbw. Ground surface extracted from TLS data. Geology based on 1:10 000 scale geological map data. H = Hughes Member of the Pennant Sandstone Formation, BD = Brithdir Member.

Below the lower slope the saturated debris/earth flow deposits (FL) are currently being trapped, and movement suspended, in a slight ground depression, which is part of the toe of an ancient landslide mass. As this basin (sediment trap) continues to fill with sediment its storage capacity decreases and without clearance the drainage ditches in this flat area are becoming blocked and ineffective. This excess surface water has resulted in a natural diversion of the drainage across the path (labelled in Figure 15). During intense rainfall events sediment-loaded water flows down the crest of the ancient landslide toe and either into the drain at the back of the gardens which catches the water and feeds it into Ebbw Fach River, or into the gardens of houses on Glan Ebbw Terrace. The control of this excess water is probably the most immediate threat posed to the properties and residents. Without regular inspection and maintenance the culvert at the back of the gardens will eventually become blocked with sediment and debris; it will become less effective, leaving the houses more exposed to the surface water flooding hazard, particularly during and immediately after intense rainfall events, and after rapid snow melt.

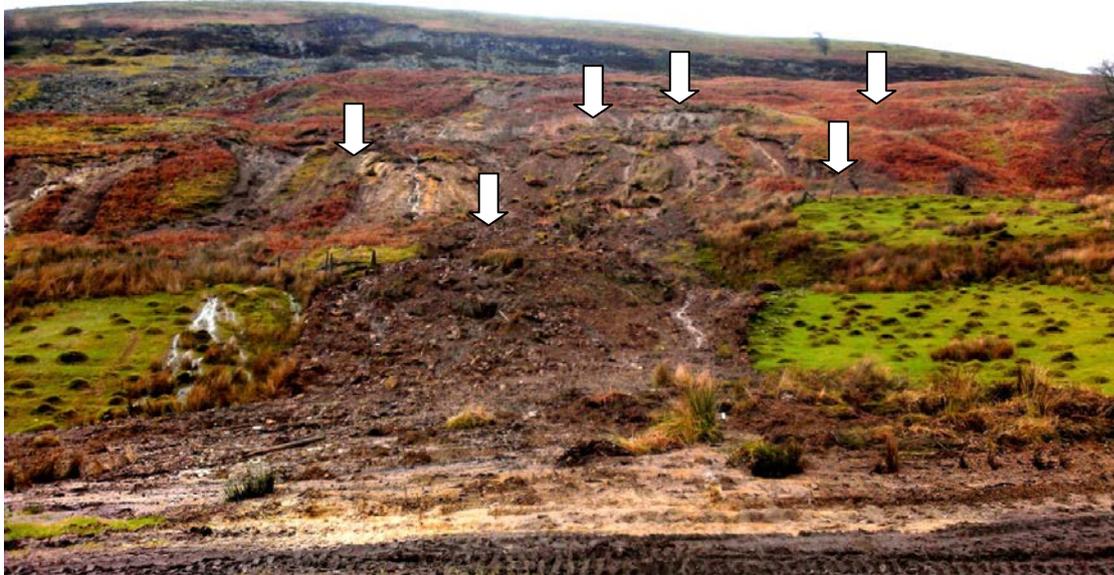
Figure 16 Photo of landslide-affected slope on 28 January 2016. Photo colour and contrast has been enhanced for clarity. Arrows show areas of noticeable change since December 23 2015.

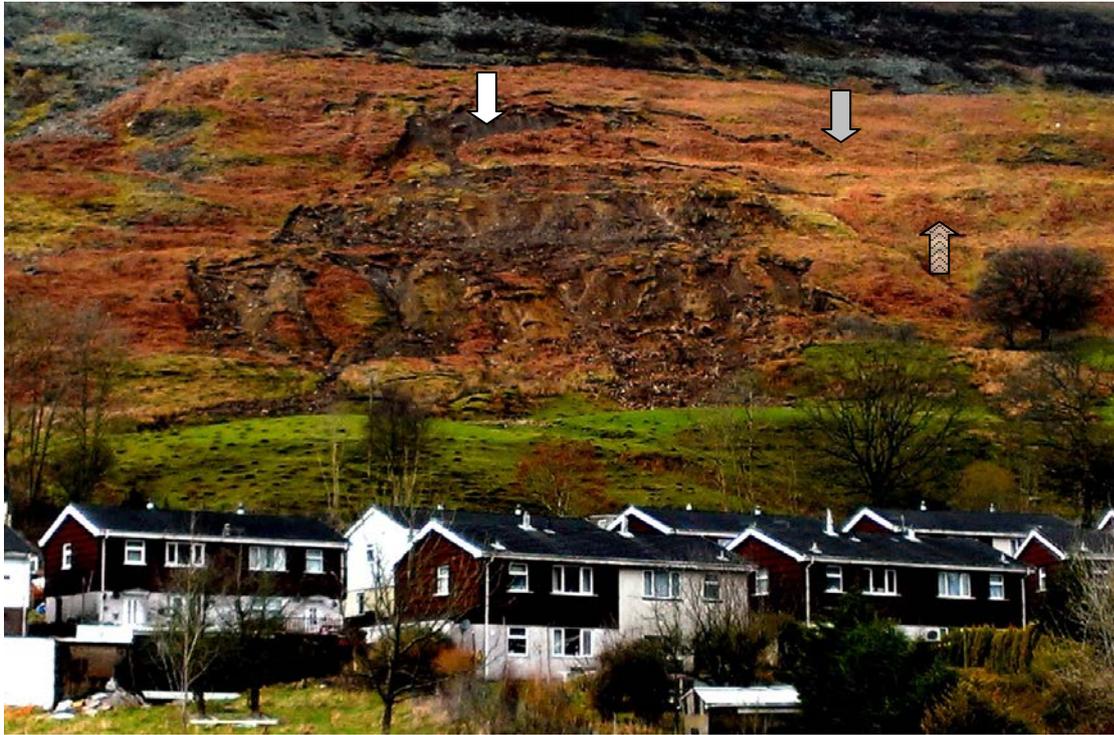
Figure 17 Photo of landslide-affected slope at Glan Ebbw taken 4 March 2016. Photo colour and contrast has been enhanced for clarity. Note the now well-developed main back scarp on the southern side of the crown (white arrow), crown cracks on the northern side (grey arrow, right side), and compression and bulging of topsoil at the toe of the upper-slope rotation (zig zag arrow, middle right). This feature is arguably present, though less well developed, in the earlier 23 December 2015 photo (Figure 1) indicating retrogressive movement. The upper row of houses is located along Glan Ebbw Terrace.

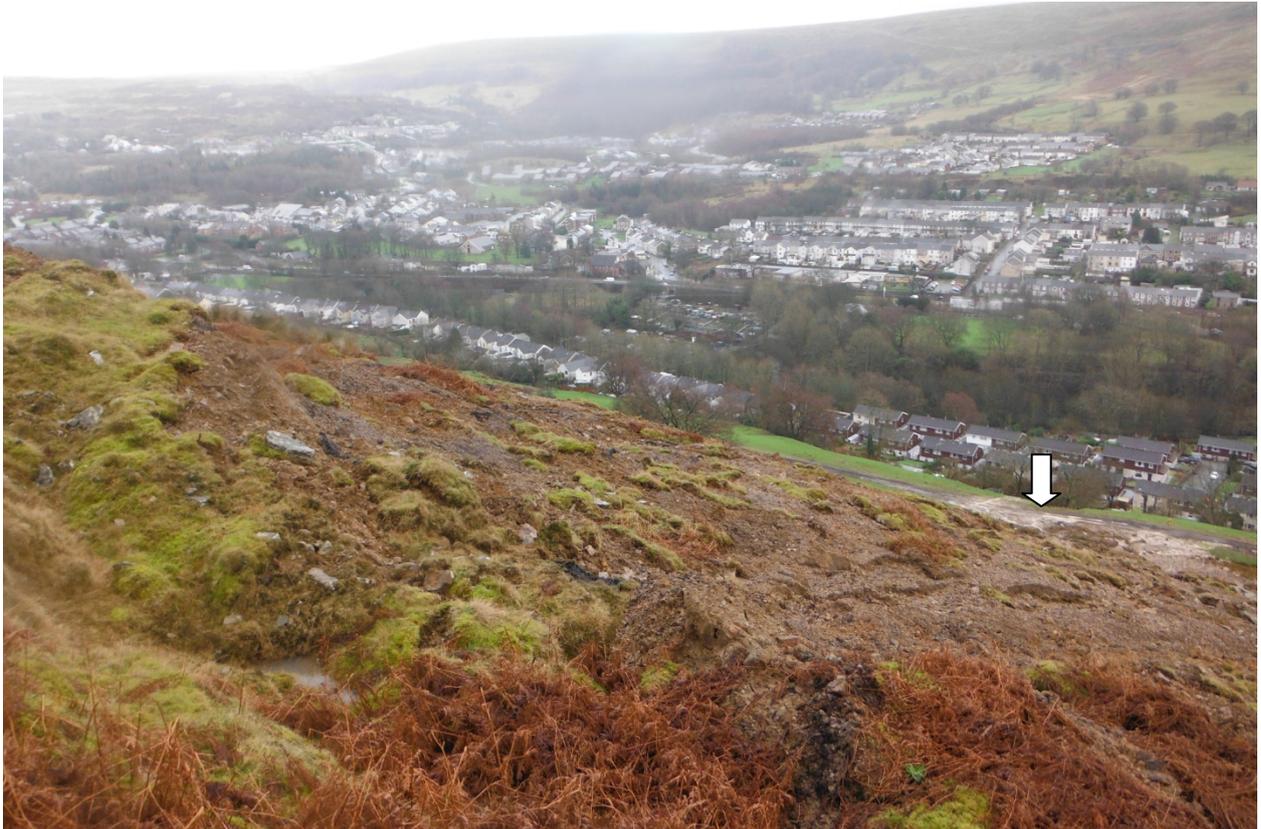
The landslide movement observed between December 2015 and April 2016 was mainly retrogressive and stemmed from the upper slope, with the main backscarp migrating upslope and extending laterally to the north. The rotated block in the upper slope dropped most on the southern side, exposing more of the bedrock on the main backscarp. As well as supplying debris for earth flows, delivery of new material and water to the mid-slope area, as illustrated in Figure

18, will have the effect of adding additional loading forces to the middle and lower parts of the slope. This increase in normal stress will take the slope further along the path to failure, and into a progressive phase of development, which in time could potentially destabilise the toe of the ancient landslide mass. This scenario could cause significant deep-seated ground movement within the vicinity of the properties on Glan Ebbw Terrace, assuming the ancient landslide mass became remobilised.

Figure 18 Photo taken on 28 January 2016 after recent rainfall. Erosion on middle slope has been stripped-off the vegetation, exposing loose bare soil. During and just after heavy rainfall, loose soil debris is translated down-slope accelerating as it spills over a steep bench, and feeding earth flows that are forming debris fans on flat ground. Sediment-laden surface water was observed to flow across the flat path area, marked by the white arrow, and flows down towards the rear gardens of some of the houses on Glan Ebbw Terrace.

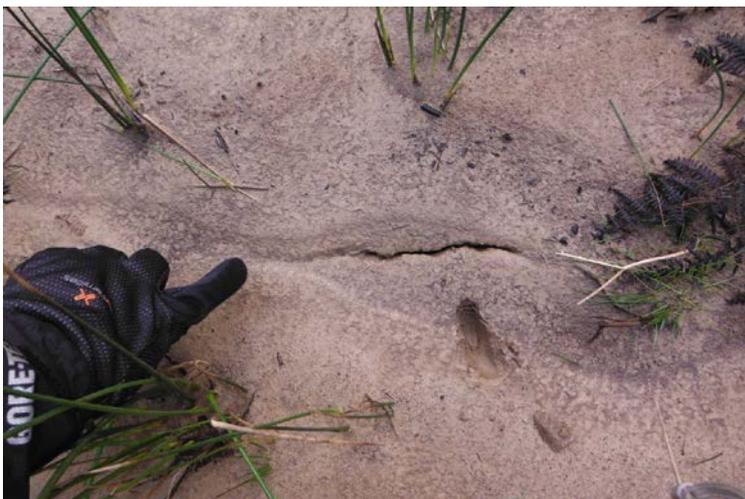
Figure 19 Small open fissure on un-slipped ground approximately 10 m from the southern flank of the landslide. The open fissure has exhumed fine-grained sand which has buried the ground cover vegetation. This feature, a mini sand volcano, provides evidence of fluidisation of sediment under conditions of excess pore water pressure in the slope, evidence that high pore pressures develop in the slope recently.
