Report of a visit to Gainsborough (earthquake damage)

Open Report OR/08/22

P. Hobbs, D. Boon & P. Witney

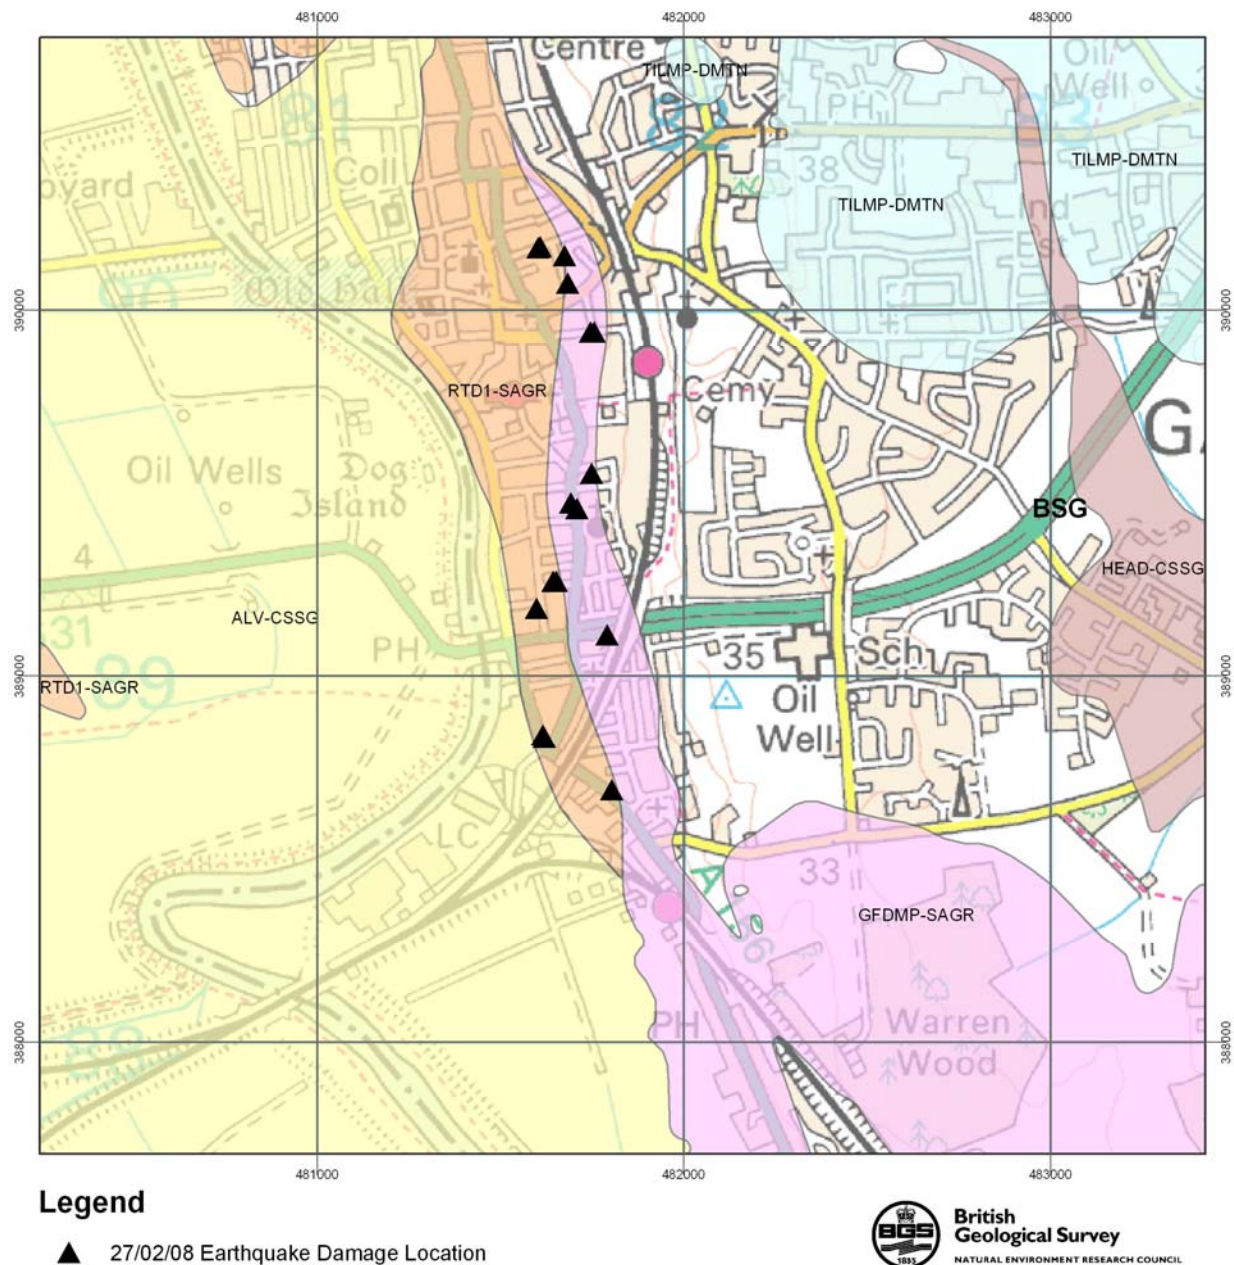
The solid geology beneath the area of observed damage consists entirely of Mercia Mudstone Group rocks. The Mercia Mudstone in the area is predominantly a 'low' to 'medium' plasticity, 'weak' mudstone with thin bands of fine 'weak' sandstone or siltstone. Gypsum is present in the form of bands and nodules (Smith et al., 1973). The superficial geology is shown in Figure 5. Superficial deposits cover the whole area of observed damage. It consists of Recent River Terrace deposits and Middle-Pleistocene glaciofluvial deposits. The terrace deposits consist of sand and gravels as do the glaciofluvial deposits. The alluvium to the west of the River Trent is described as containing a layer of running sand and thin bands of peat (Smith et al., 1973).

Figure 5 Map showing superficial geology, and recorded damage locations.

- The damage observed in Gainsborough was confined to terraced 2 and 3 storey houses.
- The damage observed in Gainsborough was confined to areas underlain by mapped superficial deposits of Trent 1st river terrace and glaciofluvial origin.

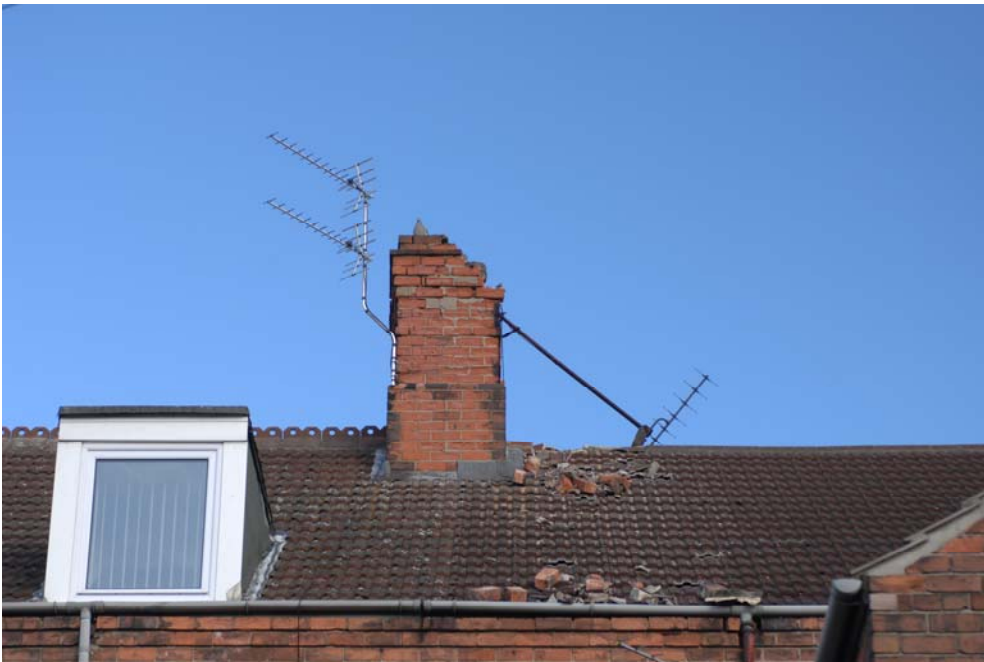
Examples of typical damage seen in Gainsborough are shown in Figure 6 to Figure 9. All observed damage, with one exception, appeared to have occurred on Victorian terraced properties; the exception being a 1922 terraced property. The examples of damage to chimneys are typical and were repeated many times over within the area shown. There were several examples of tiles missing and damaged and a couple of broken out-house roofs. These appeared to have been caused by impact from falling chimneys and subsequent making-safe operations. Examples of wall collapse and fresh cracking of outside building walls were not observed, nor was damage to gable ends and roof ridges. Many chimneystacks showed evidence of disturbance by failure of mortared joints resulting in splaying of the stack; individual bricks having dislodged but the whole remaining in place. In some cases individual chimney pots had rotated and tilted or had fallen leaving the stack largely intact.

481750	389554	8 /10	Coalville Terrace	4	Partial chimney collapse, brick and lime mortar pot debris road
481757	389940	29	Spring Gardens	4	Chimney pots bounced down roof onto pavement
481746	389940	25	Spring Gardens	4	Possible rotated chimneystack
481676	390149	22 /24	Tennyson St	4	Partial chimney collapse
481610	390173	38	Tower Street	4	Partial chimney collapse
481603	390170	34	Tower Street	4	Partial chimney collapse at rear
481685	390074	7	Tennyson Street	4	'The Limes '1888'AD' Partial chimney collapse. Debris at front and rear
481804	388690	147	Lea Road	4	Partial chimney collapse. West side of chimney affected. Red brick, poor/old mortar

Figure 6 Chimney damage, Tennyson Street [BGS4353] (27/02/08)

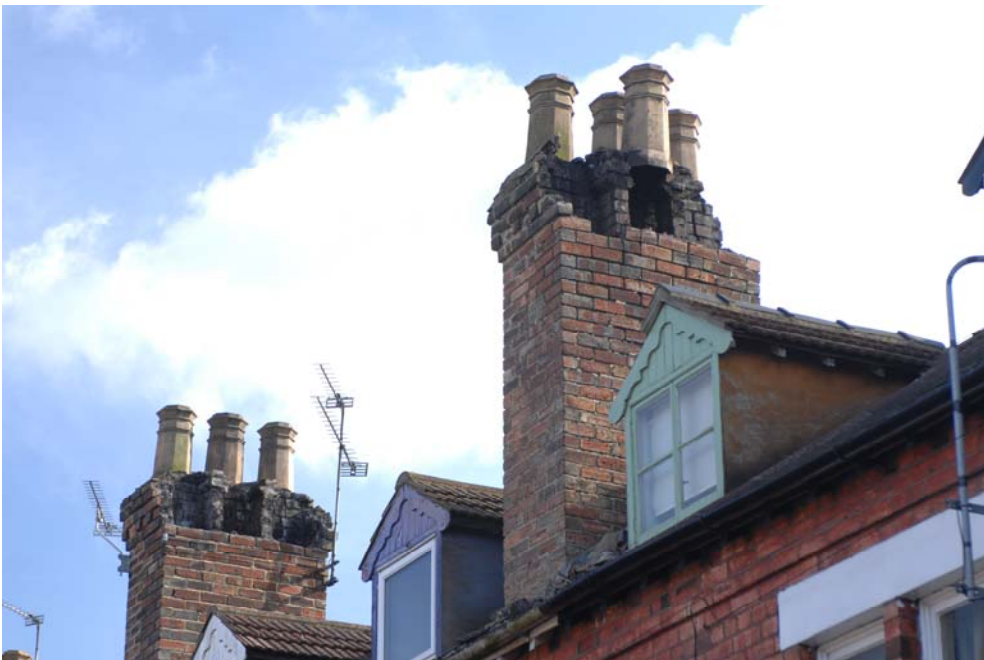
BNG E	BNG N	Number	Street Name	Damage Category*	Damage Details/ Comments
481710	389458	31	Trinity Street	4	Chimney pot, tile, roof. House built c.1900, in poor condition, poorly maintained
		?	Clinton terrace	4	Chimney pot tilt?
481653	389259	12	Portland terrace	4	Brick went through roof at rear. Terraced redbrick house. c.1920s
481645	389258	16	Portland terrace	4	Chimney destabilised, 'made safe'. House in bad state of repair
481600	389185	NA	Corner of Thornton Street	3	Plaster cracked and fallen off brickwork onto street
481620	388832	69	Lea Road, Lyceum Terrace	4	Buckling of chimneystack. Red brick. Pots intact. Stack 2.5m high
481616	388839	65	Lea Road, Lyceum Terrace	3	Chimney pot tilted, bricks moved out
481620	388832	35	Lea Road	3	Tilted chimney. Victorian mid-terrace.
481792	389113	42	Wellington Street	4	Partial chimney collapse. West side of chimney affected. Red brick, poor/old mortar
481693	389473	96a	Trinity Street	4	Chimney pot collapse

Figure 7 Chimney damage, Nos 12 (right) and 16 (left) Portland Terrace [BGS4307] (27/02/08)

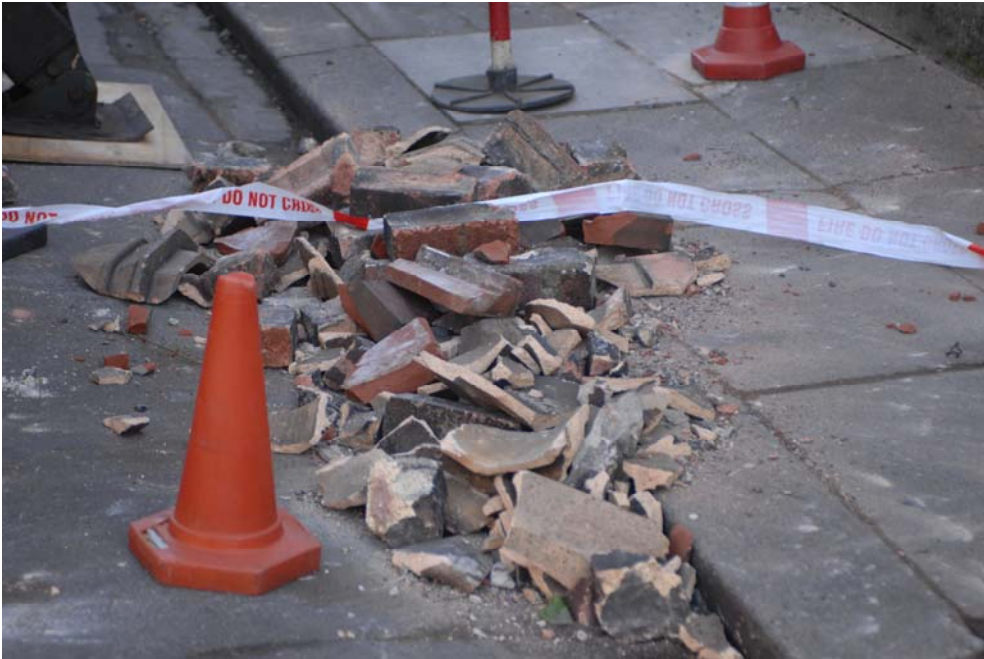
Figure 8 Masonry debris from chimney, 12 Portland Terrace [BGS4314] (27/02/08)

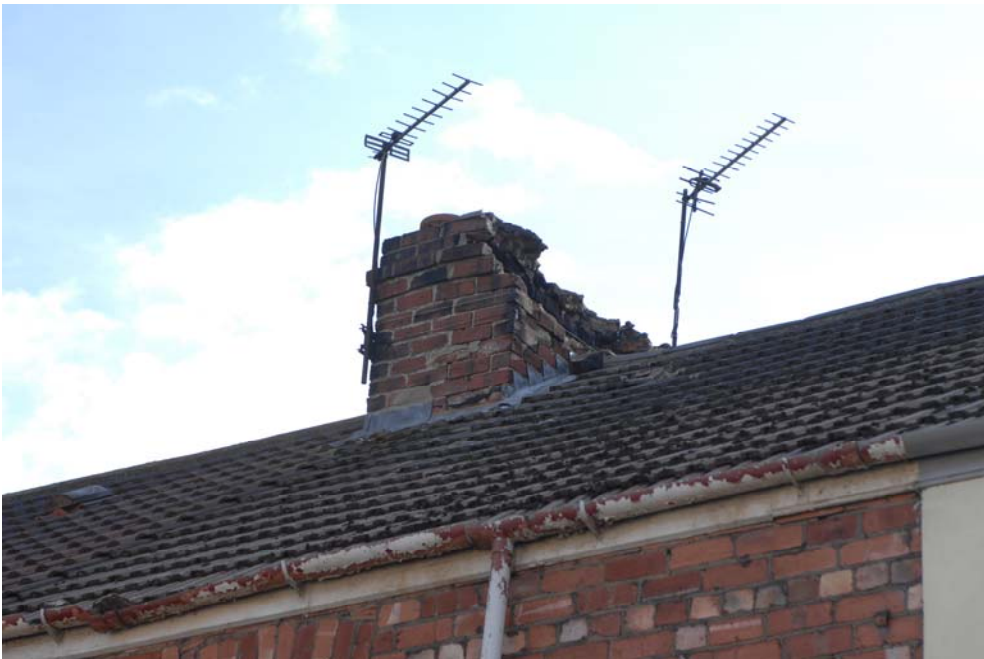
Figure 9 Chimney and gutter damage [BGS4289] (27/02/08)
