# Recent fissuring in the Magnesian Limestone at Houghton-le-Spring, City of Sunderland

Research Report RR/02/03

B Young and D J D Lawrence

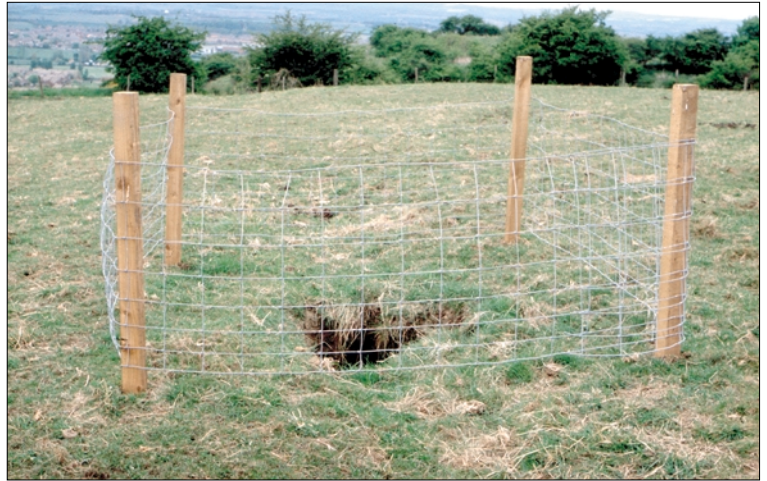
**Figure 4** Looking west towards Houghton Cut at Locality 2, Table 1. Newly opened surface fissure up to 3.3m deep. A roughly east–west aligned vertical, or steeply inclined to the north, fissure up to 0.75m wide in solid limestone was visible in the sides of the hole.

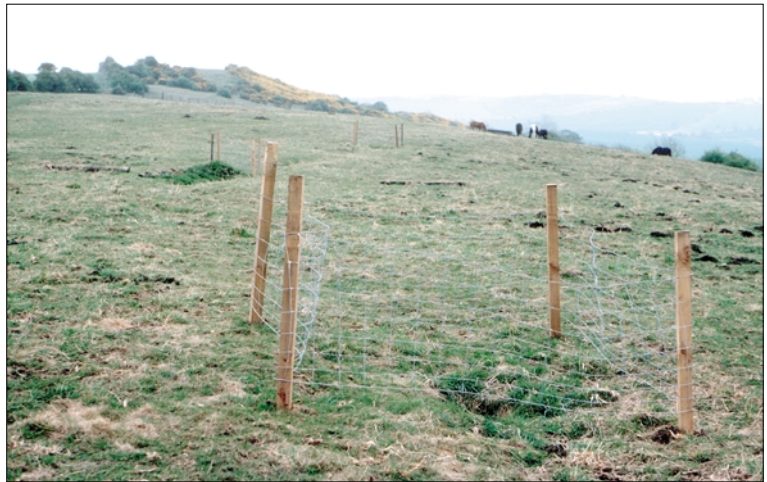
**Figure 5** Looking east from near Locality 1 in Table 1. Linear depression marking course of newly subsided fissure with fenced-off deep open fissure.

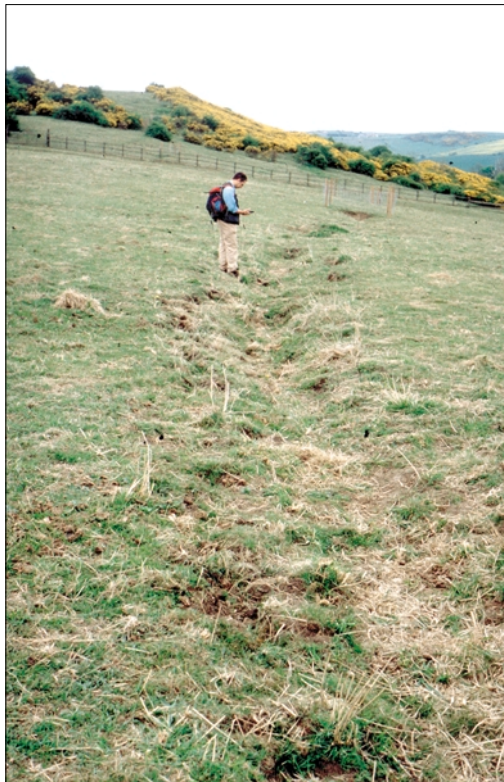
D	NZ 34628 50539–NZ 34683 50540	Long, rather sinuous linear depression up to 1.5 m wide and approximately 0.5 m deep. Abundant evidence of very recent collapse in form of fresh scars in turf and topsoil on either side of depression forming graben-like feature. Observed during June 2000 investigation as a rather indistinct line of very shallow grassy hollows.
E	NZ 34743 50560–NZ 34766 50562	Rather short linear depression up to approximately 1.0 m wide and approximately 0.5 m deep. Connects several discrete open holes. Not observed during June 2000 investigation.
F	NZ 34772 50555	Short linear depression approximately 1.0 m long, 0.5 m wide and 0.5 m deep. Not seen during June 2000 investigation.
G	NZ 34774 50545–NZ 34794 50548	Linear depression up to 2.0 m wide and approximately 0.5 m deep. Not seen during June 2000 investigation.
H	NZ 34795 50569–NZ 34872 50572	Linear depression approximately 1.0 m wide connecting several discrete open holes. Observed during June 2000 investigation as line of fissures up to 0.5 m wide and up to 1.0 m deep.

**Figure 6** Looking east along linear depression (D in Table 1).

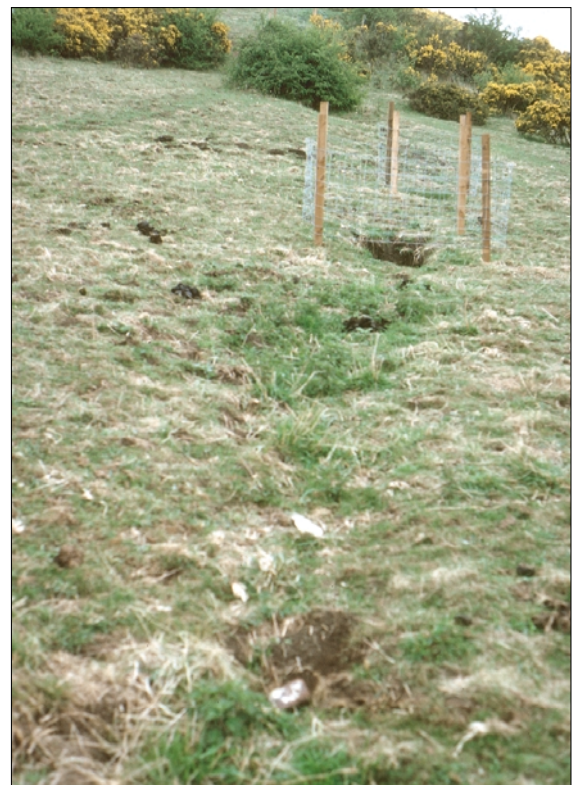
**Figure 7** Looking east along linear fissure (E in Table 1).

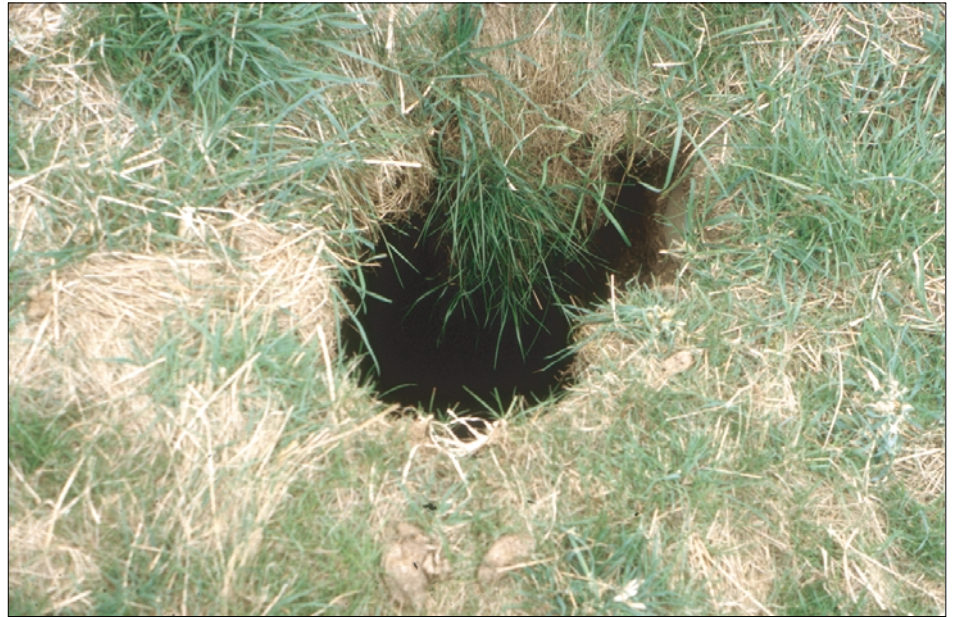
**Figure 8** Locality 2, Table 1.  
Recently collapsed recently  
opened fissure through turf.

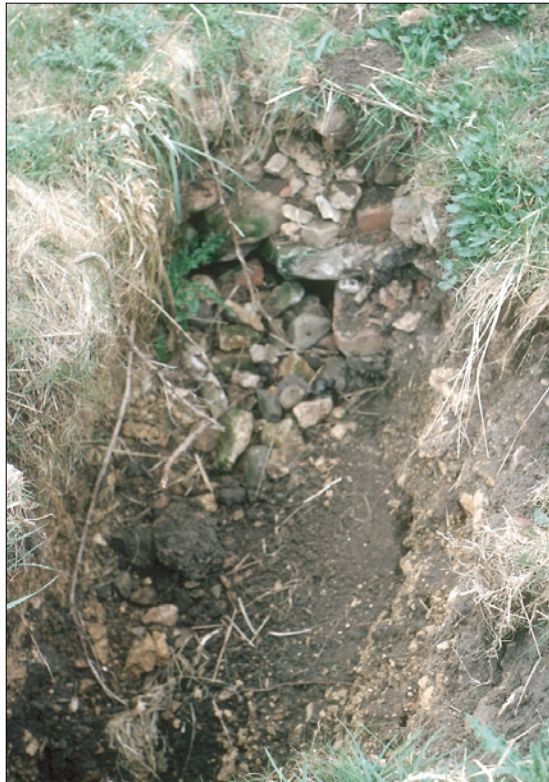
**Figure 9** Locality 8, Table 1. Looking east  
along east–west orientated fissure with limestone  
walls. Brick and limestone rubble in base of  
depression from previous fillings.

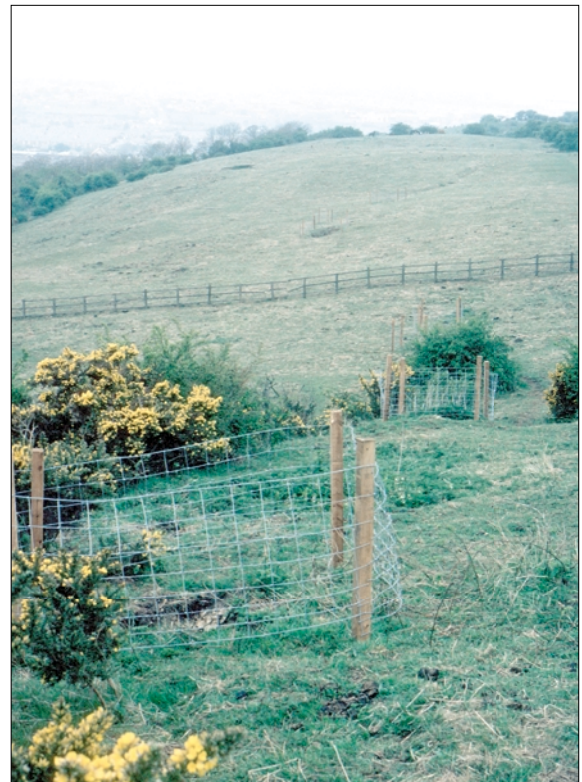
**Figure 10** Looking west towards Houghton Cut  
from hillside at western end of linear fissure  
(Locality H, Table 1). Fenced-off recently opened  
fissure in foreground. Other fissures visible in field  
beyond.

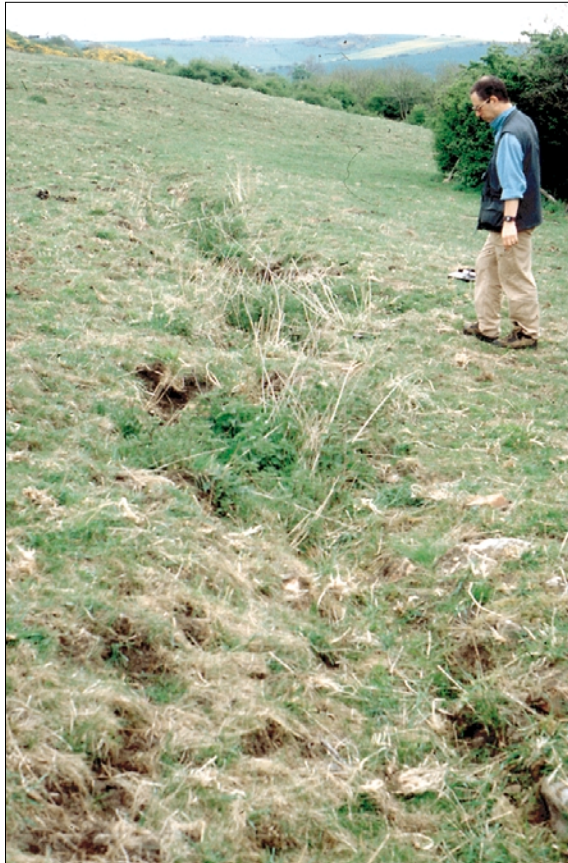
high, which exhibit a clear downthrow towards the centre of the depression (Figure 11). The depressions thus take the form of very small-scale graben structures. Their form is consistent with collapse of the surface into a dilated fracture, either a fault or major joint.

**Figure 11** Looking west along linear fissure (Locality B, Table 1). Graben-like form of fissure. Note very fresh scars in turf on either side of fissure.

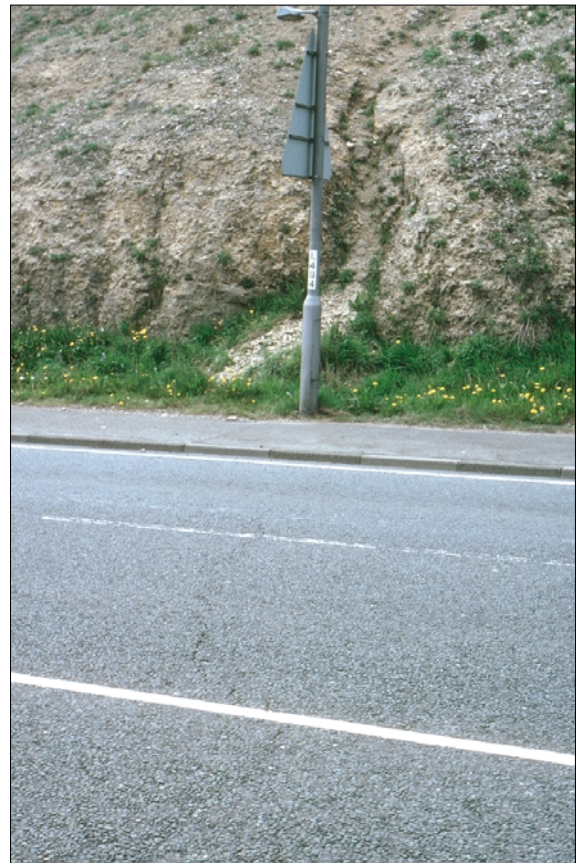
During the investigation reported here, this cracking was appreciably more conspicuous than in 2000, and had clearly extended across much of the western lane of the carriageway. No signs of cracking were found in the south-bound carriageway of the road. This cracking appears to align very closely with one of a number of distinct fissures exposed in the western wall of the cutting (Figure 12).

<b>Numbers refer to sites shown on Figure 3.</b>		
13	NZ 34364 50435	Cracking of tarmac surface of north-bound carriageway of A690 road. Observed during June 2000 investigation. Crack more conspicuous May 2001.
14	NZ 34377 50467	Site of subsidence of footpath. Active movement on adjacent fissure recorded during June 2000 investigation. Sudden collapse of hole up to 0.5 m across and approximately 0.75 m deep in May 2001; minor injuries to pedestrian.
21	NZ 34408 50467	Gap between kerb stones widened and with evidence of vertical displacement.

**Figure 12** Looking west across A690 road at Locality 13, Table 2. Cracking in tarmac surface and fissure in limestone cliff behind lamp-post.

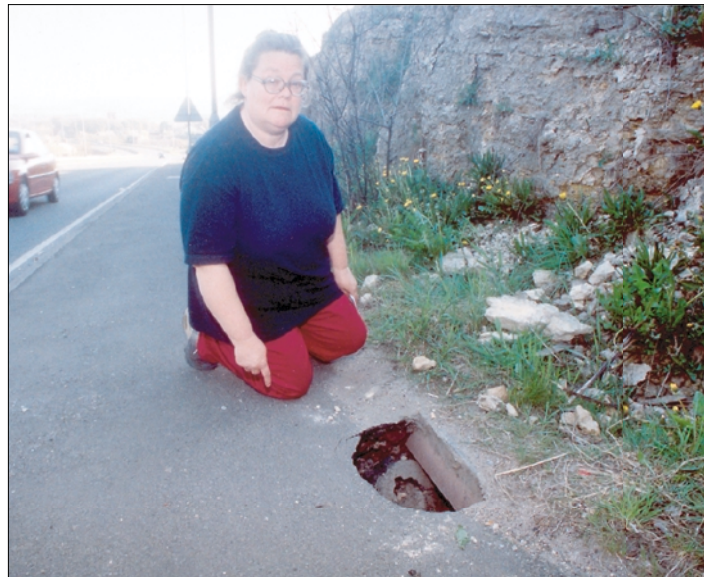
Young and Culshaw (2001, pp.10–11) also described active movements along the fissure exposed in the western wall of the cutting, and which underlies the original crack in the A690 road. Renewed movement on this fissure early in May 2001 resulted in a sudden surface collapse producing a hole approximately 0.5 m across and approximately 0.75 m deep in the pavement (Figure 13). A pedestrian who was passing at the time of the collapse sustained minor injuries (Sunderland Echo, Saturday May 12, 2001, p.3). The hole was excavated and backfilled with concrete by the City Council shortly after this incident (Figure 14).

The sudden collapse of the pavement at Houghton Cut, along the line of fracturing, is consistent with the failure of the tarmac surface several days after renewed movement in the underlying fissures. No major new fracturing of the A690 road surface was revealed during this investigation, though the cracking of the north-bound carriageway which was first noted in June 2000, appears rather more conspicuous than hitherto. It is quite conceivable that the road foundations may presently be effectively bridging any fissures which may lie beneath.

**Figure 13** Collapse in footpath on west side of A690 road at Houghton Cut, with Mrs S Ellis, who sustained slight injuries by falling into hole. Locality 13, Table 2. Photograph reproduced by courtesy of Northeast Press Ltd, Sunderland Echo, photograph No. 65414.

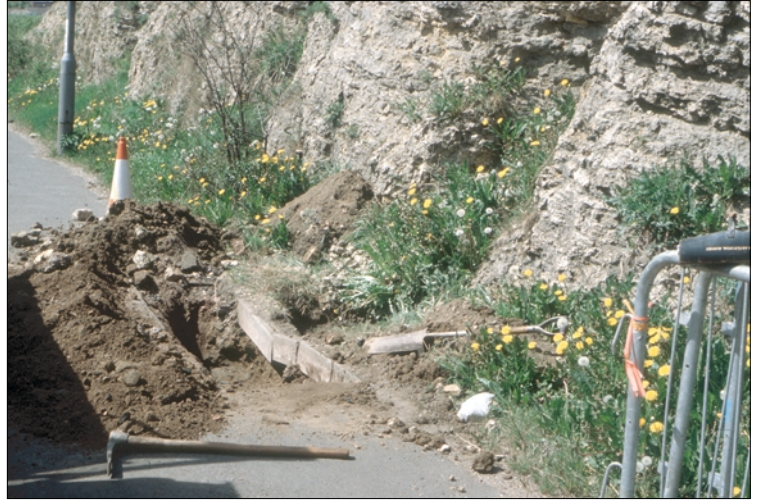
**Figure 14** Collapse in footpath on west side of A690 road at Houghton Cut showing excavation prior to filling and repair. Locality 13, Table 2.

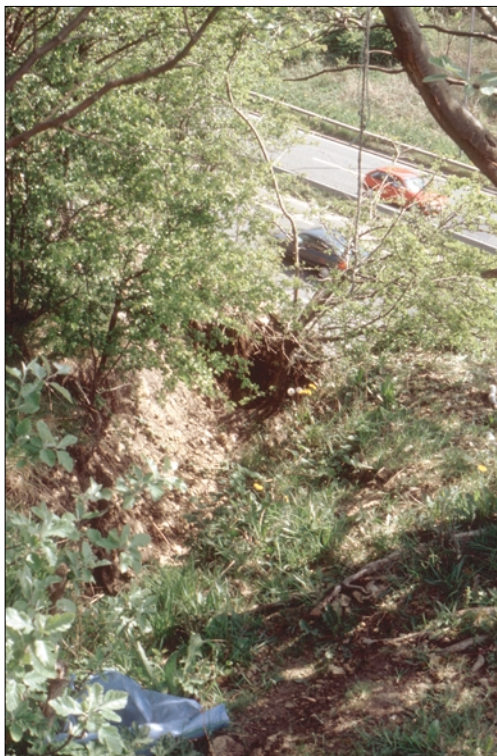
surements (Figure 15). Freshly broken soil and turf occur along much of the line of the fissure. A mature hawthorn shrub has subsided almost 1.0 m into the top of the open hole at the eastern end of the fissure.

**Figure 15** Looking east from Locality 15, Table 3. Wide, newly opened fissure in limestone, with A690 road below.

The open fissures to the west of Houghton Cut have been fenced by Sunderland City Council.

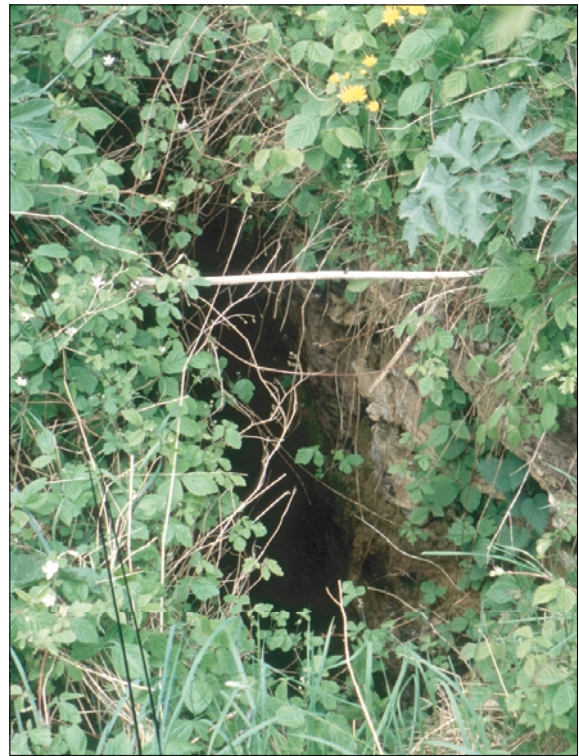
**Figure 16** Looking west along recently opened deep fissure in solid limestone. Locality 15, Table 3.

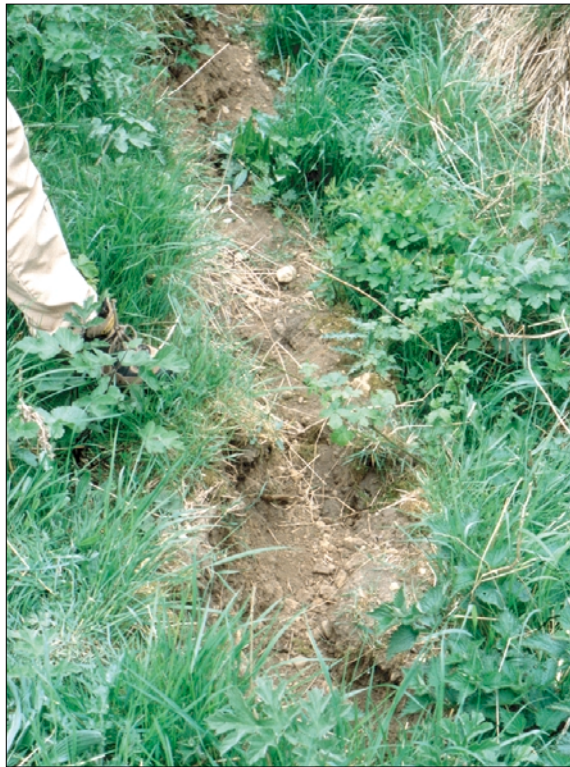
17	NZ 34308 50461	<p>Very recent collapse of topsoil along small south-facing scar approximately 1.0 m long and approximately 0.5 m high on north side of shallow linear depression.</p> <p>Linear depression observed during June 2000 investigation.</p>
18	NZ 34304 50454	<p>Open linear fissure up to approximately 3.0 m long, 0.5 m wide and at least 1.2 m deep.</p> <p>Clean limestone walls, vertical or locally very steeply inclined to the north.</p> <p>Freshly collapsed turfs in base of opening give clear evidence of very recent collapse.</p> <p>Although this fissure lies along course of depression recognised during June 2000 investigation, this prominent open fissure was not observed at that time.</p>
19	NZ 34285 50445–NZ 34304 50454	<p>Prominent, very recently subsided linear depression bearing 273, up to 2.0 m wide and 1.25 m deep.</p> <p>Abundant evidence of very recent collapse in form of fresh scars in turf and topsoil on either side of depression forming graben-like feature.</p> <p>Although this fissure lies along course of depression recognised during June 2000 investigation, this prominent open fissure was not observed at that time.</p>

**Figure 17** Locality 17, Table 3. Small recently-formed scar in topsoil.

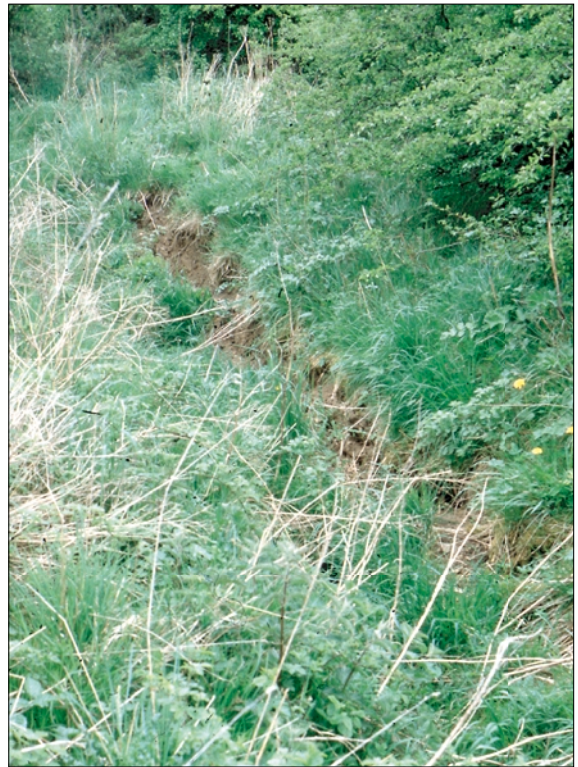
A similar, though rather smaller open fissure up to 0.5 m wide and at least 1.2 m wide, again almost totally concealed beneath thick vegetation occurs a few metres further west (locality 18, Figure 3) (Figure 17).

**Figure 18** Locality 18, Table 3. Recently opened linear fissure.

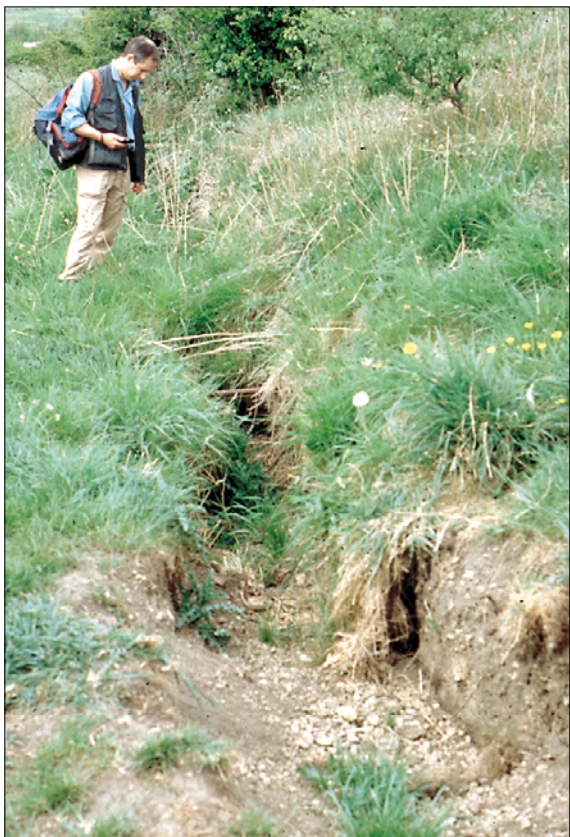
20	NZ 34199 50430–NZ 34255 50439	<p>Linear depression up to 1.0 m wide and approximately 1.0 m deep.</p> <p>Abundant evidence of very recent collapse in form of fresh scars in turf and topsoil on either side of depression.</p> <p>Locally appears to exhibit displacement to south of up to 1.0 m, though generally appears as trough, or graben-like feature.</p> <p>Although this fissure lies along course of depression recognised during June 2000 investigation, there is evidence of very considerable recent movement.</p>

**Figure 19** Looking west along linear fissure. Locality 20, Table 3.
