# Walkover survey of a landslide on the A57 (Snake Pass) road at Cowms Moor, Derbyshire in January 2008.

Open Report OR/08/006

D P Boon & H M Evans

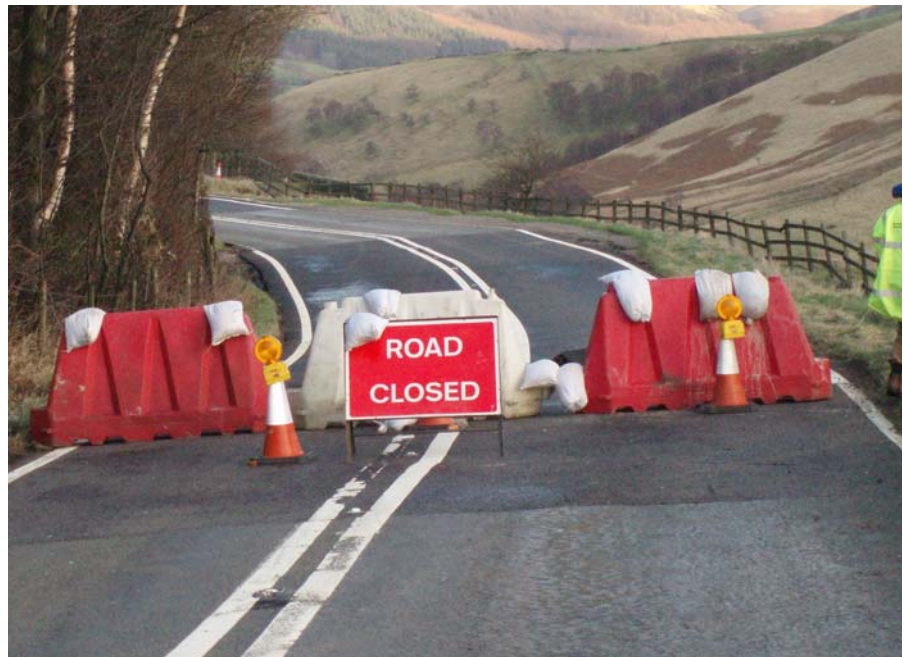
The A57 road closed for over a  
month in January 2008 due to  
subsidence caused by a landslide  
at Cowms Moor, Derbyshire.  
Photo looking east from [SK  
12935 89480].

3. The road marking shown in Figure 6 was displaced horizontally by 150 mm and vertically by at least 400 mm. The road surface was back rotated by 2 or 3 degrees producing a camber on the failed section, (see cover image). Several survey pins had been installed (presumably by DCC) across most cracks in the road top.

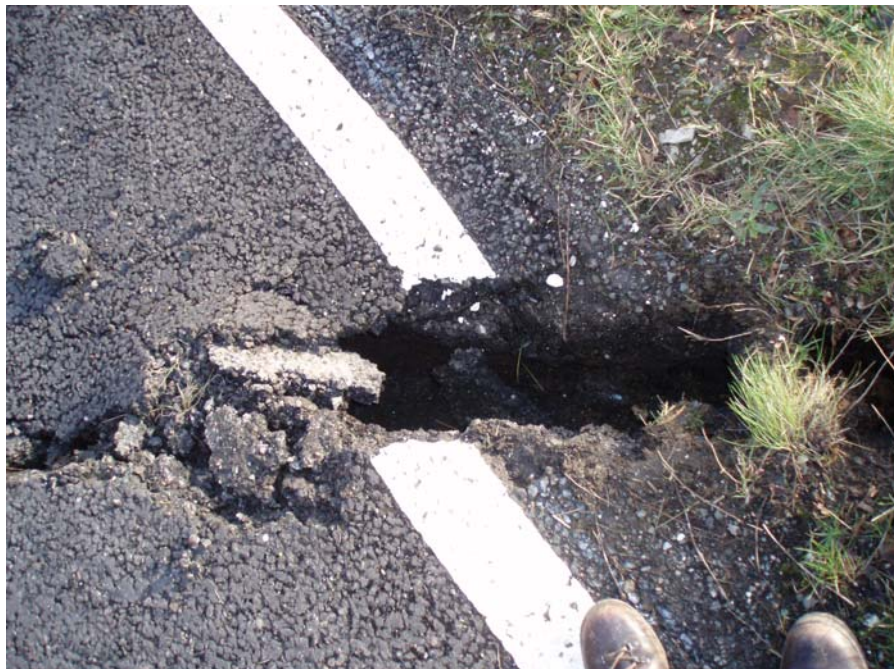
2. The road surface was deformed with fresh cracks in the tar macadam surface. At the edges of the deformed roadway, tarmac was buckled indicating compression and cracks showed a sense of shear displacement. Open tension cracks aligned parallel with the road were also noted. The cracks were up to 5 meters in length and at least 0.5 meters deep, as shown in Figure 6.

**Figure 6** Photograph showing crown crack (0.4 m deep) above the right flank of the landslide. The offset of the road markings indicates a dextral sense of slip. Taken at [SK 12845 89498].

- The curved shear cracks found in the road top are interpreted as crown cracks which mark the lateral extent of the failure. The straight cracks are interpreted as transverse cracks.

- The off-set of road markings along cracks indicates a downward and outward movement of soil and rock.
- The fresh cracks near Wood Cottage suggest the rear scarp of the landslide is located above the main road placing the road on the 'head' area of the landslide.

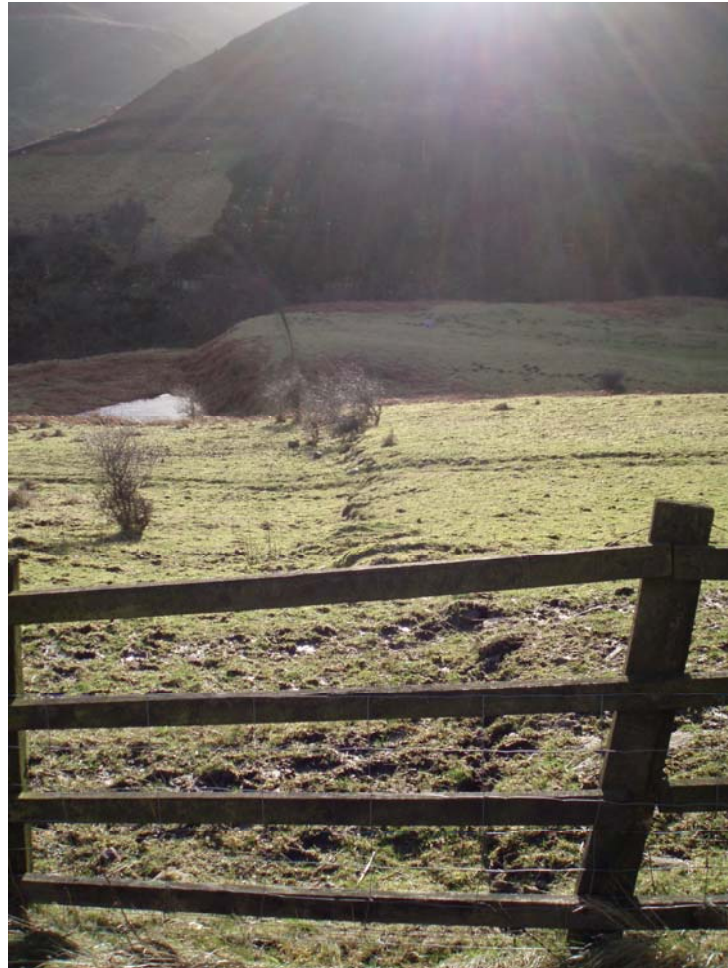
4. A linear scarp feature, shown in Figure 7, marks the western extent of the right flank of the landslide.
5. Ponding of water was observed below the road (visible in Figure 7).

6. Artesian groundwater flow conditions were noted at the concave break in slope, at the elevation of the pond (see Figure 7).

**Figure 7 Photograph showing western side scarp. Taken from [SK 12845 89495] facing south. This feature crosses the road surface. Artesian water pressure was observed above the pond (middle, left).**

- The occurrence of newly formed springs near the pond area indicates ground water was very high around the time of the failure and may be hydrogeologically confined by the fill material.

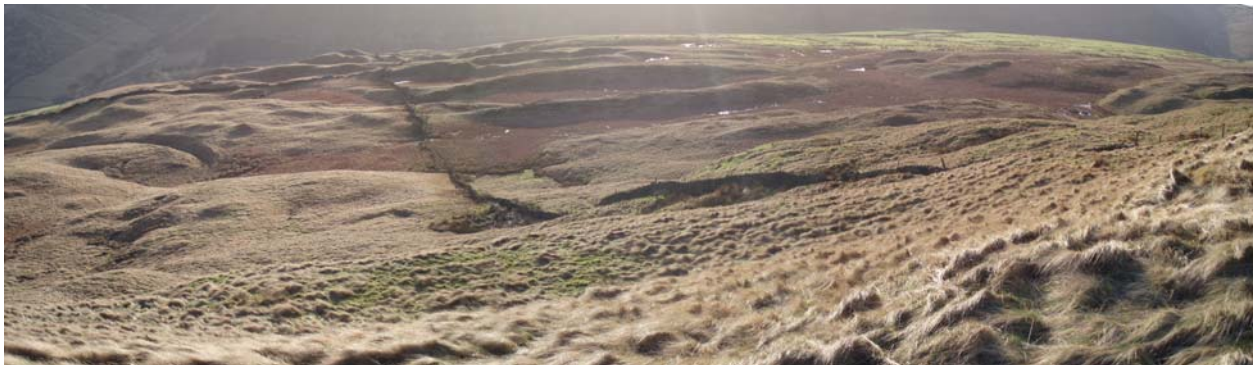
1. Discrete bench features, hummocky ground, and ponding are present across the Northern Ashop valley slope. These features are visible in Figure 8, taken from the left edge of the Cowms Rocks landslide crown looking south across the valley.
2. No fresh signs of movement were identified, although the not all the ground was covered.
3. However, a shallow peat slide was noted just below Locality 2 on the eastern part of the degraded backscarp and a 2 m high exposure of peat was noted over the brow of the hill which may be of significant.
4. A surface drain was identified crossing the upper section of slope. It is constructed as a 0.4 metre wide concave strip of concrete and was in a degraded, cracked condition.

**Figure 8** Elongated ridges or bench features are probably formed by rotation of resistant sandstone beds in the Shale Grit. Photograph taken looking south from Location 2 at [SK 13113, 90318] on the crown of the Cowms Rocks landslide complex.

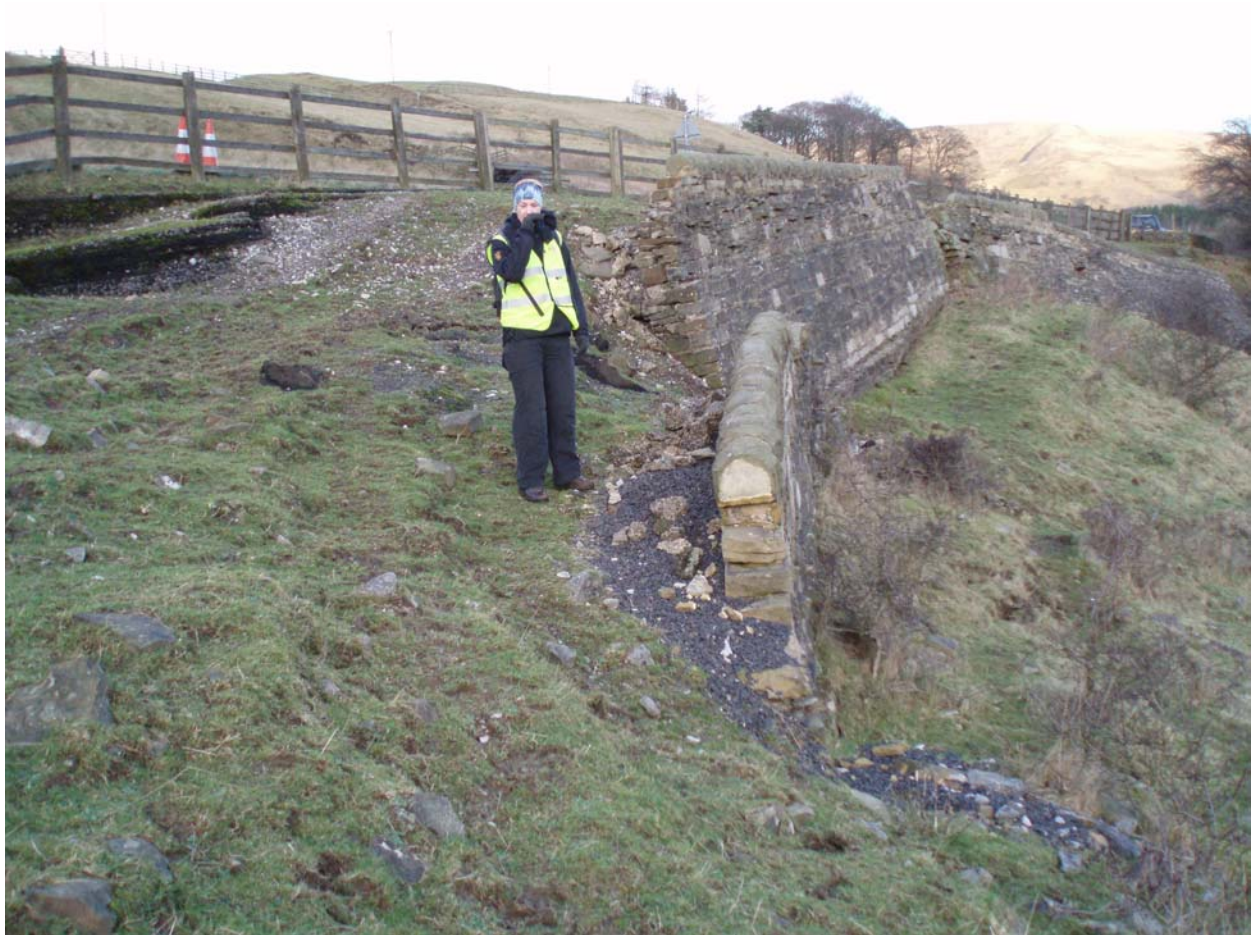
1. The old (disused) road surface and retaining wall is off-set at several points recording down slope translation and rotation of the ground.
2. The material involved in the A57 slide was not well exposed.
3. Alternating layers of road base and tarmac (Figure 9) were revealed on the faces of minor scarps below the road indicating a long history of resurfacing.
4. The material below the road may consist of made ground (artificial placed fill), slipped bedrock and soliflucted 'head', a mixed material moved down slope by freeze-thaw action and gravity in a largely periglacial environment.
5. Compression deformation of a recently erected fence above the road 50 m east of Wood Cottage does indeed suggest compression above the road.

**Figure 9** Photograph showing a displaced and rotated retaining wall and disused section of road at the eastern edge of the recent landslide. This cross cutting relationship is evidence for historical down slope movements. Taken from [SK 12935 89480] looking NE.

- The scale of displacement across the old retaining wall indicates several meters of down slope movement since the retaining wall was constructed.
- The presence of nearly two metres of alternating layers of asphalt and road sub-base material and various isolated patches of tarmac suggest the road top has been resurfaced many times.

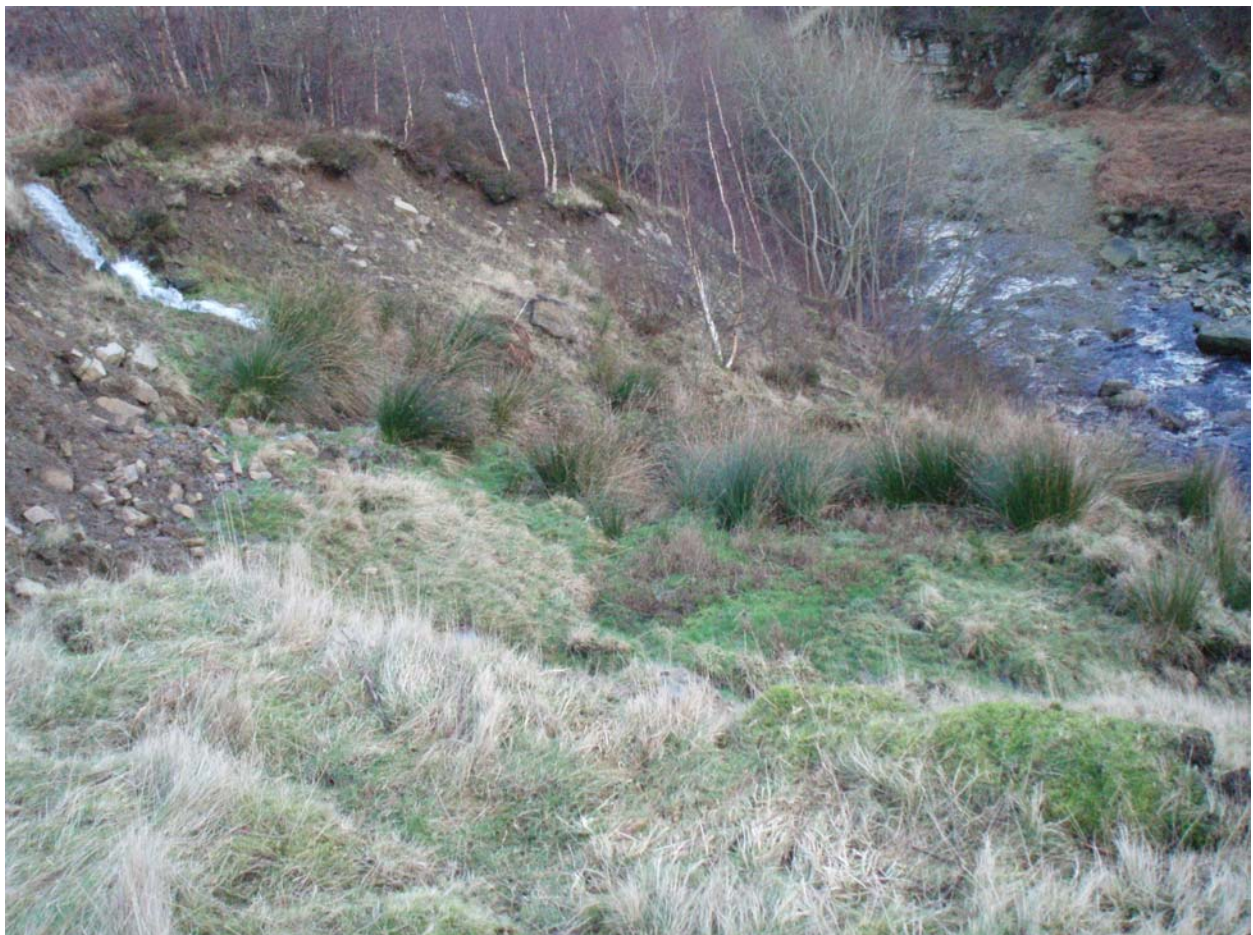
1. Firm grey sandy clay with weak to strong sub-angular sandstone and siltstone gravel, cobbles and boulders exposed in the Ashop riverbank, shown in Figure 10.
2. Large volumes of water were observed issuing out of the slope from several partially blocked and broken clay pipes 20 metres north of Location 4.
3. Recent debris slide has de-vegetated the river back.

Large amounts of rainfall that had fallen in the area during the two weeks leading up to the event and so is likely that the material was in a saturated condition when it failed.

**Figure 10 Recent debris slide on riverbank. The failure has de-vegetated the bank. Surface water emanating from springs and pipes was flowing down the bank. Photograph taken looking east from Location 4 [SK 12845 89376].**

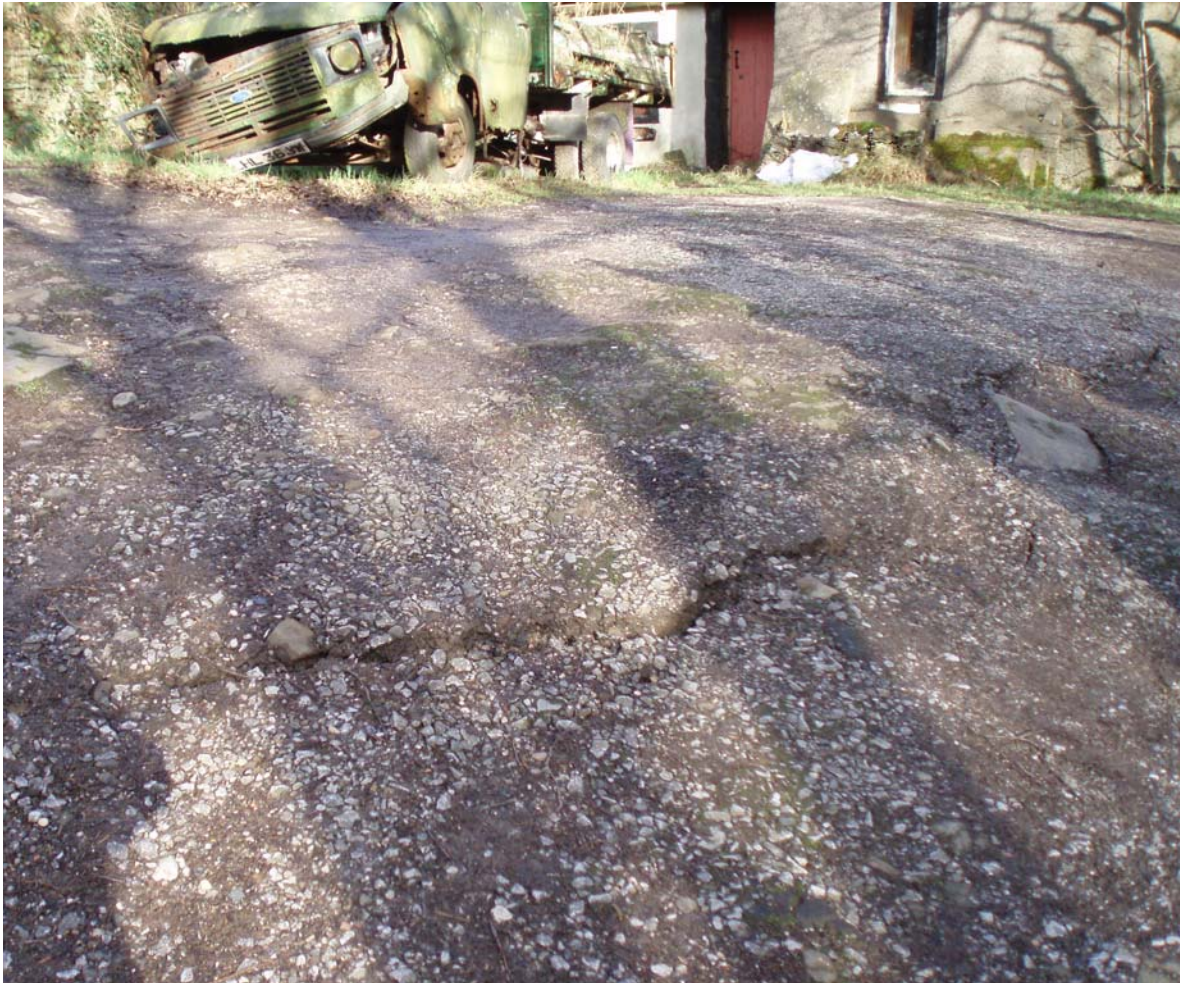
1. Fresh linear shears were found cutting across the access track to Wood Cottage.
2. Vertical tension cracks were recorded along the concave break along the driveway of Wood Cottage, shown in Figure 11.

**Figure 11** Photograph showing fresh tension cracks along the degraded scarp directly below Wood Cottage. The presence of cracking at [SK 12895 89545] provides evidence for recent reactivation of a landslide mass upslope of the A57.

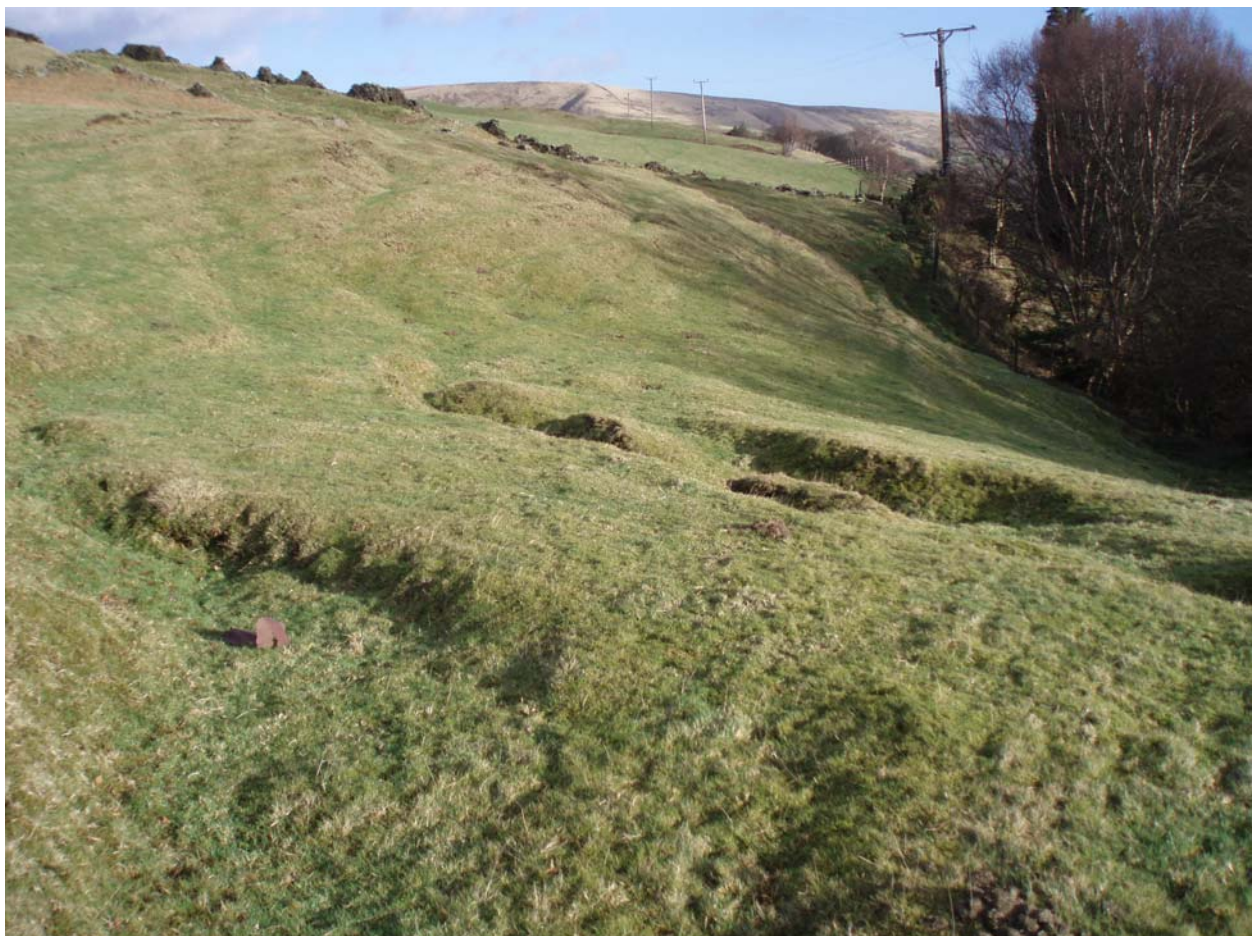
**Figure 12 Degraded features and hummocky ground scar the land surface around Wood Cottage. Note also that the line of telegraph poles in far ground have been offset and tilted. Photograph taken looking east from [SK 12841 89570].**

- Degraded surface features and hummocky ground above and below the road indicate that several other potentially unstable remnant landslide blocks exist along the route of the road.
