## **OBSERVATIONS AND IMPLICATIONS OF DAMAGE FROM THE MAGNITUDE $M_w$ 6.3 CHRISTCHURCH, NEW ZEALAND EARTHQUAKE OF 22ND FEBRUARY 2011**

Sean Wilkinson, Damian Grant, Elizabeth Williams, Sara Paganoni, Stuart Fraser, David Boon, Anna Mason, Matthew Free

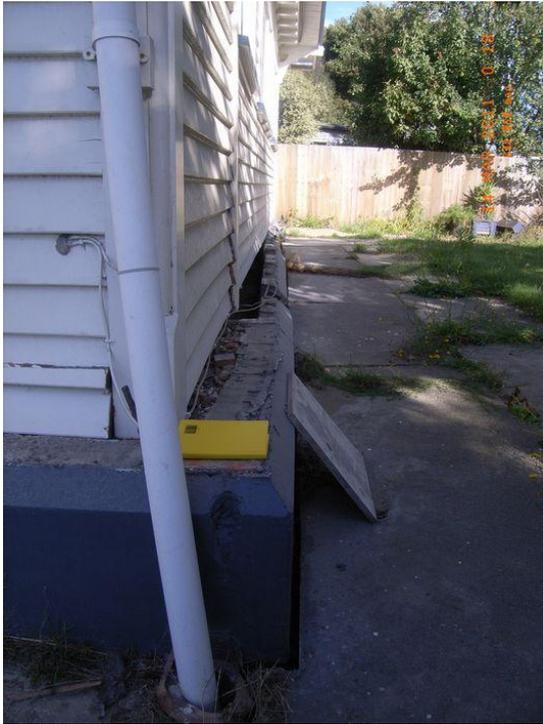
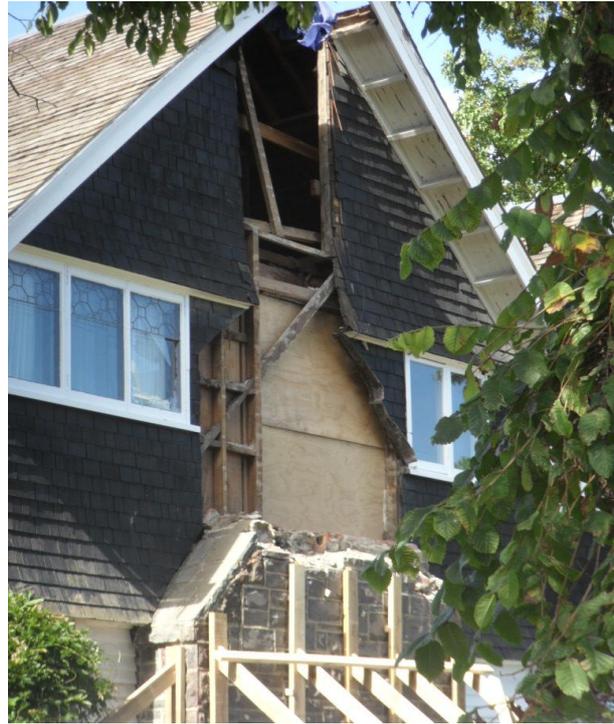
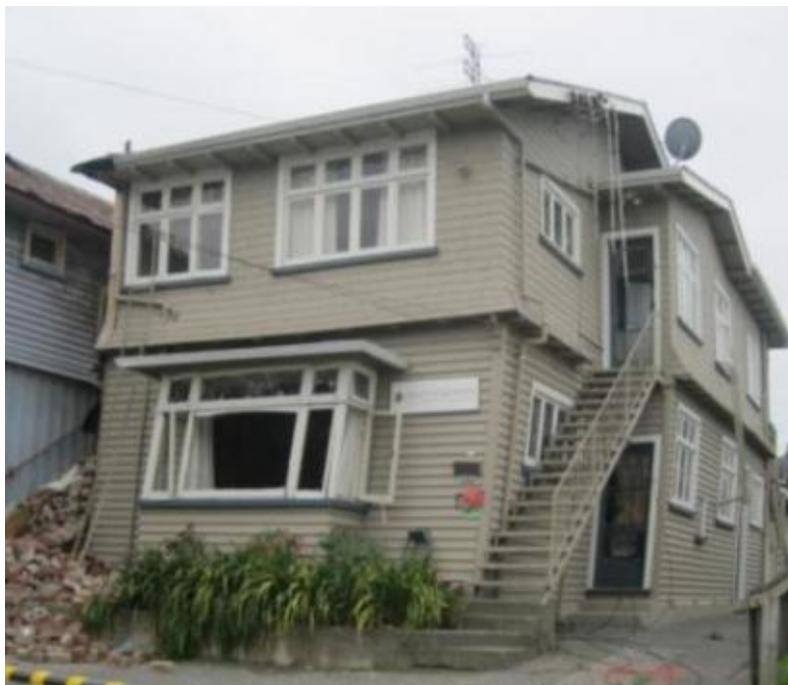
Overall, the timber building stock was structurally resistant to ground shaking in this event, despite the high ground accelerations recorded. Examples of damage to timber residential buildings are shown in Figure 1.

The damage observed by the survey team was primarily driven by failure around or beneath the structure; namely the differential movement of separate structures and fracture of concrete block foundations due to lateral spreading and settling of foundations. Foundations are discussed further in the geotechnical section, later in the paper. Another typical failure mode for timber structures was due to insufficient tying to foundation, particularly problematic in areas where the vertical acceleration exceeded 1g. A typical example of a residential timber structure that has moved off its foundation is presented in Figure 1a. Other commonly observed damage included damage to masonry components of the building: falling chimney stacks, damage or collapse of masonry facades or to external chimney breasts; and roof tile damage (Figure 1b). Several instances of soft storey failure in a timber building were also observed (Figure 1c).

Figure 1– Damage to timber structures showing (a) a timber house that has “jumped” off its foundations; (b) a timber house with relatively little external structural damage to the timber, but collapse of external masonry chimney; (c) soft storey failure at the ground floor level of a two storey timber frame house.

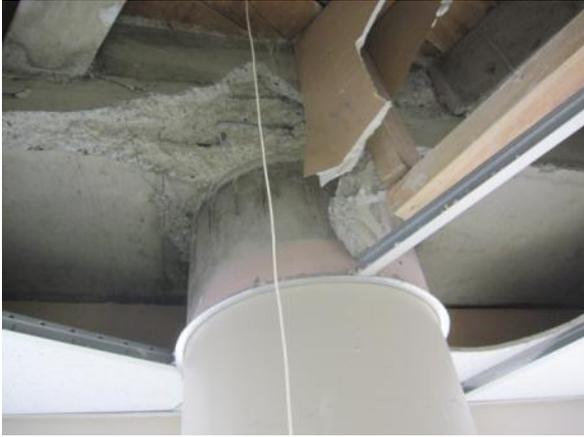
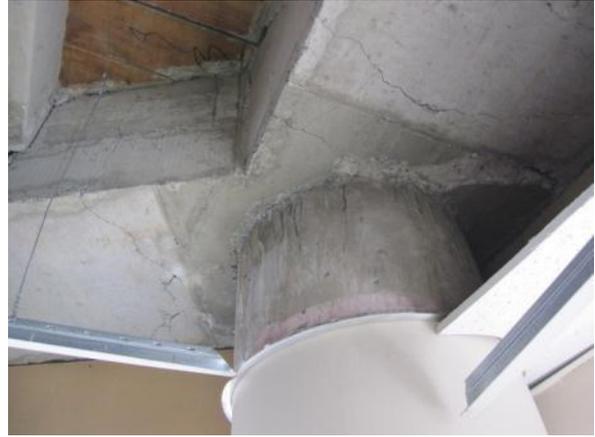
For the most part, moment frame buildings performed well, and most damage was caused by differential settlement (see Foundations section). Minor flexural cracking was observed in beams (Figure 2b) and at column bases (Figure 2a) for the most part, although in some cases flexural hinging was observed at the top of ground storey columns, along with shear cracks up the height of columns, in multi-storey buildings (Figure 3b and c). This minor cracking would not be expected to lead to a significant reduction in the capacity of the building to withstand subsequent earthquakes.

Figure 2– Beam damage observed on Level 2 (internal) inspection of building on Victoria Street. (a) Internal beam-column joint damage exposing transverse joint reinforcement; (b) flexural cracks on underside of beams at corner beam-column joint.

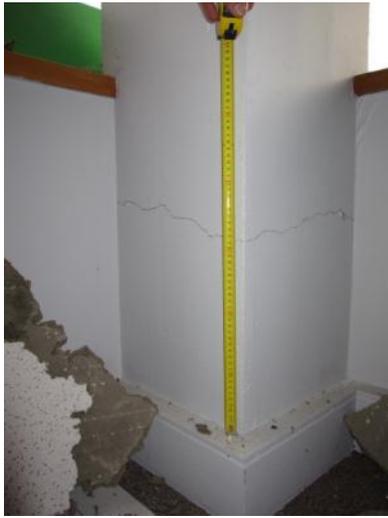
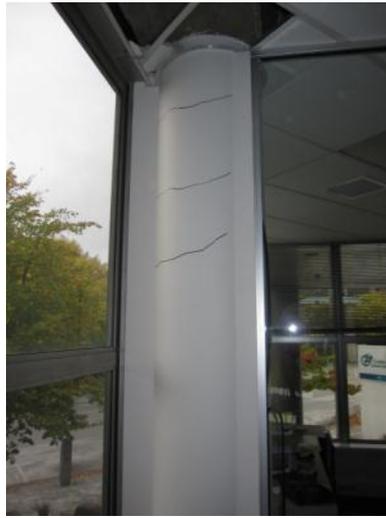
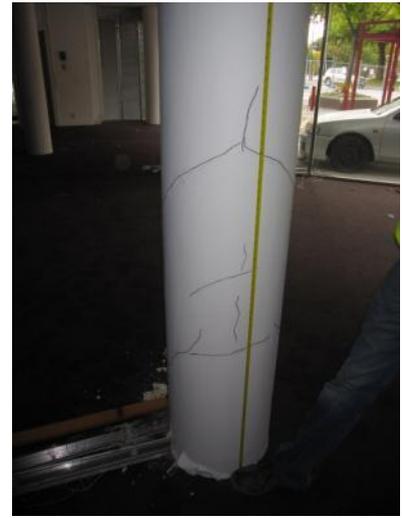
Figure 3- Column damage observed on Level 2 (internal) inspection of building on Kilmore Street. (a) Flexural crack at ground floor column base; (b) flexural cracking at top of column; (c) potential shear cracking up height of column (note: cracks drawn on column in b and c).

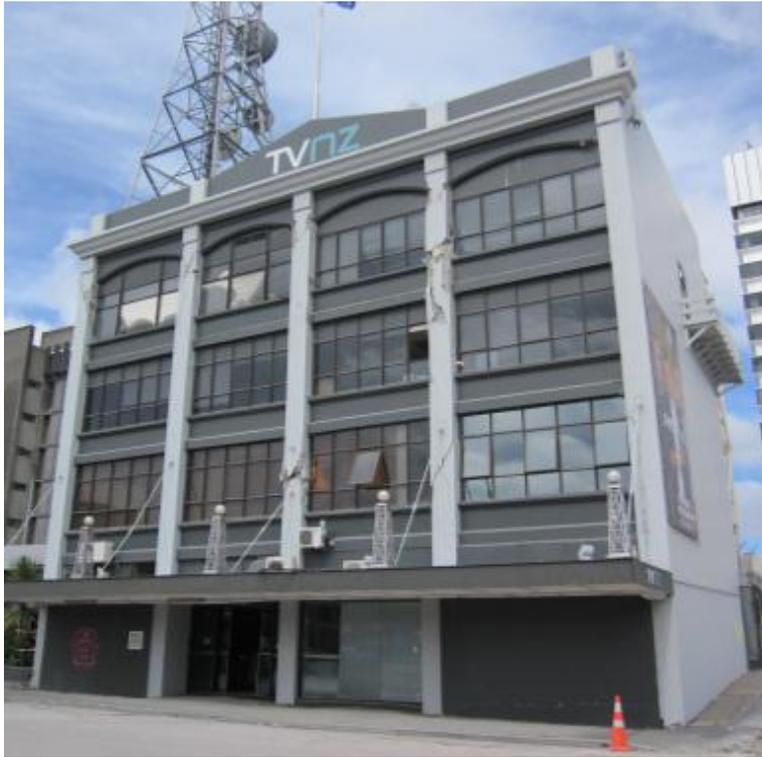
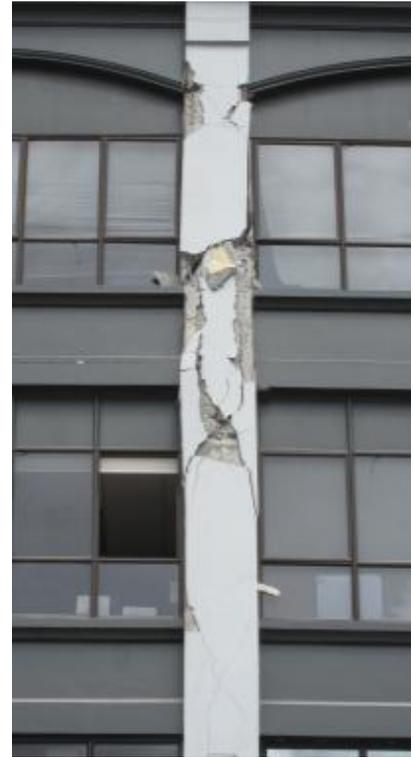
Poor performance of some RC buildings in the earthquake was due to irregularity – either horizontal or vertical – of the lateral force resisting system. A typical example of horizontal irregularity is the building shown in Figure 4. The lateral system of this building comprised structural walls on the two sides, moment frame on the street frontage, and infilled moment frame on the back wall. This would have shifted the centre of stiffness towards the rear of the building, and the subsequent torsional demand led to heavy damage to the columns and beam-column joints of the front moment frame (Figure 4b). This building has subsequently been demolished. The CTV and PGC building collapses, mentioned earlier, also appear to have been at least partially due to horizontal irregularity (Hyland Fatigue and Earthquake Engineering, 2012; Beca Carter Hollings and Ferner Ltd, 2011b).

Figure 4– Problems with structural irregularity. (a) and (b) TVNZ building with open street frontage and infilled frame at rear.

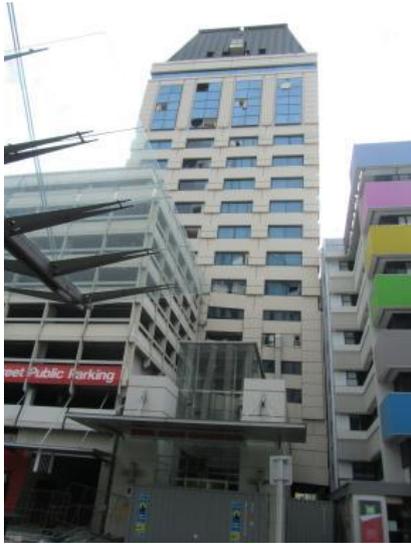
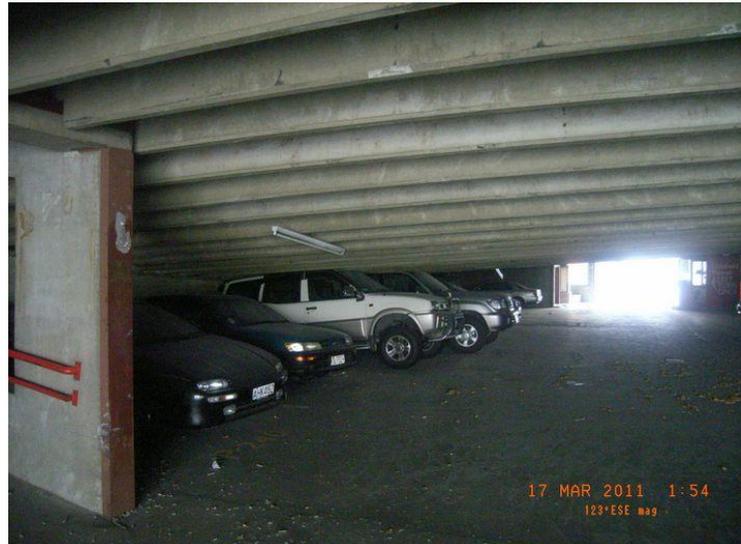
There was much anecdotal evidence from local engineers about poor structural performance due to vertical irregularity, including a prominent hotel building in the CBD with severe damage to a transfer structure at the 1st floor level. The most notable example of vertical irregularity leading to inadequate seismic performance was the 26-storey Grand Chancellor Hotel building – one of the tallest buildings in the Christchurch CBD (Figure 5). On the day following the earthquake, rescue teams were evacuated from the area around the building due to the significant lean. This lean was later established as, the south-east corner of the building dropping by approximately 800mm and deflecting horizontally approximately 1300mm at the top of the building (Dunning Thornton Consultants Ltd: 2011). The building has subsequently been stabilised for eventual demolition. Due to the unstable nature of the building, access was not possible, but EERI reconnaissance team reported that the building lean was due to the failure of a transfer structure at the 7th floor, which was required to allow an overhang over a driveway to the car park at the ground level (EERI 2011). The driveway is visible at the bottom right of Figure 5a and the car park can be seen in Figure 5b.

Figure 5 - (a) Grand Chancellor Hotel building, showing overhang of driveway at ground floor level and (b) associated car park – seen on the right of the hotel.

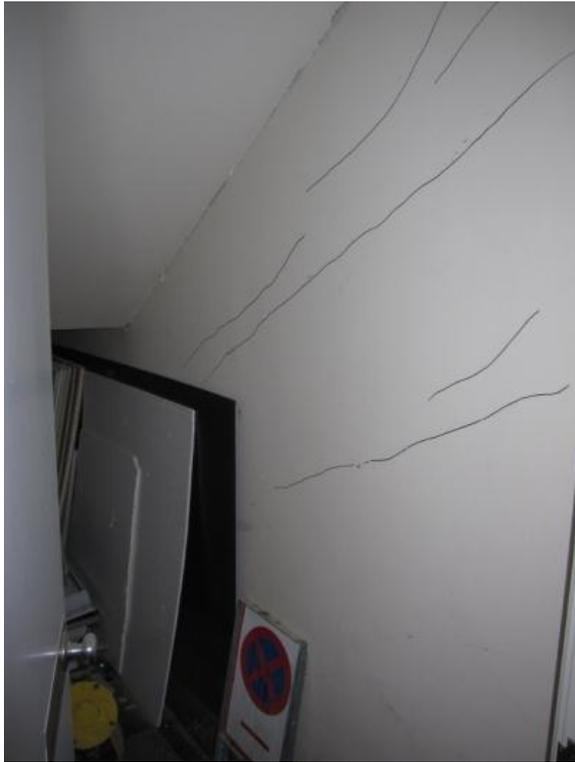
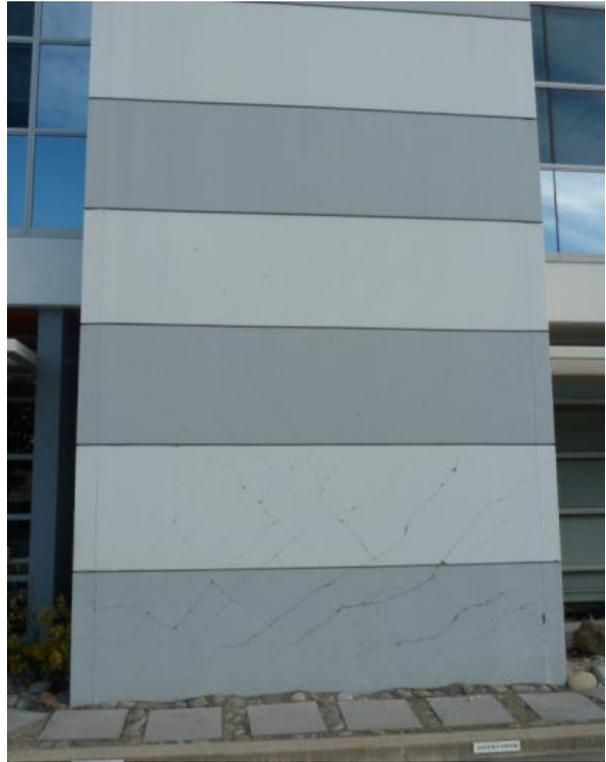
Various degrees of damage were observed to RC structural walls, from no visible cracking, to moderate cracking in plastic hinge zones (Figure 6), to significant crushing of concrete and buckling of longitudinal bars in boundary zones (Figure 7).

Figure 6– Moderate cracking in RC structural walls. (a) Cracks drawn on internal core wall in 7-storey building on Kilmore Street; (b) cracking at base of wall on Victoria Street. The building in (b) is an “indicator building”, which means that following a significant aftershock, this would be one of the first to be inspected to assess whether more widespread damage is likely.

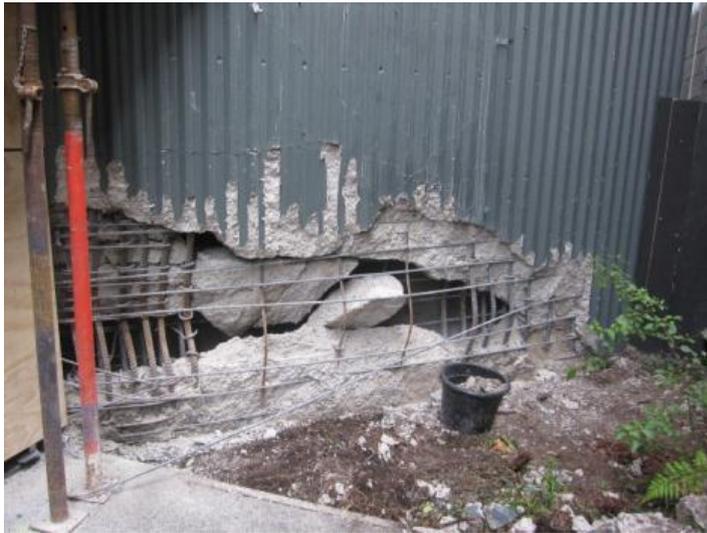
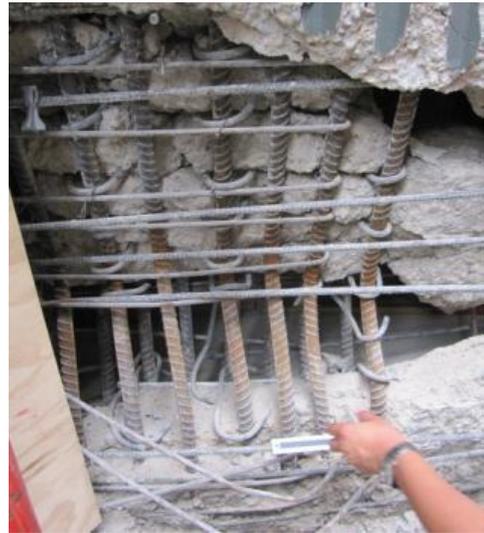
The wall shown in Figure 7 was from a 7-storey building, of apparently modern construction, with moderately reinforced but well-confined boundary zones. Note that damaged concrete had been removed from the boundary zone reinforcing cage at the time of the visit, and repair works had been designed by local structural engineers. Interestingly, the corresponding wall on the other side of the apparently-symmetric building was not heavily damaged – presumably due to openings in the floor slabs around this other wall which would have restricted the diaphragm force that could be transferred and therefore overloaded the damaged wall.

Figure 7– Significant damage to wall with well-confined boundary zones on Victoria Street. (a) Wall with core concrete removed for repair operation, and (b) close-up of boundary zone. EERI reconnaissance team concluded that this was a wall buckling failure rather than a flexural boundary zone failure due to large compression strains.

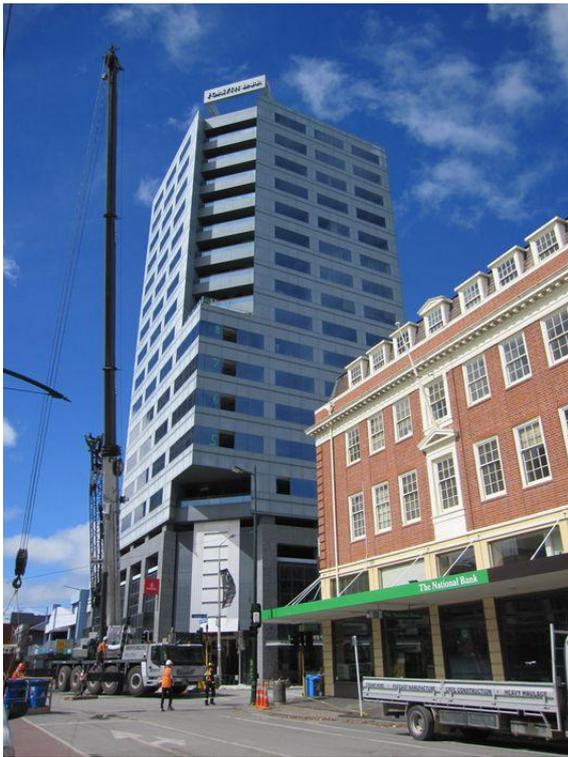
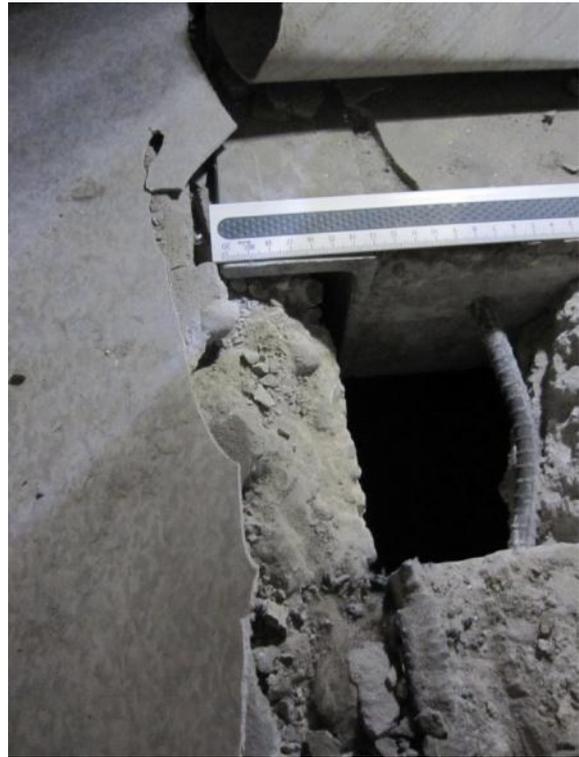
The team also observed damage at the top of stairwells as part of the Level 2 (internal) inspections. Figure 8b shows the exposed seating detail, with a seating angle of 60 mm, and a 15 mm gap (measured after the earthquake). It is not known how much gap/seating was initially provided, but the observed damage suggests that impact did occur during the earthquake.

Figure 8– (a) Forsyth Barr building where stairwells collapsed, impeding evacuation and search and rescue efforts. (b) Staircase detail exposed by damage on building on Kilmore Street; angle section provides overall seating of 60 mm, and around 15 mm gap measured after earthquake. The original gap/seating allowance is not known.

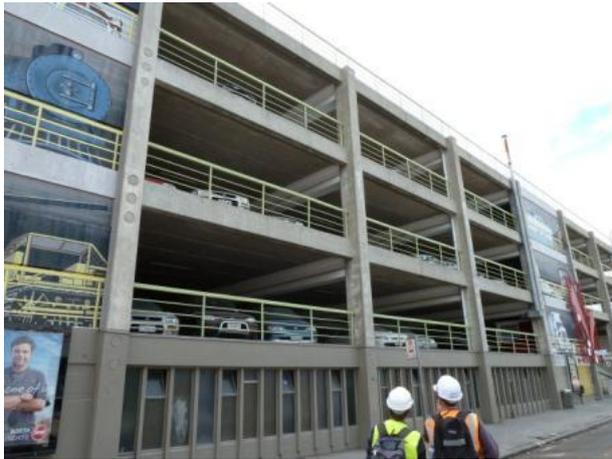
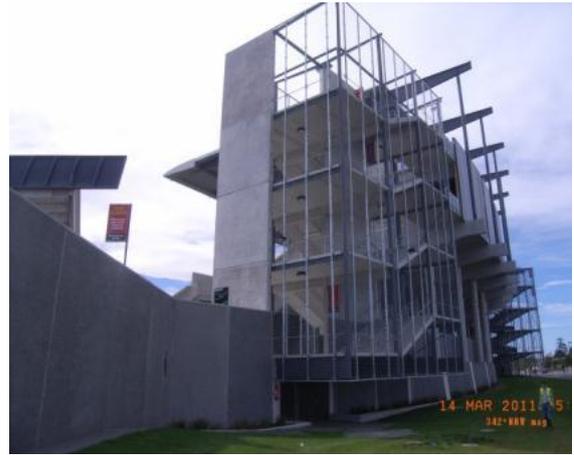
Precast concrete is also used in New Zealand for beams, columns and structural walls (Park, 2002). Figure 9a shows a parking building with precast post-tensioned concrete beams (the anchorages are evident on the face of the column). This building appeared to have sustained very little damage in the earthquake. Initially, during the team’s visit, larger precast structures, including the AMI stadium shown in Figure 9b, also appeared to have performed well with very little apparent external damage. However, the severity of the damage to the stadium became clearer after the visit, and several stands of the stadium are expected to be demolished, demonstrating the difficulty in drawing conclusions based on external assessments only.

Figure 9– Precast concrete structures. (a) Parking building on Gloucester Street with post-tensioned, precast beams, showing little damage. (b) AMI Stadium, with little damage visible from the outside (despite significant liquefaction).

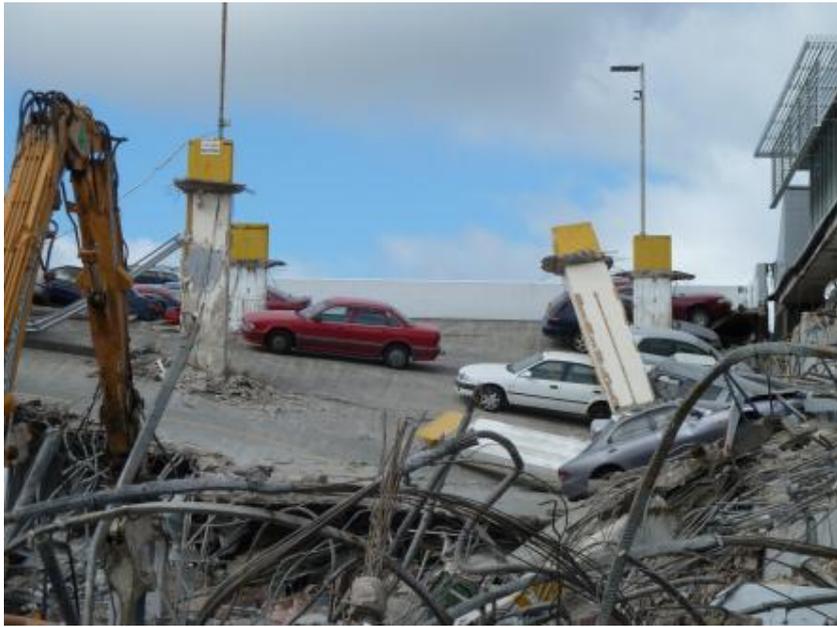
In contrast to Europe, flat slab construction is rare, although a few examples were encountered and these had variable performance, ranging from damage confined to plastic hinges in columns to catastrophic collapse. A notable punching shear failure occurred in the car parking building on Eaton Place, shown in Figure 10. This structure included a 3-storey structure supported over the street level. The top two levels of this section collapsed onto the lower level, which did not collapse – it had been demolished and removed at the time of the survey team’s visit.

Figure 10– Eaton Place parking building. Punching shear failure in RC building.

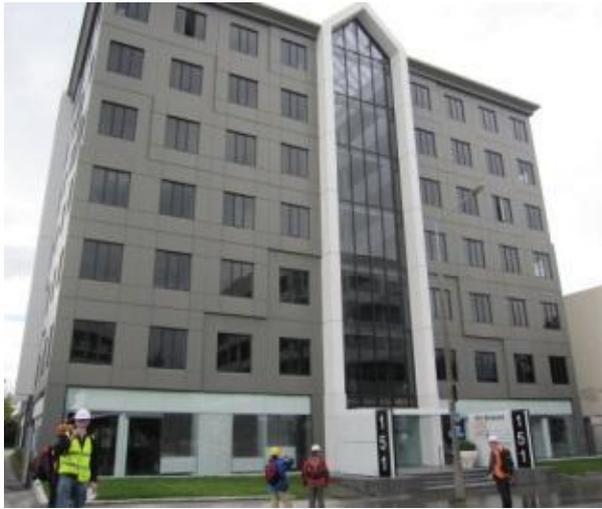
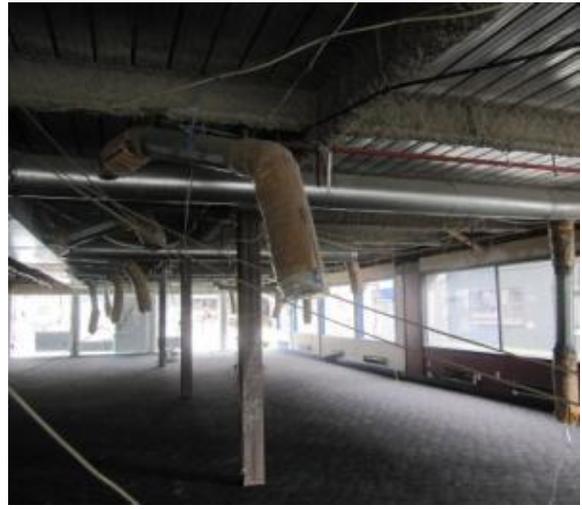
As part of detailed Level 2 inspections, the team visited a 7-storey building in the CBD with a mixed RC moment frame (ground level) and steel moment frame (higher levels) lateral system (Figure 12a). The building suffered differential settlement due to liquefaction, and there was evidence of this in ground floor columns and ground-bearing slab. There was no evidence of any damage to steel moment frames at higher levels, including on the floor that was being fitted out and therefore had beams and columns fully exposed (albeit covered in fireproofing; see Figure 12b). An area of fireproofing was removed, which showed no signs of buckling in beam flanges; however a more detailed inspection was not conducted as it would have required extensive removal of fireproofing.

Figure 12 – (a) 7-storey building in Christchurch CBD with concrete moment frame system at ground floor and steel moment frame at higher levels. (b) First floor was being fitted out so beams and columns were exposed, albeit covered in fireproofing

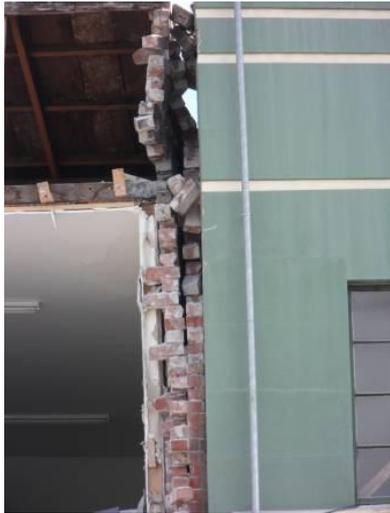
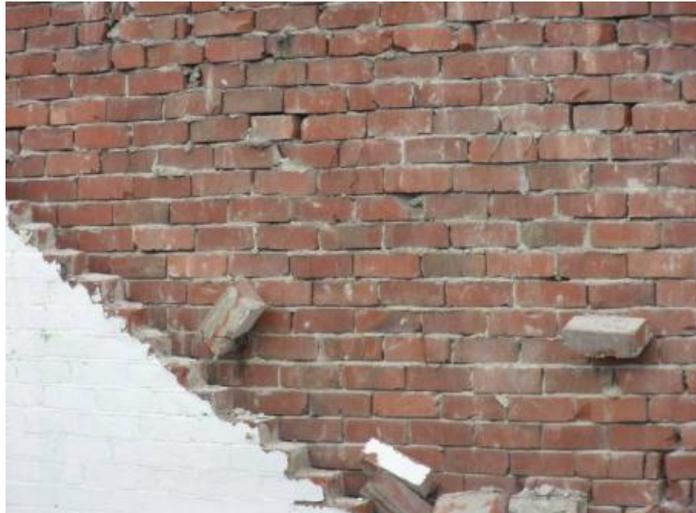
2. Masonry fabric. Whereas a number of buildings were constructed with a regular bond with good through-thickness connection, the lack of internal connection observed in some multi-leaf and cavity walls provoked separation and out-of-plane failure of wall panels (Figure 14).

Figure 14 – Evidence of damage as consequence of the poor through-thickness connections of masonry walls: (a) complete lack of headers leading to separation of the two single-leaf panels of the wall; (b) small and far apart metallic profiles unable to ensure the unitary response of multi-leaf wall and prevent out-of-plane collapse of outer wythe.

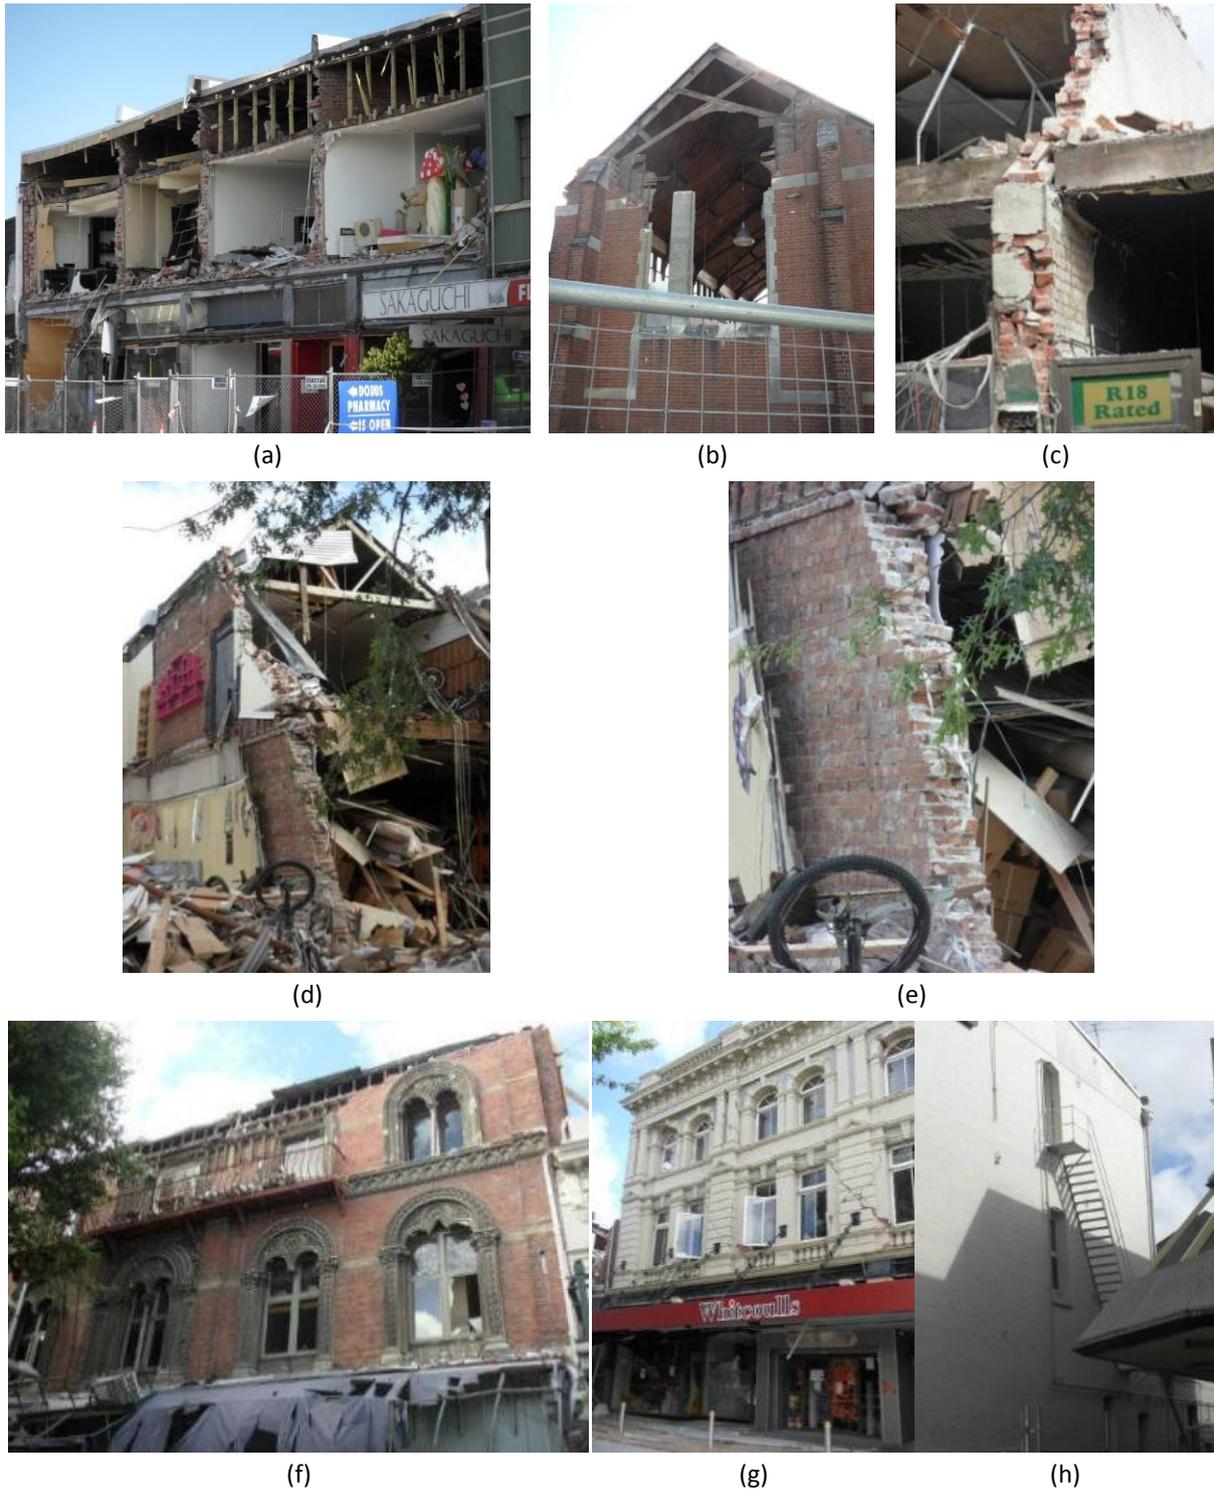
3. Quality of connections between structural elements. The most commonly observed damage mechanism involved the overturning of the front walls as consequence of the lack of effective connections to horizontal and other vertical elements (Figure 15 a and Figure 15c). In the case of both small commercial row buildings and churches, the vulnerability of vertical wall panels was aggravated by the fact that the horizontal structures only bear on the side walls, or on timber portal frames. Consequently, façades and gables behave like free standing elements with shear capacity reduced by the lack of horizontal friction that is otherwise determined by the weight of horizontal structures bearing onto the walls. The presence of better connections between the façade and other structural element shifted the damage mechanism to overturning involving portions of the side walls (Figure 15d and Figure 15e) or arch mechanisms (Figure 15f). In-plane cracking was observed only in those cases where the quality of connections, these being either original or upgraded by strengthening, ensured a box-like behaviour of the structure and the transmission of the horizontal loads depending on the relative stiffness of the structural elements (Figure 15g and Figure 15h).

Figure 15 – Observed correlation between the quality of connections and damage mechanisms. Overturning of (a) whole or (b) portion of facade as consequence of poor connections between front walls and other vertical and horizontal elements. The vulnerability of vertical wall panels was worsened by the lack of vertical compression of horizontal structures, which only bear on the side walls. Indeed the floor beams span in the direction parallel to the façade (c) and the roof trusses rest on the side walls (b). (d) Portions of side walls were involved in the overturning mechanism of the façade in case of better corner connections, like in the case of reinforced bed joints (e) detail of bed joint reinforcement. (f) Good corner connections and connections to floors with lack of connection to roof structure determined a horizontal arch mechanism involving only the top portion of the front wall. (g) X-shape cracking indicates a box-like behaviour that allows the transmission of horizontal loads in the various structural elements and the activation of the in-plane resistance. (h) In this case the box-like behaviour was achieved by the improvement of connections by regularly spaced anchors.

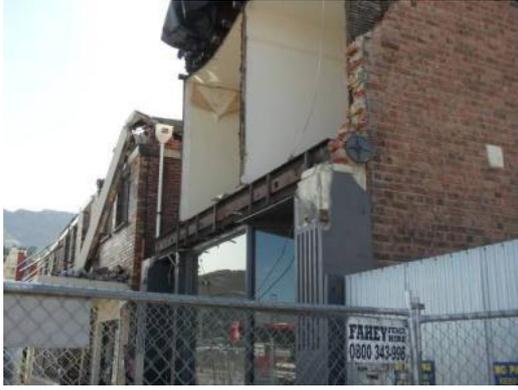
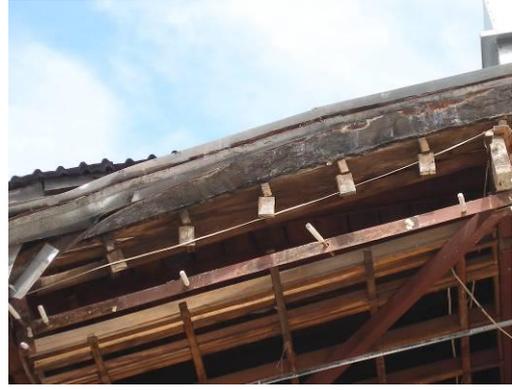
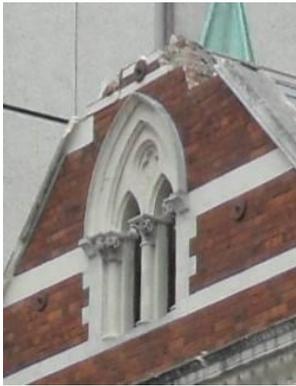
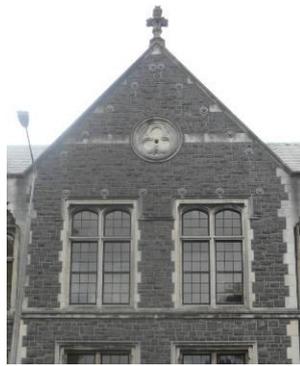
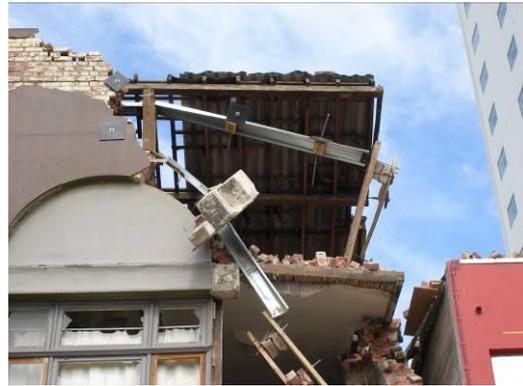
Figure 16 – Metallic anchors: (a) example of application for connection of floor beam to wall. Note that the lack of connection in the other direction determined the out-of-plane failure of the façade. (b) Insufficient size and (c) ineffective positioning of the elements compromised the performance of connectors; yet (d) the better layout and size of elements proved effective in preventing damage in similar structures. (e) Failed steel girt and anchors.

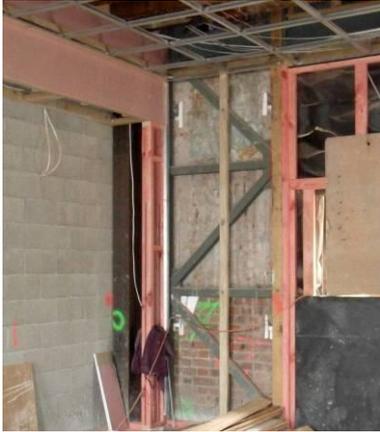
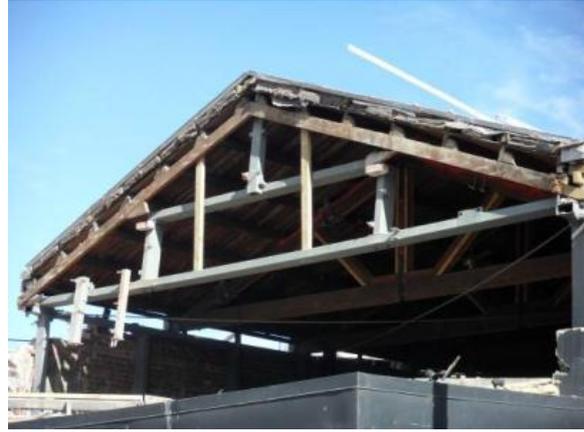
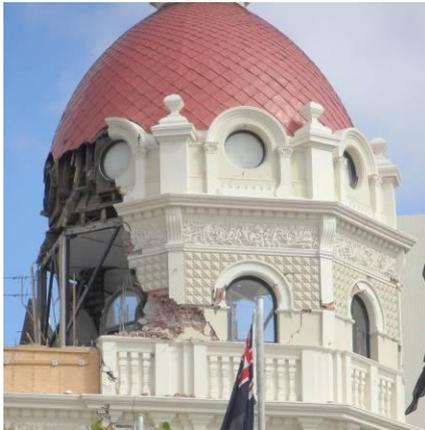
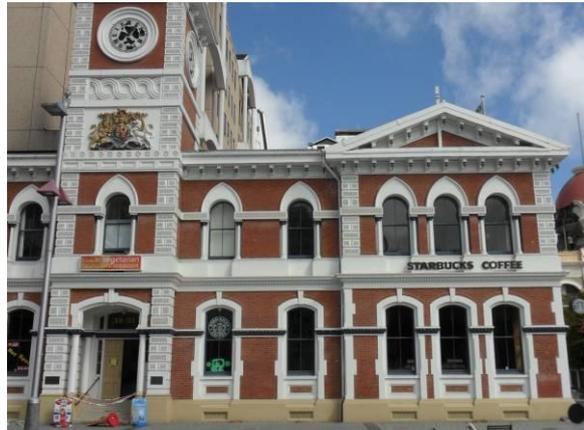
2. Steel bracing and steel frames (Figure 17a and Figure 17b). Even if frames performed well and prevented the collapse of horizontal structures, the sizing and spacing of connections between braces and walls was insufficient to restrain the out-of-plane mechanism of masonry panels (Figure 17b and Figure 17c). In fact, a better global performance is likely to be due to better detailing (Figure 17d).
3. Concrete frames presented the same problems as steel frames: despite behaving well during the earthquake, they were not sufficiently connected to prevent out-of-plane damage to the masonry walls.

Figure 17 – Examples of (a) steel bracing and (b) additional steel frame. Although in some cases the retrofit by steel bracing proved highly successful (d), in others the bracing, despite preventing the collapse of the roof, could not prevent the overturning mechanism of masonry panels (c). This constitutes a major drawback both in terms of safety and, for heritage buildings, of loss of original material.

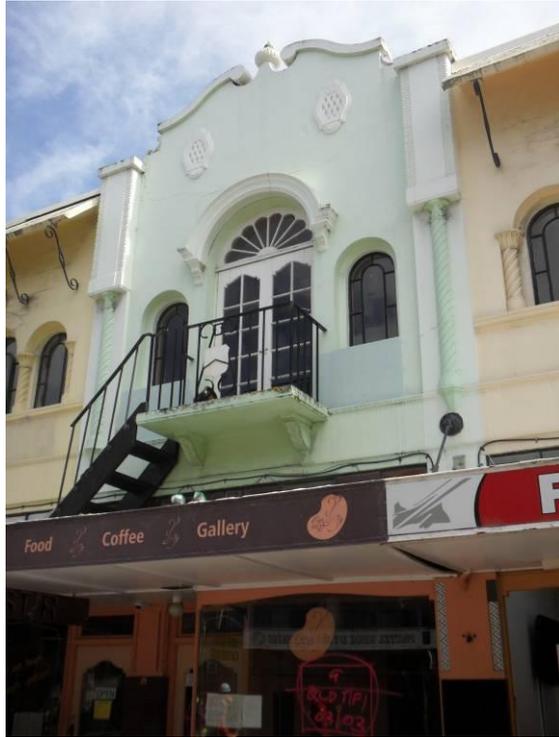
The majority of observed reinforced masonry (RM) structures were two-storey commercial buildings, which performed well and did not suffer any major structural damage (Figure 18). Damaged buildings suffered from bad construction practice issues, such as lack of reinforcement bars or grouting. However, this was mostly the case of 1960s and 1970s auxiliary structures or gravity bearing structures only, such as additions to older buildings or garages (Figure 19), and internal blockwork walls.

Figure 18 –Undamaged and lightly damaged RM buildings in the CBD.

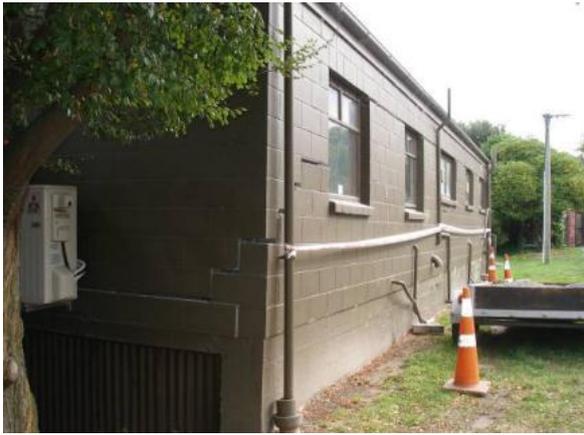
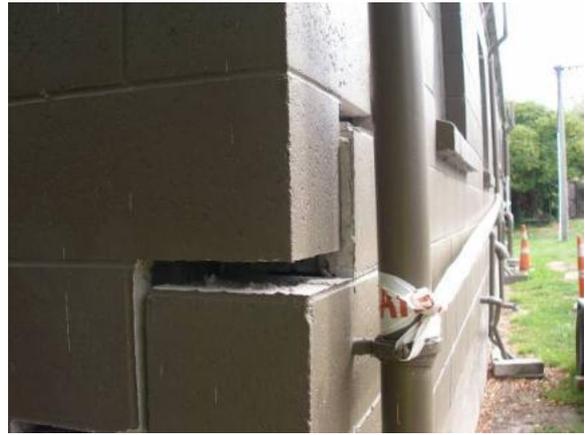
Figure 19 – 1970s RM addition. The building was badly damaged due to differential settlement in the ground. However, neither reinforcement bars, nor grout were to be found in the masonry.

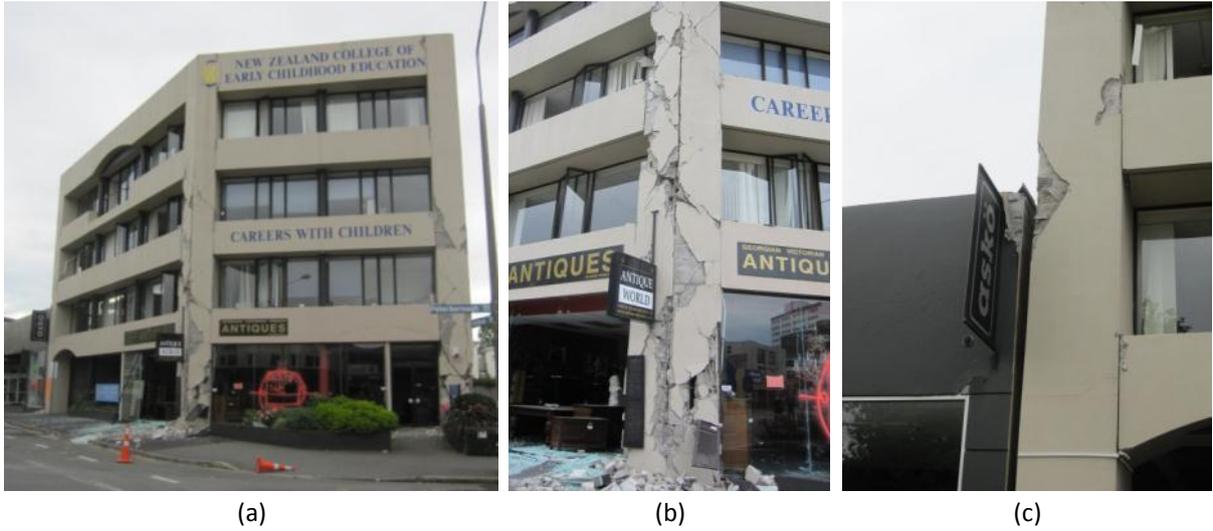
A notable example of a heavily damaged commercial RM building is shown in Figure 20. The building was on an obtuse-angled street corner, and therefore the layout was almost triangular, one very open façade (Figure 20a) with two long RM walls along the other two sides. This led to a heavy concentration of demand at the front corner column, which appeared to be rather lightly reinforced (Figure 20b). The neighbouring building was also very close (but unconnected) and pounding damage was observed in both buildings (Figure 20c).

Figure 20 – Heavily damaged commercial RM building on Victoria Street. (a) Irregular layout led to (b) heavy concentration of demand on corner column. (c) Some damage due to pounding with adjacent building was also observed.

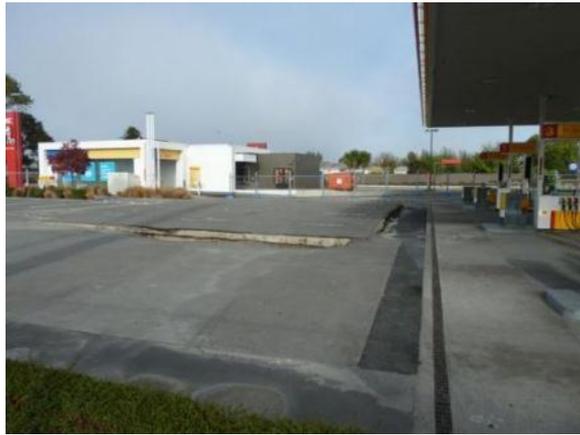
Figure 21 – A petrol station having suffered liquefaction. The underground storage tanks at this station have floated when the soil was in a liquefied state. The station was closed at time of survey.

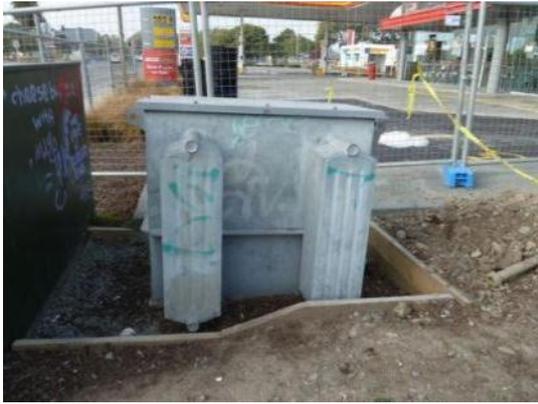
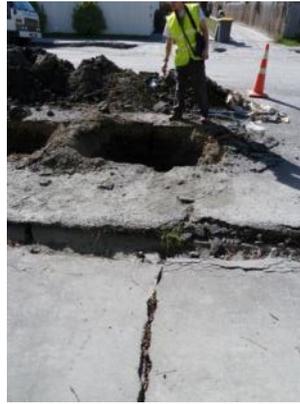
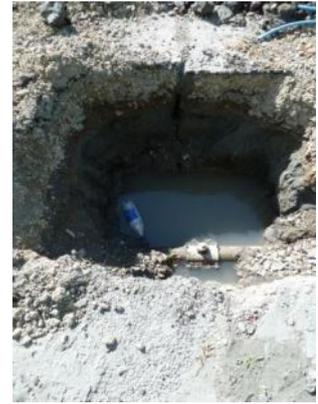
Figure 22 – (a) An electrical services box that had tilted due to liquefaction; it is not known if this resulted in loss of service. (b) A typical services failure that has been exposed ready for repair. This service was located approximately 200m from the river and was damaged from lateral spreading – note the crack in the road substrate in (c), this crack occurred across the entire road surface and is displayed in (b).

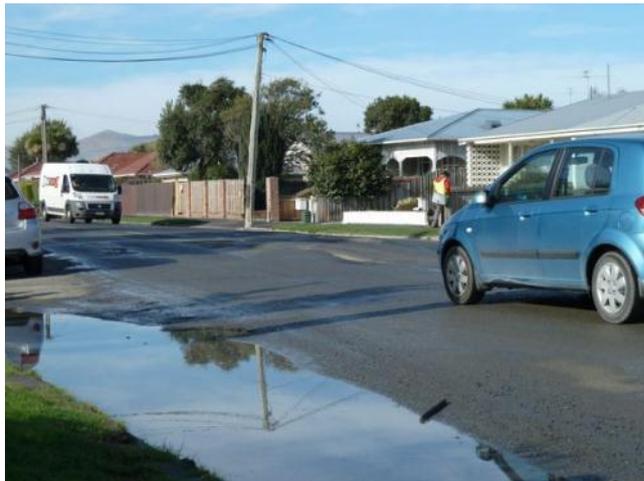
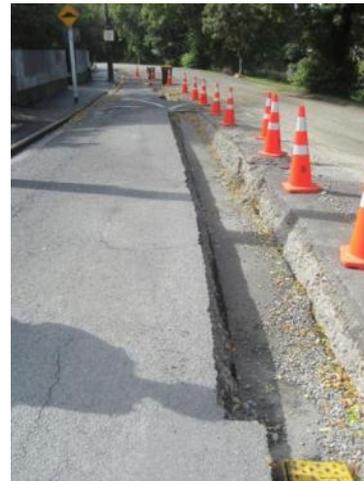
Figure 23 – (a) A residential road showing large undulations in the surface. This particular section of road had a speed restriction of 30 km/hr; however, for this particular section observed speeds were much less than this. This level of deformation of the pavement was not unusual and large areas of Christchurch experienced this level of damage. (b) Road failure due to lateral spreading. The trees in the top right of the photo show the start of the bank down to the river. Note the fire hydrant (yellow in the bottom of the picture showing that settlement had occurred along the service alignment. This was a common theme in the failure of roads and services due to lateral spreading.

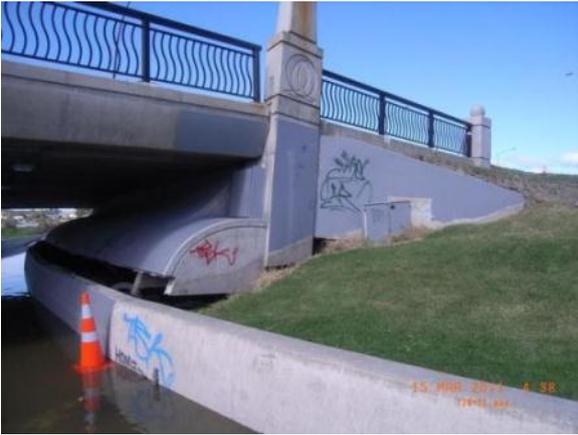
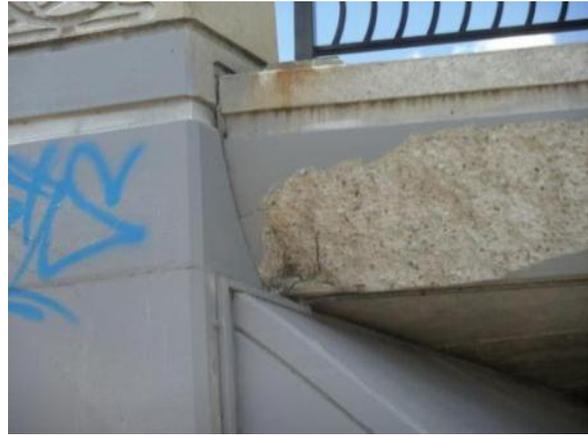
Damage to bridges due to ground shaking was minimal, with no bridges collapsing or significantly moving off their substructures due to ground shaking and damage was generally limited to spalling of concrete resulting from pounding (see Figure 25b), or movement of the superstructure on the substructure. There was some damage due to plastic hinges forming in columns and bridge piers. The greatest damage to bridges resulted from the widespread and acute lateral spreading experienced during the earthquake. This damage was generally confined to the abutments that suffered various degrees of rotation (Figure 25a). Flow of the soil towards the river generated very large lateral forces. These forces pushed the abutment towards the river; however, the bridge decks prevented movement at the top of the abutment (resulting in rotation of the abutment and a corresponding displacement, towards the river, at the base of the abutment). As the base of the abutment was connected to the piles, the tops of these piles, which had insufficient stiffness to resist the resulting lateral forces, moved relative to the bottom of the piles causing a relative rotation between the abutment and the pile and resulting in the observed plastic hinges. It was not possible to determine how far the piles may have moved towards the river however all the bridges inspected had plastic hinges at the tops of the piles and so they must have provided some lateral resistance and it is recommended that this be investigated. The lateral spreading also resulted in settlement of the approach road. The mechanism for this is that the abutments, which are on piles, do not settle vertically; however as the soil spreads towards the river there is a corresponding loss from the embankments causing the approach roads to settle. This mechanism was common and was the main reason for speed restrictions and failure of the services in the bridges.

Figure 25 – (a) Abutment failure of the Anzac Drive bridge (built in 2000), caused by lateral spreading. The abutments of this bridge were founded on steel piles, embedded well into the abutment, and it is assumed that plastic hinges formed in the tops of these piles. (b) Spalling of the bottom of the bridge deck at the abutments.

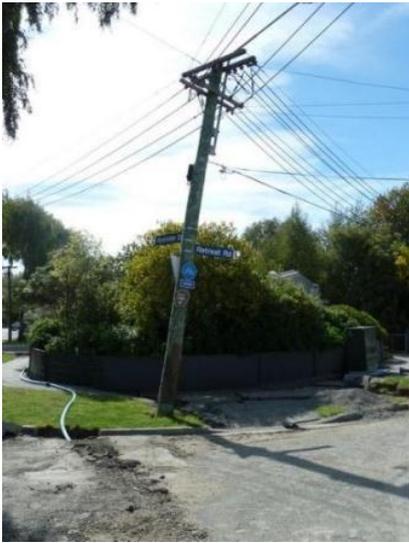
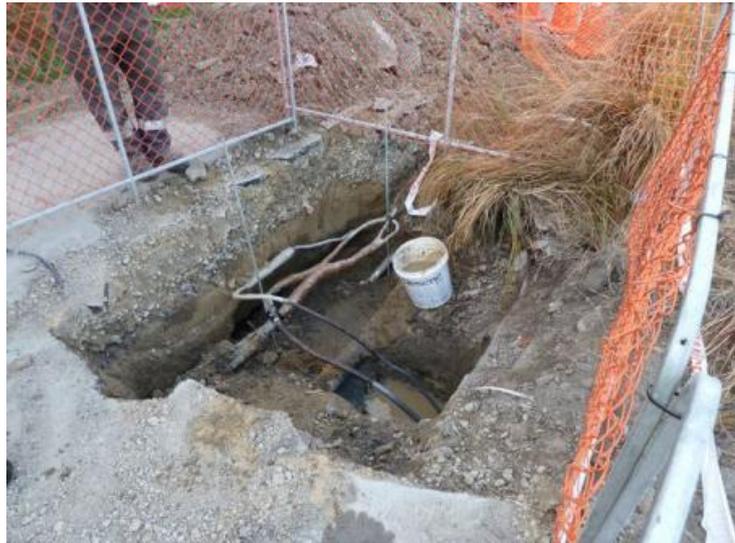
Figure 26 – (a) Out of plumb telecommunication poles were common in areas of liquefaction. (b) Repair of buried services was commonly observed at the time of survey and this picture depicts a telecoms service being repaired.

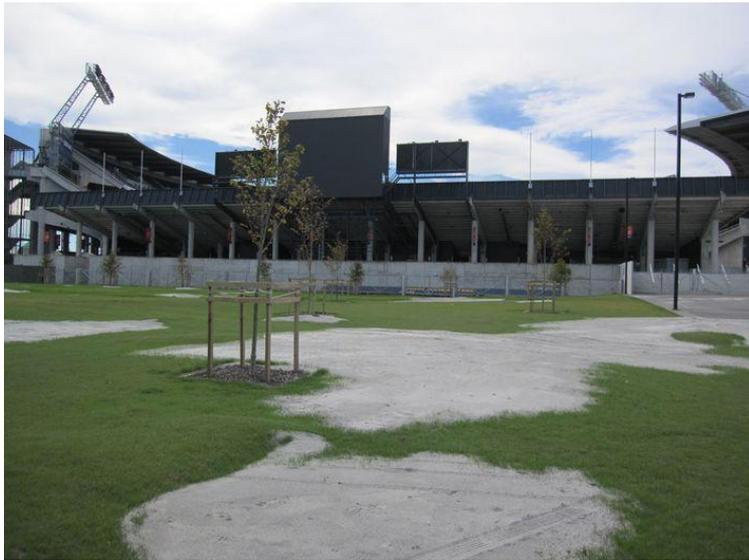
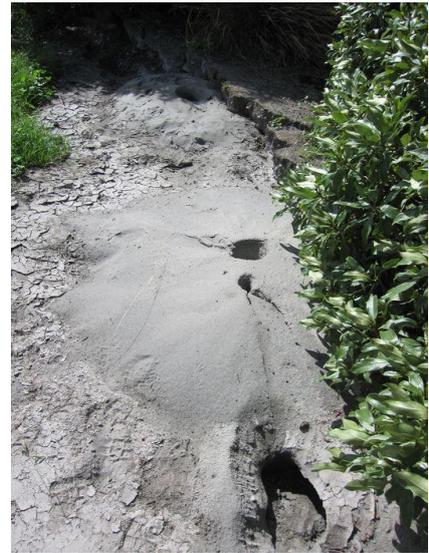
Figure 27 - (a) Sand boils outside the AMI Stadium generated from liquefaction of the Yaldhurst Member of the Springston Formation during the February 2011 earthquake. (b) Typical sand boils observed in suburban areas of Christchurch
