## **OBSERVATIONS AND IMPLICATIONS OF DAMAGE FROM THE MAGNITUDE $M_w$ 6.3 CHRISTCHURCH, NEW ZEALAND EARTHQUAKE OF 22ND FEBRUARY 2011**

Sean Wilkinson, Damian Grant, Elizabeth Williams, Sara Paganoni, Stuart Fraser, David Boon, Anna Mason, Matthew Free

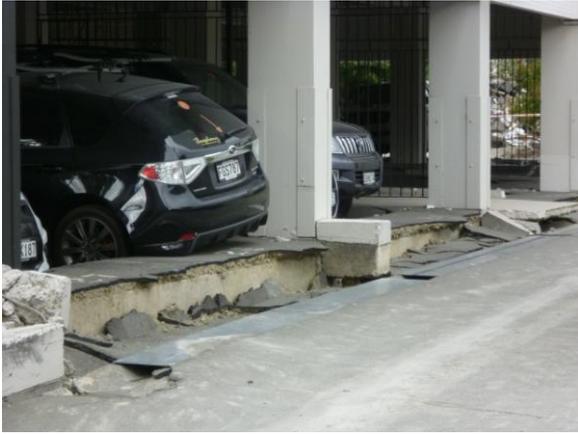
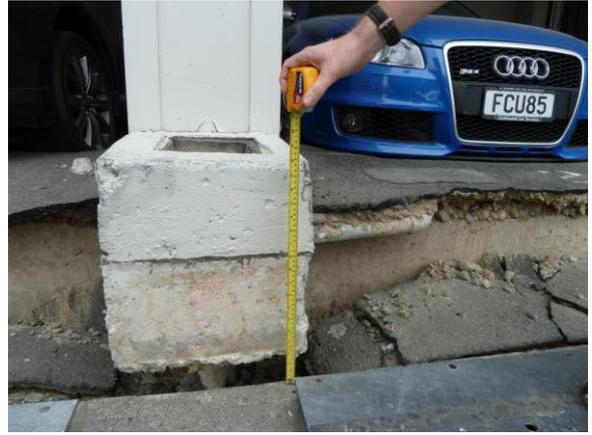
At the time of survey, only two of the buildings observed by the EEFIT team could be confirmed to have piled foundations. The performance of these two buildings was mixed. One 6-storey building, in an area of very severe liquefaction (but little evident lateral spreading) was shown to suffer minimal settlement compared to the surrounding ground. Figure 28 shows the foundation beams of the building exposed by almost 300 mm, trapping the cars parked inside.

Figure 28 – (a) and (b) Exposed foundation beams in a building with piled foundations.

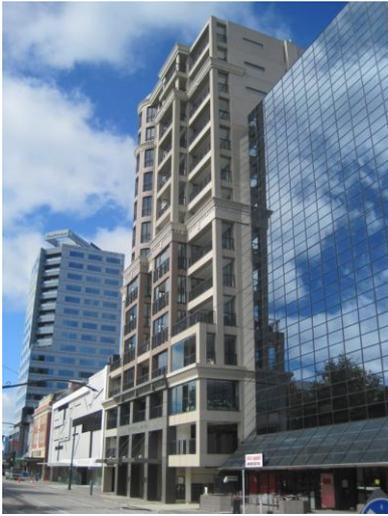
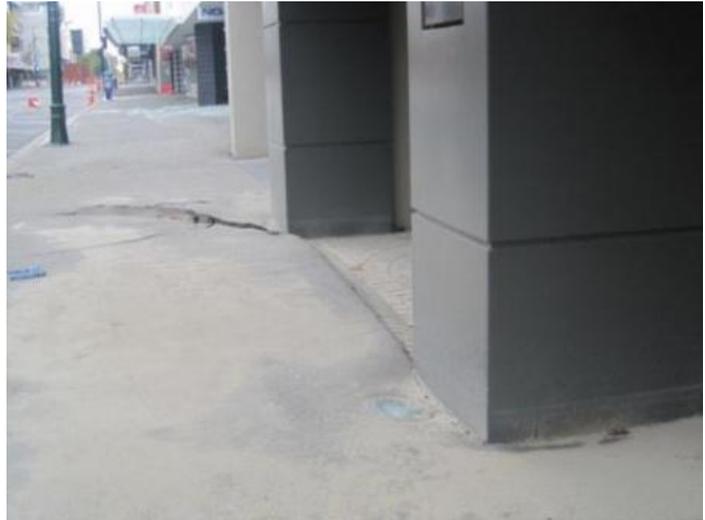
Another observed building (Figure 29) was confirmed to be on piles, though the depth of these piles was varying, with some quite shallow (Cubrinovski and McCahon, 2011). This building was one of two adjacent high-rise buildings tilting significantly, shown in Figure 29a. In the N-S direction, the buildings were tilting away from each other, while in the E-W direction they were tilting towards

Figure 29 - (a) Two multi-storey buildings tilting relative to one another. The taller building is thought to rest on piles of varying lengths. (b) Slight bulging of the pavement near the columns of the piled building.

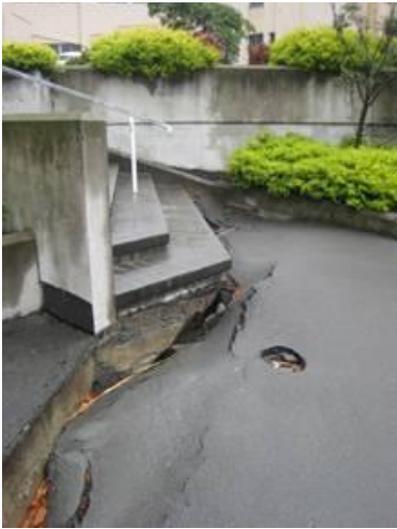
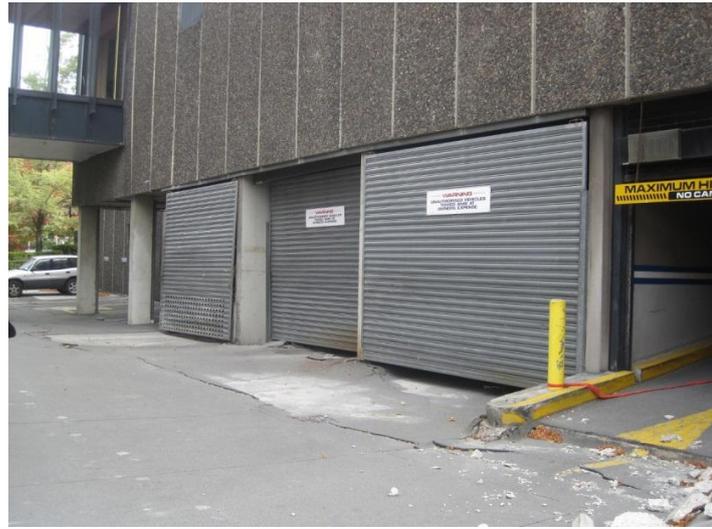
Figure 30 – (a) Localized settlement of the ground relative to a 20 storey high-rise building on a shallow raft foundation. This type of settlement was observed on all sides of the building. (b) Settlement of the ground relative to a large-plan multi-storey building with shallow foundations.

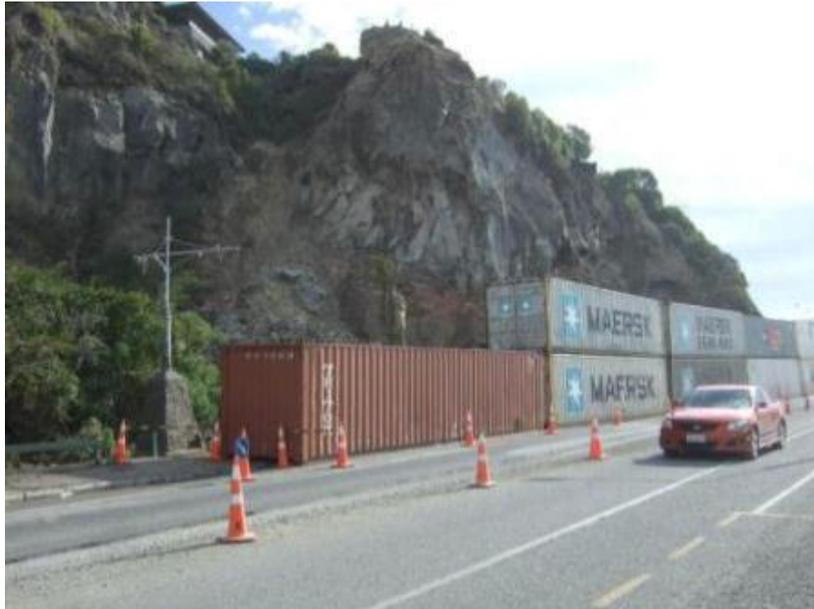
Figure 31 - Cargo containers have been temporarily placed between the cliff and Main Road to intercept any further falling debris. The rock fall debris obstructed the west bound (left) lane closing it to traffic.
