Ethiopia: CCTV well field review 2009

CR/09/080N

D F Ball

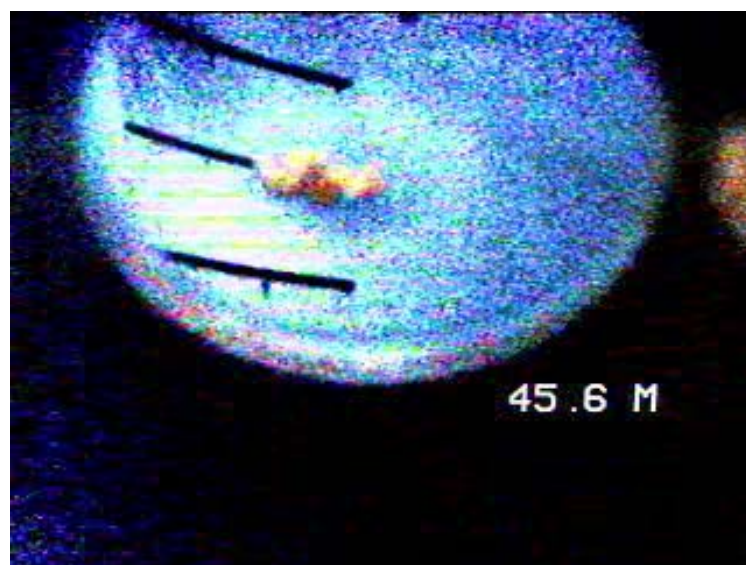
Figure 5. Screen slots and iron bacteria in the Gayo borehole

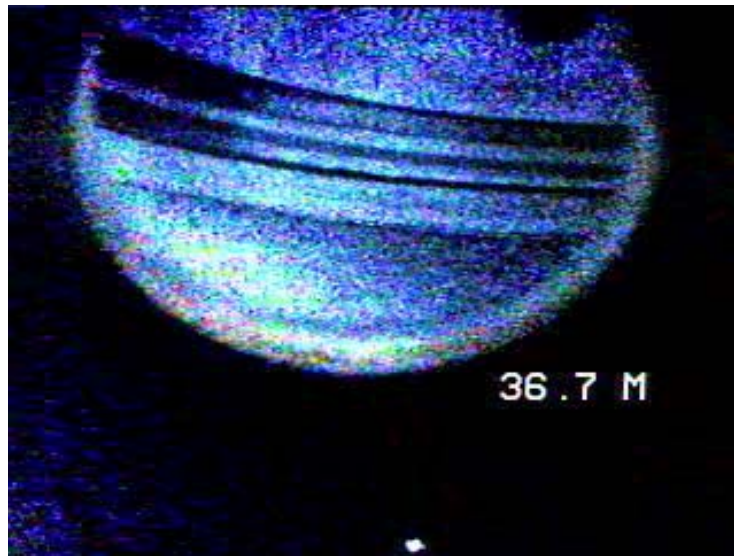
Figure 6. Partly-threaded PVC casing in the Gayo borehole

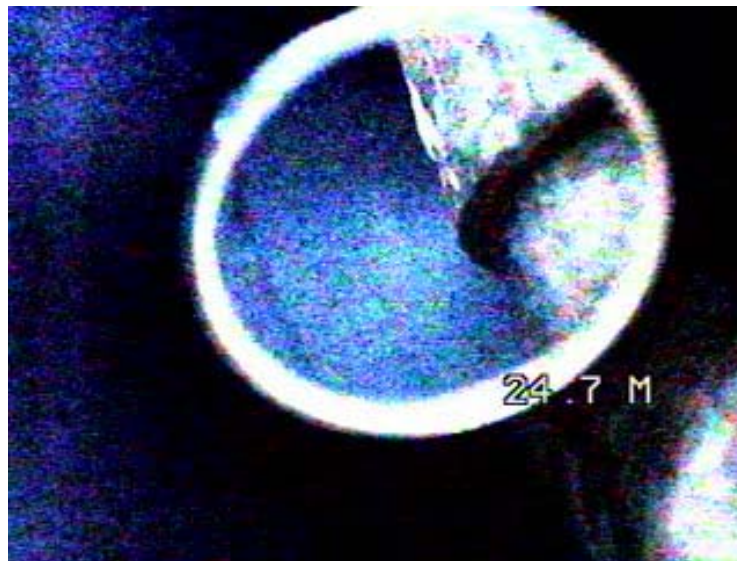
Figure 7. Steel rising main in the Gasory borehole

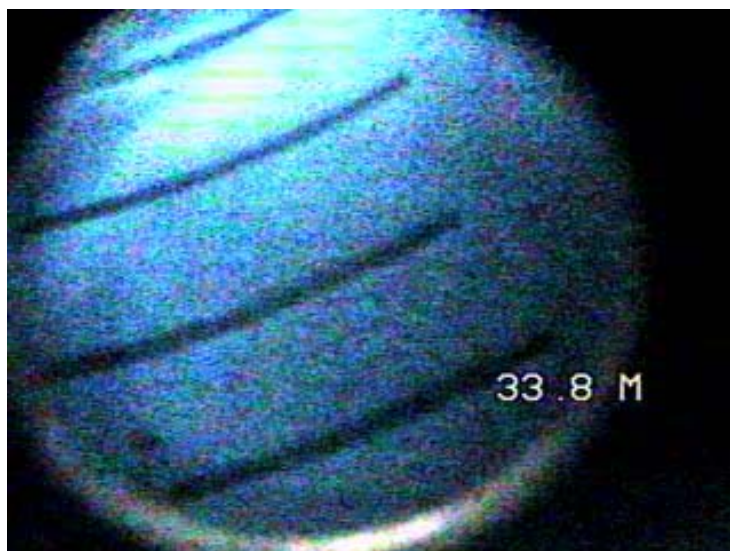
| SITE | CR SCREEN LENGTH (m) | SURVEY SCREEN LENGTH (m) | RATIO SURVEY SCREEN LENGTH TO CR SCREEN LENGTH | CR to SURVEY DIAMETER RATIO | WELLHEAD CONSTRUCTION |
|---|---|---|--|---|---|
| Wayou | 15+ | 12.8 | 0.85 | 1.0 | Poor |

Figure 8. Wayou borehole at 33.8 m below surface

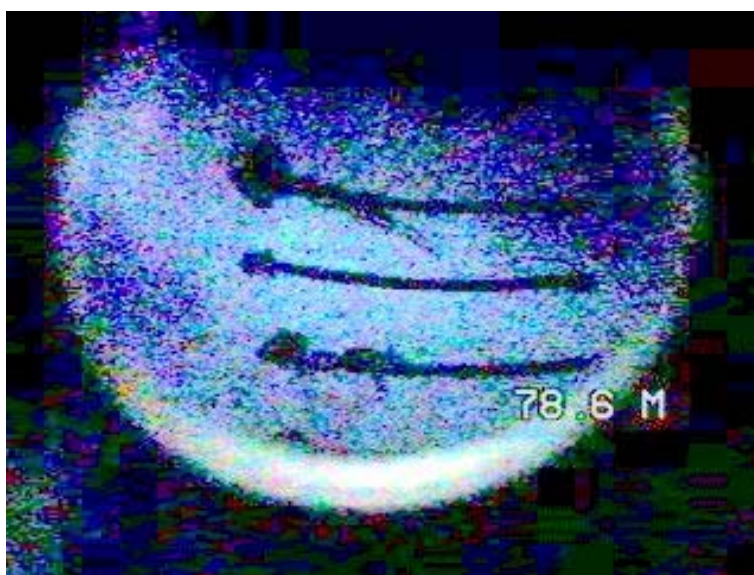
Figure 9. Partially-blocked screen in the Tatesa borehole at 78 m bgl
