East Cliff Landslide, Bournemouth

Last updated 15:00, 07/06/2016

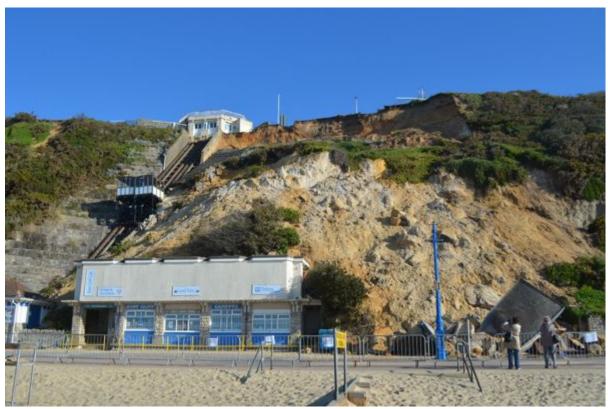
Landslide at East Cliff, Bournemouth, 24 April 2016. East Cliff lift (funicular) on far left, café on left and destroyed toilet on right. Undercliff Drive in foreground.

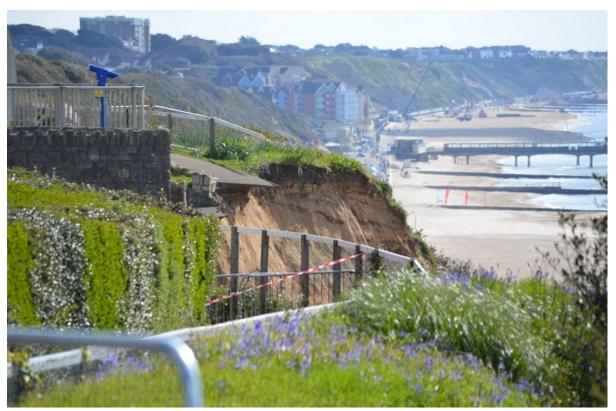
Backscarp of the East Cliff landslide, Bournemouth, 24 April 2016.

The landslide occurred on Sunday 24 April 2016 at approximately 05:00 on a section of East Cliff where it is approximately 35 m high with an overall angle (unslipped) of about 36 degrees.

The landslide is one of <u>partial rotation</u>, <u>and possibly translation</u>, <u>with debris flows</u> in the central and lower parts. A steep backscarp remains and a small secondary slip mass was seen at the upper eastern side of the main slip mass.

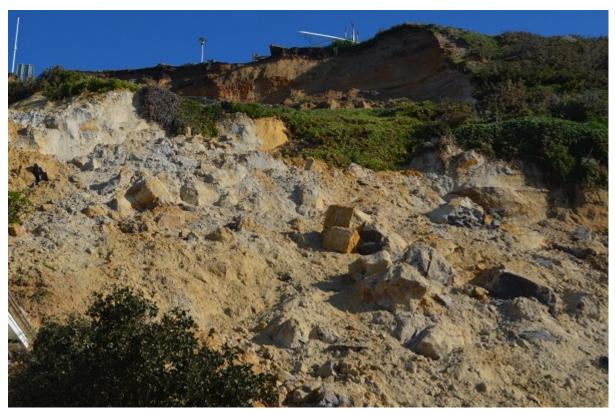
The slip mass of the East Cliff landslide, Bournemouth, 24 April 2016.

The landslide split either side of the café block (which remained intact) forming two masses of material. The slip masses contain several large boulders up to approximately $2 \times 1 \times 1$ m. The larger, eastern mass progressed farther downslope than the western due to the destruction of the toilet block. The slip mass as a whole appeared potentially unstable and further movements were considered likely.

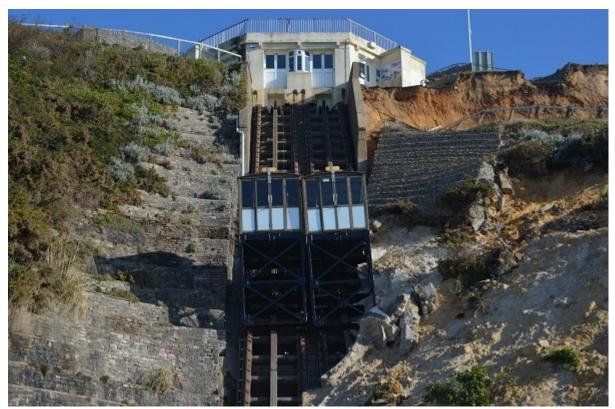
East Cliff lift funicular railway, constructed 1908, after the landslide, Bournemouth, 24 April 2016.

Little revetment masonry from the flanks of the East Cliff lift (constructed 1908) was evident in the landslide, though the eastern flank had dropped several metres leaving the concrete wall exposed. It is therefore possible that the landslide had overridden the bulk of the masonry on the central and lower parts of the slope.

The lower part of the lift track had been overridden by the landslide and the eastern of the two cable vehicles was affected, though they both remain in place. The western end of the upper part of the landslide had been curtailed by the concrete wall running along the trackside, thus effectively forming a western sidescarp.

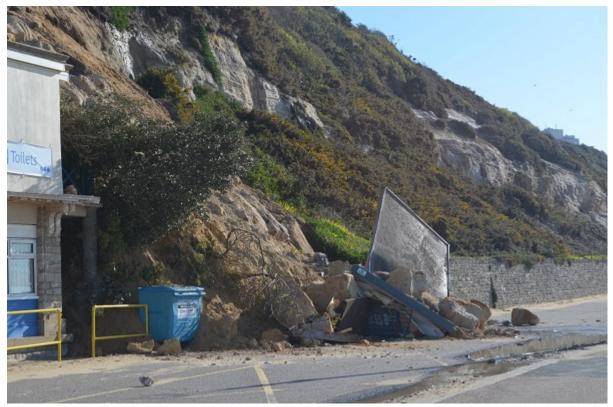
Toe of the landslide at East Cliff, Bournemouth, showing the toilet block, 24 April 2016.

What appeared to be clean water was seen emerging from the destroyed toilet block onto the road. This is assumed to be from a fractured water supply pipe within the toilet block. No water was observed emerging from the landslide itself, although access onto the landslide was not possible and hence the presence (or absence) of water within the landslide could not be confirmed.

A small landslide occurred at the location of the toilet block in 2008, destroying the previous block. The block now destroyed was its replacement.

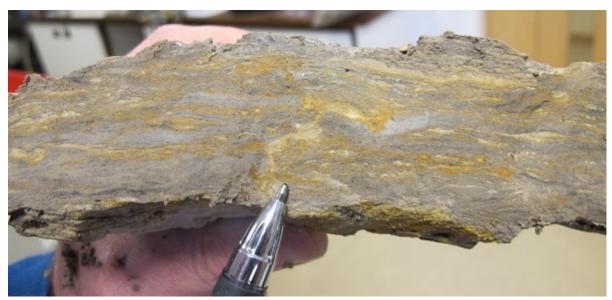
Example of Branksome Sand Formation bedding. Specimen taken from landslide debris. Thinly interbedded/laminated silty sands and silty clays, with a sand-filled drying (?) fissure.

The laminated and thinly bedded rocks of the Branksome Sand Formation are susceptible (in water) to <u>slaking</u> and possibly a tendency towards <u>liquefaction</u> resulting in total breakdown of the fabric. This is facilitated by the lack of cementation within the sand/silt component and possibly by swell/shrink action (on wetting) within the clay component. This gives the

Branksome Sand a rating of 'unstable' in the 'rock material stability in water' classification (BS EN ISO 14689-1).

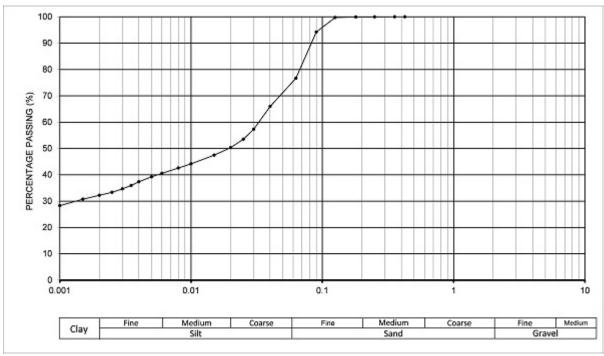
Particle size chart for Branksome Sand Formation sample. Note dominance of coarse silt/very fine sand.

The particle size chart shows the dominance of very fine silt and coarse sand with a significant clay content (sand: 23.3 per cent; silt: 44.5 per cent; clay: 32.2 per cent).

The intimate juxtaposition of sand and clay, characteristic of the Branksome Sand Formation, allows rapid movement of water through the rock mass and exposure of the clay component to water and hence swell/shrink deformation and cracking. These conditions are likely to have contributed to the development of a landslide shear plane within the Branksome Sand Formation, which has migrated upward to the cliff top forming a continuous surface.
