# Reconnaissance visit to assess the hydrogeology of the Oku area, Sekyere West District, Ashanti Region, Ghana.

Internal Report IR/01/153

J Davies and J Cobbing

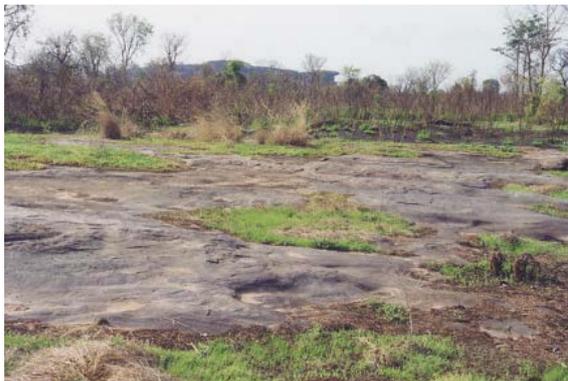
**Plate 1. Sandstones of the Obosum Formation, Voltaian Series cropping out near Bonkrom, eastern Afram Plains**

These sandstones have been subjected to long term tropical weathering to depths in excess of 40 m. This has resulted in the cementation of fine-to-medium sandstones with a mixture of red iron oxide and black manganese oxide cements resulting in loss of any primary permeability. The main water bearing targets appear to be fracture zones but although much work has been done on the location of such fracture zones using remote sensing techniques little has been done to characterise the geo-hydraulic nature of these fractures (World Vision, 1995). Studies using data derived from production boreholes to the east indicate that the upper weathered zone may form a

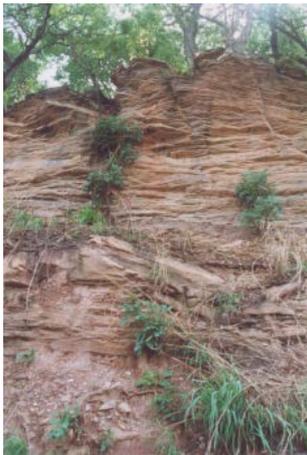
**Plate 2. Micaceous flaggy sandstones and mudstones of the Obossum Formation, Voltaian Series cropping out in a scarp south of Ejura**

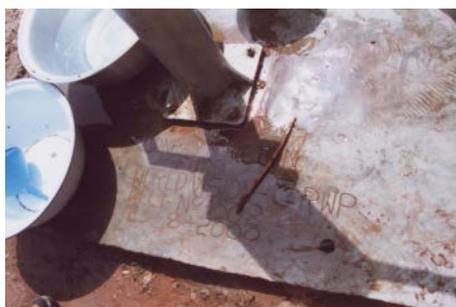
**Plate 3. Details of World Vision (WV) Bh 1502 on well head plinth**

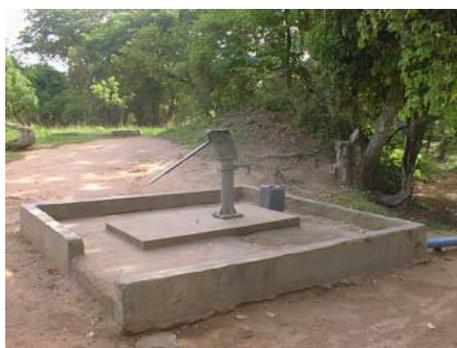
**(lat N7°21.514' / long W1°0.462')**

At the first site to the north of the village a group of three boreholes were seen (Plates 4-6). These boreholes were drilled more than 4 years ago. Each had a good yield for about the first three years, during which unrestricted pumping took place. In each case the borehole began to fail after this time. Although the surrounding area and stream flood regularly for prolonged periods during the wet season, there is no parallel increase in borehole yield, indicating that little or no recharge reaches the aquifer. Sandstone was noted cropping out in an adjacent stream section.

**Plate 4. WV Bh 681, poor yield, no recharge - formerly the best yielding pump in the area.**

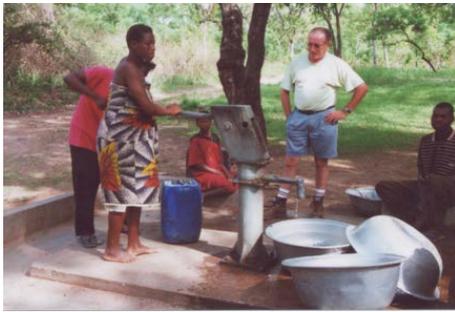
**(lat N7°21.49' / long W1°0.46')**

**Plate 5. WV Bh 497, poor yield, no recharge**

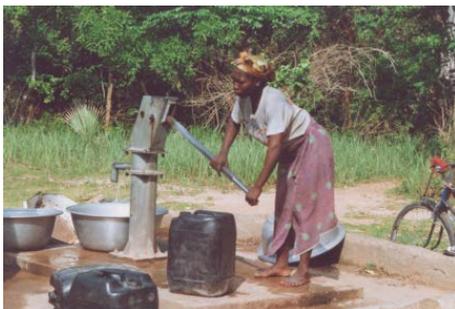
**(lat N7°21.504' / long  
W1°0.44')**

**Plate 6. WV Bh no number, poor yield, no recharge**

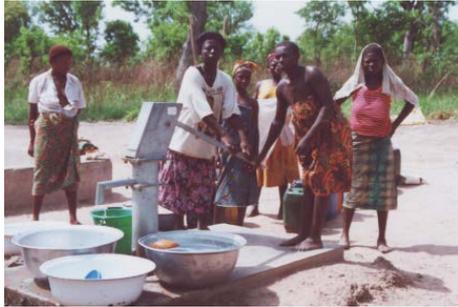
**(lat N07°22.311'/  
long W01°00.545')**

A similar history of yield decline followed the drilling of a fourth borehole (Plate 7) at the second site. Here the borehole yield was initially so good that Father Patrick and the local community considered equipping the borehole with a motorised pump with the aim of reticulating water to other parts of the village. Unfortunately the yield declined to 10-20 basins per day after a single year of use. The aquifer does not receive active recharge from floods or rainwaters.

**Plate 7. WV Bh 1502 completed 23/8/2000**

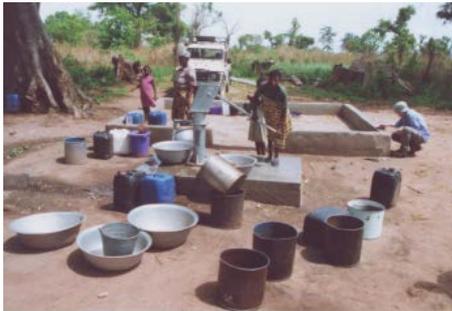
**(lat N07°20.697'/  
long W01°00.020')**

At the third site yet another poorly yielding borehole was viewed which initially had good yield (Plate 8). Seepage water accumulates within the borehole over night to provide some 5-6 basins of water in the morning. Following this abstraction it takes more than one hour to fill a basin with water at the reduced yield which presumably equates with the rate of seepage inflow. Again there is no improvement in rate of yield during the wet season indicating little or no recharge to the underlying fractured aquifer system.

**Plate 8. WV Bh 1506, poor yield**

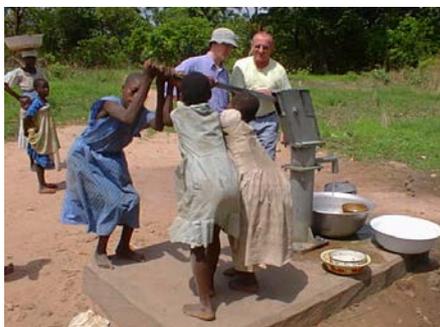
(lat N07°20.659'/ long W01°00.295')

At the fourth site the team viewed the 'Macho Pump', so called because it requires several people to operate it (Plate 9). This borehole, according to Father Patrick, has been low yielding and difficult to operate since installation. This borehole was located adjacent to a stream course on a lineation but still has a poor yield of 5-6 basins per day and receives little or no wet season recharge.

**Plate 9. WV Bh (no plate) ('Macho Pump')**

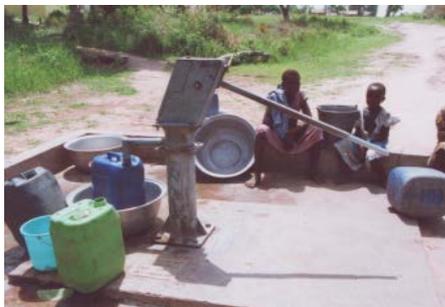
A second borehole at the fourth site (Plate 10), located further away from the stream course than the 'Macho Pump' was also inspected. Again this borehole has had a poor yield since it was installed. Little or no improvement in yield is noticed during the wet season implying little or no recharge to the underlying aquifer system.

**Plate 10. WV Bh 498, poor yield, no recharge. (N7°20.659'/W1°0.195') Children have to wait up to 30 minutes before additional water can be pumped from this borehole**

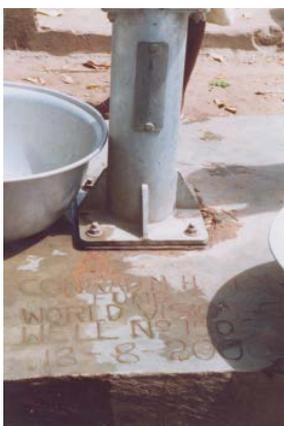
Borehole water levels can be measured by passing an electrical dipper through an access hole normally covered by a metal plate (Plate 11).

## **Plate 11. Borehole access hole located on an India Mark II hand pump**

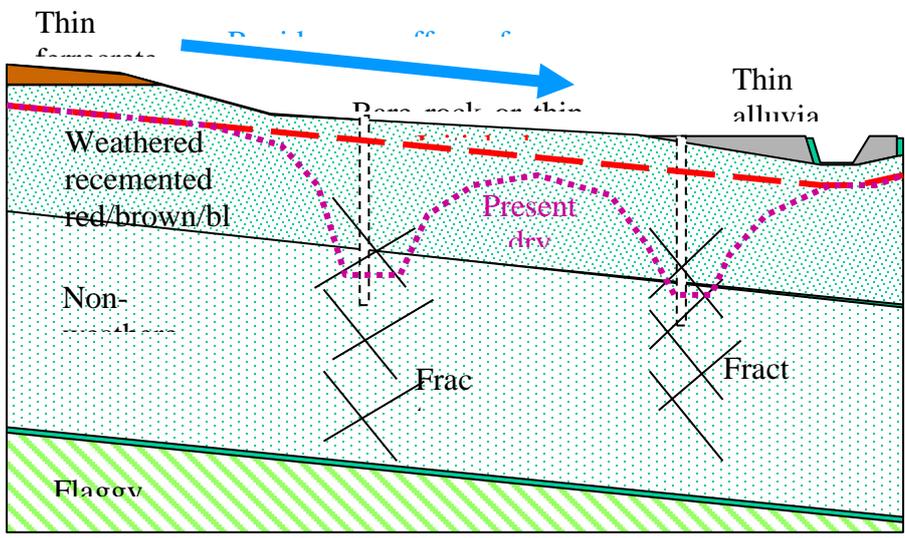
The area is underlain by a consolidated sandstone formation of unknown thickness that appears to dip to the north-east (Figure 3). This formation may be underlain by a flaggy sandstone formation that crops out along the valley of the Afram River to the south-west. The boundary between the two formations is marked by a scarp some 30-60m high. The consolidated sandstone formation forms a poor aquifer, water being found mainly along fracture zones, but there are no borehole data to substantiate this assumption which is based upon experience drawn from the APDO area to the east. That the flaggy sandstone formation forms a good aquifer is shown by the incidence

**Figure 3 Cross-section showing possible geology and hydrogeology of the Oku area**

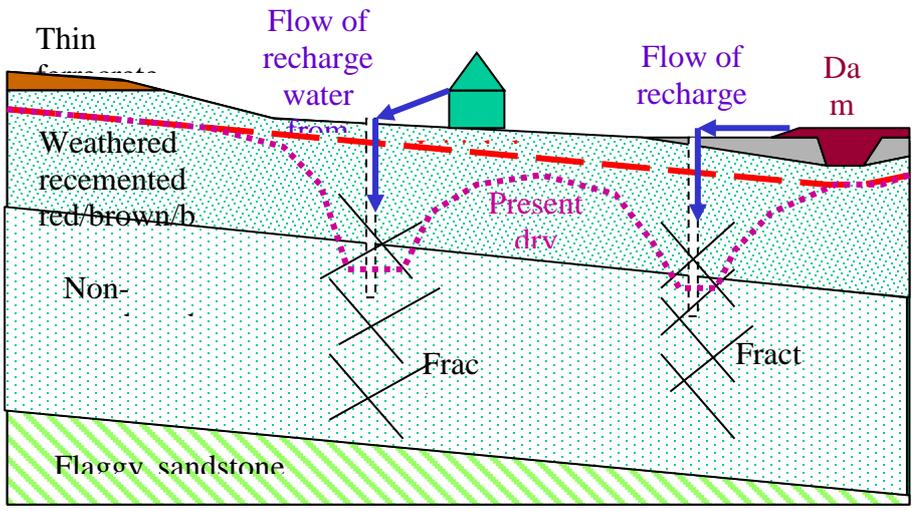
**Figure 4 Cross-section showing possible methods of artificial recharge of rainwater to the underlying fractured consolidated sandstone aquifer**

From the limited data available the consolidated sandstone appears to have a permeability of about  $3 \times 10^{-7}$  to  $1 \times 10^{-6}$  m/s, which is typical for fractured consolidated cemented sandstones. Given the decline in pumping yield experienced since borehole installation the water resources of the system appear to have been successively mined over the years with little active recharge by seasonal rainfall reaching the system. Presumably any fractures and permeable horizons within the sandstone would have been dewatered over the years. Water now enters the system by seepage from the low permeability rock alone. Presumably in such a consolidated sandstone formation the emptied void space may still be open to receive water injected by artificial recharge. In the short term a falling head test should be undertaken upon one of the formerly high yielding boreholes to see if this is still the case. If there is scope for artificial recharge, consideration should be given to the seasonal recharge of rainwater to the underlying aquifer to provide a dry season resource. This may be done using water collected in roof-top catchments and/or filtered stream water collected in ponds (Figure 4).

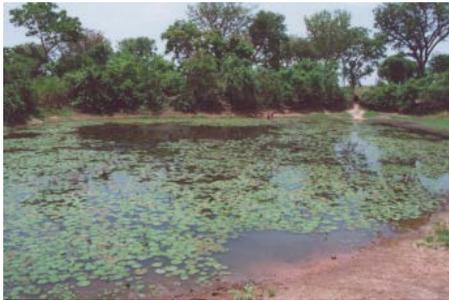
**Plate 12. Berem Pond**

A small dam that contains water all the year round was inspected at Berem some 10km to the south of Oku (Plate 12).

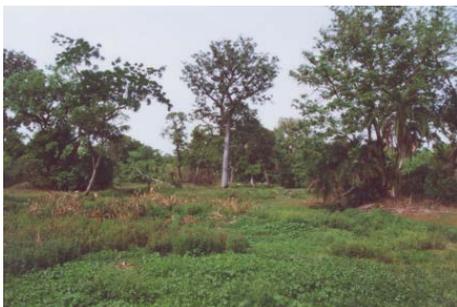
**(lat N7°21.937' / long W1°0.64')**

The first site (Plate 13) is located in a small valley north of Oku village where shallow pits were excavated to obtain water from the alluvium during the dry season. The stream course could be dammed to increase the amount of water stored in the shallow pits in the dry season.

**Plate 13. Oku dam site 1**

A large diameter dug well, possibly with radial collecting laterals to increase the yield, could be constructed in one of the thicker areas of alluvium in a shallow valley, such as the first site mentioned above (Plate 13). The river and rainfall in the rainy season would recharge the alluvium, which would act as a storage medium and potentially constitute a source of water throughout the dry season. The success of such a well would partly depend on the thickness of alluvium in which it was constructed. A survey using trenches or a hand auger would need to be conducted to identify the thickest part of the alluvium. The well could be dug by hand at a diameter of around two metres, and it is advisable that a ferrocement or similar lining be used to reinforce the top two or three metres. Such a lining should project above the surface of the ground to provide some protection from flooding and contamination. The laterals could be constructed by trenching radially from the well, below the water table, then filling the trenches partially with some coarser, permeable material such as gravel before completely backfilling with alluvium. A dug well would be less vulnerable to surface contamination than a pond, as the natural filtering effect of the alluvium would remove impurities. A dug well could be constructed almost entirely with local materials and labour, although it is potentially vulnerable to flooding and is also dependent on the thickness of the alluvium.

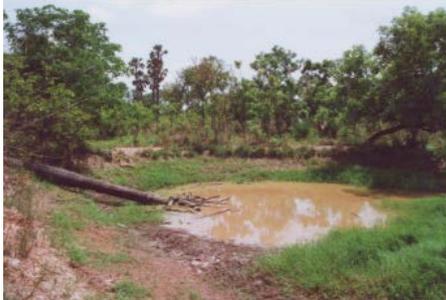
**(lat N7°20.529' / long W0°59.744')**

**Plate 14. Dam site 2**

The second site, an old dam located east of Oku Junction, was excavated by a logging company and has fallen into disuse (Plate 14). It could be re-excavated using a logging company bulldozer.
