Initial report on the Scroggs Cleuch landslide, Lockerbie, December 2006

Internal Report IR/06/138

N R Golledge

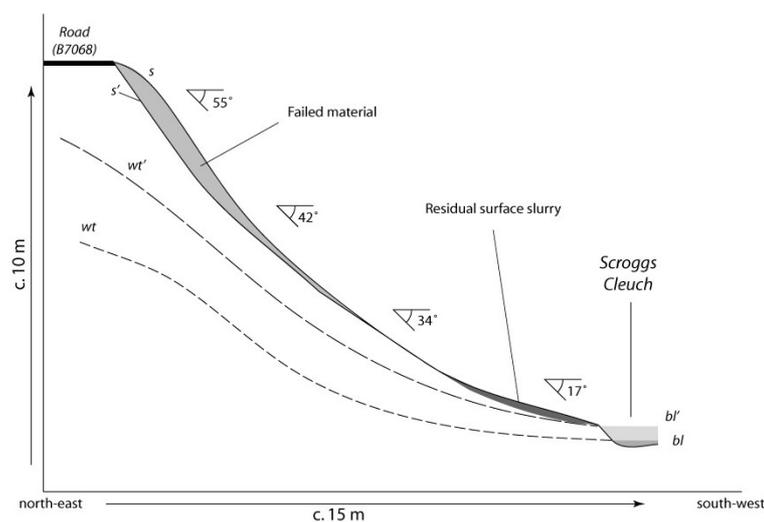
The 8 m wide headscarp tends from initially sub-vertical to an approximately 55° slope within the top metre. Downslope measurements show a decreasing slope angle towards 17° at the toe. Failure appears to have occurred in the upper 3-5 m of the red-brown silty diamicton (subglacial till) that makes up much of the area. In total the failure site is c. 10 m high from scarp to toe, and approximately 15 m in length (Fig. 4).

Figure 4. Schematic drawing of the failure site showing slope angles and locations of failed and residual material. wt and wt' represent hypothetical normal and elevated pre-slide water table positions respectively. bl and bl' denote normal and elevated pre-slide water levels respectively, and s and s' are pre and post-failure ground surface approximations. Not to scale.

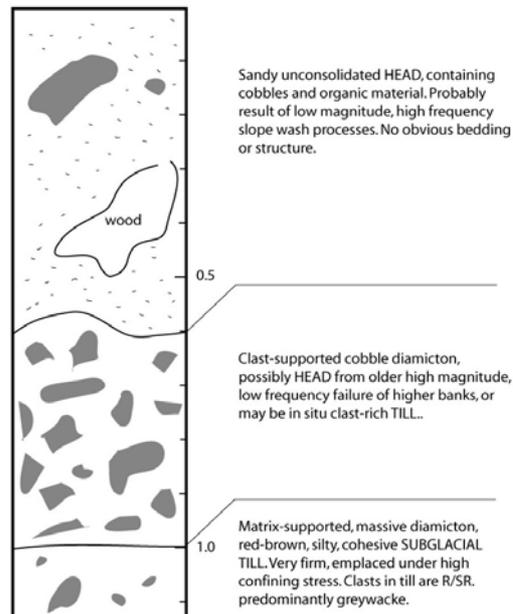
This is likely to have been the case along the length of Scroggs Cleuch. The exposed material in the eroded banks proved at one location to be comprised a c. 0.5 m thick surface unit of poorly consolidated red silt and sand with cobbles and organic material, overlying a 0.4 m thick clast-supported cobble diamicton that in turn rested on cohesive, matrix-dominated red diamicton at the water level (Fig. 5).

Figure 5. Vertical section through water-level bank exposure c. 10 m SSE of failure site.

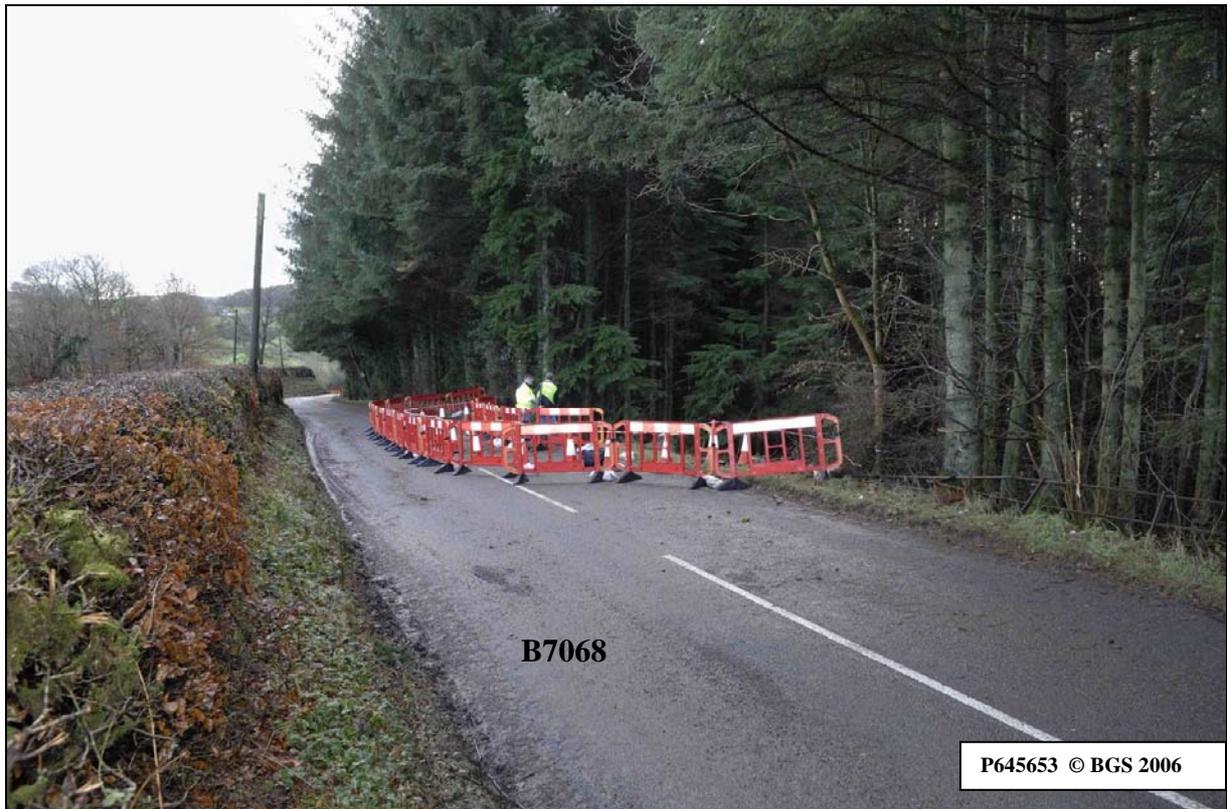
i) View SSE along section of B7068 near Scroggs Cleuch, showing failure site

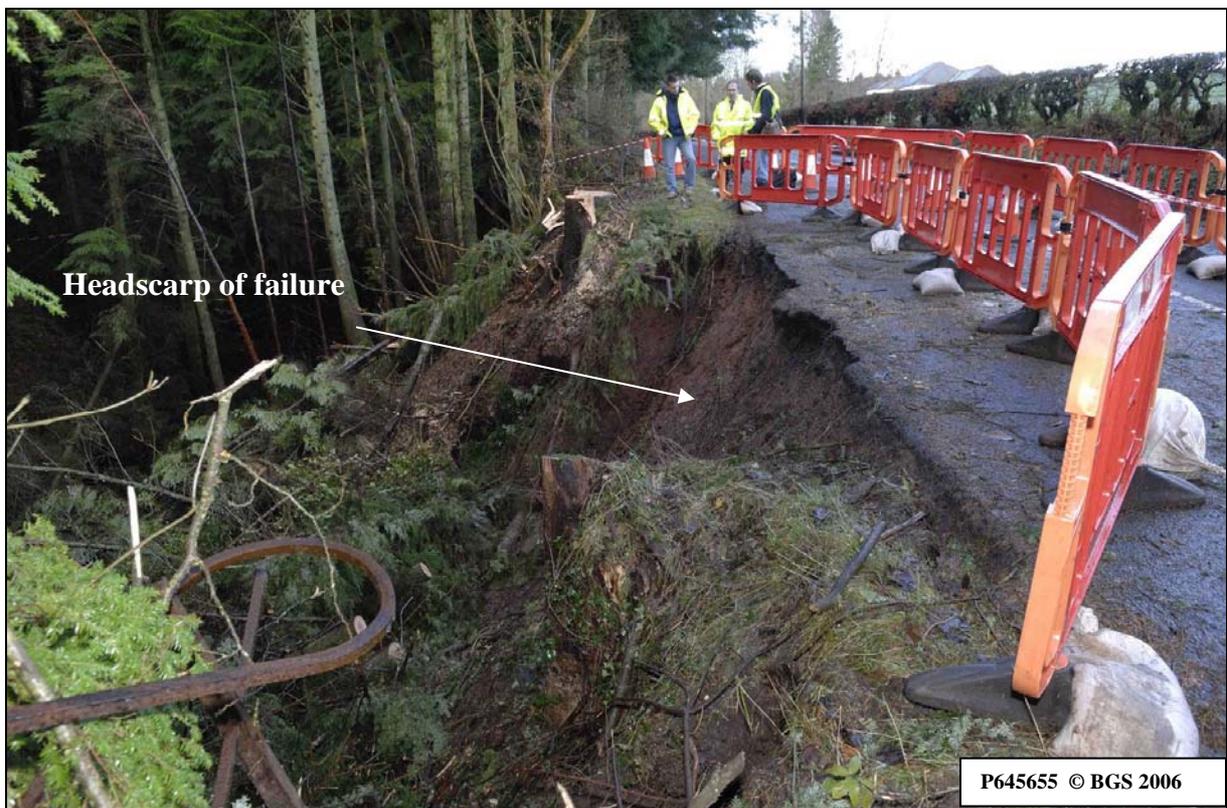
Marginal portions of the road also failed, and scarp-parallel tension cracks of centimetre-scale width and decimetre to metre-scale length were visible within the tarmac. Evidence of older failures and subsidence of the road edge was also noted to the NNW and SSE of the failure site. Road construction appeared to consist of 80 mm tarmac over 120-150 mm hardcore, directly lain on the glacial substrate. The accessible portion of the headscarp showed abundant root growth throughout the substrate. The presence of tree roots may have aided coherence of the substrate both prior to and during failure.

ii) Headscarp of failure, view NNW

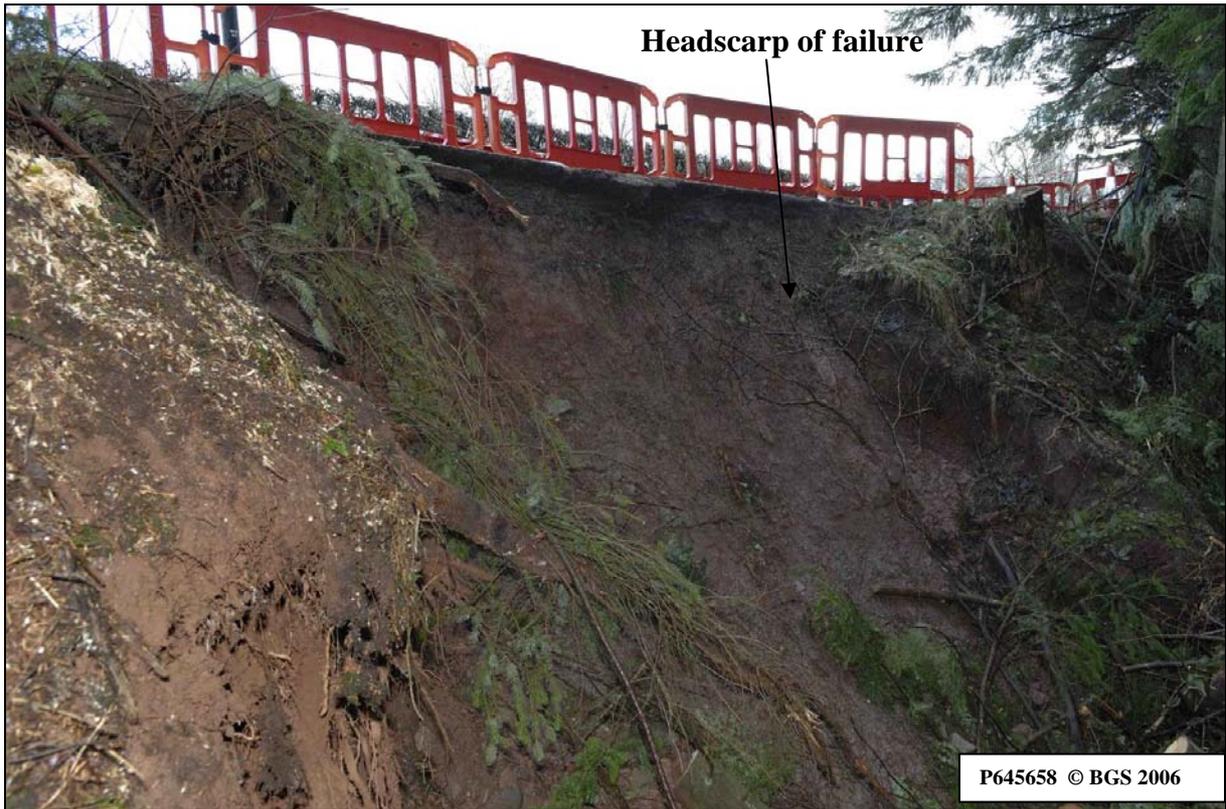
iii) Failure scarp of landslide

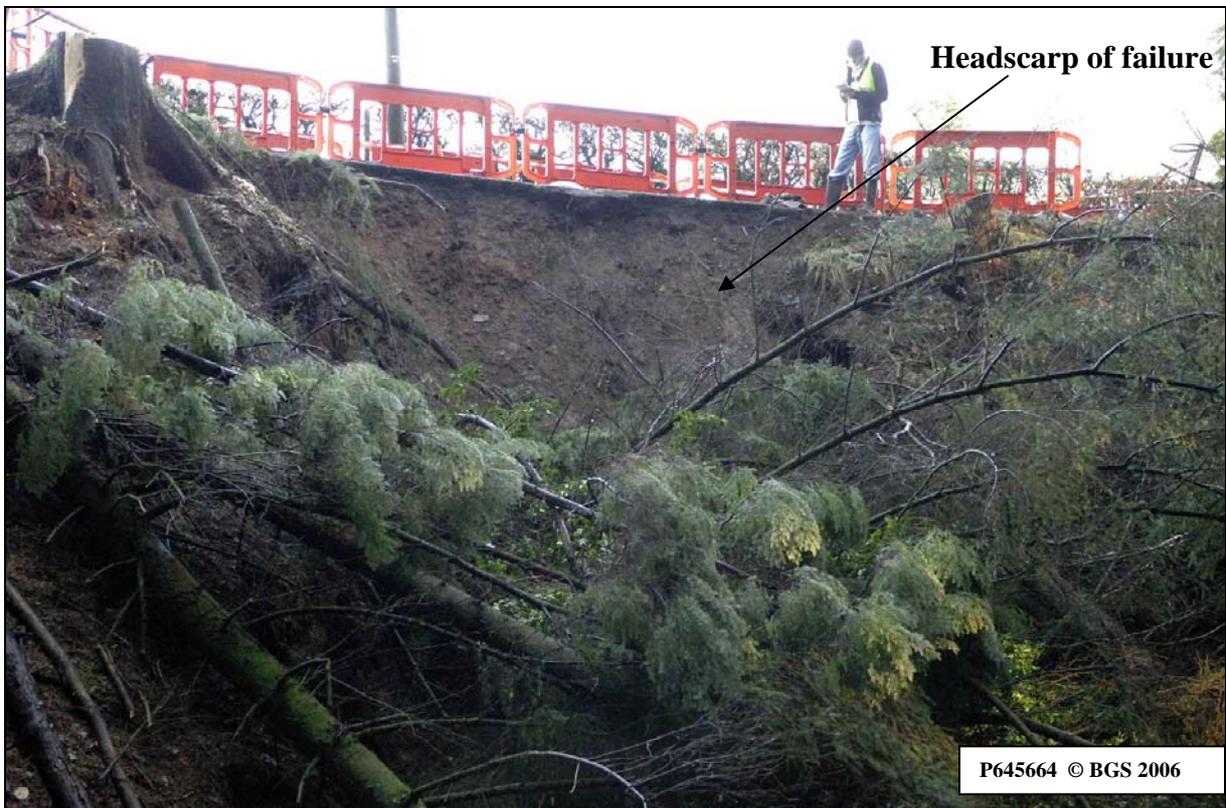
The failure site is densely wooded, and in clearing the road and making the area safe, many of the trees on the failed material had been felled and lay in the gully overlying much of the slipped material. Therefore, access to the slide was only possible at the headscarp and at the toe, and in both cases only at the sides.

iv) Fallen and felled trees obscure midsection and toe of landslide

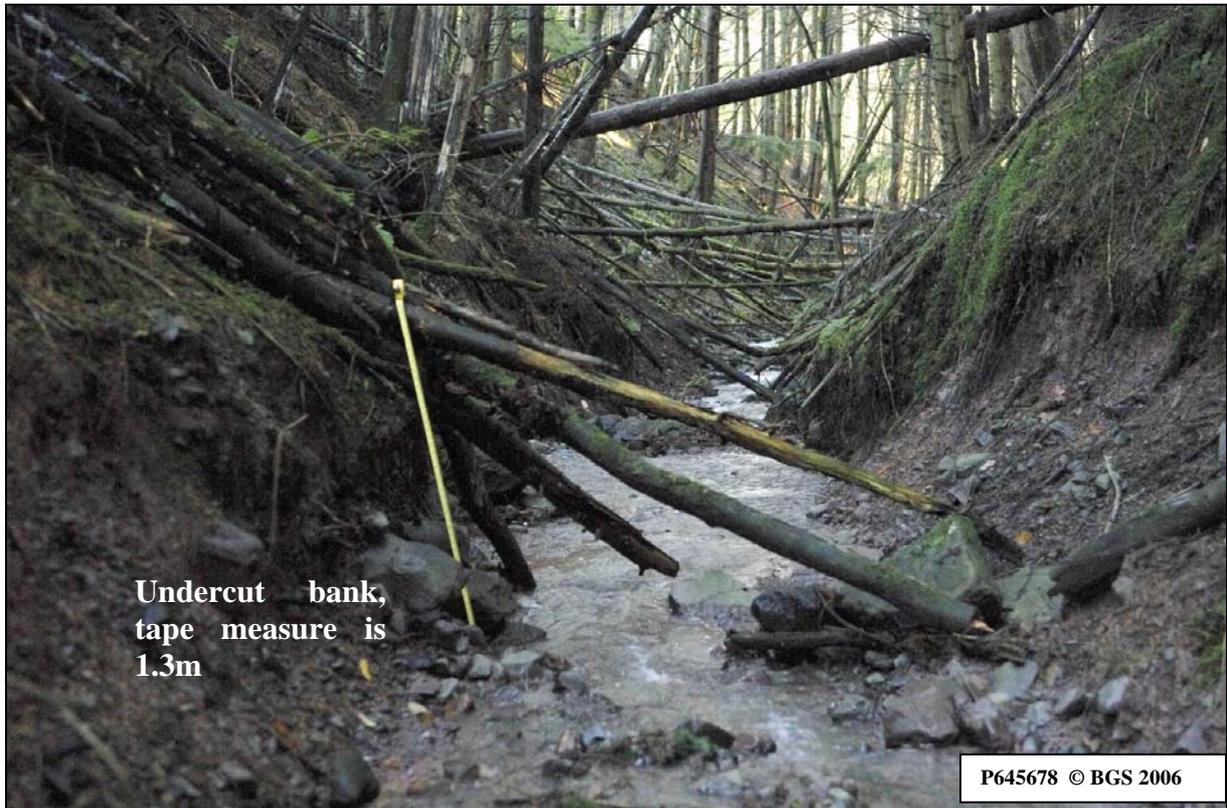
No loose material was seen in the area of the headscarp, but material accumulated near the toe was clearly disaggregated except where bound by tree roots. At the toe itself, much of the loose material was saturated and formed a slurry. The gully into which the material slumped hosts a narrow burn c. 1 m wide and normally only a few decimeters deep. The banks downstream of the failure site, however, showed signs of oversteepening to a height of 1.3 m above the observed water level, consistent with their having been undercut by a significantly larger volume of water.

v) Scroggs Cleuch looking SSE from landslide toe. Note undercutting of banks on both sides

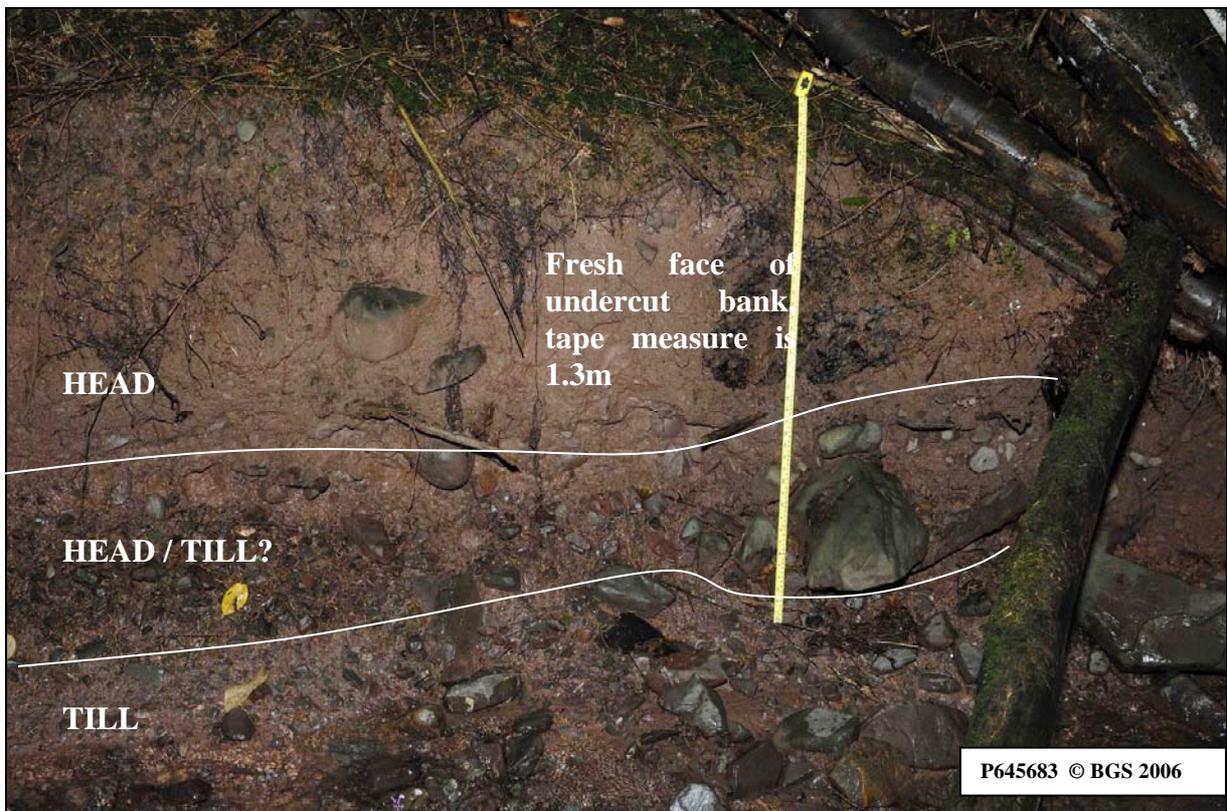
vi) Freshly eroded face cut in bank; section as in Figure 5.

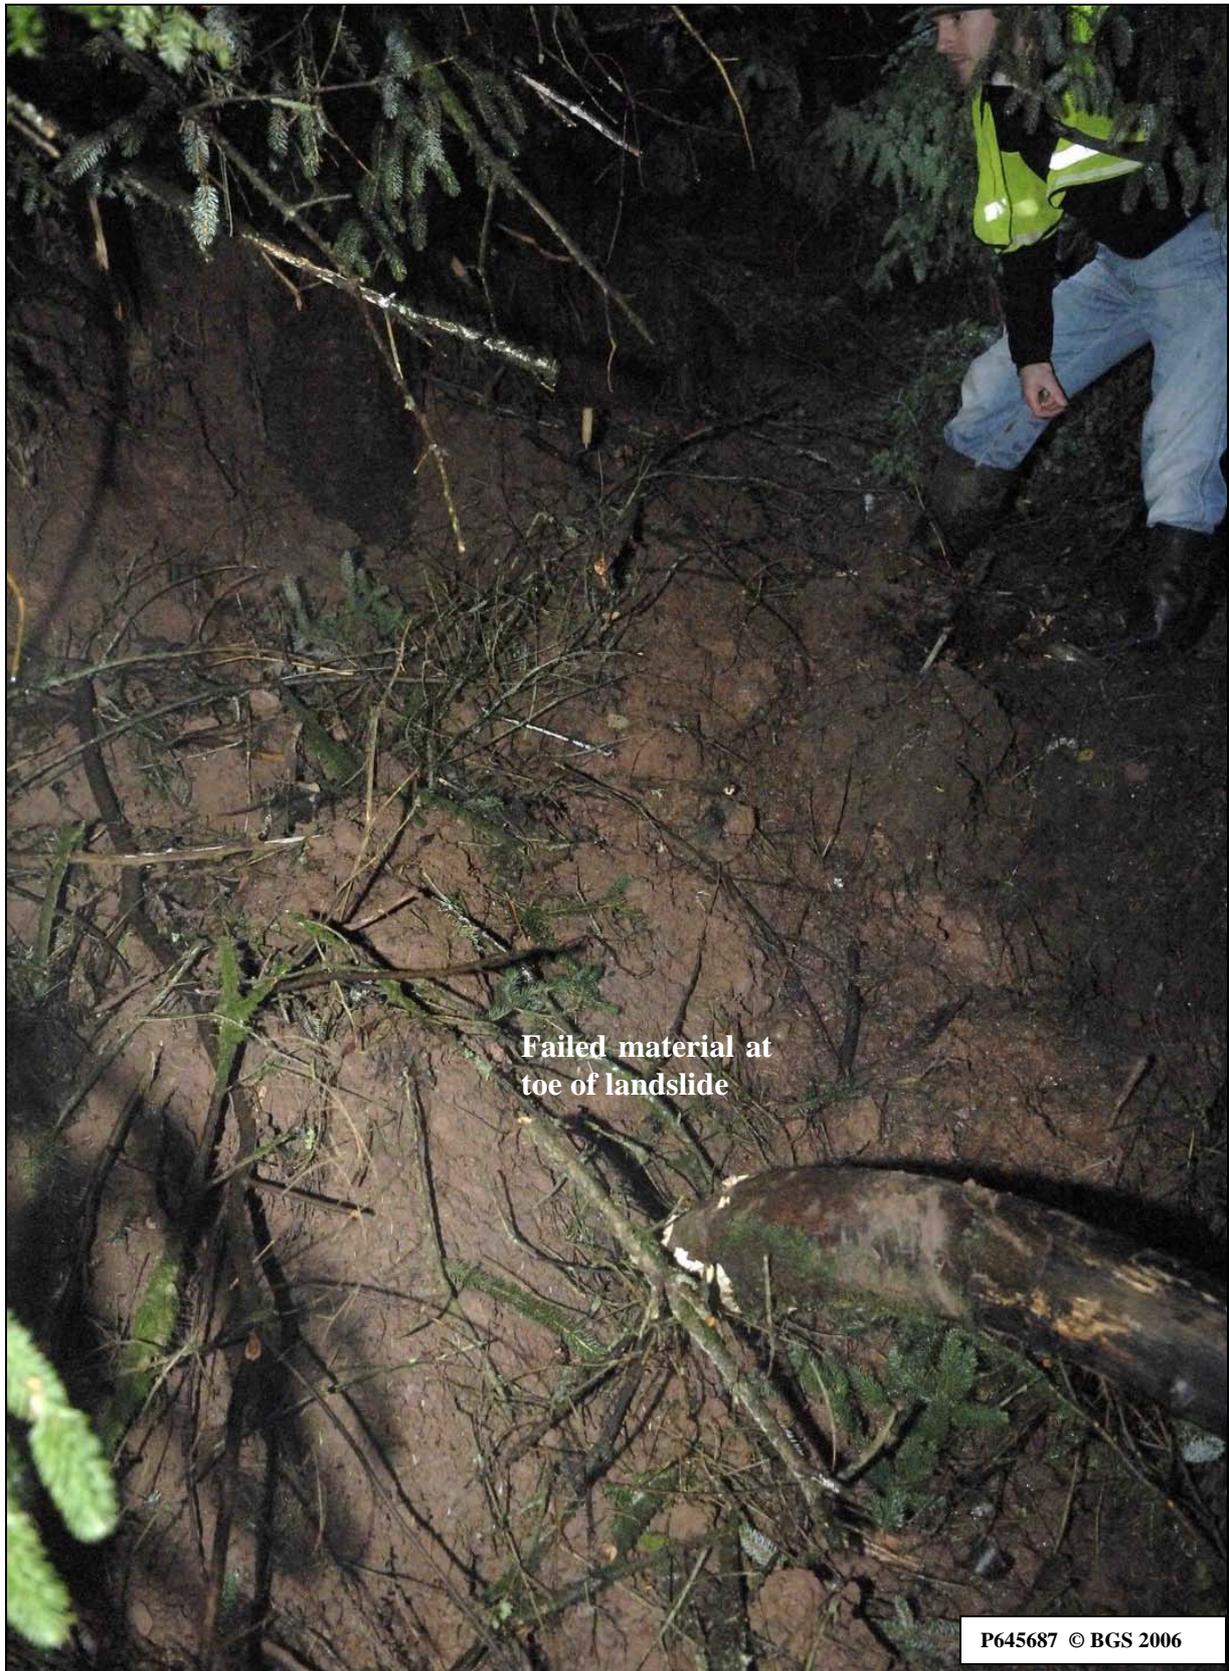
vii) Partially dewatered failed material at toe of landslide, incorporating vegetation

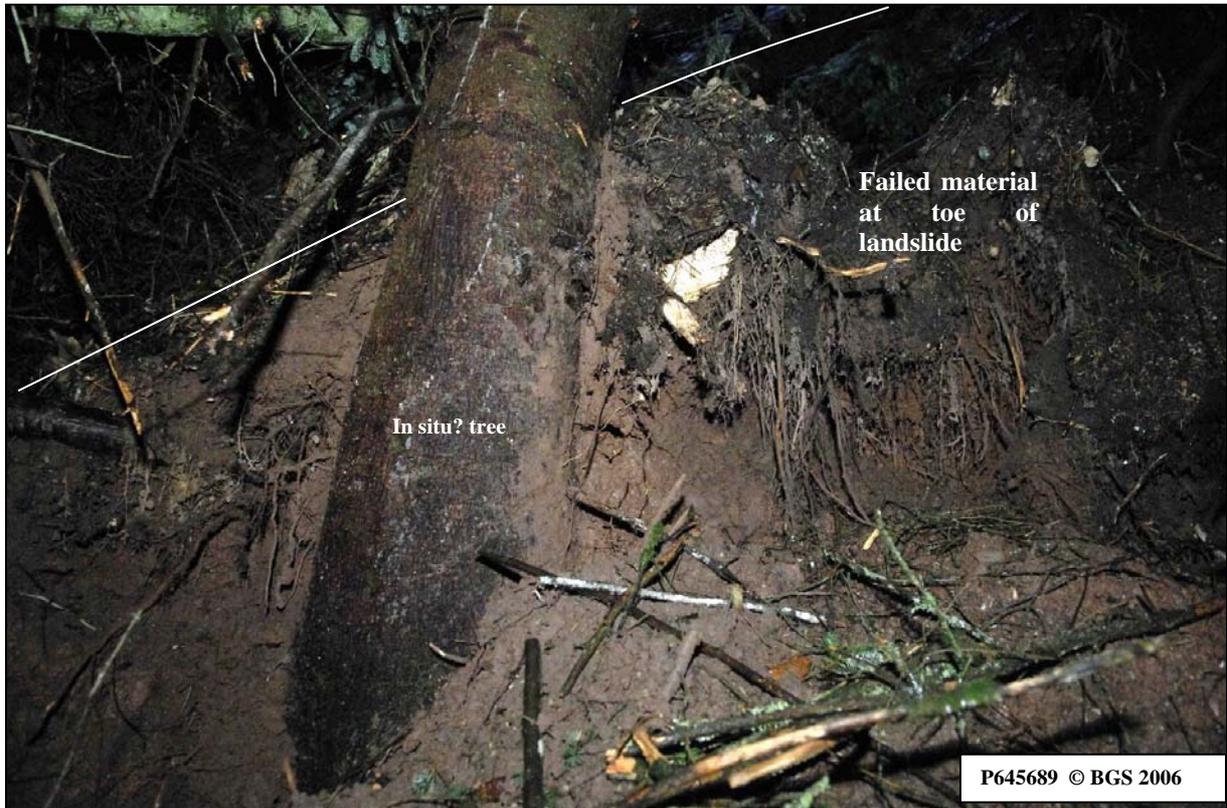
viii) Cross-section through toe of landslide, sediment surrounding possibly in situ tree.
