The Horncliffe landslide, Berwick-upon-Tweed, December 2008

Open Report OR/08/071

N R Golledge

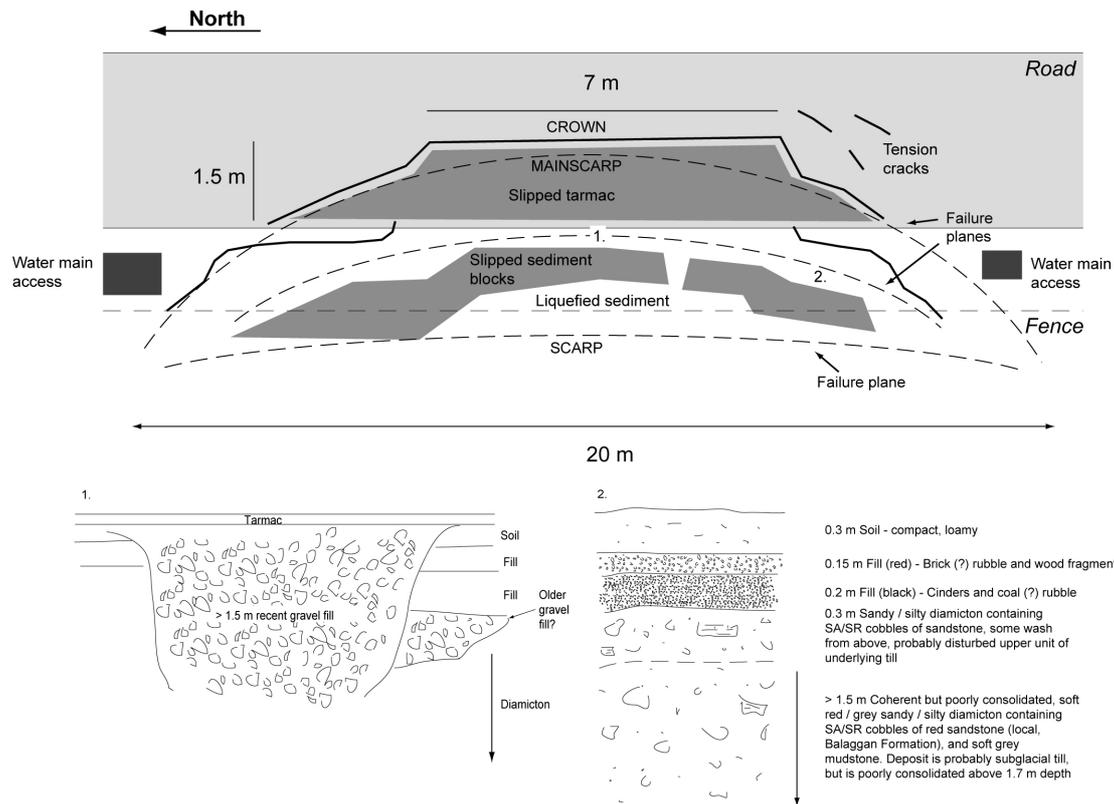
subsequently backfilled with loose, c. 50 mm-grade gravel aggregate, to a depth of >1.5 m. Following bank failure, the new tarmac laid over the aggregate had slumped (c. 0.3 m drop) and buckled and detached from the older portion of the road (Fig. 4 and Appendix).

The c. 20 m wide main scarp (Fig. 4, 5, 6A) displaces a c. 7 m-long section of tarmac from the road, with tension cracks in the road evident to the south. The gradient of the slip surface tends from initially sub-vertical to flat within the top few metres, where semi-intact blocks of the failed material formed a bench. Below this bench a secondary scarp marks the top of the debris flow gully, which drops initially sub-vertically before grading to an average slope of c. 26.6°. Failure appears to have occurred in the upper 3-5 m of the red-brown silty diamiction (subglacial till) that makes up much of the area. In total the failure site is 21.8 m high from scarp to toe, and is 48.75 m in length (Fig. 6B). In plan, the failure has an inverted ‘teardrop’ shape, with the widest part at the top. The failed area beneath the centre of the primary failure plane is delimited by an arcuate backscarp, undercut or oversteepened striated and grooved flanks, and a central area of displaced vegetation, rock (aggregate) debris, and liquefied sediments. This contrasts with the area of river bank to the south, where it is still wooded and where the slope remains relatively intact. Below the main scarp in this area are several minor scarps, hidden amongst the trees, identifying rotational blocks that have slipped only a short distance. No evidence was seen in this area that failure had resulted in a debris flow.

Figure 4. Schematic plan drawing of the mainscarp of the failure, showing locations of principal failure planes, backscarps, slipped material and the two vertical sections (1 & 2) shown below. Not to scale. 1. Vertical section through recent gravel infill at the centre of the mainscarp, and 2. Vertical section through in situ sediments and fill at southern end of mainscarp.

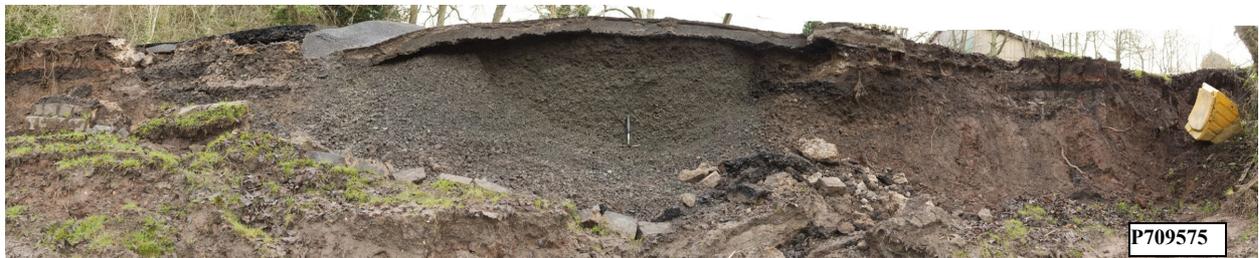
Figure 5. Panorama of the mainscarp of the failure, showing the central area where recent gravel fill has been washed out, leading to undermining and collapse of the road. Note the reddish diamicton overlain by black and red fill to either side of the grey gravel. Grit bin (right) and hammer (centre) for scale.

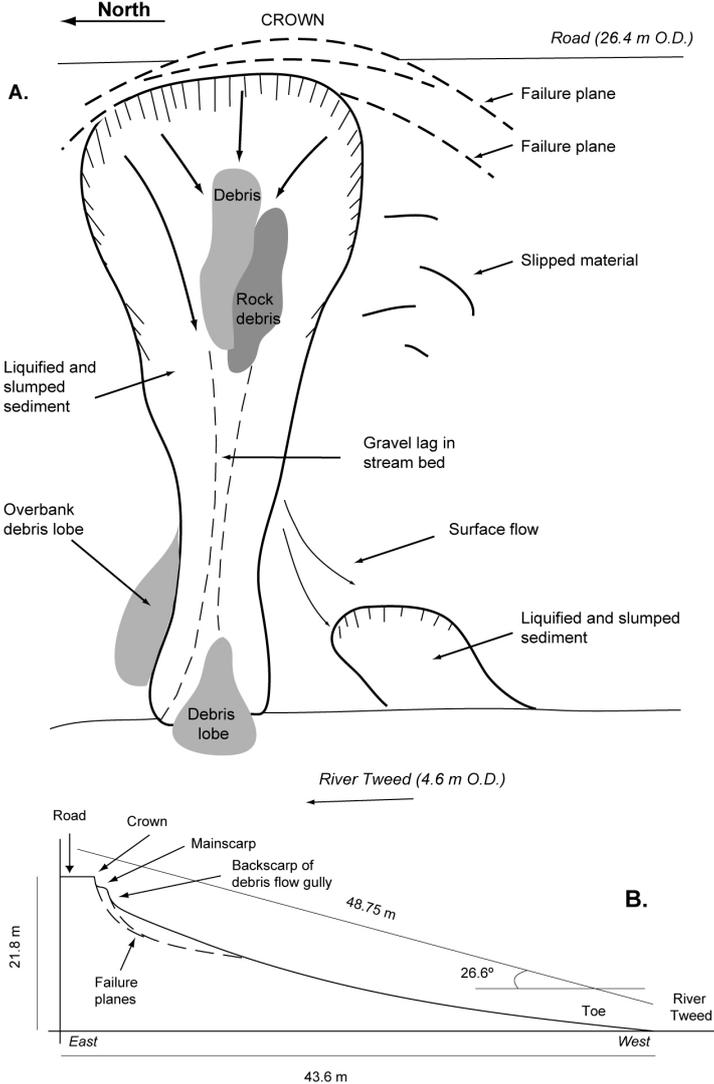
Figure 6. A. Schematic plan drawing of the failure site showing locations of principal failure planes, backscarps, and residual material. Not to scale. B. Cross-profile of the failure, showing length, height, and mean slope angle.

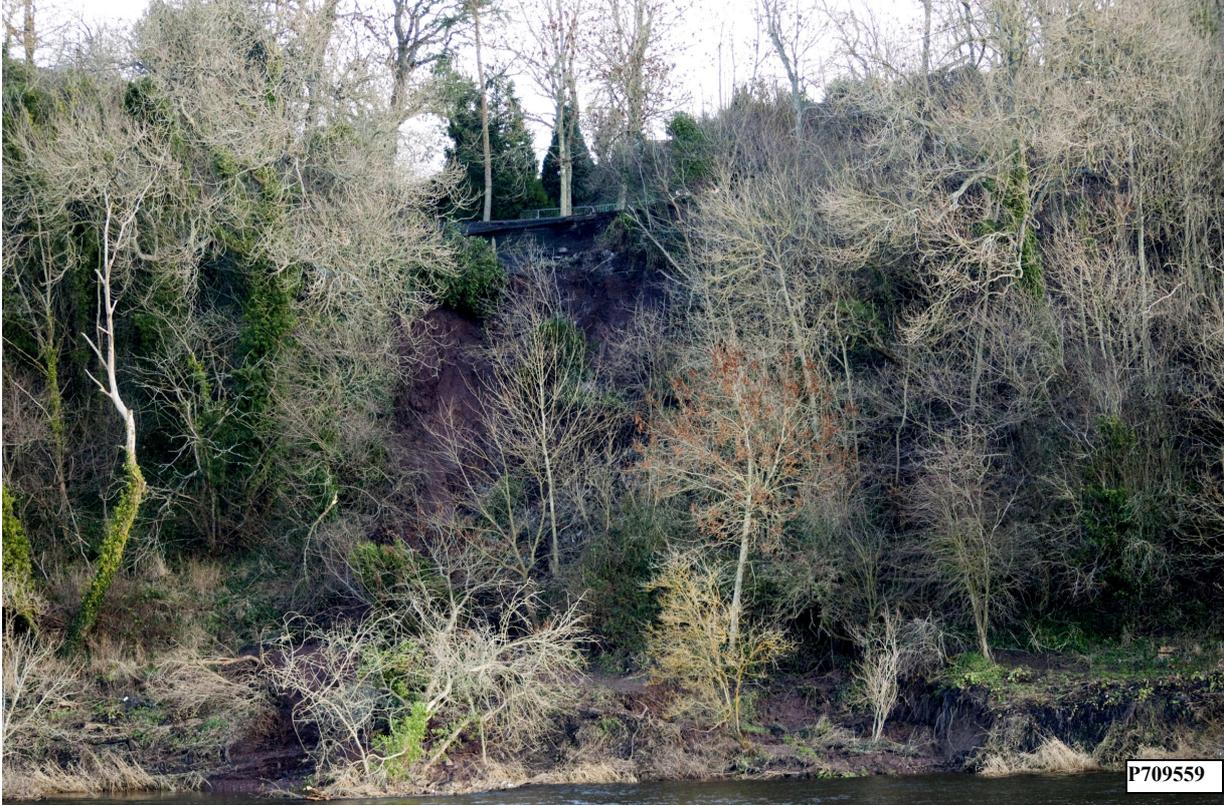
i) View of landslip from west bank of the River Tweed. The road can be seen in the centre top, the mainscarp beneath, and the debris lobe entering the river at the toe.

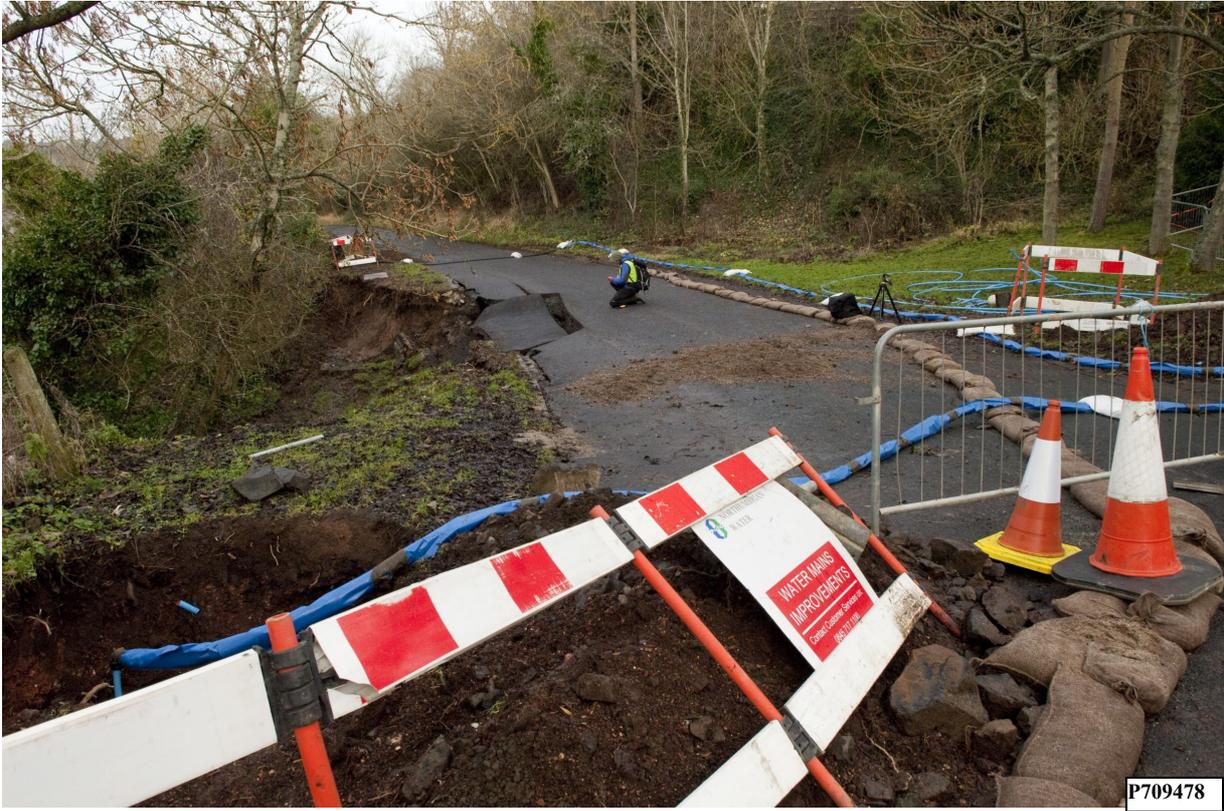
ii) The failure site, looking north. Note the temporary blue pipe diverting the water main.

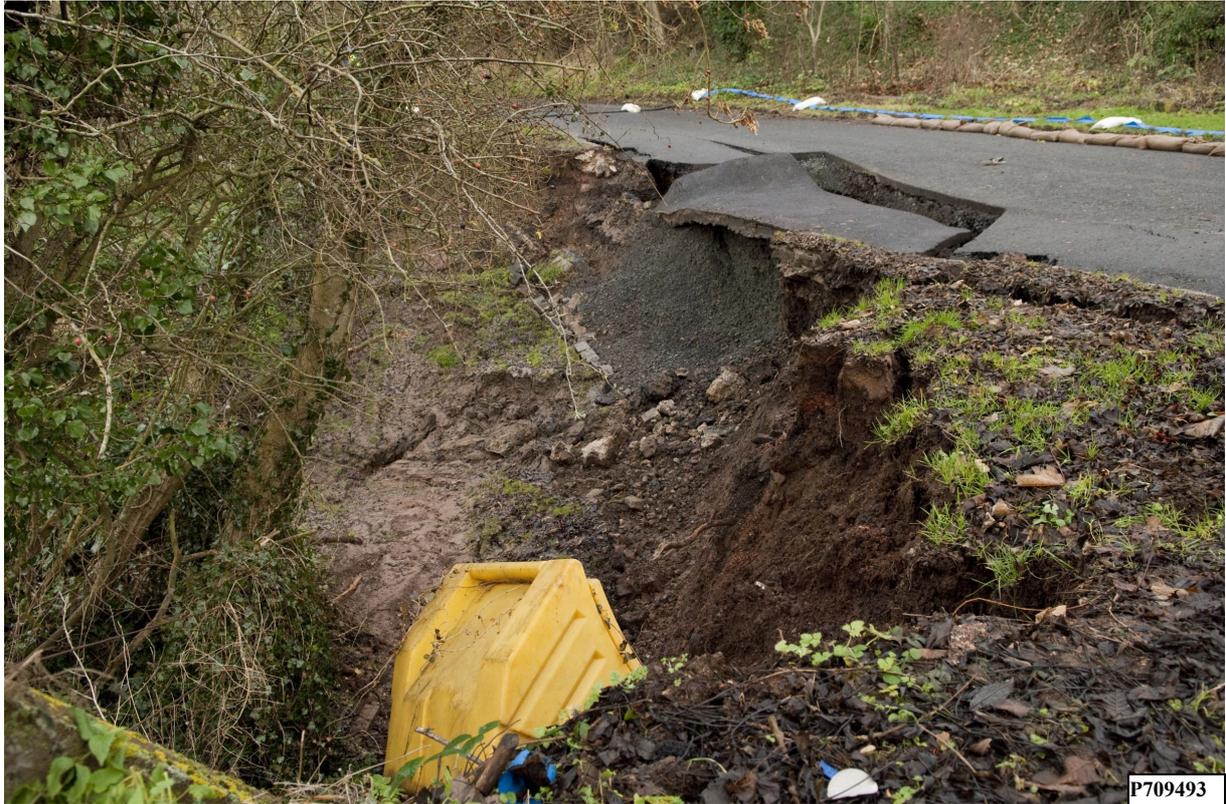
That the failure scarp is centred on the location where recent excavations and backfilling occurred may indicate some connection between the two. However, it is also reported that an old culvert used to flow under the road at this point. The failure of the bank has removed or disguised much of the evidence of both, thus a causal link is hard to establish. Nonetheless, it is most likely that this failure was precipitated in a similar manner to bank collapses in similar materials elsewhere (e.g. Golledge 2006). The overriding trigger in such cases is elevated pore water pressures within unconsolidated substrates, which reduce sediment cohesion and their load-bearing ability. Where such pore pressure changes are localised, the contrasting shear strength of adjacent sediment masses preferentially focuses failure into the weakest area. That the bank to the south of the failure slipped, but did not liquefy into a debris flow, suggests that hydraulic conditions at the site were markedly different to those in the surrounding area. Rainfall was not reported to have been particularly heavy in the days before the failure, thus it seems likely that liquefaction of the sediments occurred as a result of localised build-up of water within the substrate near the recently excavated area. The free-draining gravel used to backfill the excavation may have aided natural drainage of the hole, but may have resulted in a water-table anomaly that increased the fluid content of the substrate immediately below, thereby raising pore water pressures in the sediments and leaving them prone to collapse initially in a rotational manner, followed by liquefaction of the mobilised sediments. The water may have been sourced from the culverted stream or from the ruptured water main prior to its repair.

iii) The collapsed section of road at the crown of the failure. Note the grey gravel used as backfill material after recent maintenance work on the water main.

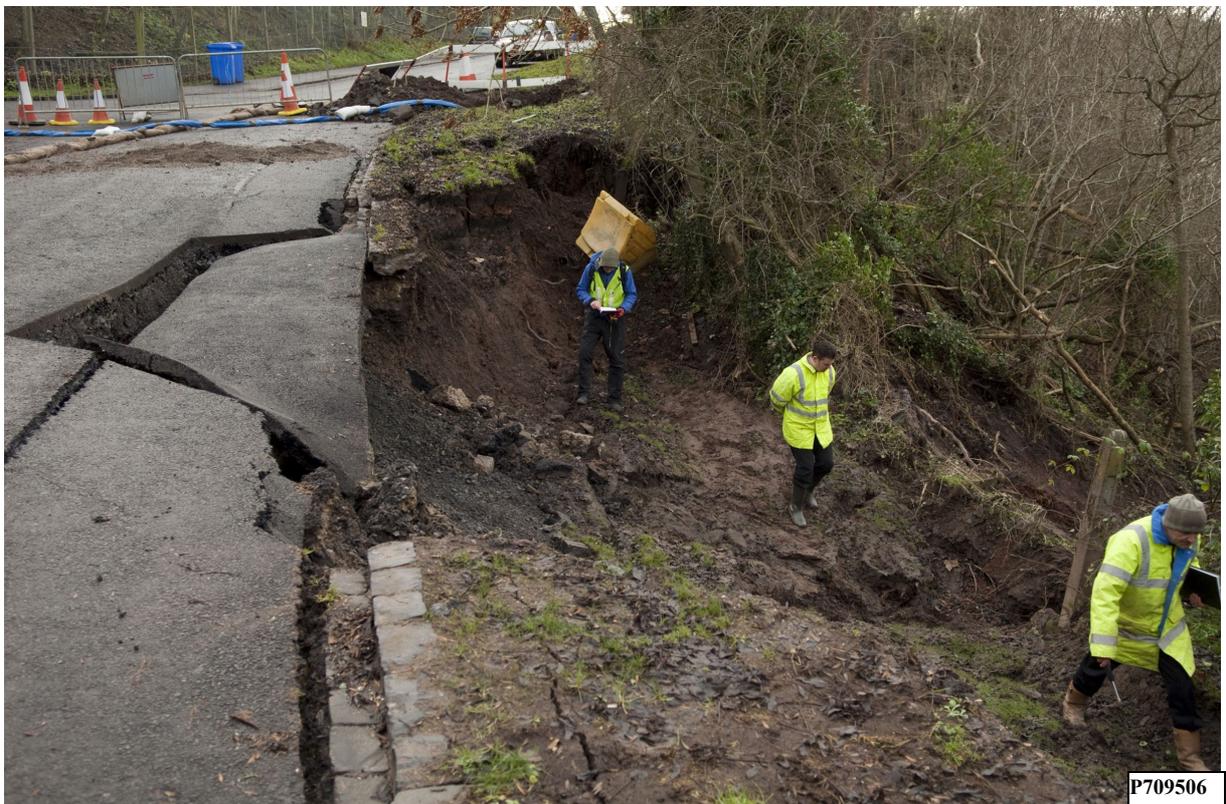
iv) View south showing the crown of the failure, and the flat 'bench' of slipped and liquefied material. To the right is the top of the main failure gully and its backscarp.

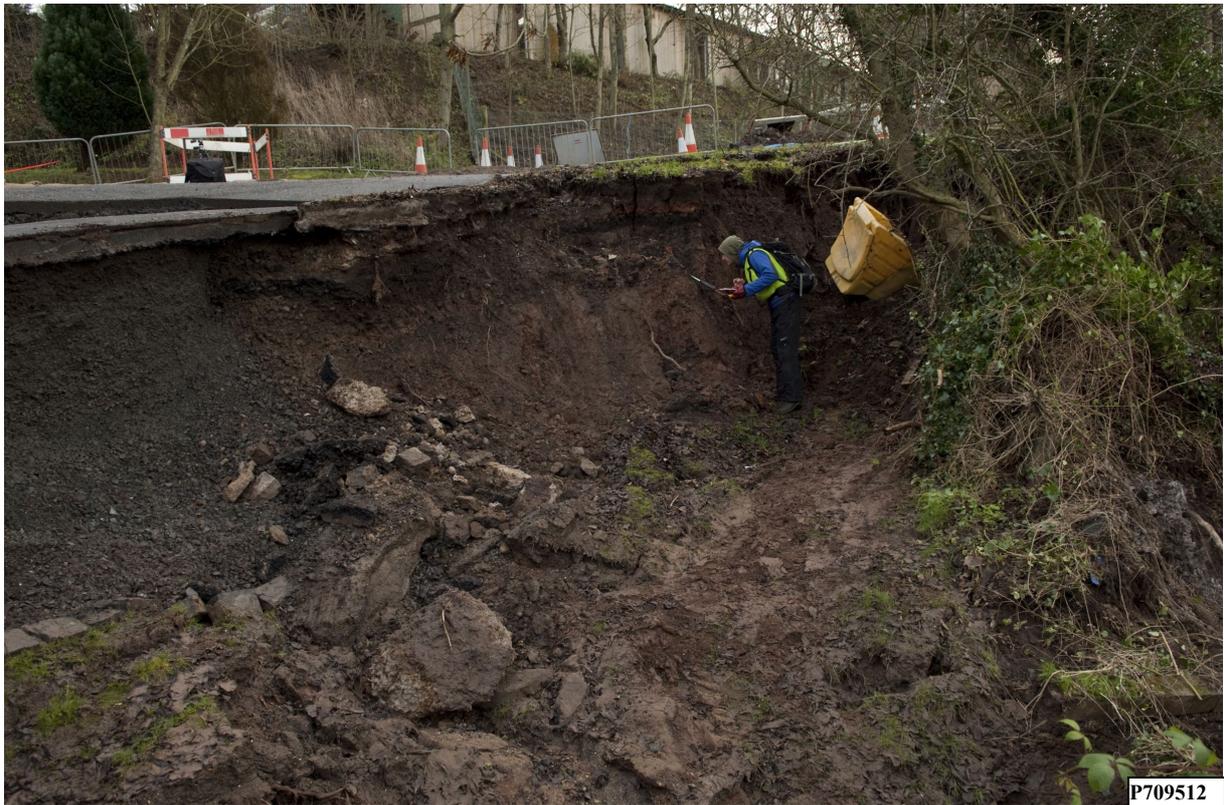
P709512

v) The mainscarp of the landslide and the flat bench of slipped material. Note the in situ diamicton composing the majority of the scarp, and the washed-out grey gravel backfill to the left.

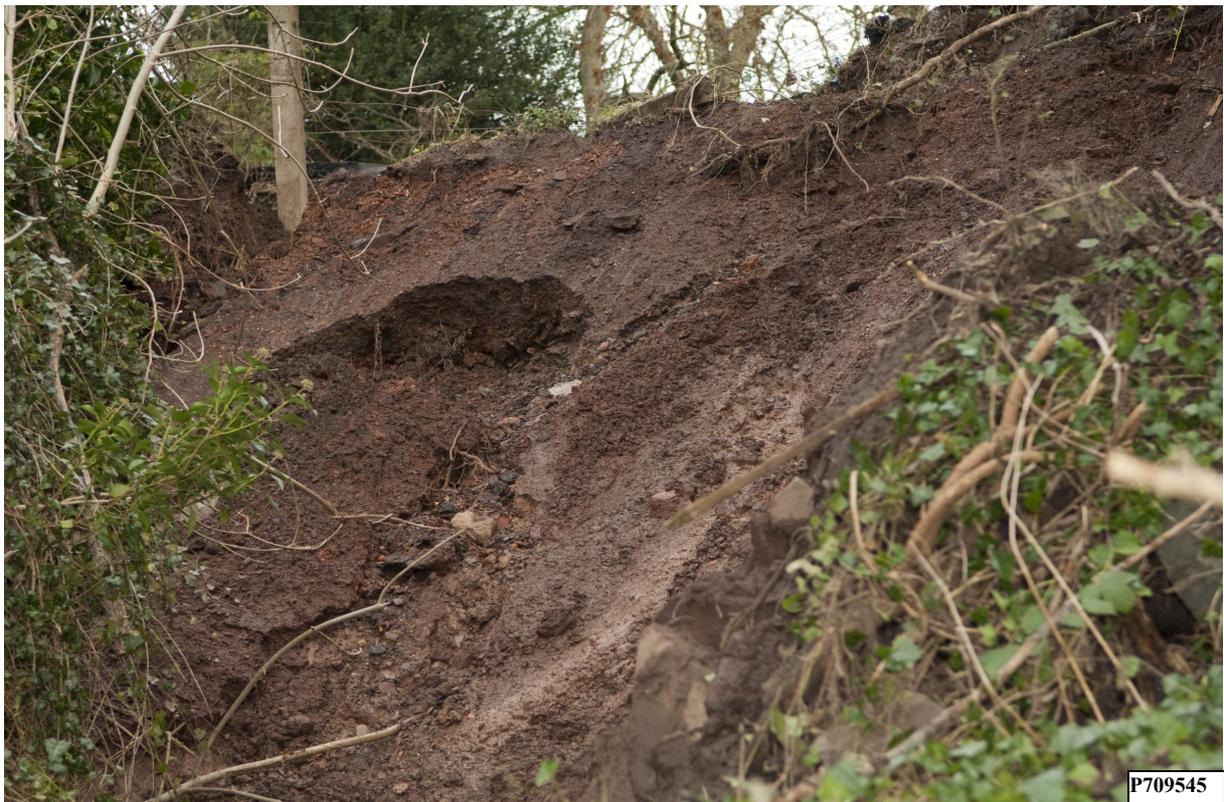
P709545

vi) Backscarp of the debris flow gully. Note emergence of the small stream from beneath c. 1 m sediment, left of centre.

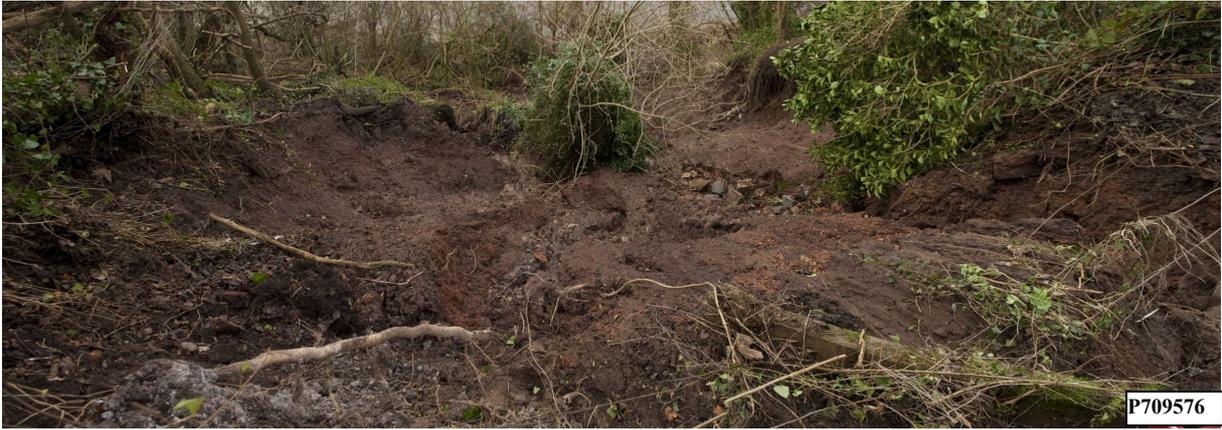
vii) Panorama of the failure scar from the main scarp, looking down to the river.

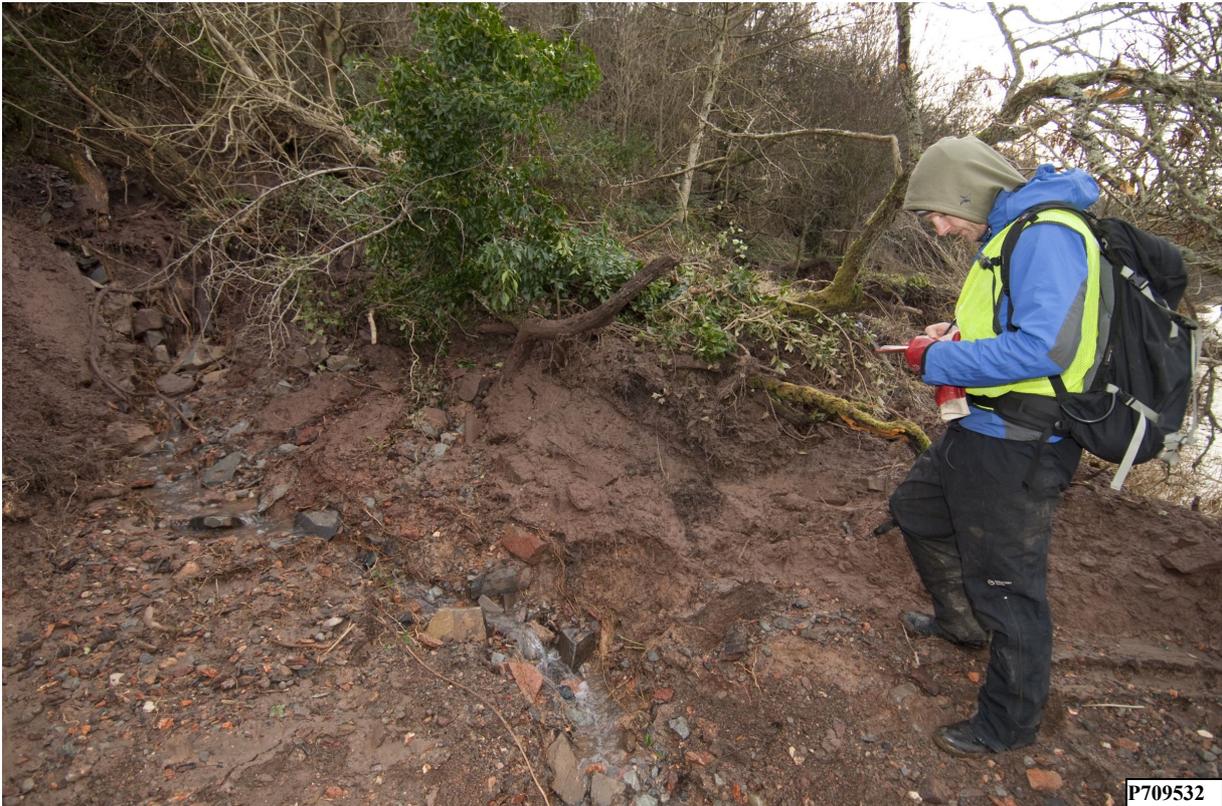
viii) Stream and debris fan at toe of landslide. Note the displaced vegetation and mixed lithologies of rock debris.
