**The Geology and Cliff Stability at Nefyn,
North Wales –
Interim Report**

A.D. Gibson and A.J. Humpage

May 2001

Gibson, A.D. and Humpage, A.J. (2001).
The Geology and Cliff Stability at Nefyn, North Wales – Interim Report
British Geological Survey Commissioned Report
CR/01/101

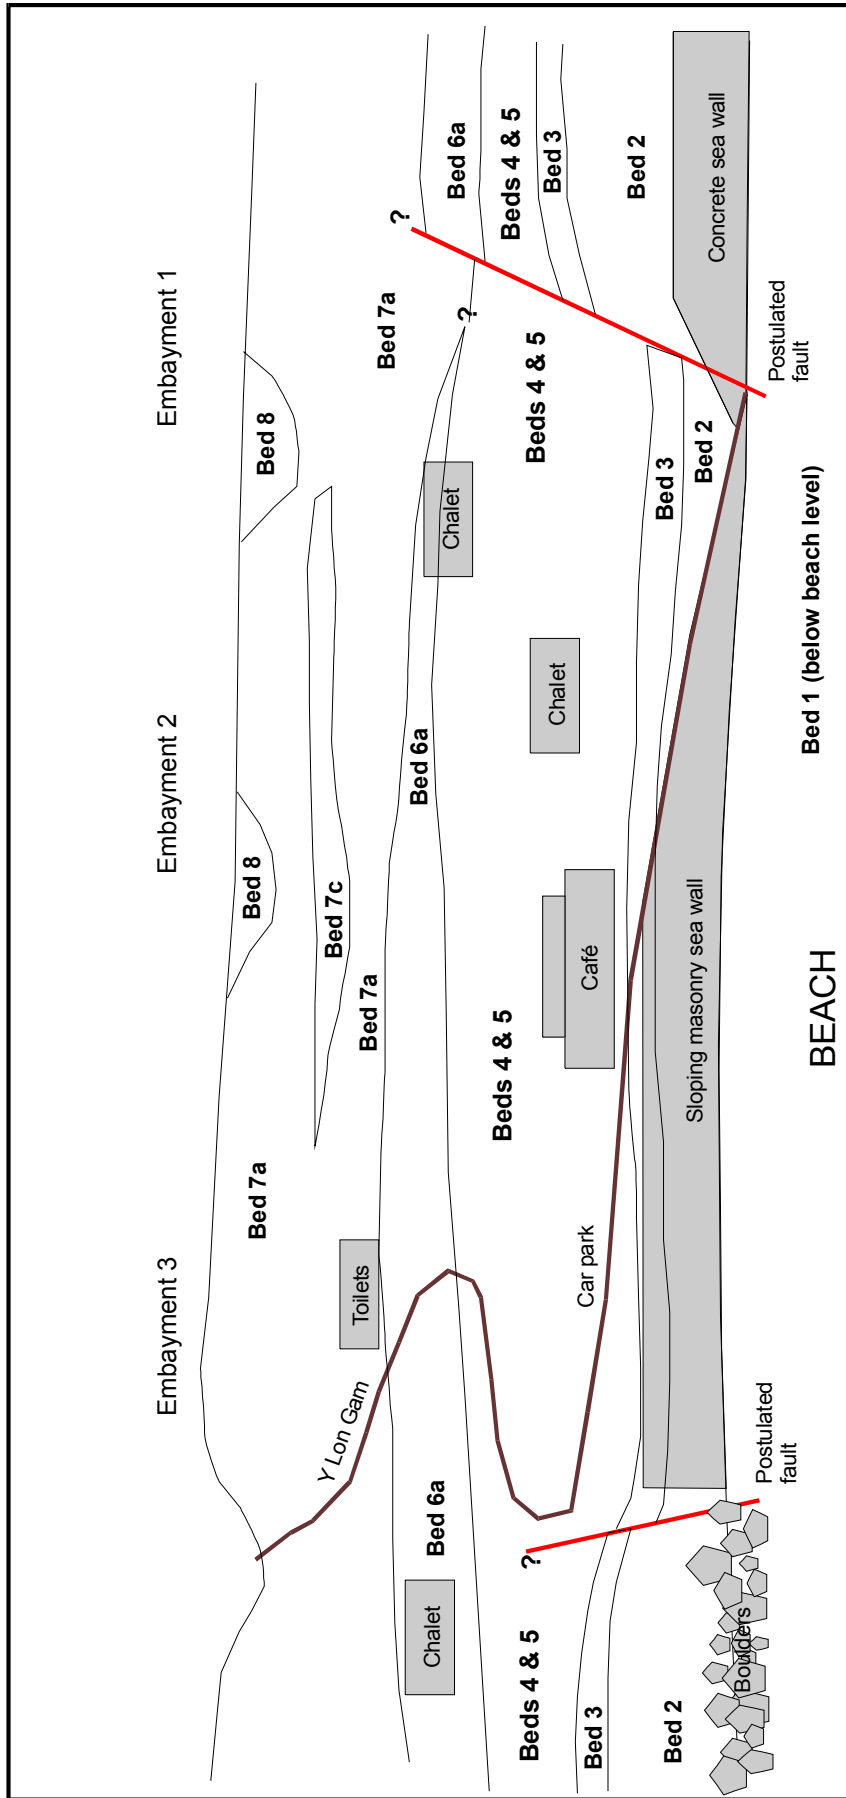
Within the area of Y Lôn Gam, the basic succession described above can be identified. However, it is slightly complicated by the presence of small faults at points adjacent to the end of the road ramp and at the upper end of the car park (Figure 3). These small faults have resulted in the observable downward displacement of the cemented cobble gravel bed (Bed 3) from approximately 10m above beach level to only 3m to 4m above beach level. This movement appears to have post-dated the deposition of the gravel, but occurred concurrent with, or immediately prior to, the deposition of the grey laminated silts (Bed 4) and massive silty clays (Bed 5), as these units appear to be thicker in this area compared to elsewhere in the southern part of Nefyn Bay. It should be noted that these faults are postulated, as their position is obscured by surface material.

Further displacement on these faults may have occurred following the deposition of Beds 4 and 5, as a significant thickness of brown laminated silts (Bed 6a) occurs below the toilet block. The toilets are built on a bench at the top of this unit. This unit appears to thin westwards and may be absent behind the demolished chalets above the road. Further evidence of continued syn-depositional movement is shown by a significant thickness of cross-bedded medium-grained sand (Bed 7a) observable behind the demolished chalets. High on the undercliff within the sand, an additional unit is identifiable, which is termed Bed 7c in Figure 3. This is a brown, stiff laminated silty clay that is thickest behind the shop.

Figure 3: Schematic geological section in the area of Y Lôn Gam showing postulated geological relationships in this area. Note Bed 7b is not present in this area. **NOT TO SCALE**

Within these embayments it seems likely (Figure 3) that the beach café sits above Bed 3, the chalets which occur at a higher elevation upon the upper surface of either Bed 4 or Bed 5, and the toilet block on top of Bed 6a. In all of these instances, there has been an unknown amount of excavation, fill and re-grading of slopes over time so it is impossible to determine the original, natural morphology of the ground.

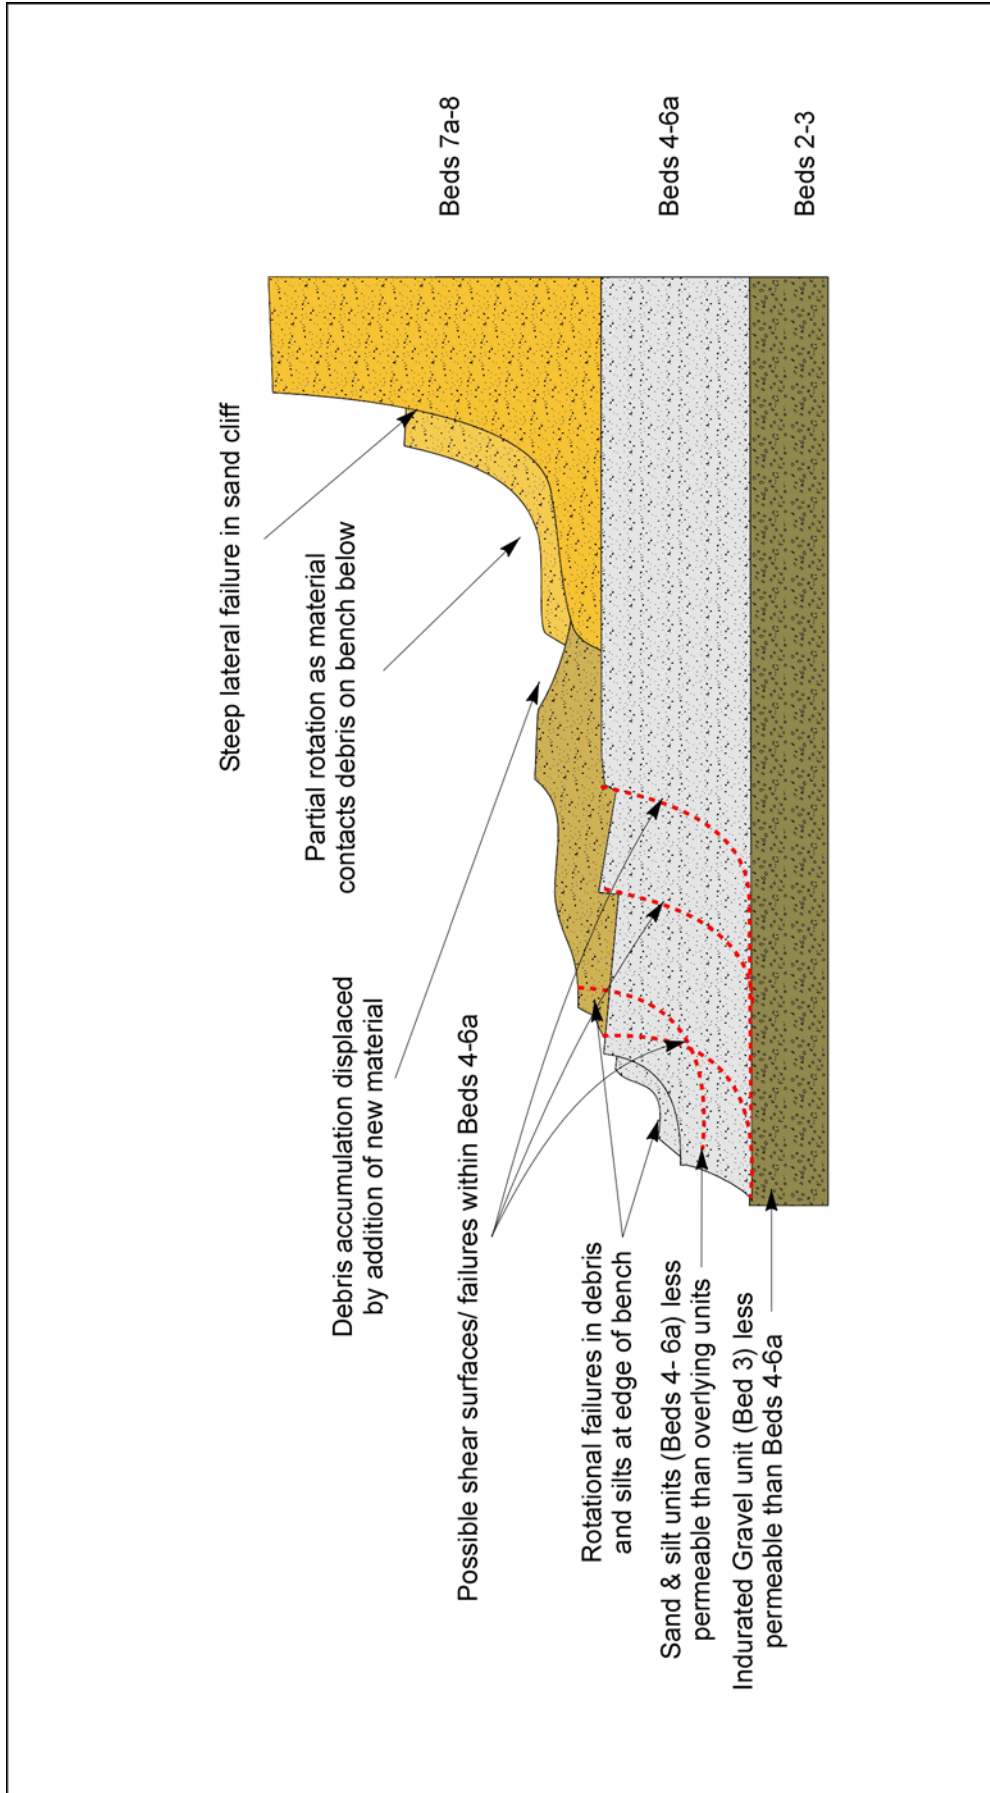
Figure 4: Diagram showing development of slump materials from Beds 7a-8, and rotational failures above Bed 3. For diagrammatic purposes only. **NOT TO SCALE**

At the leading edge of the bench formed by Beds 4 and 5, this concentration of water can lead to rotational failures in both *in situ* deposits and the superficial cover, with failure depths ranging between 1m and 6m (Figure 4). Water issuing further inland results either in spring sapping, gully erosion or the generation of mudflows, depending upon the amount of loose material and vegetation present, and localised slope morphology. Again such features vary widely in size.

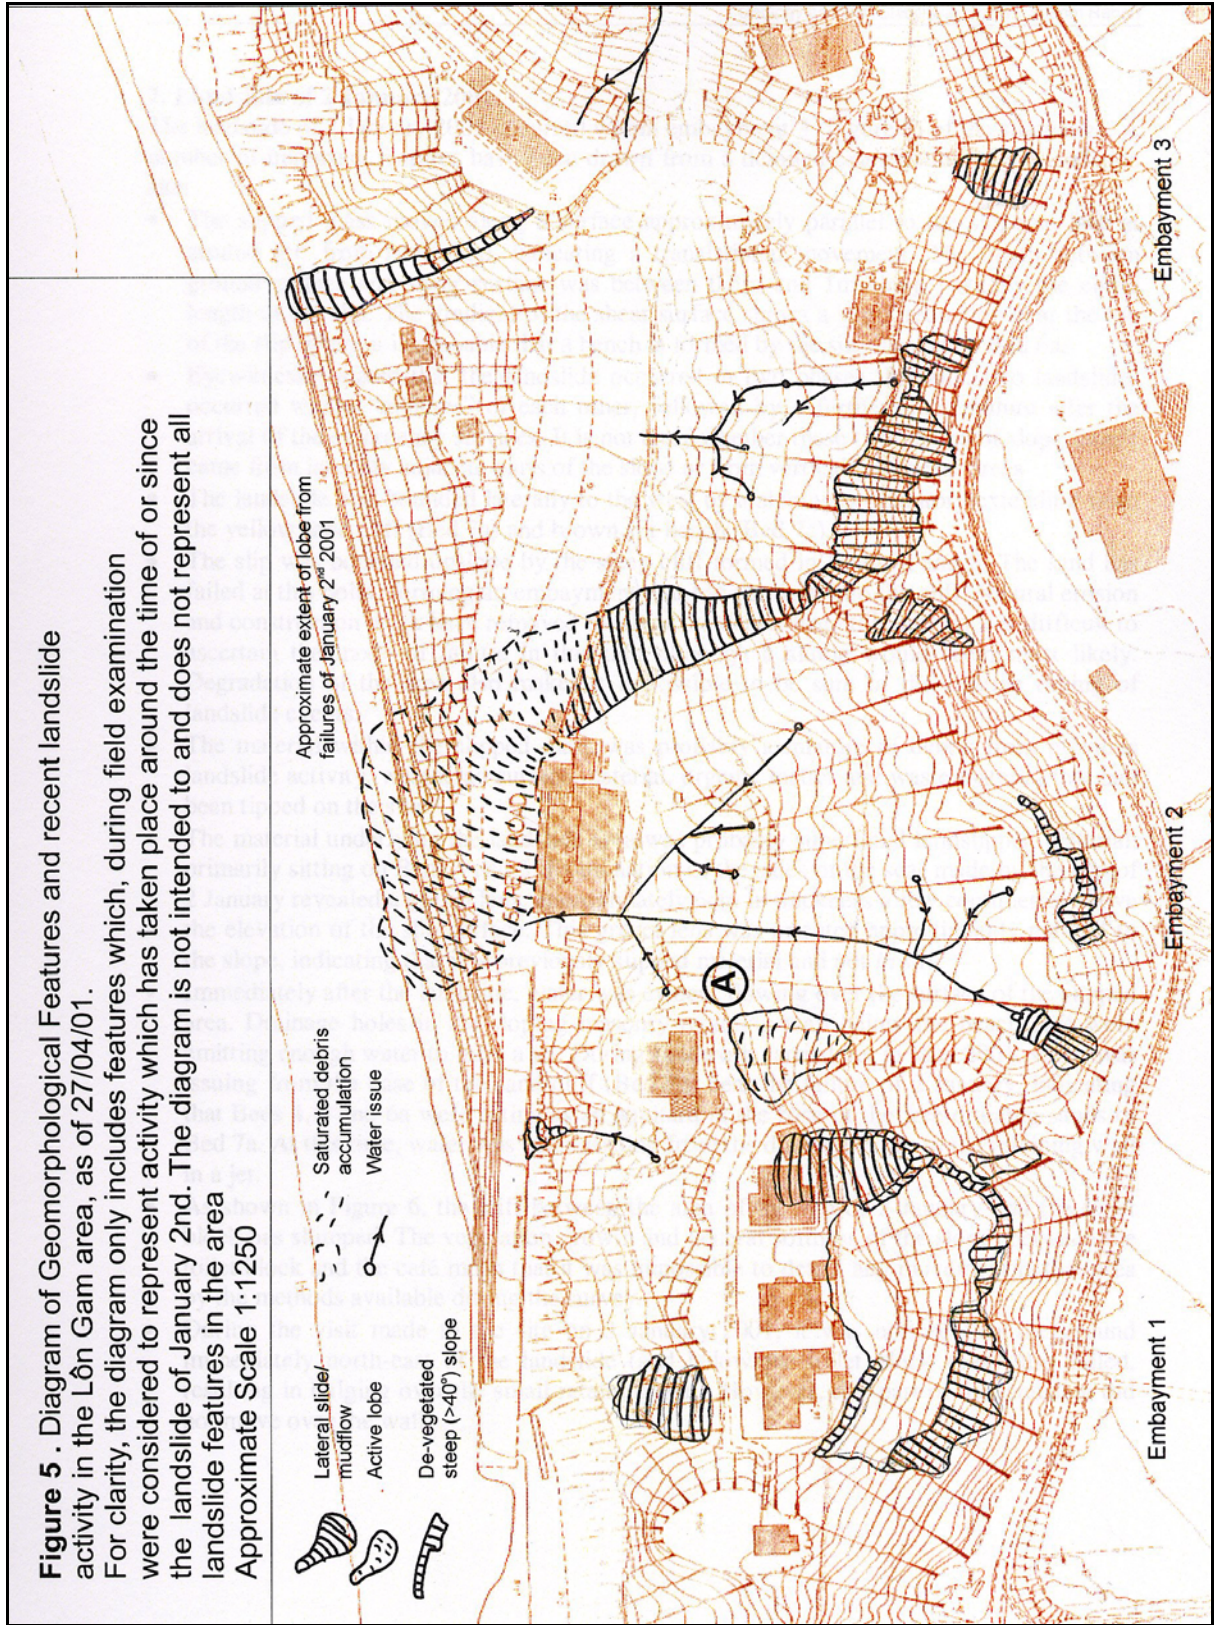
As shown in Figure 5, the area considered by this report is mainly concerned with activity within three embayments defined by the cliff line. Four chalets (two of which have been demolished) lie in the westernmost embayment, the beach café in the central one and toilet block in the easternmost.

Consideration should be given to the stability of lobate feature A in Figure 5 upon the bench formed by Beds 4 and 5. This feature is characteristic of a translational failure within the superficial deposits and appears to be less well-drained than other similar material on this bench. At the time of investigation (14-18 May 2001), this lobe appeared to be wetter than its immediate vicinity and was ‘bulging’ towards the coast. In such a state, it is thought that this feature may be susceptible to failure if porewater pressures increase or the area is in some other way disturbed.

The sloping masonry sea wall immediately north-east of the beach café could be seen both from aerial photographs and field surveying to be bulging towards the sea. This bulging may indicate stresses that are placed on the wall by the movement of material in the area of the café. Such movements could be the result of deep-seated landslide activity.

The landslide of 2 January 2001 occurred within embayment 3 (Figure 5) of the study area. A number of important features have been drawn from a detailed examination of the landslide site:

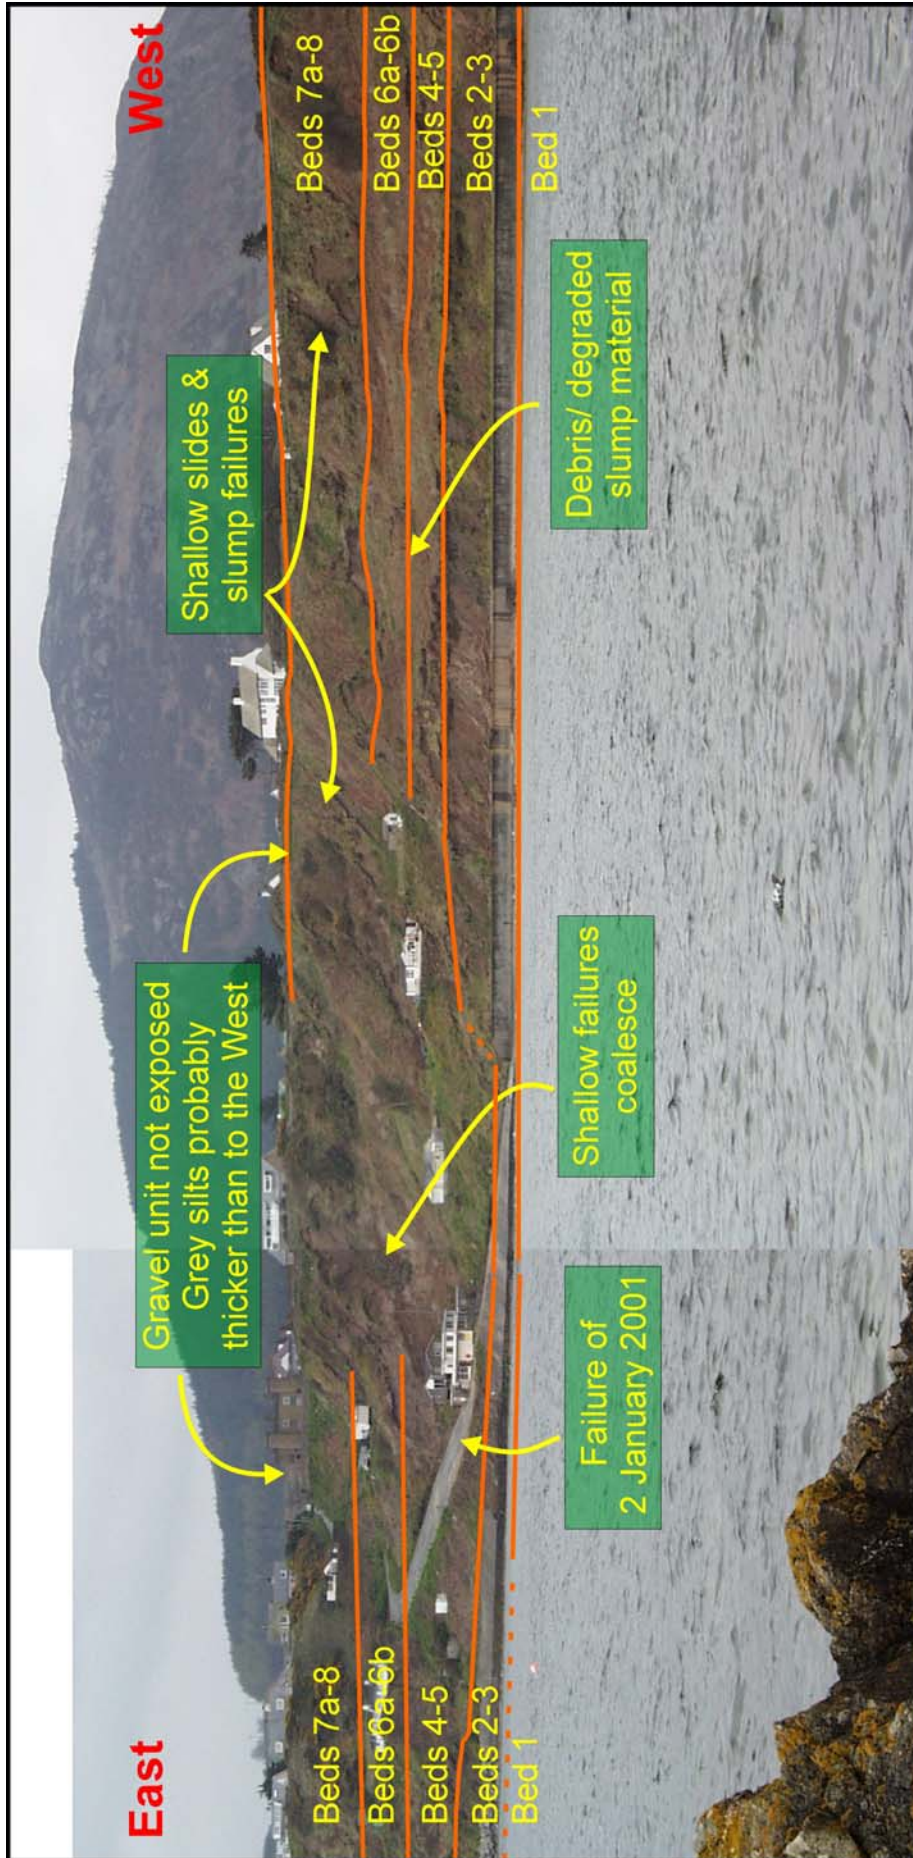
- As shown in Figure 6, the cliff between the area of the slip of 2 January and the toilet block has slumped. The vegetation growth and general softness of the slopes between the toilet block and the café mean that it was impossible to detect any movement in that area by the methods available during the survey.

Figure 6: Photo-montage showing the outline geology adjacent to the landslide of 2 January 2001. Highlighted are some of the observed landforms
