**DESIGN MODIFICATIONS TO THE AANDERAA
CURRENT METER SPINDLE ASSEMBLY**

REPORT NO 19

1975

**NATURAL ENVIRONMENT
INSTITUTE OF OCEANOGRAPHIC
SCIENCES
RESEARCH COUNCIL**

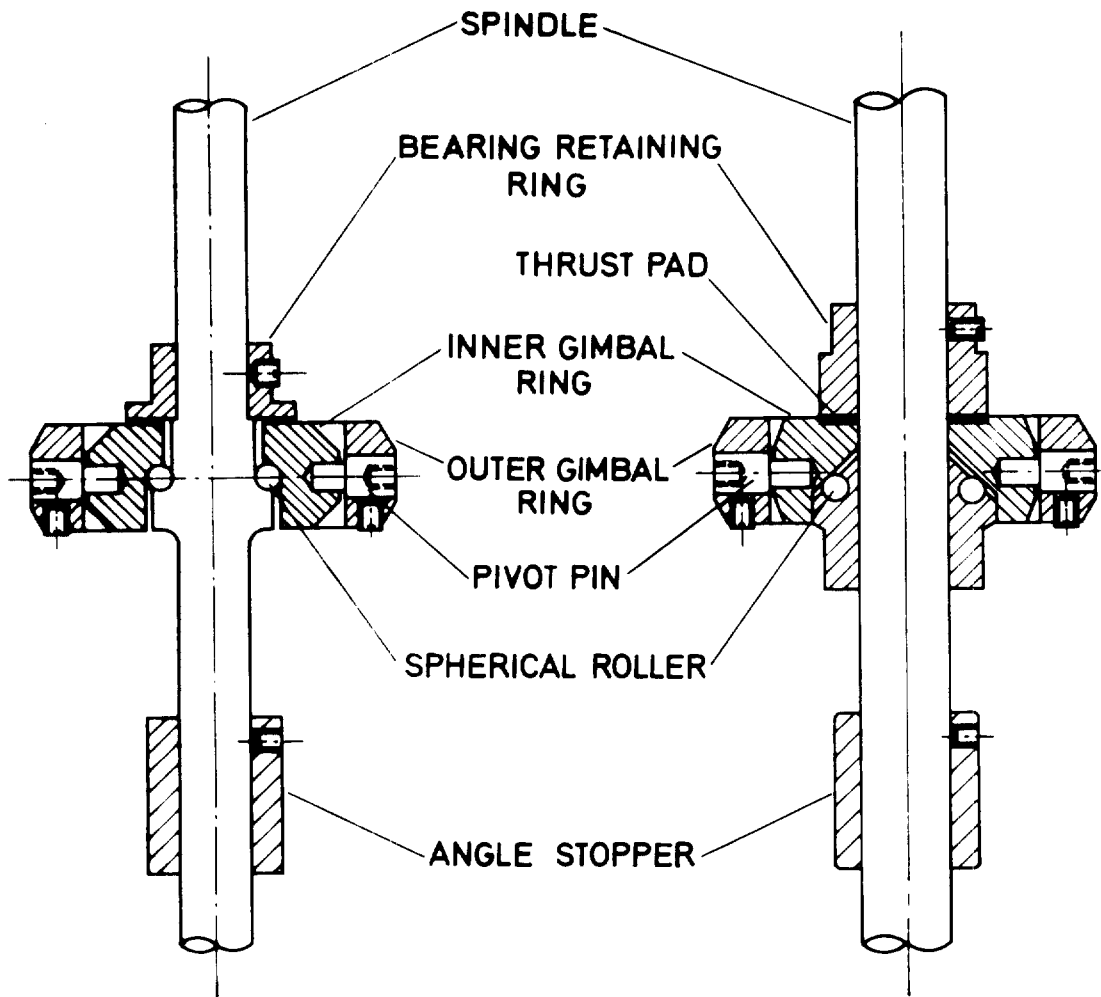
FIGURE 3.

Whilst the recording unit itself has proved to be both satisfactory and reliable, a number of problems have arisen with the spindle assembly from which the equipment is suspended. On recovery a number of spindles have suffered severe corrosion and/or have been severely bent, the latter possibly due to trawling by fishing vessels operating in the station areas. Galvanic corrosion and severe pitting in the ball races have been major problems frequently resulting in catastrophic failure of the apparatus.

A new bearing assembly has been designed in an attempt to improve the reliability and performance of the system, figs. 3 and 4. The bending resistance of the spindle was increased by enlarging its diameter and the bearing geometry modified to alleviate pitting. Material changes were introduced, stainless steel components used for bearing surfaces being electroless nickelled and hardened. A p.t.f.e. thrust pad was positioned between the bearing retaining ring and the outer race to provide a low friction surface. This could easily be replaced if worn or damaged and also acted as an insulator to reduce galvanic action between gimbal and spindle. A comparison of the materials used in the two versions is shown in table 1.

The bearing unit was packed with "Shell" outboard grease during assembly and neoprene 'V' ring seals fitted either side of the race. This provided lubrication, corrosion protection, sealing against the intrusion of suspended particles and dampening of high frequency oscillations. All screw holes were finally sealed with wax for added protection.

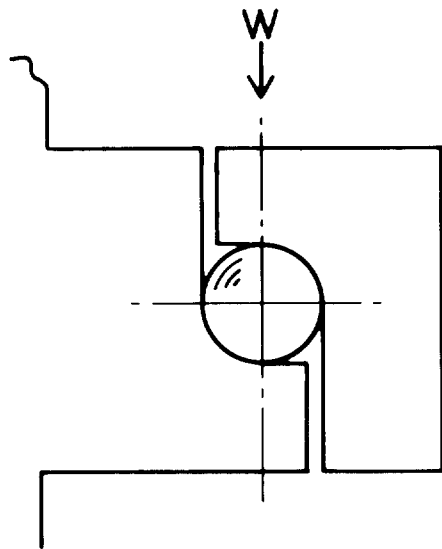
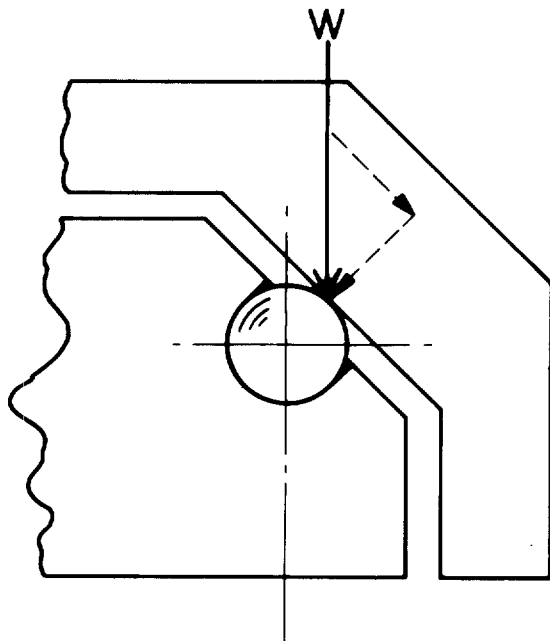
FIGURE 4.

Turbulence around the meter and associated mooring equipment gives rise to both high and low frequency oscillations of the current meter assembly. The pitting in the ball races could be attributed to this movement, particularly when a high percentage of suspended matter is present in the surrounding water. It was necessary, after recovery, for each spindle assembly to be completely stripped and examined for wear so that damaged components could be replaced. Frequently the complete unit has been discarded.

BALL - RACE TRACKS
EQUAL LENGTH

BALL - RACE TRACKS
UNEQUAL LENGTH

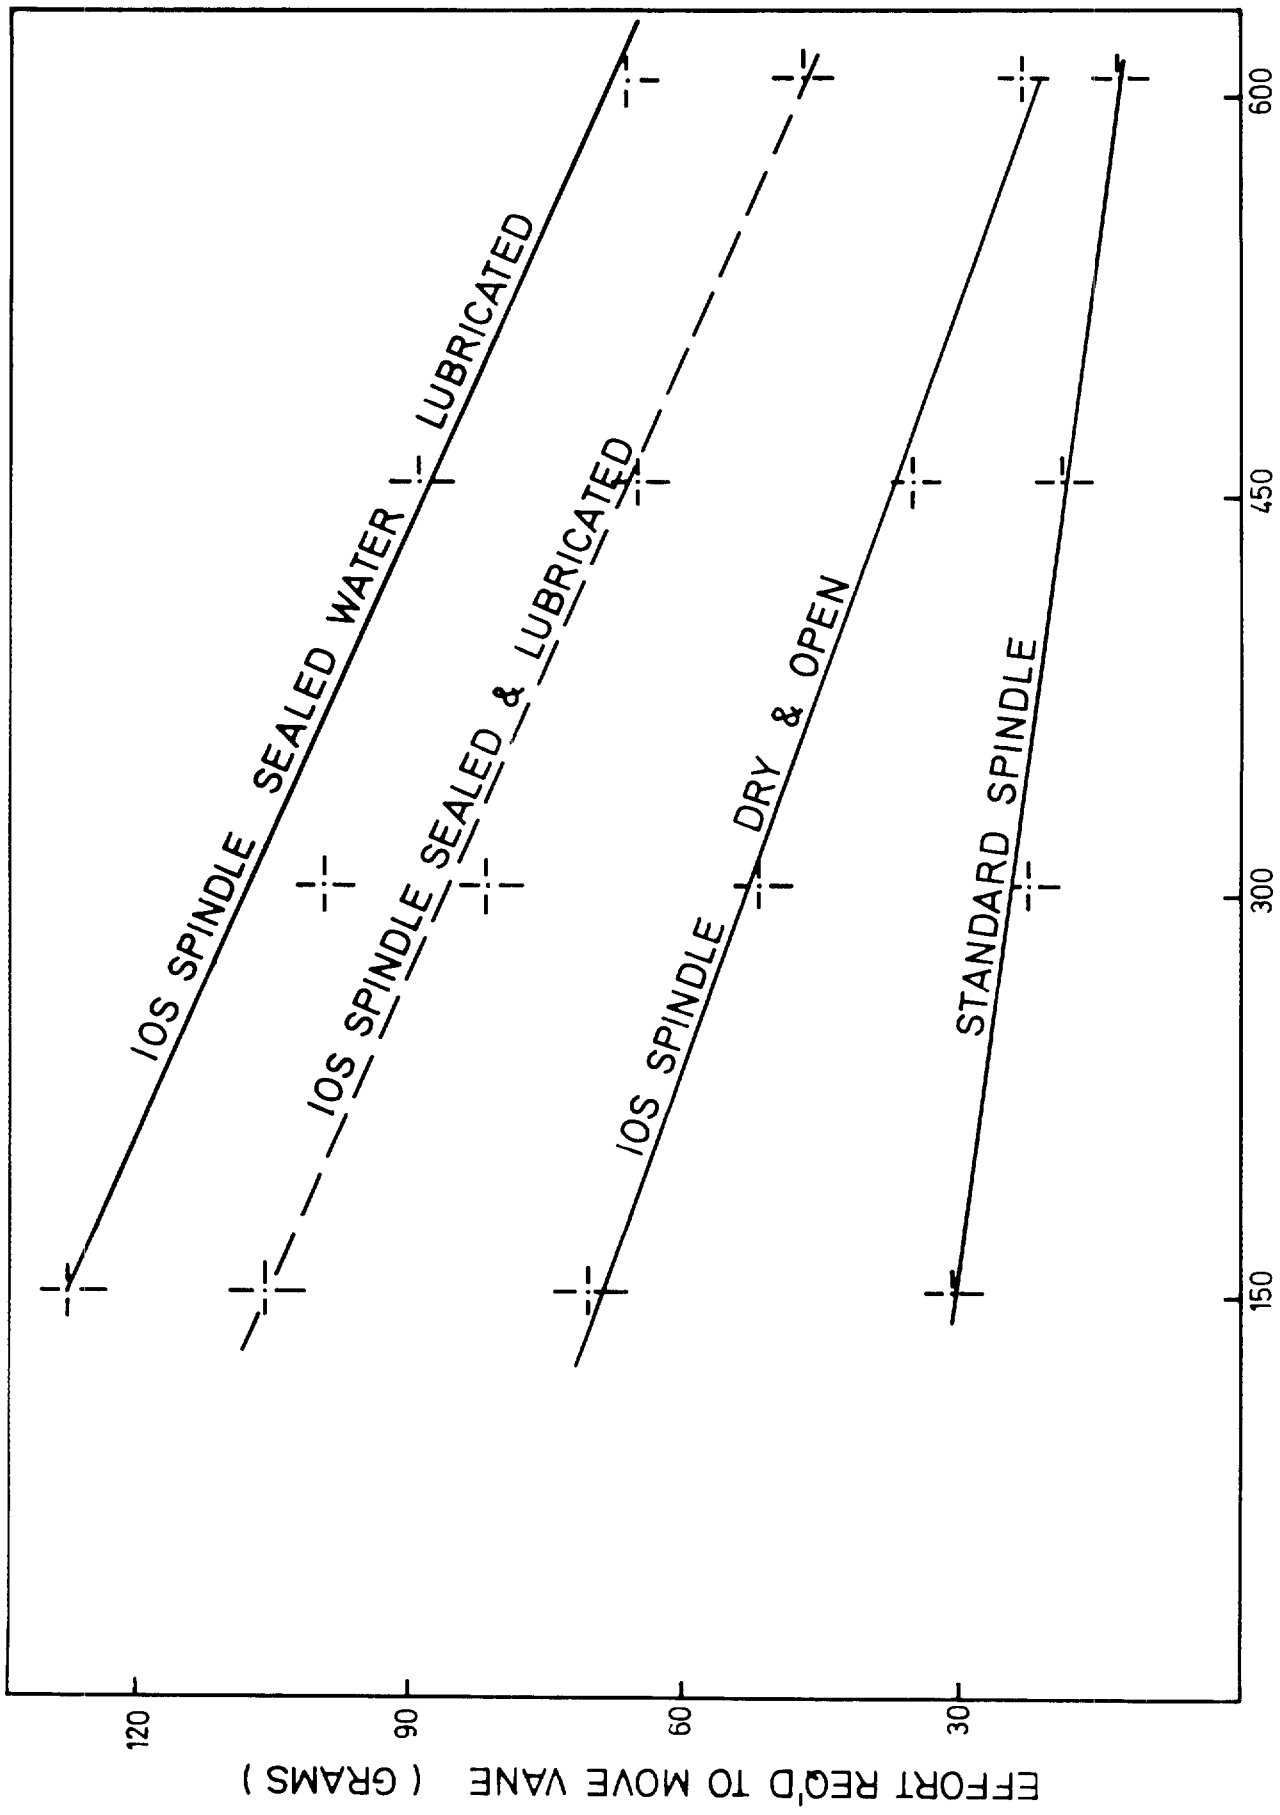
FIGURE 5.

advanced state of corrosion and exhibited considerable wear. It was therefore decided to use this station to conduct tests on the prototype spindle manufactured to the new design. Experiments were carried out using lubricants of different viscosities, sea water lubricated, with and without V seals. It was encouraging to find that a spindle which had seals fitted and was sea water lubricated returned with only minor abrasion to the bearing surface and no indication of pitting. To date no better substitute for the outboard grease has been found, other samples tested rendering the movement too stiff or the seals were unable to retain the lubricant. Comparable efforts required to move the fin/meter assemblies are indicated in the graphs in fig. 5.
