# INSTITUTE of HYDROLOGY

# COLCHESTER CAR AUCTIONS, ESSEX PRELIMINARY HYDROLOGICAL SURVEY

## INTRODUCTION

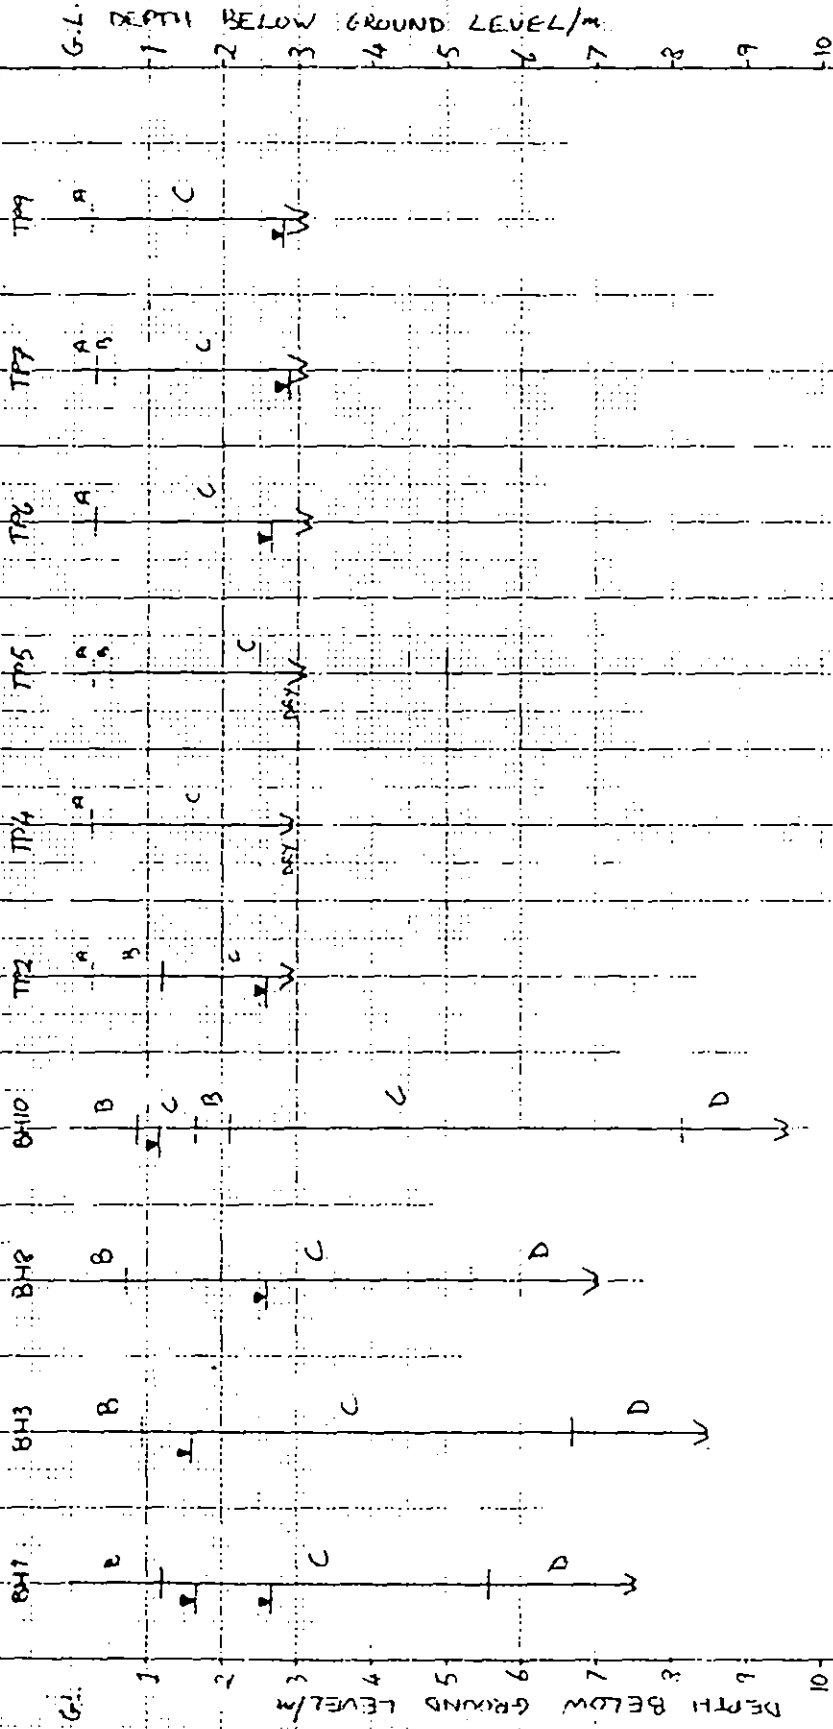
Fig 1a.

The surface deposits overlying the sands and gravels range from about 0.25m to about 1.2m in thickness. Over most of the site there is a thin surface soil layer having a thickness of about 0.3m. However, at the following locations the soil layer overlies a silty sandy clay layer of about 1m in thickness (layer B in Figure 1):

There are no reports of water being encountered in the clay layer. Water levels are reported at depths generally of 2 to 3m, although water levels of 1.2 to about 1.7 were reported at BH10, BH1, BH3, and JW1 in the area of the auction hall and in the south east corner of the site. There is no particular evidence from the lithological data to indicate perched aquifers within the sands and gravels, although the water level at BH10 occurs in a sand layer within the clay layer.

LOGS SHOWING MAIN LITHOLOGICAL UNITS AND WATER LEVELS

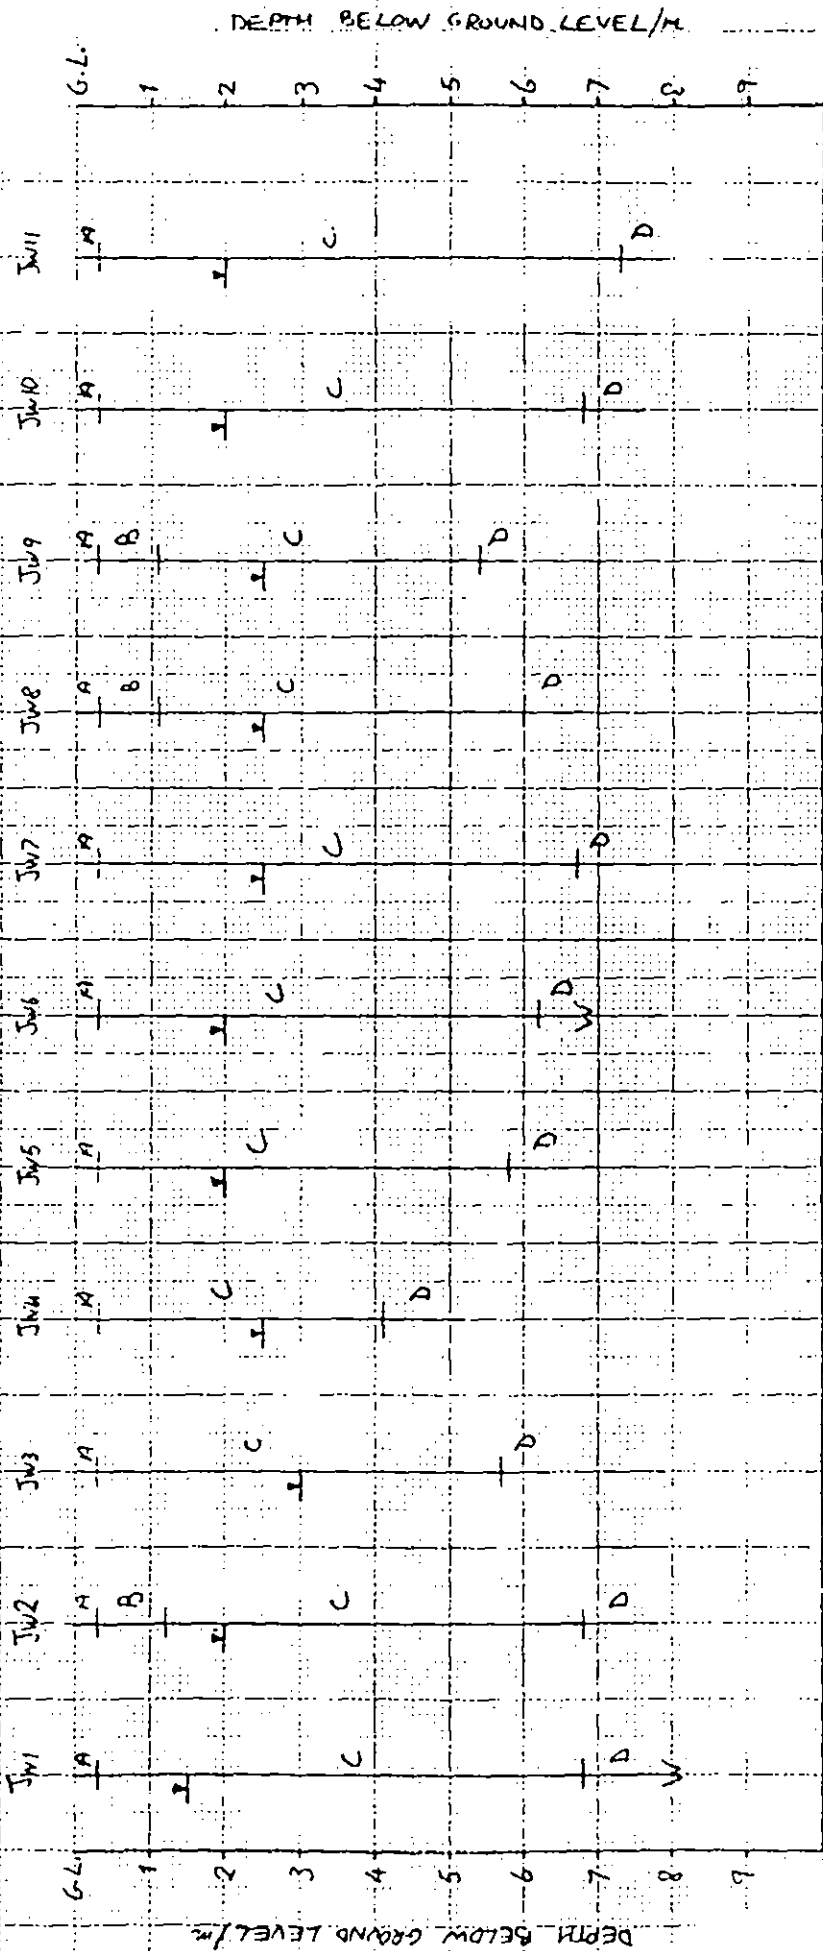
Fig 1b.

LOGS SHOWING MAIN LITHOLOGICAL UNITS AND WATER LEVELS

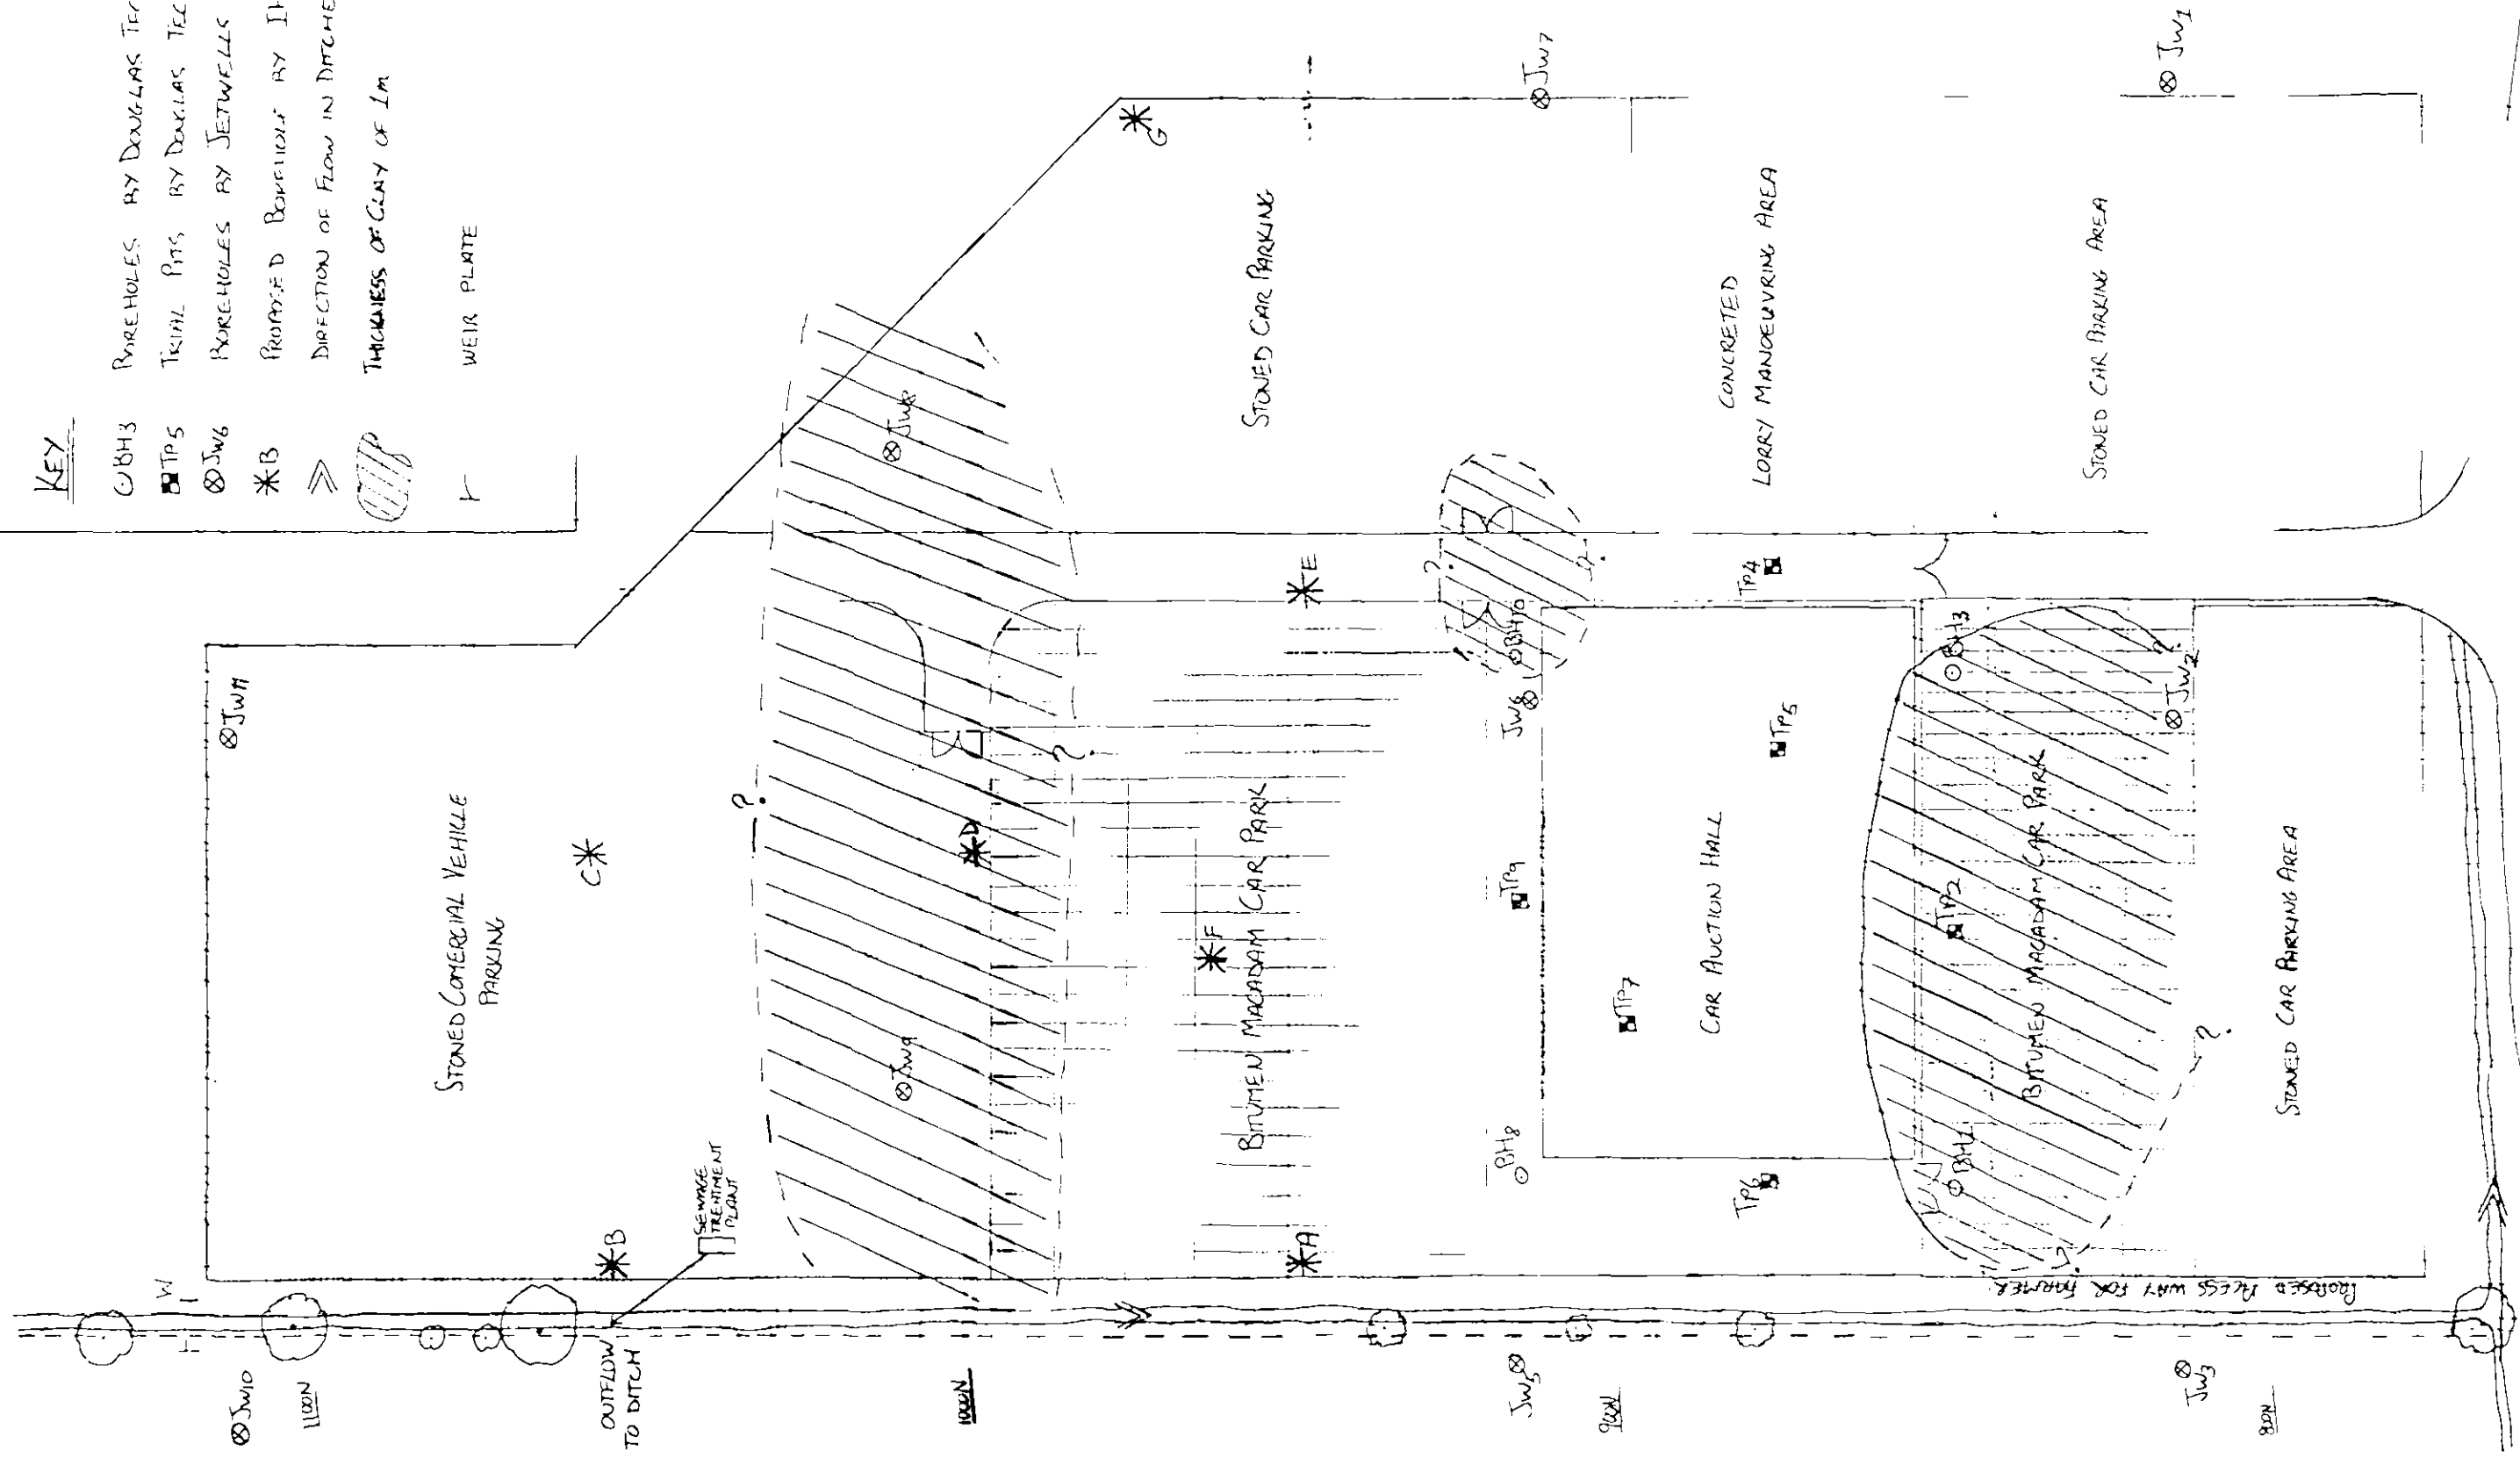
Fig 2.

The available lithological information has been used to indicate the possible extent of the clay layer as shown in Figure 2.

The available information suggests that the clay layer does not underlie the tarmac area north of the auction hall, except perhaps along the western part of this area. However, if this is the case then there may be some difference in the supporting strength at the boundary of the clay layer and the thin soils on sands and gravels when the clay layer is subject to wetting. This is an engineering aspect beyond our particular expertise.

The following programme of further investigation is proposed to obtain information on these aspects. The suggested locations are shown in Figure 2. As far as possible these have been chosen to reduce the amount of drilling on the tarmac area.

- construct seven piezometers (sites A to G in Figure 2) to depths of 3m to obtain lithological information on the surface deposits and for water level measurements
- install a gauging site on the ditch
- install a raingauge at the site.

- construct three piezometers in the immediate area of the tarmac car park (sites A or D plus E and F in Figure 2) for lithological information and water level measurements
- undertake a surface geophysical survey using electromagnetic techniques (EM) to define the distribution of the surface clay layer
- visual records of flow in the western ditch
- use the daily rainfall records of the nearest meteorological station.
