National Coal Board : Opencast Executive

**HYDROLOGICAL SURVEY
GARNANT SITE**

January 1985

**SIR ALEXANDER GIBB & PARTNERS
CARDIFF OFFICE
124 CATHEDRAL ROAD
CARDIFF**

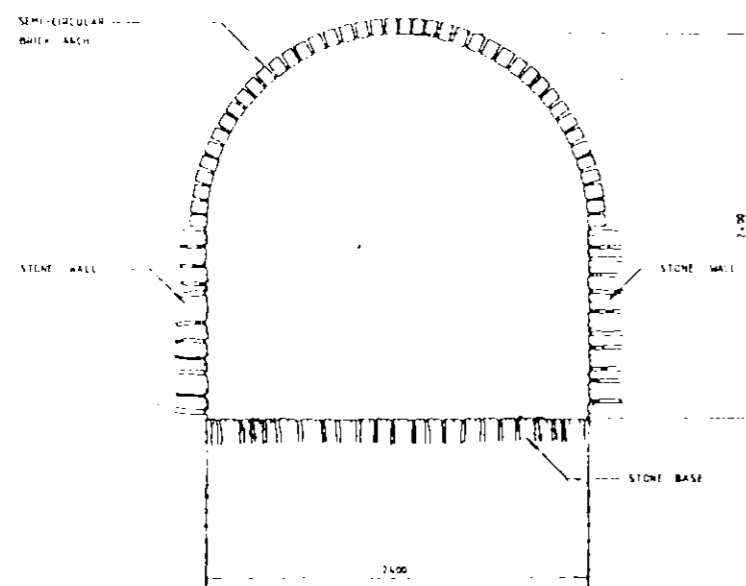
SECTION A TO B

- A - B: This comprises walls of dressed stone, a semi-circular brick arch and a stone pitched invert. The culvert appears to be in a good state of repair although there is one isolated hole, 660 mm. deep in the invert of the culvert where the stone pitching has been lost.

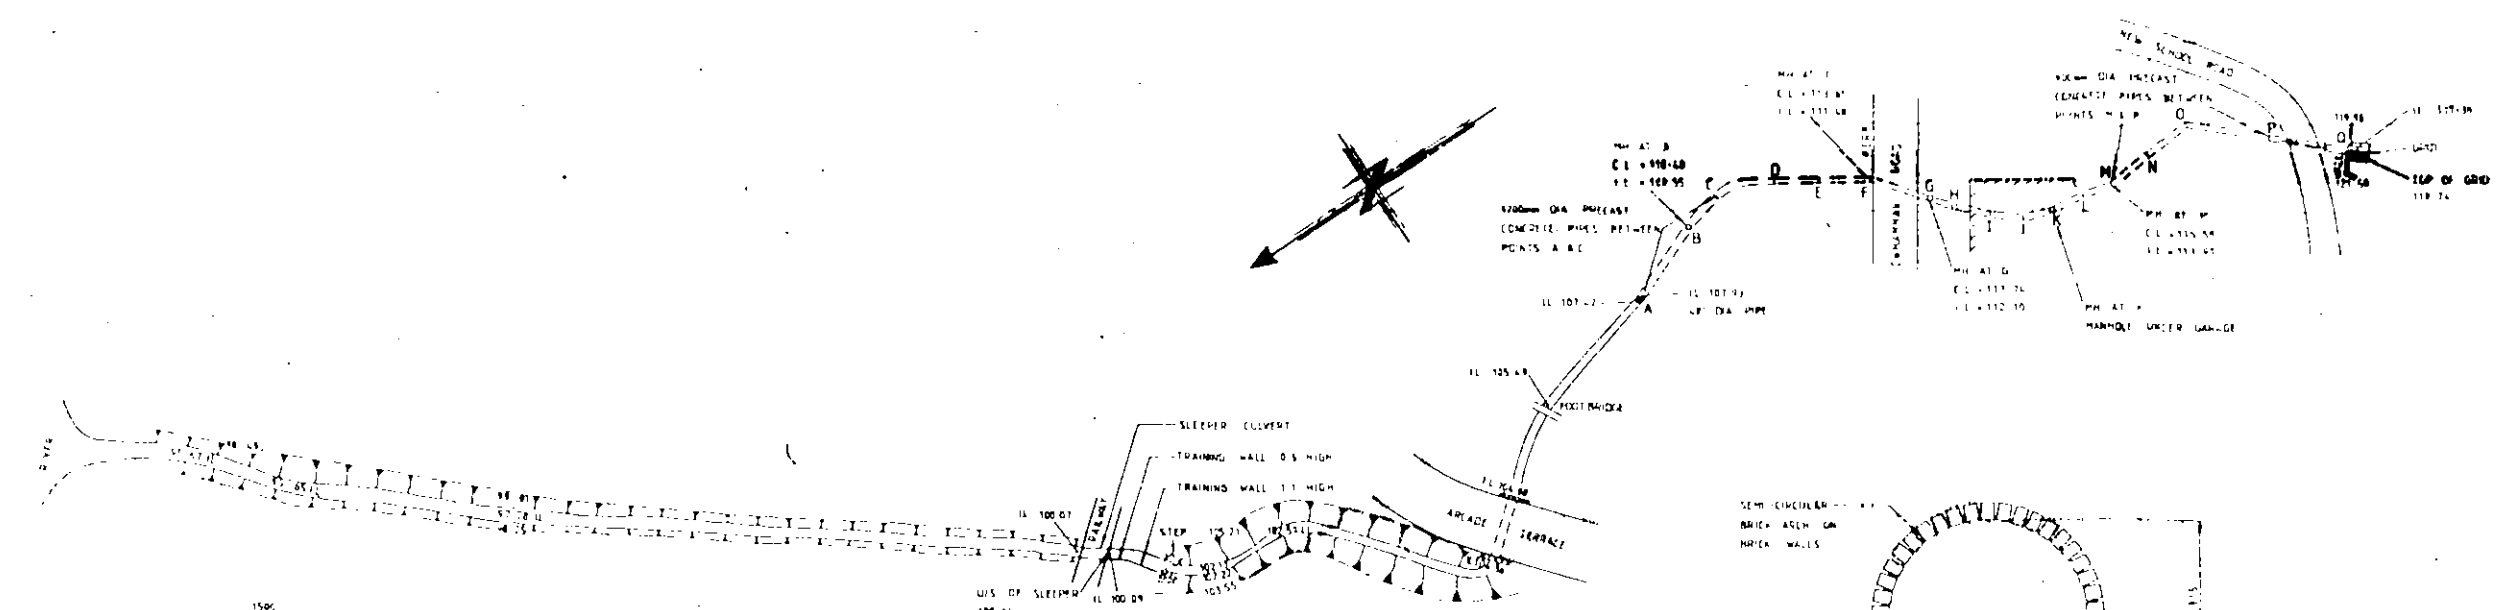
PLAN ON NANT MAEN CULVERT

M - P: These lengths comprise 900 mm. diameter precast concrete pipes 75 mm. thick. There are 28 pipe lengths of which 12 have longitudinal cracks top and bottom. The longitudinal cracks along the invert of the pipe are also showing signs of being enlarged by the effects of the water.

P - Q: This length of culvert comprises stone walls, semi-circular brick arch and brick floor. It is in a very good state of repair except that near point P, there is a crack through the complete section of the culvert. This varies from 40 mm. width at the invert of the culvert to 100 mm. at the soffit.

Repair work is required to the Nant Maen culvert between points F and K.

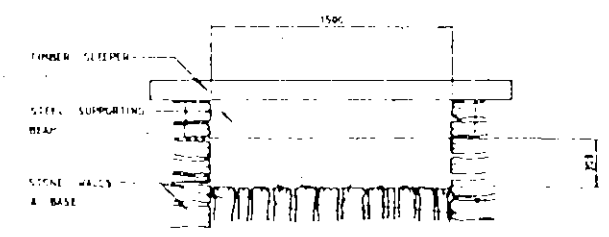
CULVERT UNDER RAILWAY

Where the Nant Maen passes under the railway the culvert comprises stone walls and a roof constructed of sleepers. It is in a good state of repair.

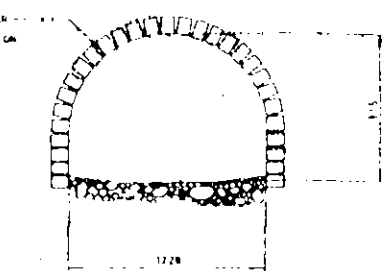
CULVERT UNDER ARCADE TERRACE

Where the stream passes under Arcade Terrace road, the culvert comprises a brick arch 900 mm. high and 1200 mm. wide at its base, with a rubble base. The culvert is in a good state of repair.

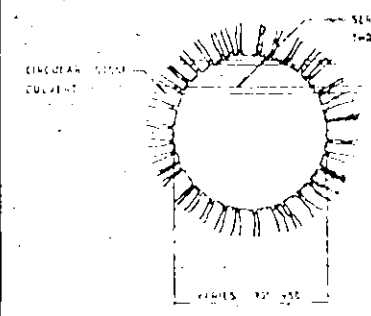
SECTION F TO H

- F - G: At point F, an inspection chamber is situated over the culvert and which has a small diameter hole knocked through its base into the soffit of the culvert. Also a number of pipes enter the culvert at this point. Just upstream of point F, there is a step of 430 mm. in the invert of the culvert. The section changes to a circular stone culvert 0.9 to 0.95 metres diameter. The stonework is in need of pointing and the roof has been damaged by services passing through. At point G is a manhole.

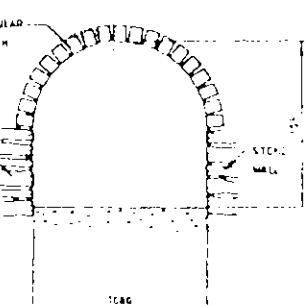
SECTION L TO M

L - M: The culvert is slightly larger over this length and comprises stone walls, semi-circular brick roof and a concrete invert which are all in a good state of repair. At point M, is a large chamber about 2.0 m. x 1.5 m. in size, but which is not completely roofed over.
