HONG KONG DRAINAGE SERVICES DEPARTMENT
香港渠務署

Contract No: DSD/LD/1/94

**The Hydrological/Hydraulic Investigation
on
Hung Shui Kiu Drainage Channel**

Executive Summary

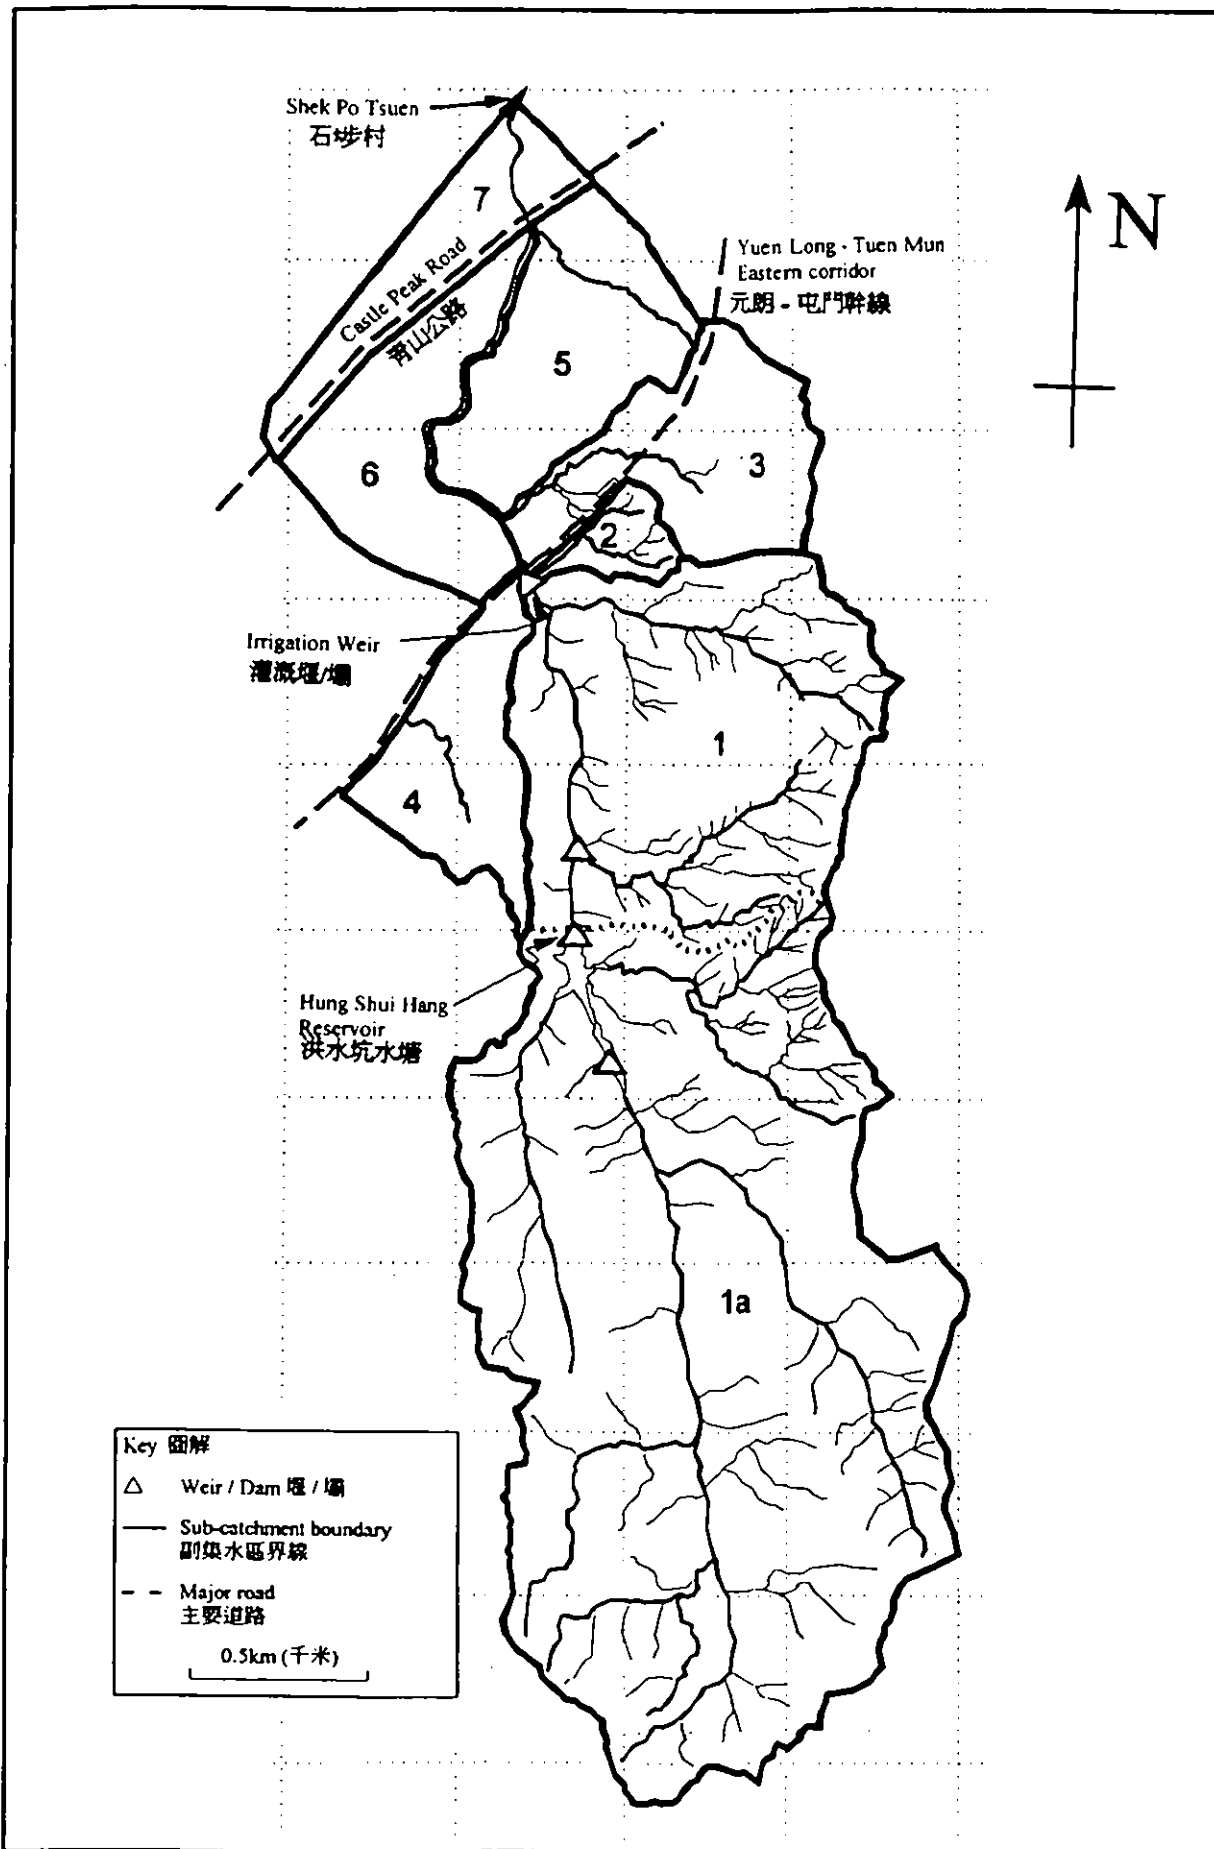
Figure A - The Hung Shui Kiu catchment.
圖 A - 洪水橋集水區

Detailed hydrological models, based on the unit hydrograph approach, were constructed of the Hung Shui Kiu Catchment upstream of the Shek Po Tsuen gauging station (see figure A). These models were calibrated against observations taken during and after the two flood events and used to determine the runoff hydrographs expected from the 1 in 2, 10, 50 and 200 year return period design rainstorms.

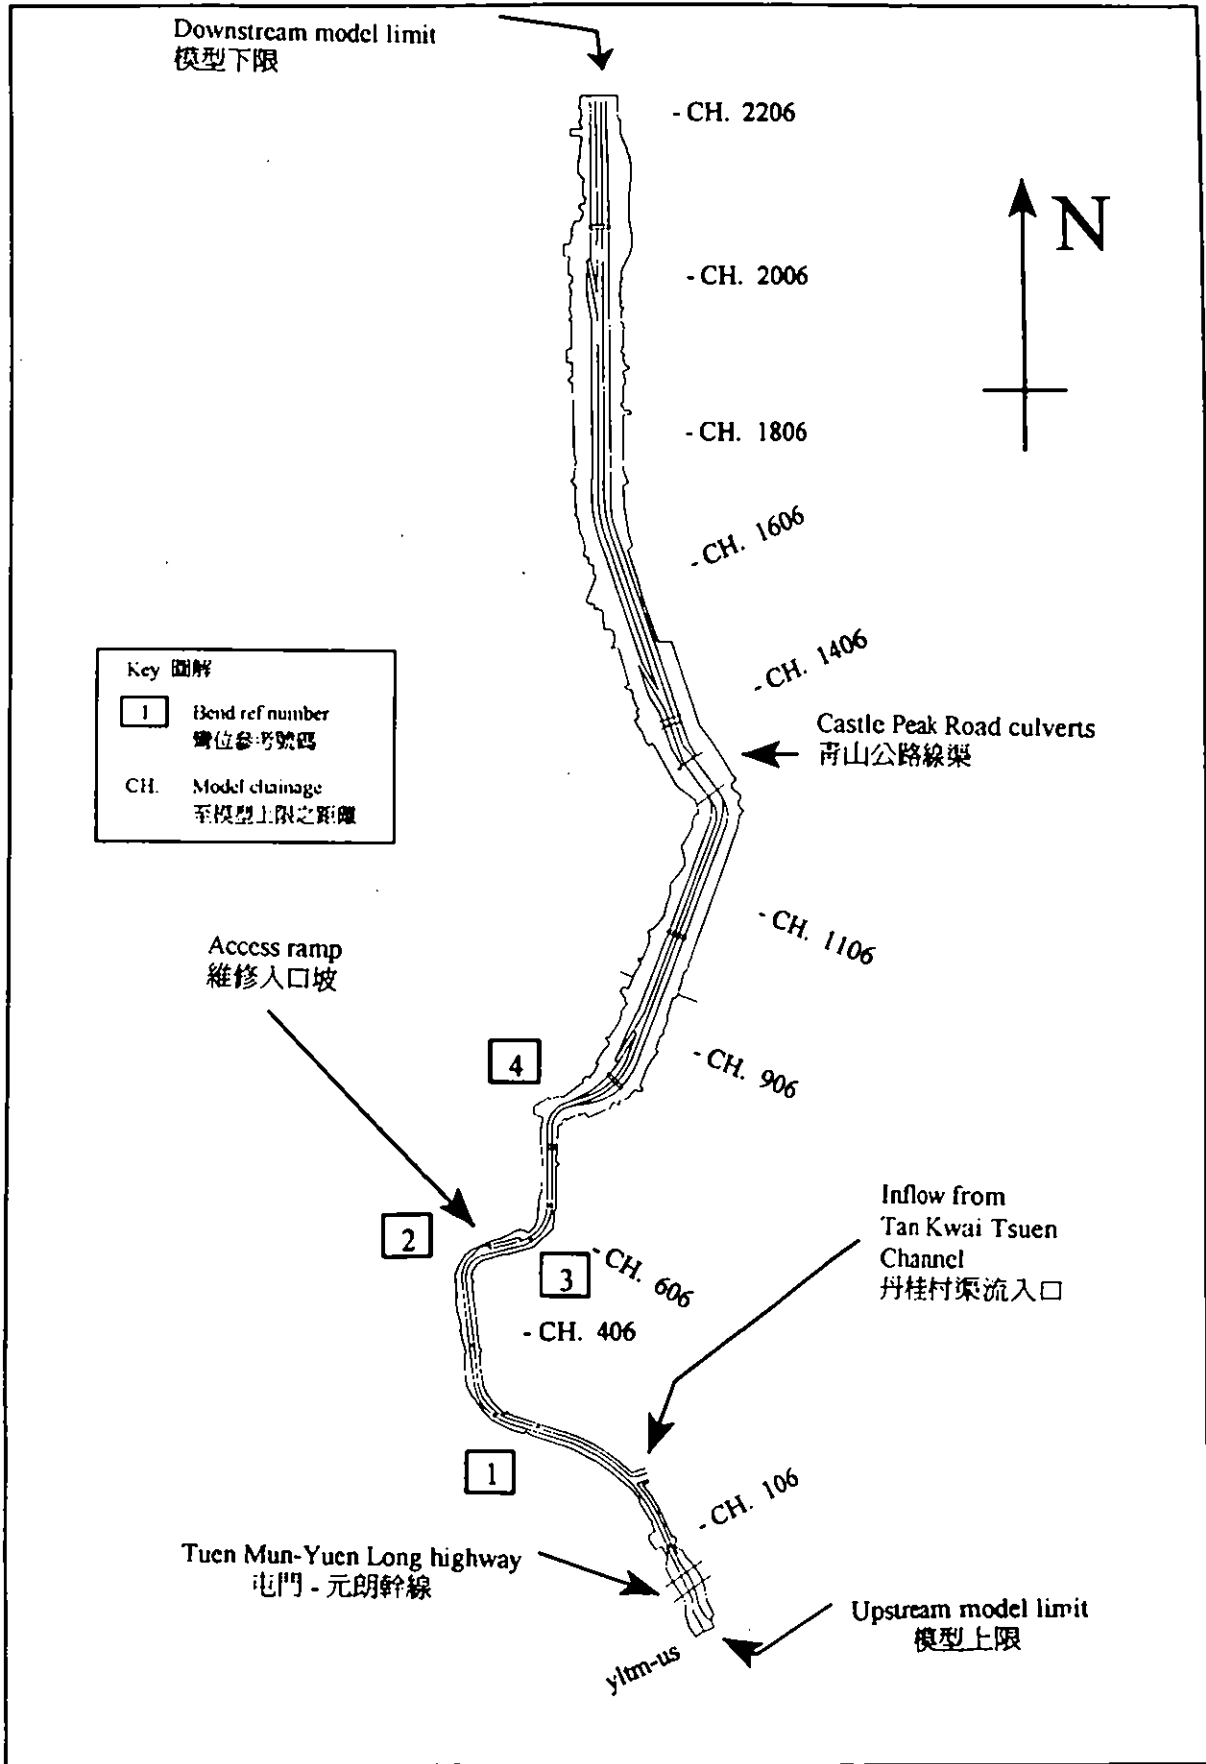
Figure B-Layout of the hydraulic model
圖 B-水力模型平面展示圖

A one dimensional hydrodynamic model (see figure B) was constructed of the Hung Shui Kiu Channel from the irrigation weir upstream of the Tuen Mun-Yuen Long Highway to the Shek Po Tsuen gauging station. The model was calibrated against the two recent flood events, using the inflow discharges determined from the hydrological models and water level observations taken during and after the events. The model was used to assess the improvement offered by the existing remedial measures implemented by the Hong Kong Drainage Services Department since the flooding occurred and to evaluate potential improvement offered by various options for short term and long term remedial works.
