Research & Consultancy Report No. 18

NOC Liverpool Unit 117 Glider deployment report
for the DEFRA MAREMAP Project
April - May 2012 deployment

C Balfour & P Knight

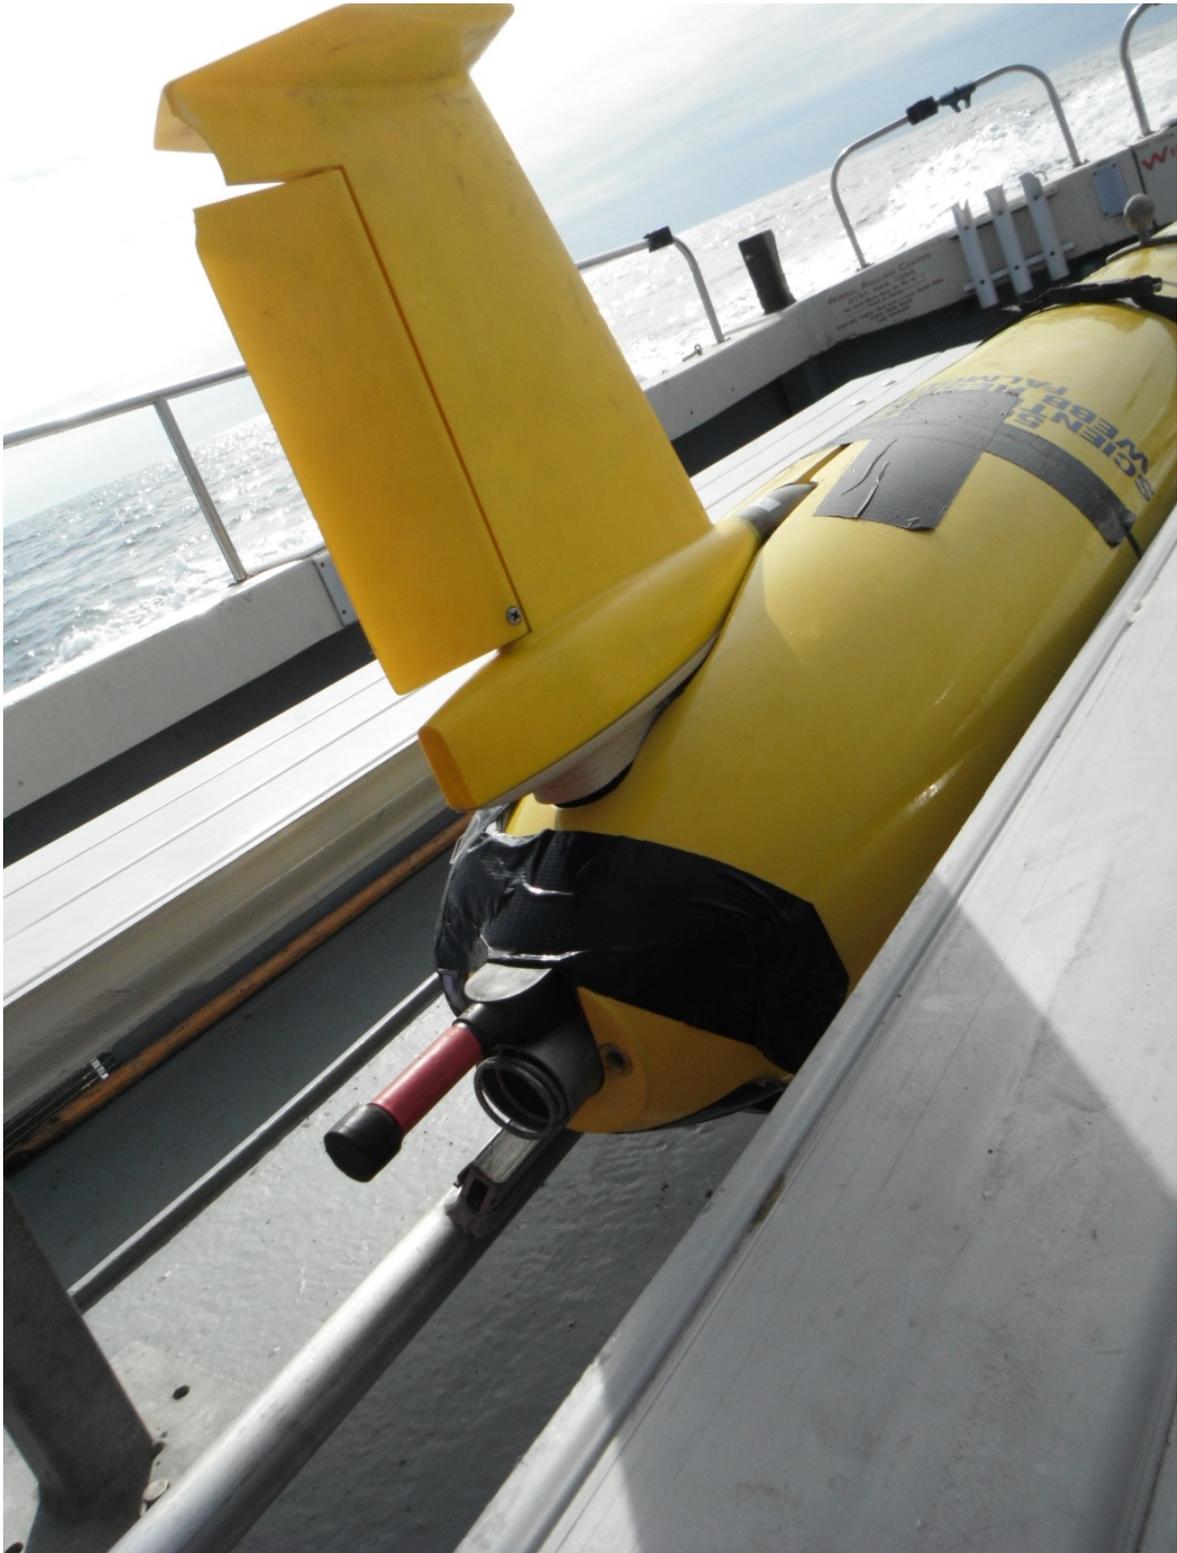
Fig. E3. Unit 117 Glider Emergency Recovery Rear Tail and Fin Damage

The jettison weight has been released (release spring visible) and the recovery damage to the upper part of Digifin rudder and mounting is visible. The Digifin appears to be working correctly after the damage was sustained

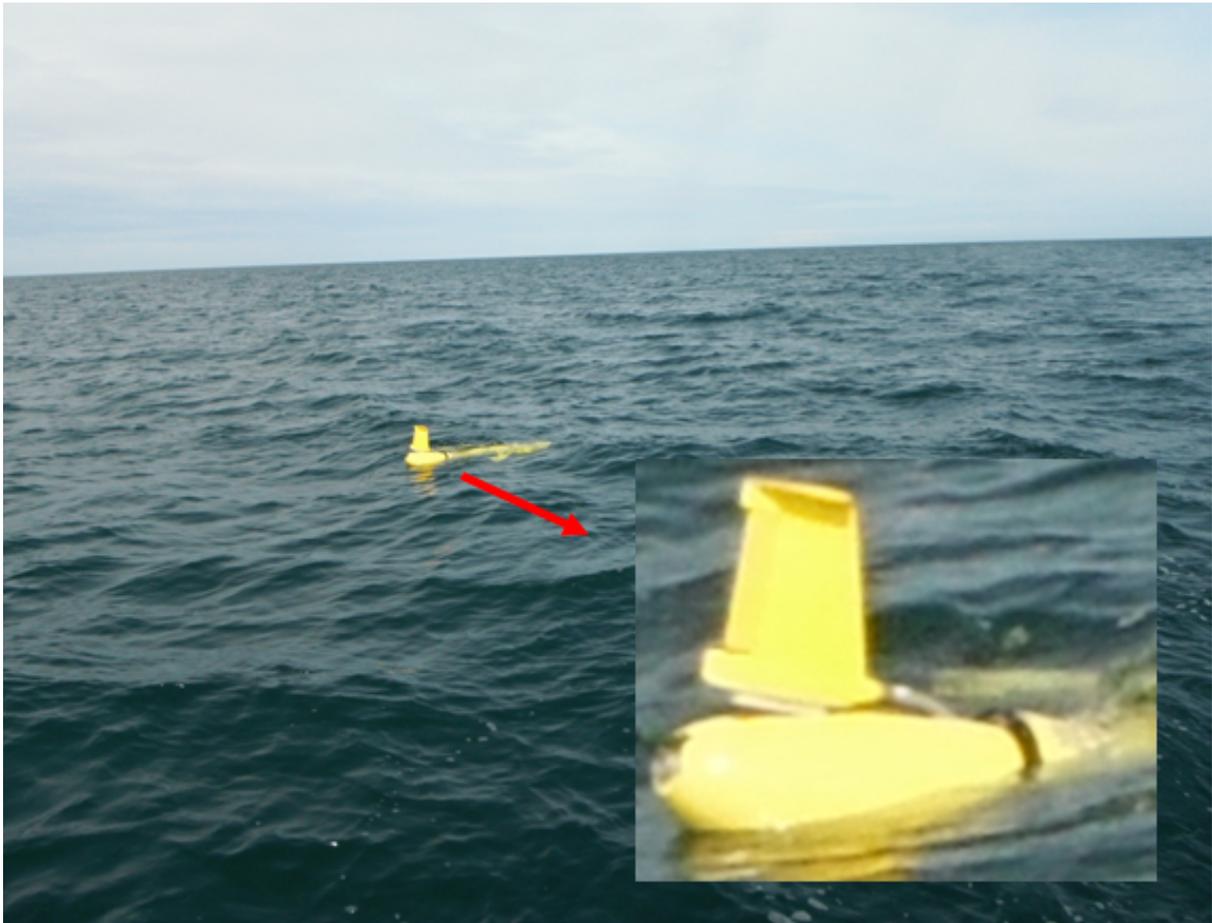
A close up picture of the glider before recovery shows the rear cowling out of place. This cowling covers an air bladder that is inflated when the glider surfaces. The bladder inflation raises the tail section for improved visibility and communications. The glider communications antennas are moulded into the tail section.

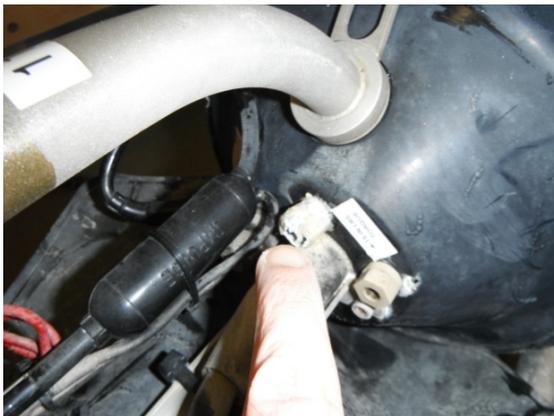
The glider had several scratches through the hull paintwork, particularly near the upper metal cleat mounting. Significant degradation of the rear hull zinc anode was observed although the nose section zinc anode seemed to be in good condition. Both of these anodes were verified as being in good condition before the deployment. Scraping and pitting was evident in the front rubber outer section behind the forward hull. Severe corrosion had occurred on the edge of the aft hull in several sections just above the recess into which the forward edge of the rear air bladder cowling sits. The heads of the screws holding the rear tail cowling had been sheared or corroded off and probably lost at sea. The outer part of the buoyancy piston and bellafram (rolling diaphragm for buoyancy control) arrangement was heavily fouled with fine sediment deposits. Possible reasons for this include progressive sediment contamination (sedimentation). Alternatively or in addition to this perhaps these deposits were collected or significantly increased during a collision, entanglement, dragging, lodging in the seabed or scraping of the seabed by the glider. The photographs in figs F1 to F14 are a sequence of pictures used to illustrate the glider general condition after the emergency recovery during the initial examination in the NOCL glider laboratory at the Vittoria Dock store.

Rear hull sacrificial anode degradation.
The zinc anode had almost completely corroded away

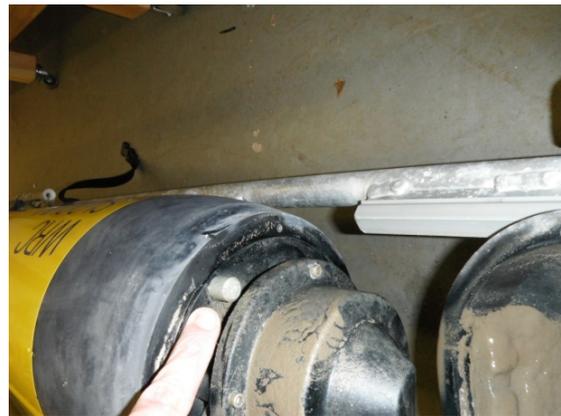
The front zinc sacrificial anode was in good condition

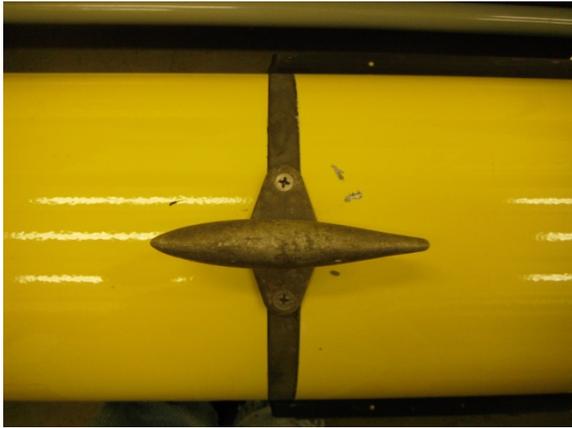
Paintwork Scrapes Near to Upper Cleat

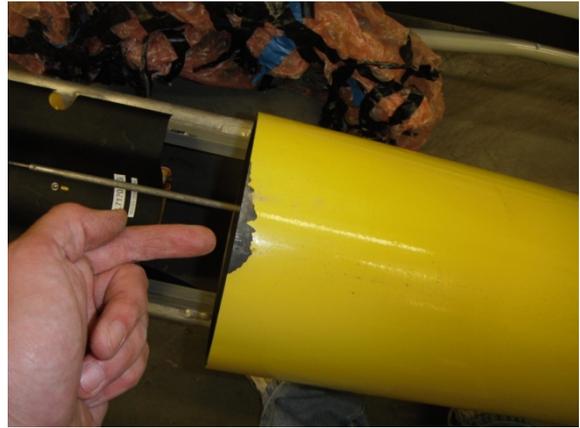
Paintwork damage to the underside of the front of the rear hull section

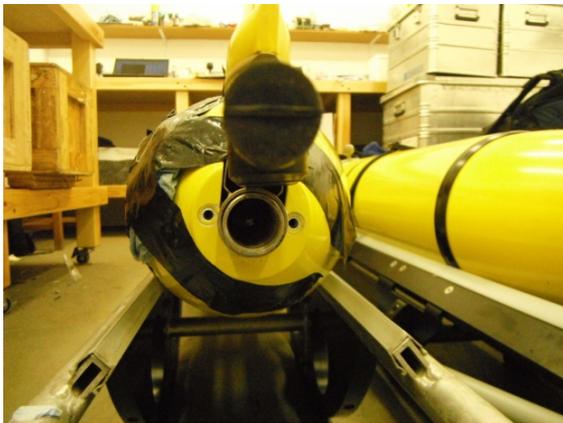
Sheared rear cowling retaining screw heads

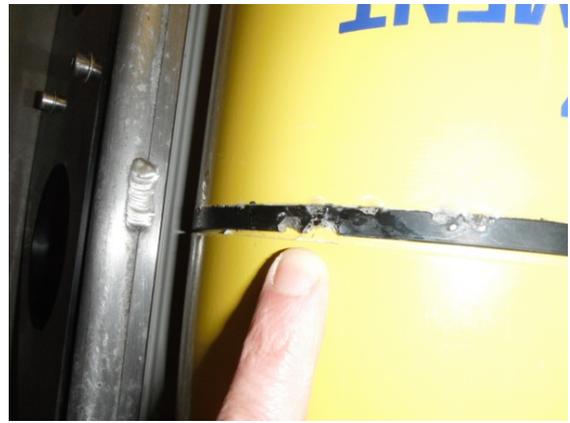
Rear metal hull corrosion. This was probably not impact damage because the plastic cowling is not damaged

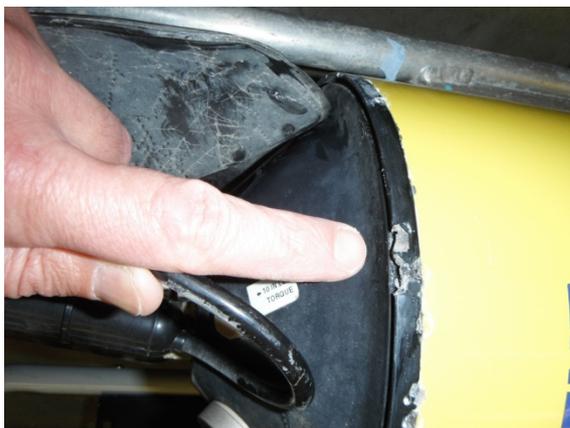
Significant rear hull corrosion has occurred

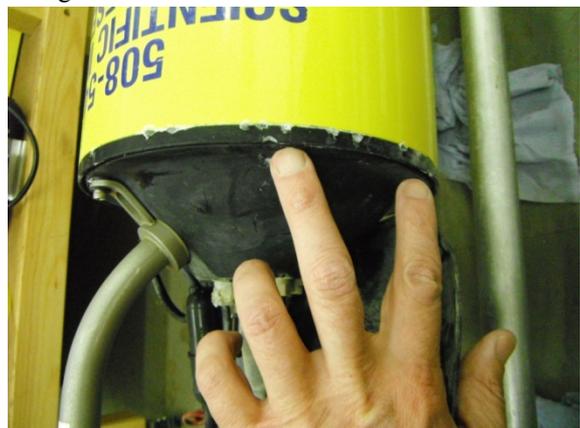
Rear hull corrosion. The white deposits between the rear hull and the bulkhead seal appear to be small barnacles

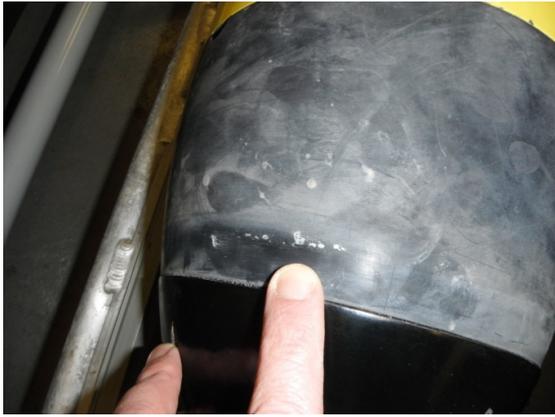
Forward rubber section pitting and scraping

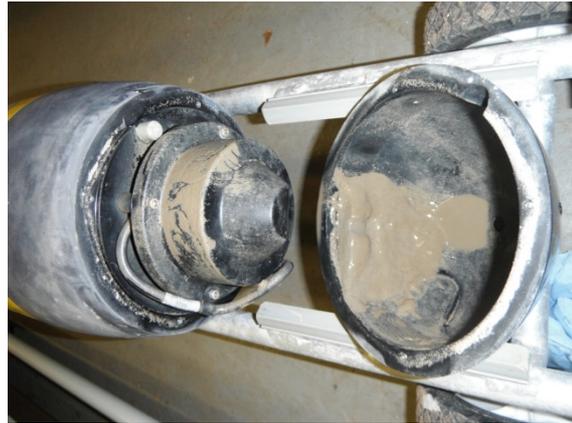
Sedimentation behind front Cowling in front of the Altimeter

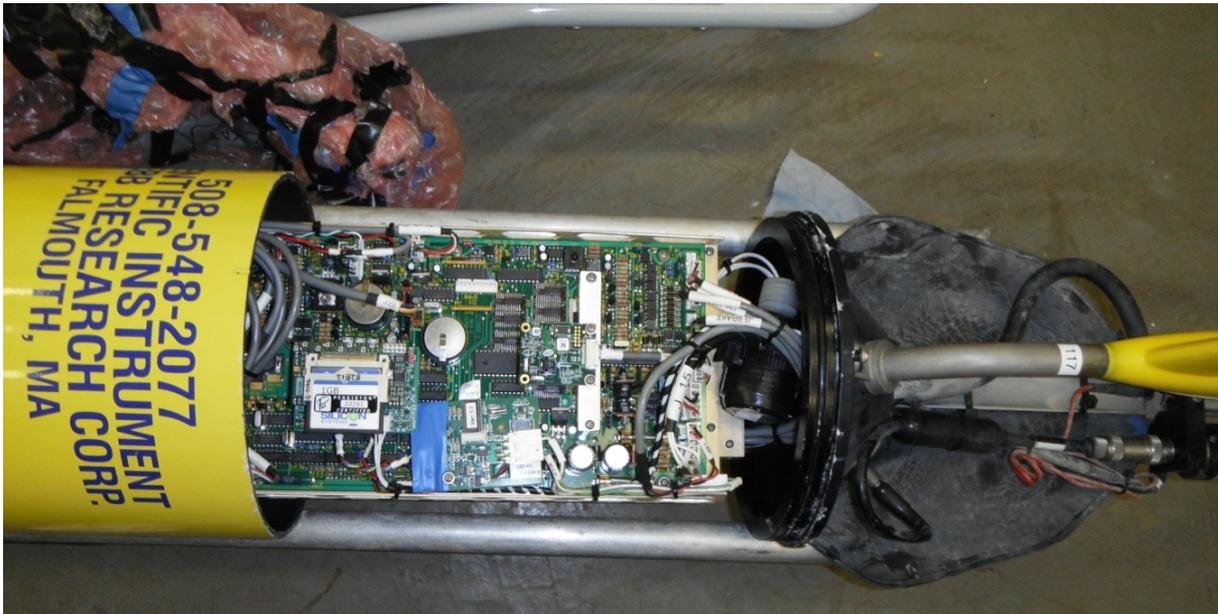
The internal glider components were in pristine condition and there was no evidence of seawater ingress, battery electrolyte leakage etc

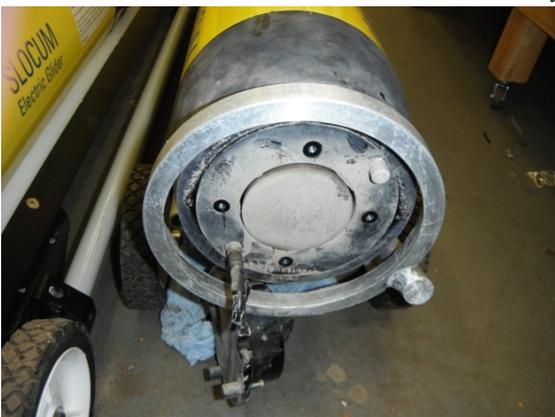
Bellafirm Moved Forward. The sedimentary contamination has almost dried out to leave a white powdery sand deposit in most areas.

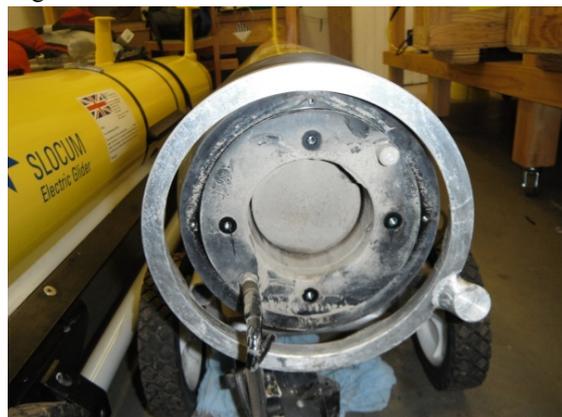
The ballast position was enabled and the bellafirm was moved to neutral, or 0cc, which is midway in its range of travel

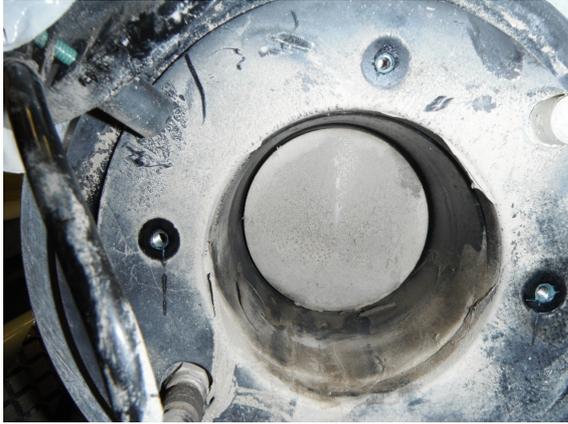
Bellafram drawn inwards. There are no obvious signs of damage to the rubber surfaces etc

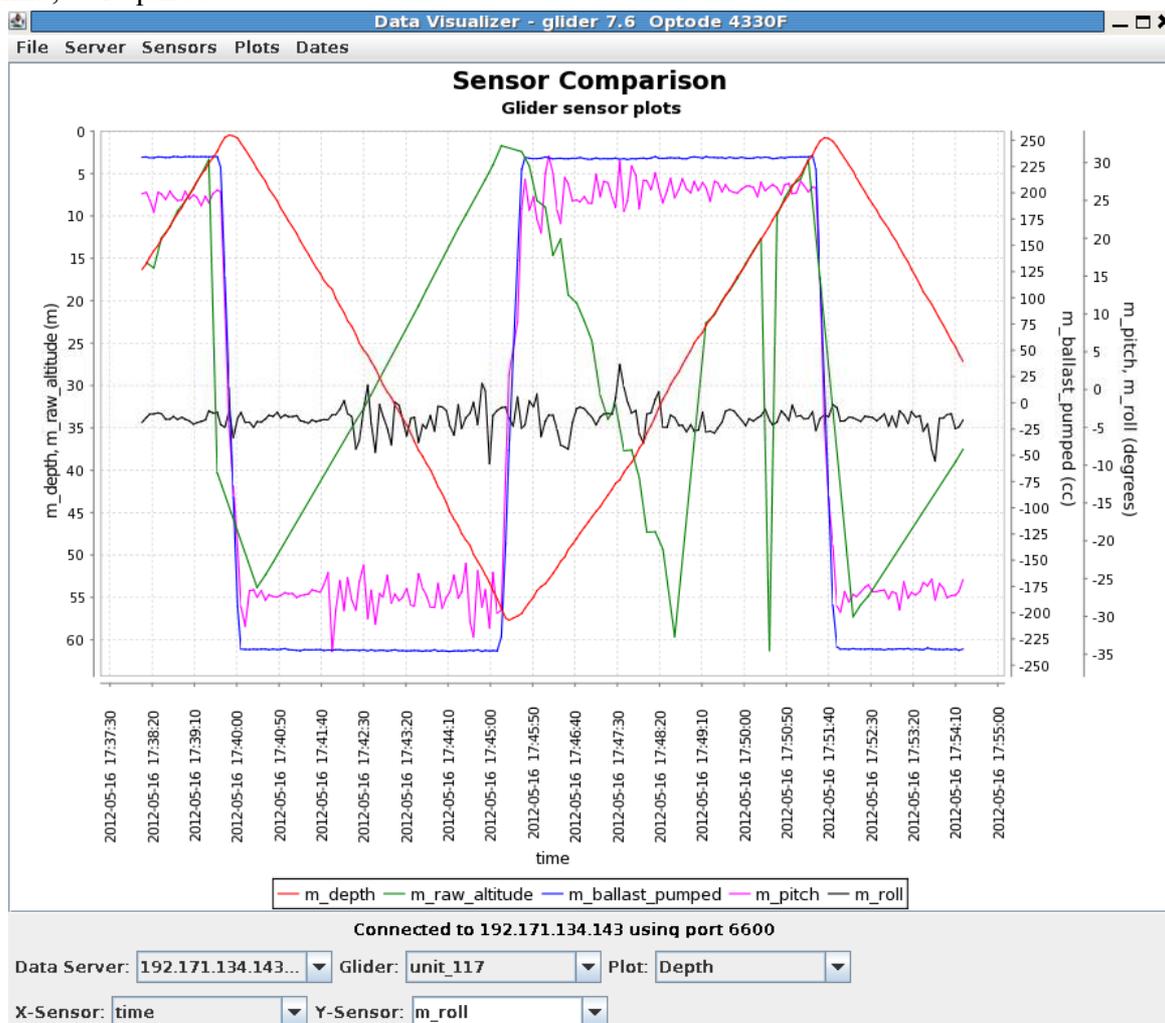
Fig. F5. A Fully Executed Glider Inflection Before the Suspected Entanglement of the Glider Close to the Seabed Occurred

To determine the most likely cause of the glider failure the downloaded glider data was plotted and analysed. Figure F5 shows that prior to the problem the glider was diving correctly (m_depth plot), receiving seabed range information from the altimeter (m_altitude and m_raw_altitude plots) and inflecting as expected when the seabed was approached. This normal dive and climb cycle occurred throughout the deployment until the glider suddenly lost the ability to inflect and climb. On Wednesday 16th May 2012 at 23:27:29 GMT the glider surfaced, reporting a mission abort and that the glider emergency surfacing jettison weight had been released. Figures F6 to F11 show a series of glider data plots that

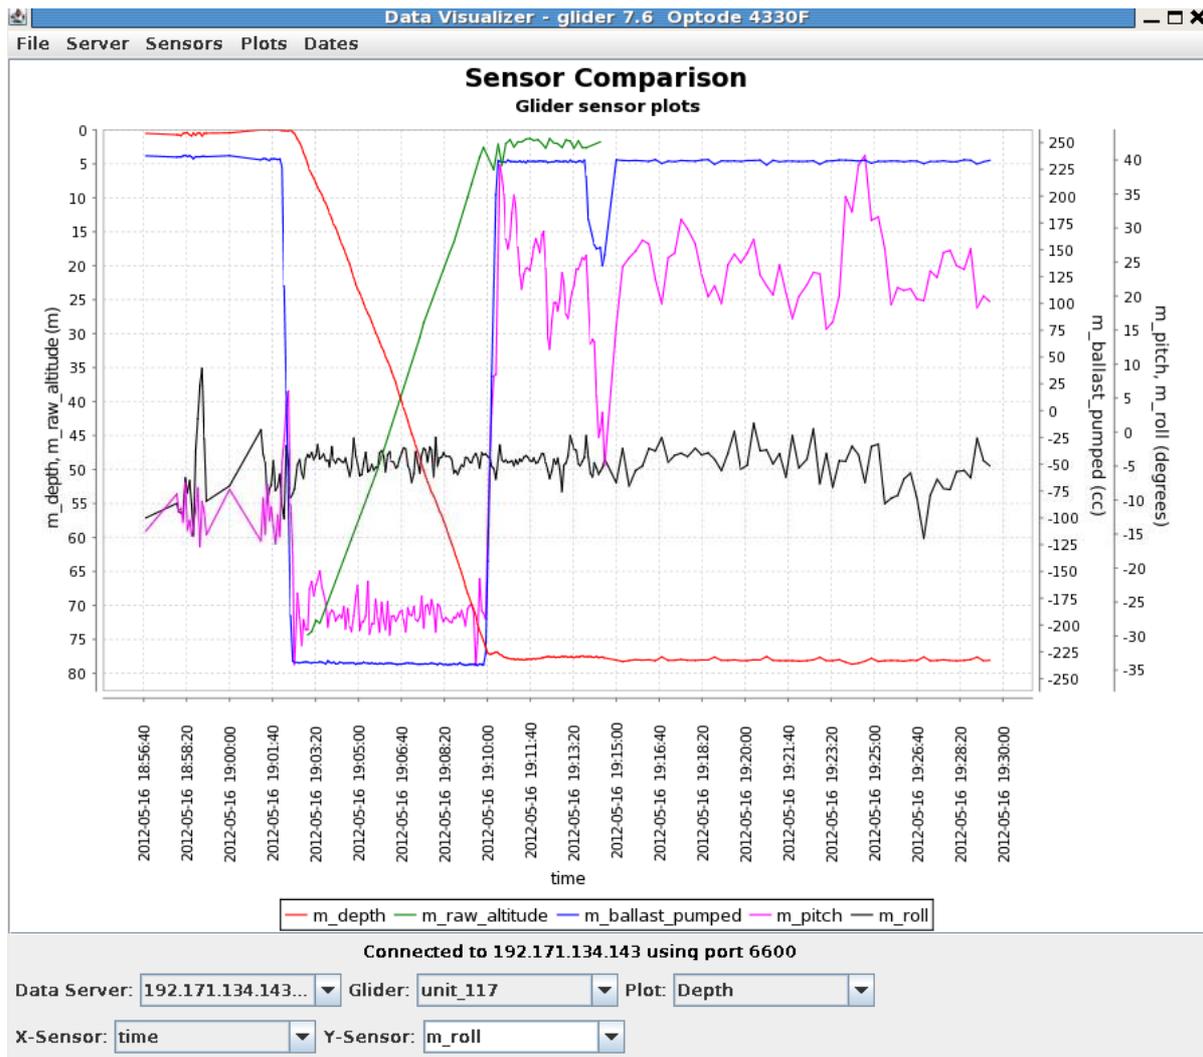
Fig. F6. Plots of m_depth, m-raw-altitude m-ballast-pumped and m-pitch and m-roll leading up to and beyond the suspected glider entanglement.

The possible reason why the glider lost the ability to inflect and climb would seem to indicate some form of entanglement, lodging in debris or mud, or dragging has occurred close to the seabed. The plots of the demanded and measured buoyancy changes by the glider in figure F5 (c_ballast_pumped and m_ballast_pumped) demonstrate that the glider buoyancy pump operated correctly and physically moved the ballast outwards to try to initialise a climb, as required.

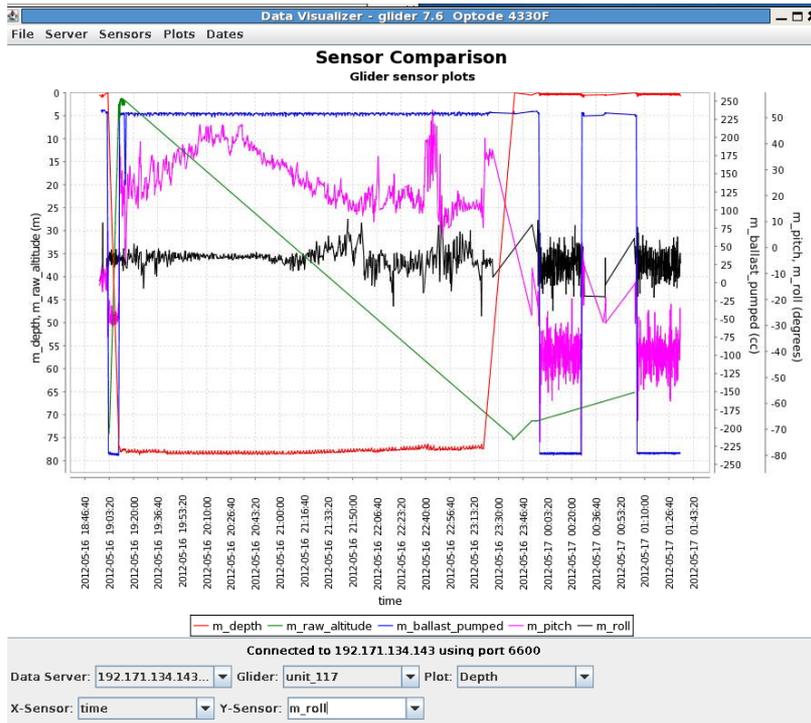
Fig. F7. Glider Movement after Suspected Entanglement

When the problem occurred the pitch of the glider has gone positive to $\sim 26^\circ$ in response to the changed in measured ballast (bellafram moved outwards to climb). The depth remains reasonably constant, pointing towards some form of entanglement with the glider nose section pointing upwards (positive pitch). The pitch of the glider just after the problem occurs also seems to indicate large subsequent oscillations between up to $\sim -5^\circ$ and $\sim +40^\circ$.

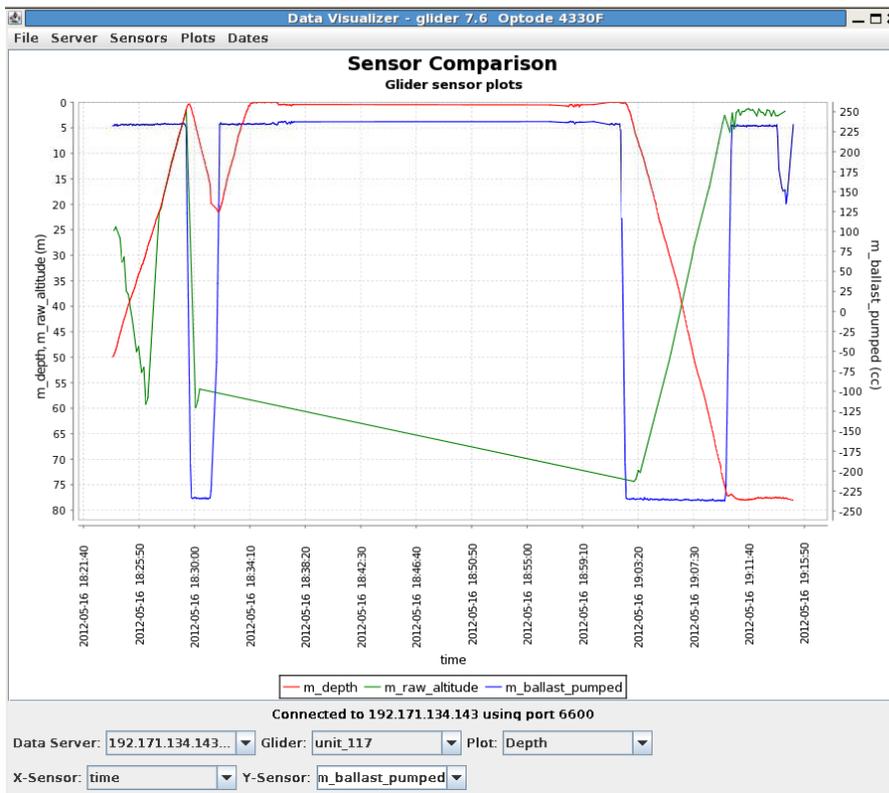
Fig. F10. Expanded plots of the final dive

An altitude of ~75m is measured, 5m into the dive that results in a total depth of ~80m. At ~75m into the dive the glider buoyancy pump moves the ballast outwards to try and initiate an inflection and subsequent climb
