# A Walkover Survey of a Landslide on the A6024 at Little Hey, West Yorkshire

Urban Geoscience & Geological Hazards Programme Internal Report IR/04/181

G O Jenkins & H J Reeves

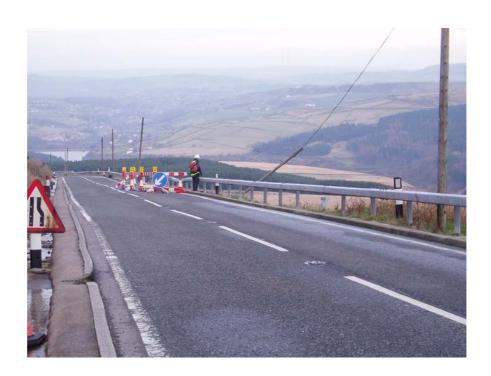
Damage to infrastructure, Little Hey Landslide, A6024, West Yorkshire

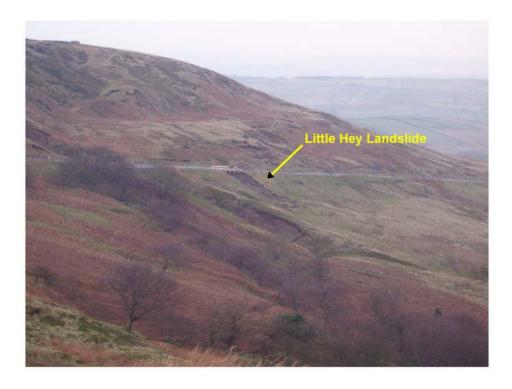
Observation of the Little Hey Landslide during the walk over survey (Figure 3.1) showed it to be approximately 35 metres in length (downslope) with a maximum width of 7 metres (across slope). The average slope gradient in the vicinity of the landslide was approximately 25°, with the surrounding natural slope closer to 15° (Figure 3.2). The Little Hey landslide was classified as a shallow non-circular rotational failure (slump) degrading into an earth debris flow (Figure 3.3), which moved in a south-easterly direction (135°) and undercut the foundations of the A6024 road to Holmfirth (Figure 3.4). Fig. 3.3 shows evidence that the Little Hey Landslide is part of a much larger-scale landslide, that exists above and below the A6024.

The material in the slide consisted of weathered, very soft, light grey mottled rusty orange, fine to coarse sandy CLAY. This material was saturated, due to the large amounts of rainfall that had occurred in the area both during the weekend of the 27<sup>th</sup> November 2004 (information obtained whilst talking to Peak District Ranger) and during the summer of 2004 (Anon, 2004).

Figure 3-1. View close-up of Little Hey landslide taken from [BNG <sup>4</sup>09821 <sup>4</sup>03950], facing 002° (N) (H.J. Reeves, BGS © NERC 2004)

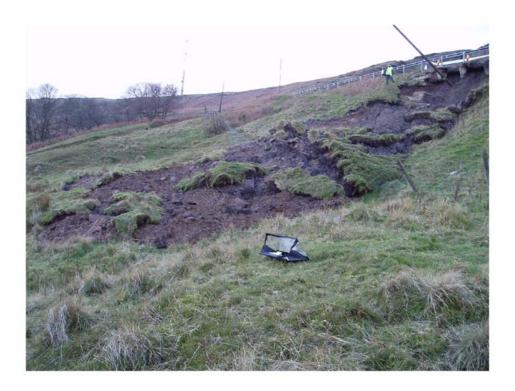
Figure 3-2. Close-up view of Little Hey landslide detail. Photograph taken from [BNG <sup>4</sup>09851 <sup>4</sup>04402], facing 260° (SW) (H.J. Reeves, BGS © NERC 2004).

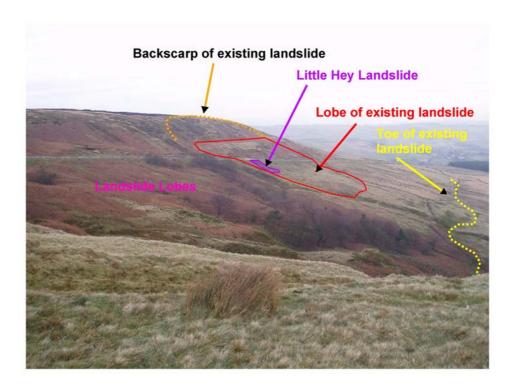
Figure 3-3. Evidence for large-scale landsliding on the slopes around the Little Hey landslide. Photograph taken from [BNG <sup>4</sup>09821 <sup>4</sup>03950], facing 002° (N) (H.J. Reeves, BGS © NERC 2004).

Inspection of the wider area around the landslide indicates that the Little Hey landslide is located in an area of more extensive, large-scale landsliding. The Little Hey event may represent partial re-activation of these larger failures. However, a more detailed site and geomorphological investigation would be needed in order to identify the nature of slope movements on this hillside.

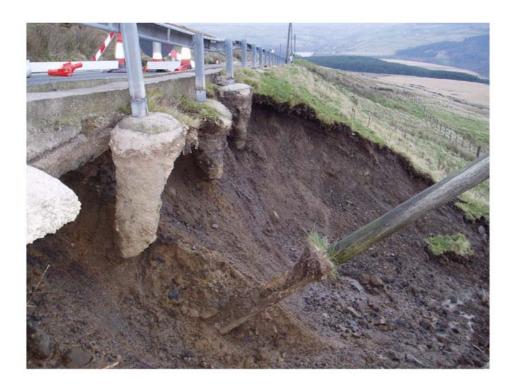
Figure 3-4. Undercutting of the A6024 due to the slope failure at Little Hey landslide. Photograph taken from [BNG  $^4$ 09861  $^4$ 04401], facing 030 $^\circ$  (NE) (H.J. Reeves, BGS © NERC 2004).

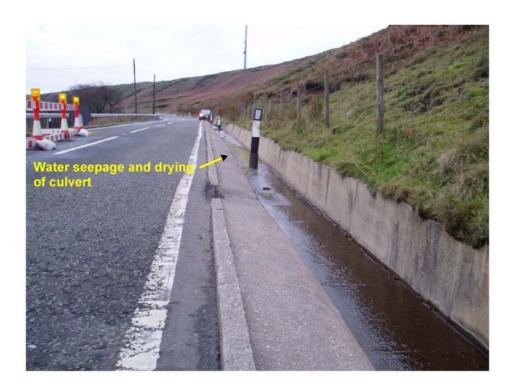
A drainage culvert was observed immediately behind the backscarp of the landslide on the northbound side of the A6024 (Figure 3.5). This was constructed from paving slabs and was presumably designed to intercept drainage of water above the road. Water was present in much of the culvert at the time of the field visit, although it was absent where the landslide undercut the road and reappeared again further down the road past the landslide (Fig. 4.4). It is thought that leakage from this culvert could have introduced additional water into the already saturated ground under the road, causing an increase in the pore water pressure leading to the failure of the slope below the road. It could also be possible that the landslide above the road had affected the foundations of the culvert, causing the culvert to be uplifted and leak.

Figure 3-5. View of the drainage culvert immediately behind the Little Hey landslide. Photograph taken from [BNG  $^409865$   $^404414$ ], facing  $240^{\circ}$  (SW) (H.J. Reeves, BGS © NERC 2004).

The cause of the failure is likely to have been due to the leakage of water from the culvert on the north-western side of the A6024 between the Woodhead Reservoir and Holmfirth. The introduction of water under the road increased the pore water pressure of already saturated sediments on the slope below it (following a wet summer and period of heavy rainfall), and resulted in the failure of the slope.
