Source, character and weathering style of building stone in Culzean Castle & Country Park, Ayrshire

Commissioned Report

CR/14/114N

Martin R Gillespie, Paul A Everett and Emily A Tracey

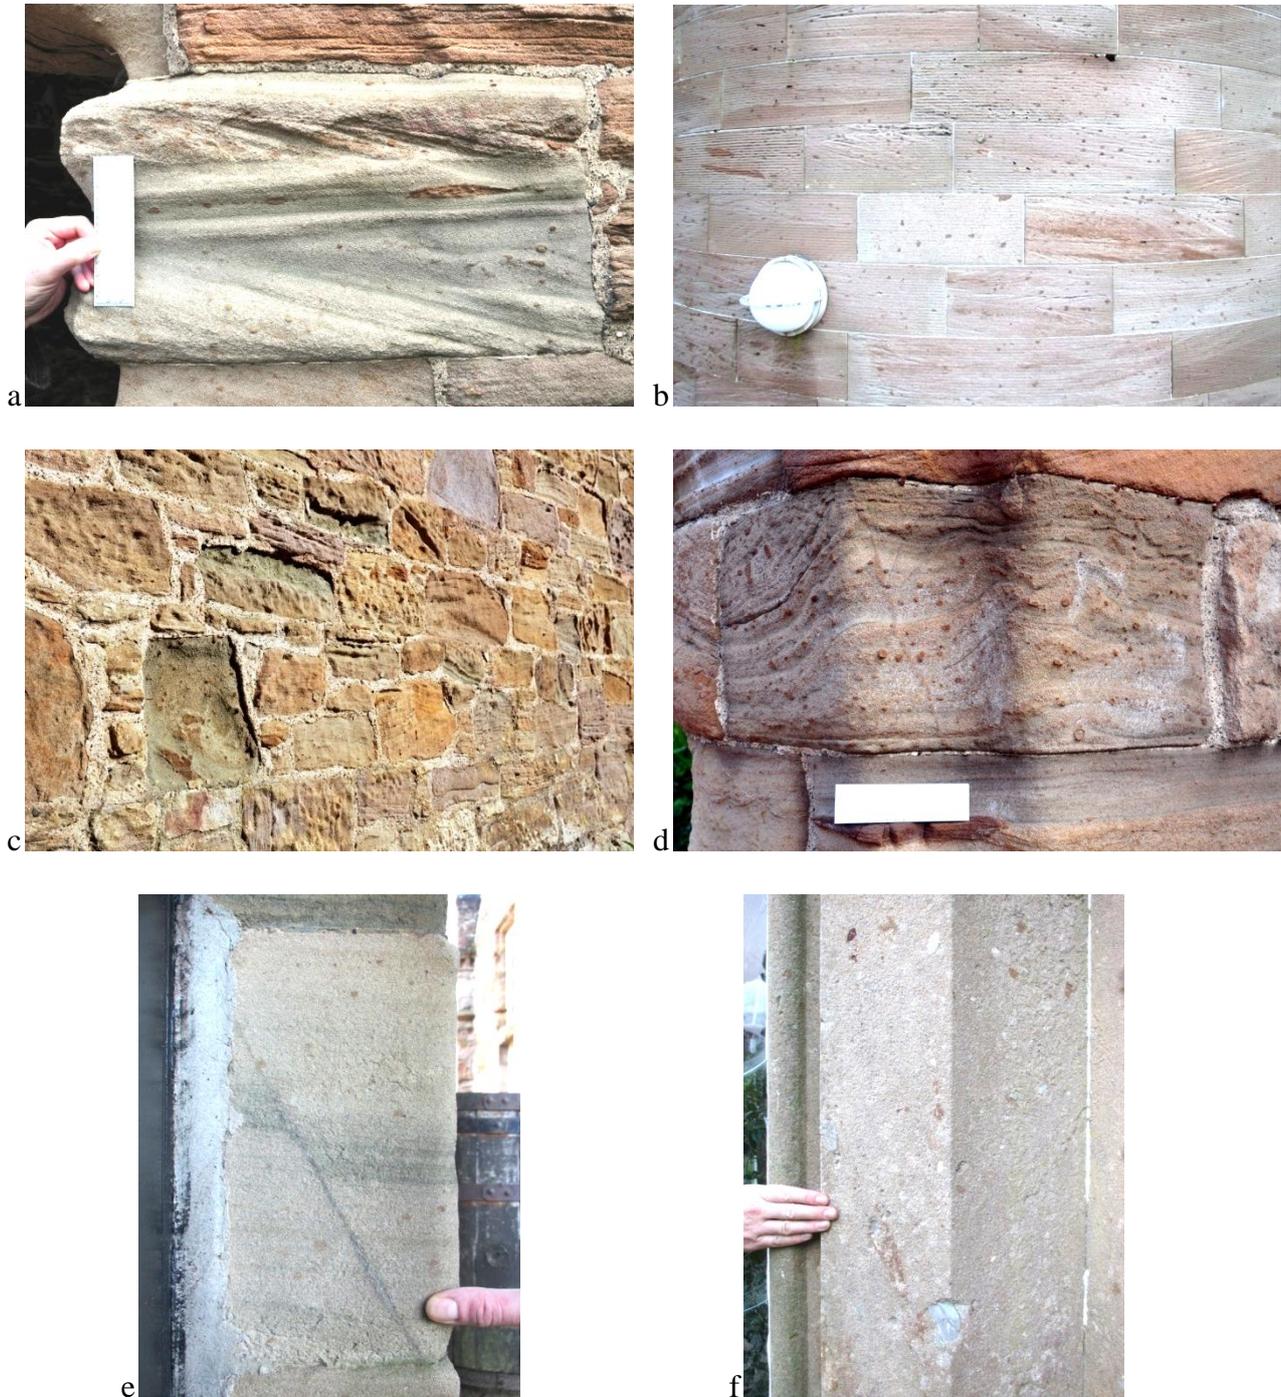
Figure 5 Macroscopic character of Swanshaw sandstone

a - Block of greenish Swanshaw sandstone showing cross-bedding, ferruginous spots and soft-bed erosion (Ruined Arch, south tower). b – Ashlar from St Murray's quarry showing parallel bedding and cross-bedding with ferruginous spots and patches (Culzean Castle West Wing). c - Rubble wall showing the typical range of colour in Swanshaw sandstone; some blocks, particularly green stone, show locally significant material loss behind relatively recent repointing mortar (New Stables, west elevation). d - corner block of weathered Swanshaw sandstone showing contorted bedding, hairline veins, iron-rich spots and salt efflorescence (Ruined Arch: south limb). e – Small fault (granulation seam) showing minor offset of beds in Swanshaw sandstone (Home Farm). f – A mullion of pinkish grey sandstone from St Murray's quarry with scattered grey to reddish brown mud flakes (Camellia House).

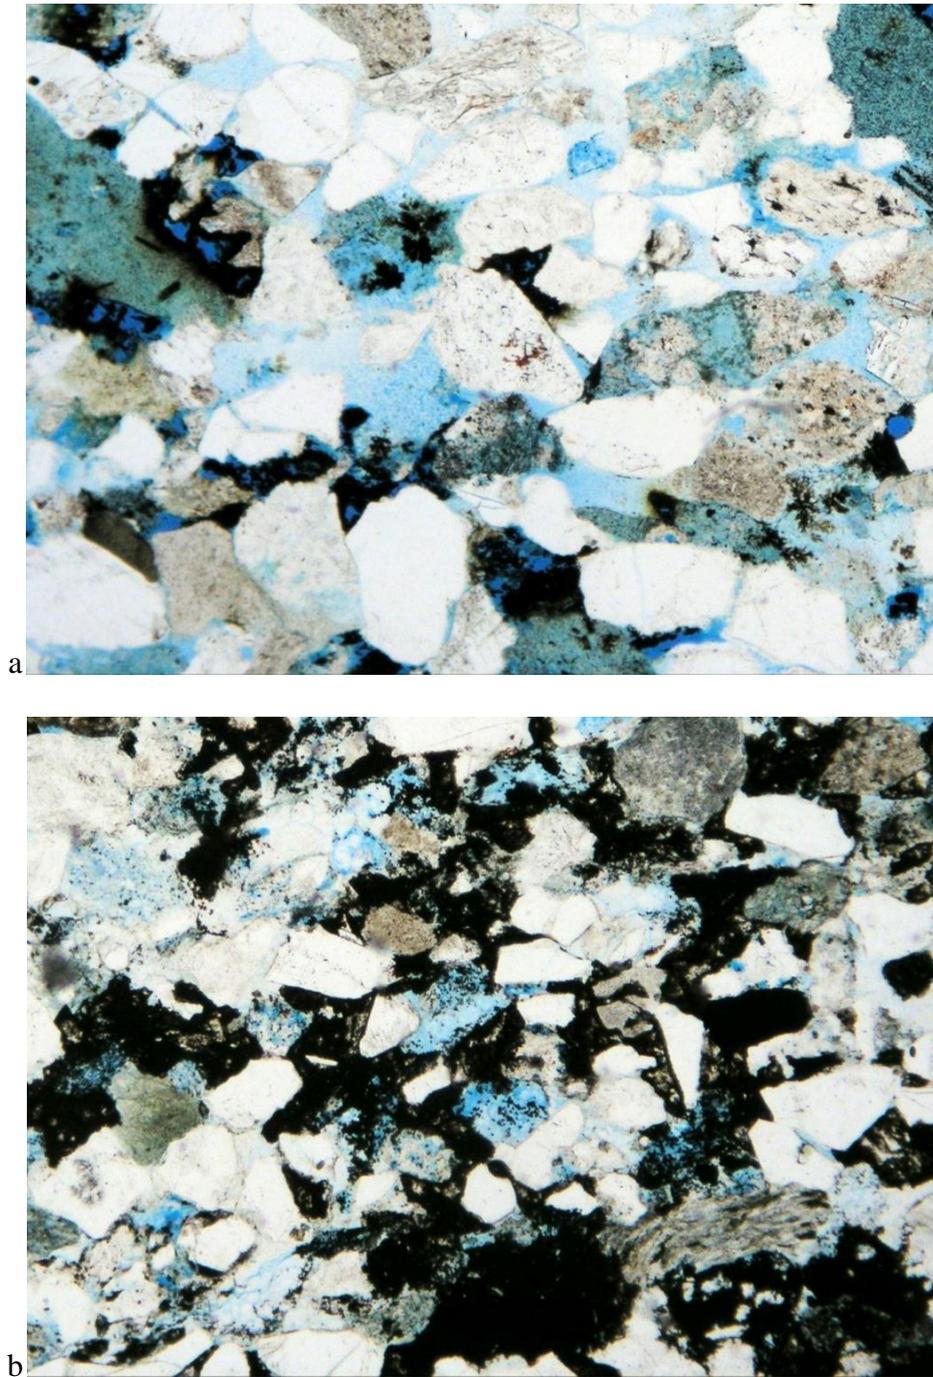
Figure 6 Microscopic (thin section) character of Swanshaw sandstone

a – Typical stone from Gas House quarry (sample ED11209). b – Typical stone from Ballochneil quarry (sample ED11211). The field of view in both images is around 2 mm wide. In both images: white grains are quartz, light brown grains are mainly feldspar and mottled green to grey grains are rock fragments (fine-grained volcanic rock); black patches are iron oxide, mottled pale blue areas are kaolinite clay and dark blue areas are pore spaces. A small proportion of fresh iron carbonate mineral is contained within the iron oxide in the sample from Ballochneil quarry. In both samples the iron oxide shows evidence that it has formed from the dissolution of iron carbonate, including preserved mouldic pore spaces.

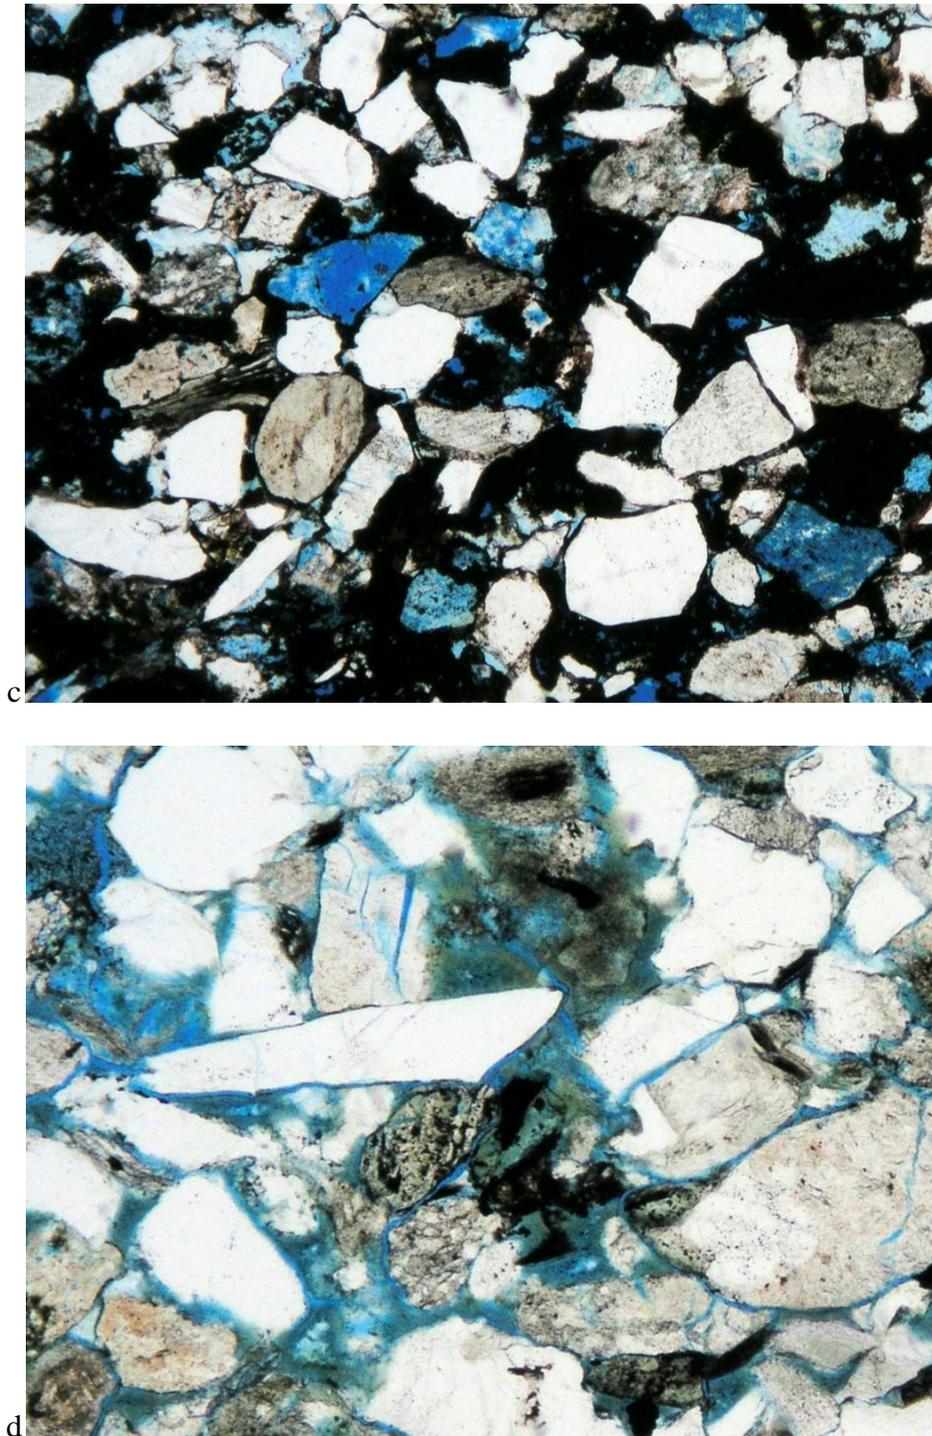
Figure 6 (continued)

c – Typical stone from St Murray's quarry (sample ED11214). d – Strongly weathered Swanshaw sandstone recovered from a building in CCCP (sample ED11359). The field of view is around 2 mm wide in the top image and 1 mm wide in the bottom image. In both images: white grains are quartz, mottled green, brown and grey grains are mainly fragments of fine-grained volcanic rock, though a small proportion are feldspar; black patches are iron oxide, mottled pale blue areas are kaolinite clay and dark blue areas are pore spaces. The St Murray's stone (c) has a large proportion of iron oxide and no carbonate mineral; mouldic pore spaces after dissolved rock fragments are common. The strongly weathered sample (d) shows green chlorite developing on many grain boundaries and along widened gaps between the sand grains; the green mineral is the cause of the increasingly green colour of strongly weathered stone, and the widespread gaps between sand grains are the cause of granular disintegration.

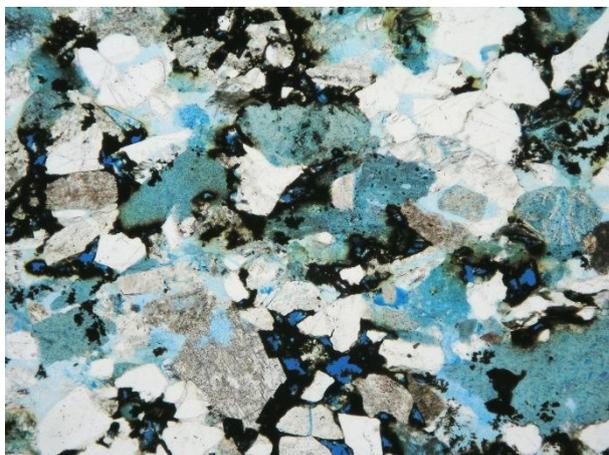
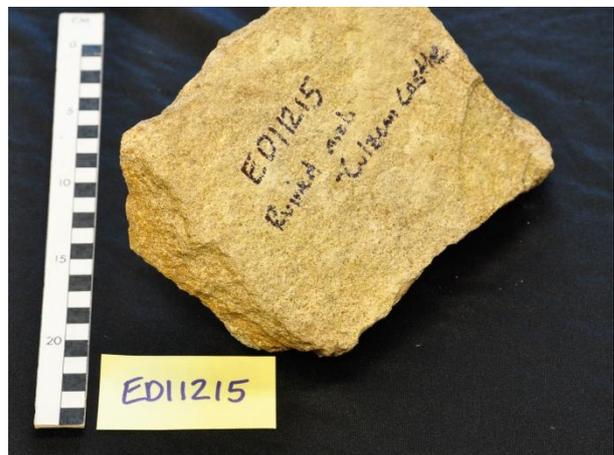
- 3) The sample contains two carbonate minerals - calcite and iron-rich carbonate (dolomite, ankerite or siderite) - both of which have experienced dissolution. Calcite crystals enclose (and therefore post-date) iron oxide crystals.

- 4) Some of the biotite mica biotite has altered to green chlorite. Some rock fragments also display a greenish tinge, due to the alteration of mafic minerals to green chlorite. Most rock fragments and feldspar grains have been replaced by clay; this has been taken into account in the detailed classification.

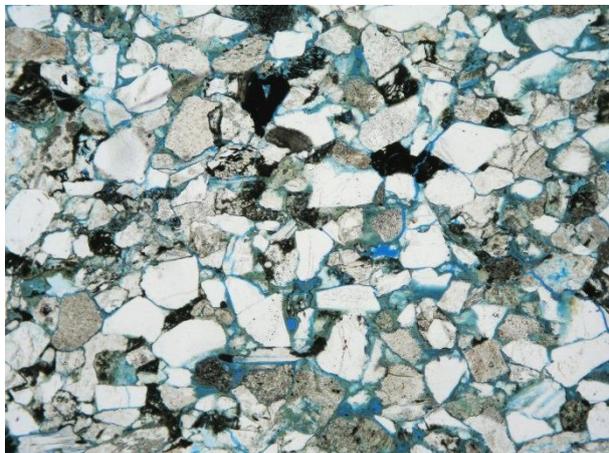
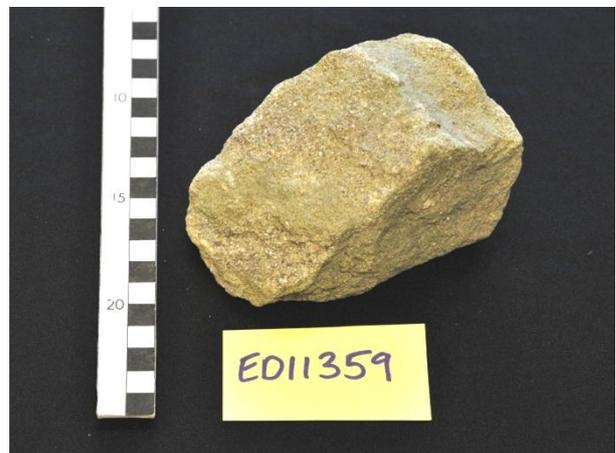
- 1) The entire sample consists of strongly weathered stone.
- 2) Most detrital grains appear to be “floating”, i.e. they are not in contact with other grains in the plane of the thin section and are separated from each other by narrow gaps (filled by blue resin in the thin section). Despite the relatively low pore volume, the high connectivity of these gaps contributes to high permeability in the stone. In places the gaps are infilled with a green mineral, possibly chlorite or corrensite. This mineral comprises c. 9% of the thin section area and is classified as ‘clay’.
- 3) The mineral zircon is present in trace proportions (<<1%).
- 4) The sample reacts vigorously to 10% HCl solution, indicating that the carbonate mineral is dominantly or entirely calcite. The calcite is relatively fresh and has not suffered significant dissolution.

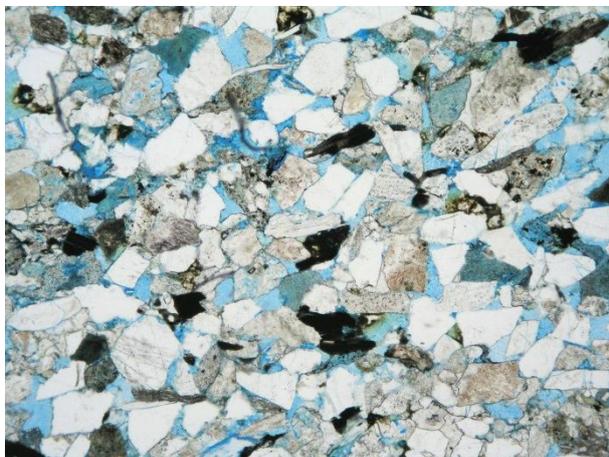
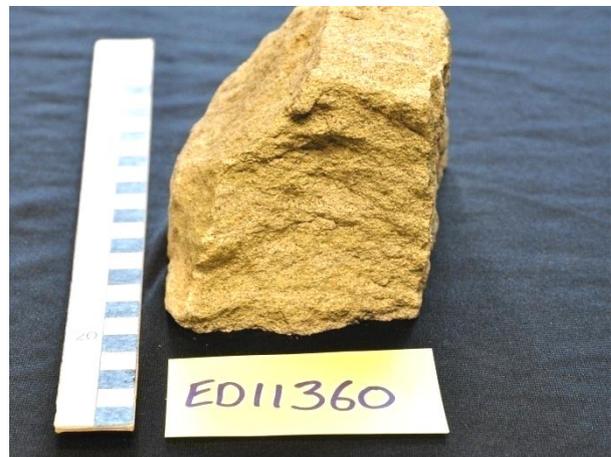
- 1) The entire sample consists of weathered stone.
- 2) Some of the material classified as clay is a green mineral (possibly chlorite or corrensite) which forms c. 1% of the thin section area and has grown in gaps between the detrital grains and patches of clay.
- 3) The sample reacts strongly to 10% HCl solution; indicating that the carbonate mineral is dominantly or entirely calcite. The calcite is relatively fresh, and occurs in scattered patches up to several millimetres across.
- 4) The minerals tourmaline and zircon are present in trace proportions (<1%).
- 5) Most of the rock fragments and feldspar grains have been replaced by clay; this has been taken into account in the detailed classification.
