Renewed fissuring in the Magnesian Limestone beneath the A690 road at Houghton-le- Spring, City of Sunderland

Internal Report IR/03/111

B Young

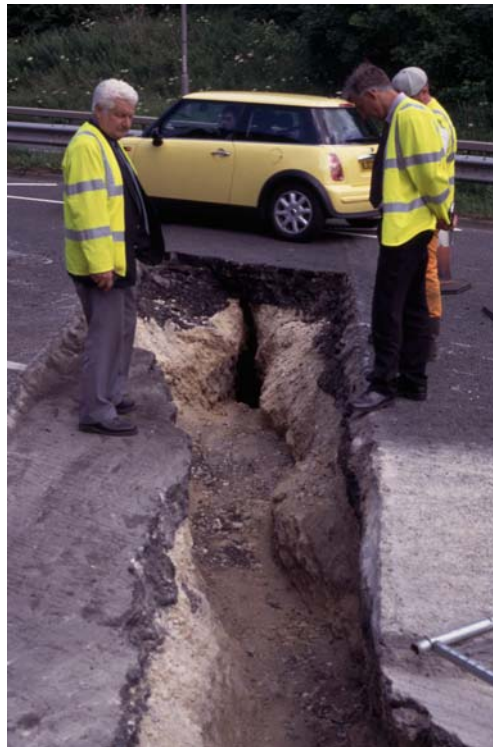
Front cover

Fissure exposed beneath near-
side lanes of north-bound
carriageway of A690, 20 June
2003. Walls of solid dolomitic
limestone and open fissure
beneath tarmac can be clearly
seen

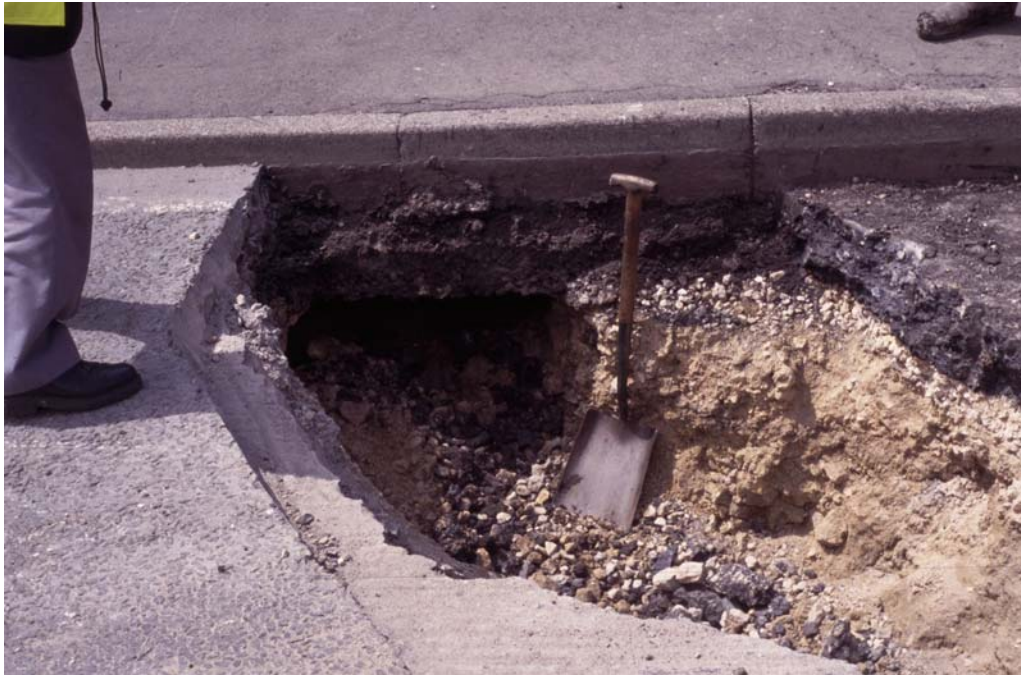
On 20 June 2003, Sunderland City Council Highways Department staff observed significant depressions in the previously repaired tarmac in the nearside lane of the north-bound carriageway of the road and ordered an immediate investigation by removing a section of tarmac. This showed a substantial void immediately beneath the tarmac at a depth of about 0.2 m from the surface (Figure 1).

Immediately beneath the kerb, at a depth of roughly 0.2 m from the surface an open void up to 0.5 m wide, 1.0 m deep and extending for several centimetres beneath the pavement was clearly visible (Figure 1).

Figure 1. Void beneath pavement, adjoining north-bound carriageway of A 690 road, exposed during repair work 20 June 2003.

It is understood from City Council staff that the excavations were reinstated by filling with dry broken rock compacted to the level of the base of the tarmac. A flexible membrane was placed over the rubble fill and tarmac was placed above this to make good the road surface.

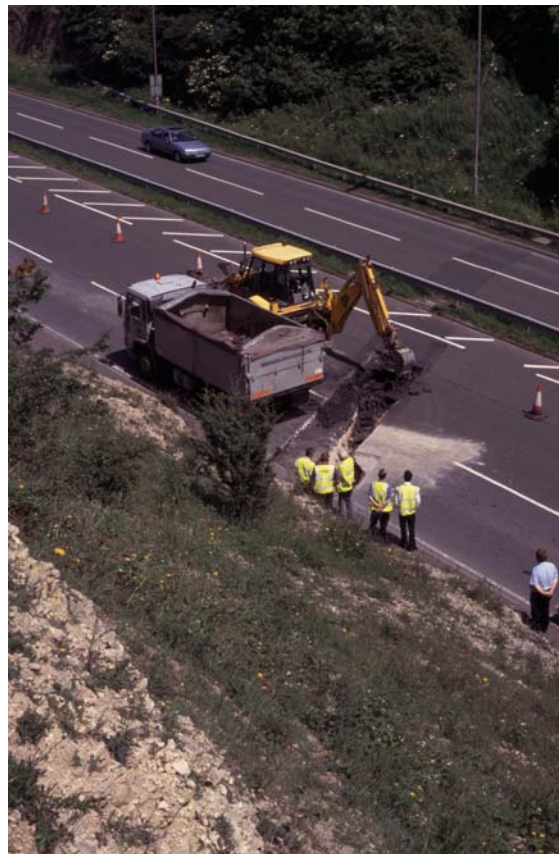
At the time of this examination a trench up to 2 m wide and approximately 1.5 m deep had been excavated along the line of the original fissure, across the two westernmost lanes of the north-bound carriageway (Figures 2 - 3). So far as could be established the road at this point comprised up to 0.5 m of tarmac resting upon at least 0.5 m of dolomitic limestone rubble. Distinguishing limestone sub-base from broken limestone *in situ* beneath the road proved difficult. However, over much, perhaps the whole, of the excavated trench solid, *in situ*, limestone was present at depths of between 0.75 to 1.0 m from the road surface.

Figure 2. Excavation of fissure across north-bound carriageway of A 690, 20 June 2003.

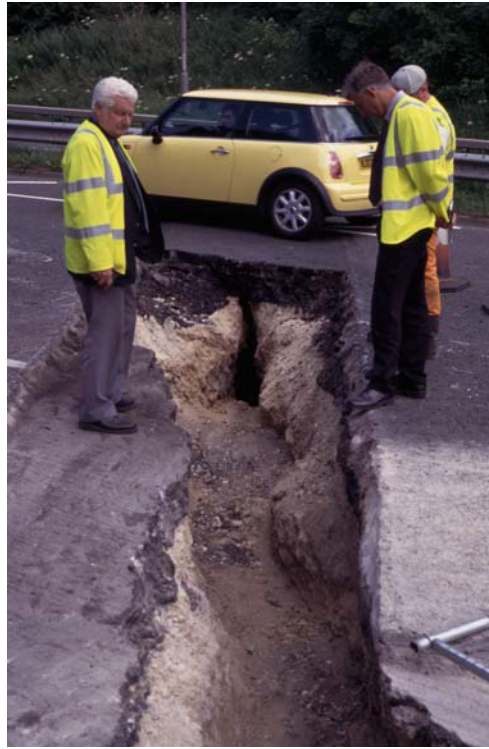
Over the remaining length of the trench a prominent fissure could be traced across the full extent of the excavation in solid limestone (Figure 3). This, the only fissure exposed in the excavation, is clearly the same fissure that became apparent in April 2000. Solid limestone walls were separated by up to 0.3 metres of dolomitic limestone rubble, though it was impossible to determine whether this was a natural filling to the fissure or whether it comprised sub-base materials pushed into the fissure during excavation.

Figure 3. Fissure exposed beneath near-side lanes of north-bound carriageway of A690, 20 June 2003. Walls of solid dolomitic limestone and open fissure beneath tarmac can be clearly seen.

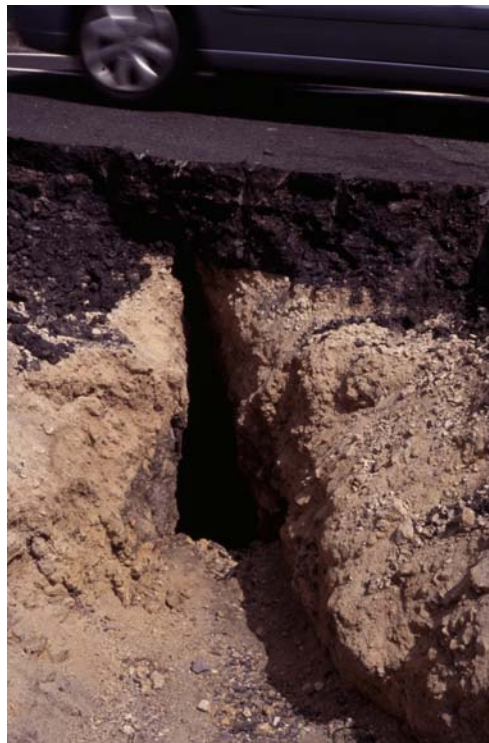
Excavation at the extreme eastern end of the trench, immediately adjoining the eastern lane of the carriageway, exposed an open void, almost totally free of any filling. Here the void, up to 0.2 m across, was seen to be effectively bridged by the tarmac covering (Figure 4). The void proved to be over 3.0 m deep and was up to a maximum of 0.5 m wide, approximately 1.5 m from the surface. Detailed examination proved difficult but, so far as could be established, the sides of the fissure comprised solid dolomitic limestone with no evidence of dissolution or accumulation of 'flowstone' deposits. No distinguishing features were observable within the limestone walls and thus it was impossible to estimate any relative displacement across the fissure. A small amount of broken limestone rubble was observed on the floor of the void, though it was impossible to establish whether this was a natural partial filling or material

Figure 4. Detailed view of the open fissure immediately beneath the tarmac, seen in Figure 3.

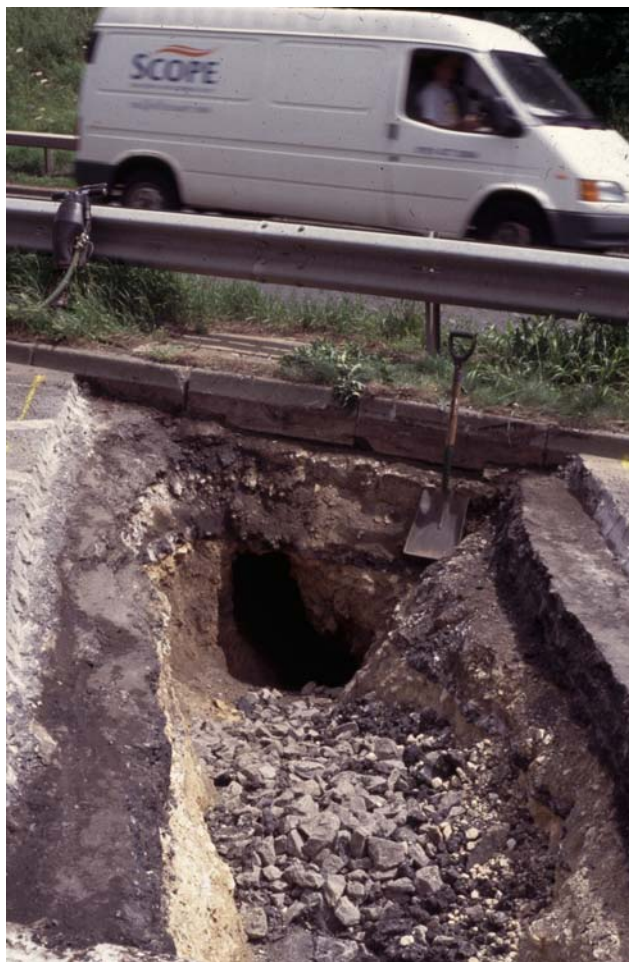
The eastern wall of the excavation, immediately beneath the crash-barrier in the central reservation, revealed a continuation of the fissure as an open void immediately beneath the tarmac (Figure 5). From a width of around 0.1 m beneath the tarmac the void continued downwards as a fissure dipping southwards at 50° and widened rapidly to a maximum of 0.66 m at a depth of about 1.0 m from the surface. The walls were seen to comprise solid dolomitic limestone. Although coated with dolomitic dust, perhaps the result of excavation, the walls appeared clean and fresh with no sign of dissolution or accumulation of 'flowstone' deposits. A few blocks of limestone were present on the floor of the void, though here again it was impossible to establish whether this was a natural partial filling or material introduced during excavation. Here, too, it was not possible to determine any displacement across the fissure. The void was seen to continue downwards for at least a further metre or so below the level of the excavation and clearly continued eastwards beneath the central reservation and westernmost portion of the south-bound carriageway. The precise extent of this extension could not easily be measured, though the void appeared to extend eastwards for at least 1.0 to 1.5 m and appeared to extend slightly southwards from the alignment of the course of the original fissure, though this too proved difficult to measure. A notable feature of the void was the gentle circulation of cool air within it, suggesting a connection with void spaces beyond those observed. The workmen undertaking the repairs commented that when first cut this void appeared to suck dust into it.

Figure 5. Open fissure immediately beneath tarmac, exposed in excavation of the outside lane of the north-bound carriageway of A 690 road, during repair work 23 June 2003.
