BGS Oriented Seabed Rockdrill (BRIDGE Drill) - Engineering Report for scientific cruise JR63

CR/01/157N

Smith, D.J., Brett, C.P., Wallis, D.G., Derrick, J.F.

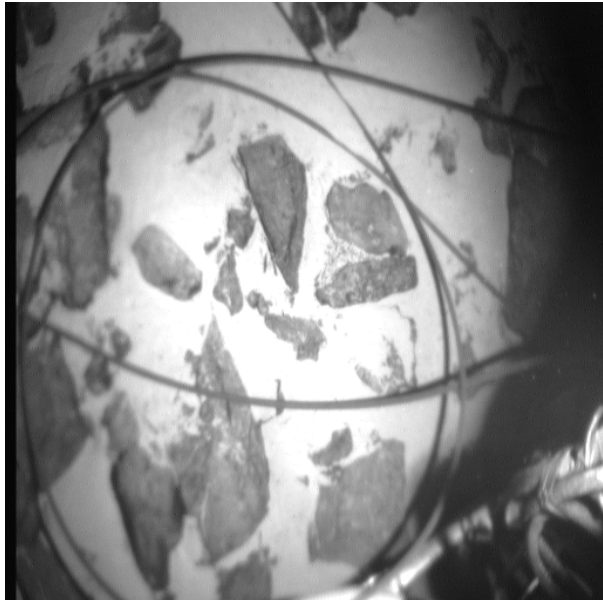
BR38

Site BR37 was completed without incident at 02:53. During the course of site BR38, after spending some time trying to find a suitable site, the ship's winch failed with the rig on the seabed. It was only able to pay out cable and not haul in and too much cable was paid out - as witnessed on the seabed photograph which clearly showed several coils of cable on the seabed. It took approximately two hours for the fault (a blown fuse in the control system), to be found and rectified. The drill was then recovered to deck at 09:09 to assess if any damage had been done to the cable or drill rig. No damage was apparent and the drill was re-deployed for site BR39. This site and the following two (BR40 and BR41) were completed without incident by 16:38. During operations on site BR42, the drill rig was lifted off the seabed and moved on several occasions as normal. However on one lift, the weight came onto the cable lifting the rig clear of the seabed but with pitch and roll indicators showing that the rig was very steeply inclined. This indicated that the cable had snagged on the rig, which was gently lowered back to the seabed. On lifting off again the cable came clear of the rig, which was once again hanging vertically in the water column. It was decided to commence drilling at the next landing of the rig, despite having a poor seabed photograph. This was interpreted as the camera having been moved out of alignment by the cable snag. However, on lowering the drill table it simply continued travelling down until it reached the bottom stops, leading to speculation that the drill barrel had been lost. The drill was recovered to deck at 19:14 and was found to be intact, undamaged and with the camera in its correct position. It had been a sediment site after all. The

cable was inspected and, despite having a noticeable kink in it, no strands of the armouring had been broken and were considered usable. Site BR43 was then completed without incident and the drill was deployed for site BR44 at 23:17.

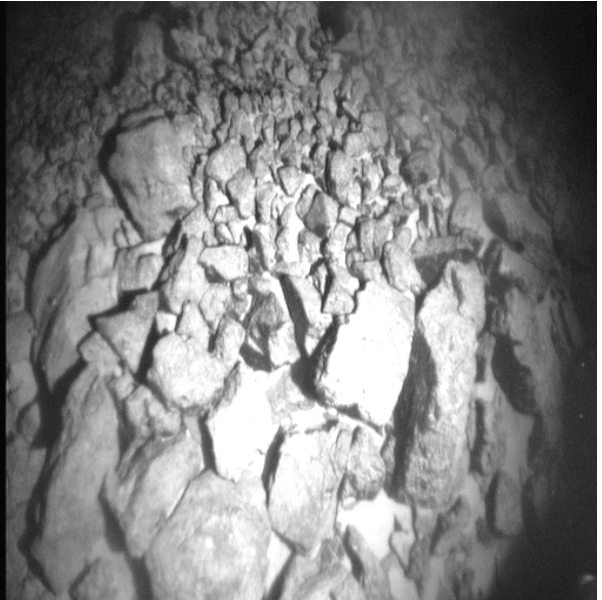
Sites BR69 and BR70 were completed by 07:00. At this last site it was very difficult to take photographs, the operation of the camera being very intermittent and with degraded quality. On recovery the camera bottle was replaced by the original bottle, which had been repaired since its earlier failure. On trying to take a test photograph on deck this second bottle failed immediately. The root cause of the problem was then traced to the lamp, which was found to have a cracked lens and had suffered water ingress. The lamp was replaced with the spare. The immediate failure of the camera bottle in the deck test was traced to a blown fuse. This was replaced and this camera bottle re-installed on the drill rig. All these changes were carried out between sites and no significant time was lost. The camera bottle, which had failed on the seabed, was examined and repaired whilst drilling operations proceeded. Site BR71 was completed at 12:28 and the core barrel assembly was changed prior to BR72, using an impregnated G9 drill bit. Site BR72 was then completed without incident at 16:58, the G9 bit appeared to drill faster than the surface set diamond. During the deployment at site BR73, compass auto-compensation routines were run. Compass 2, the top one, was fine with a score of 9, 7. However compass 1, the lower one, failed to calibrate and communication to it was lost. The site was completed using the top compass only. The lower compass is housed within the main subsea electronics bottle and, on recovery on completion of site BR73 at 21:28, the main electronics bottle was changed for the spare (S/N 1004). During deployment at site BR74 several attempts to calibrate the new compass (S/N 9100026) were made. The best score being achieved was only 6, 7 indicating an accuracy of only 4°. The top compass remained good.

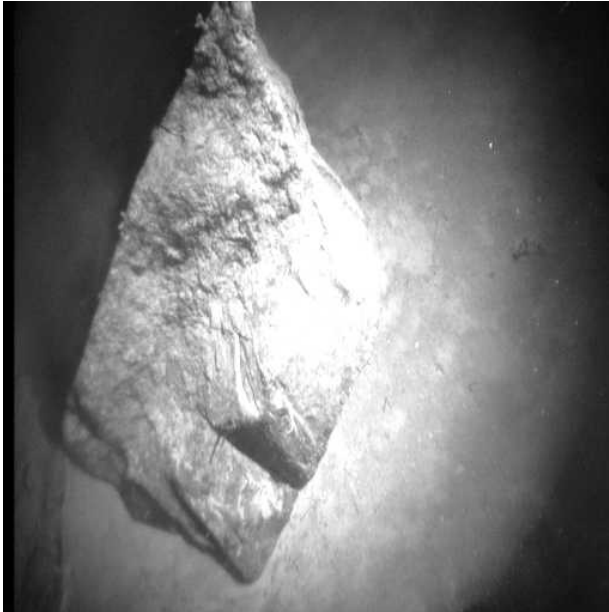
Site BR74 was completed successfully at 07:24 after requiring 15 attempted landings and 14 photographs to select a suitable site. However, on recovery, it was found that the drill bit was broken, having completely lost one section of the impregnated head. It was thought this was probably caused by the bit hitting the seabed on one of the many attempted landings at this site. The bit was replaced with another G9. On the next site, BR75, it was noticed that the retraction seemed to be very slow. On recovery at 11:10 it was found that the retraction motor was almost seized. This was a Franklin motor and it was replaced with a Lowara motor. Thereafter, sites BR76 and BR77 were completed without incident by 20:29 and BR78 started. Further attempts to calibrate the lower compass resulted in similar values, or failed altogether. Use had been
