Report of a walkover survey and desk study of the South Beach Landslide, Whitehaven, Cumbria

Internal Report IR/07/002

This report describes a walkover survey and desk study by the British Geological Survey to assess the geological properties of a landslide at South Beach, Whitehaven, Cumbria, which resulted in a fatality on the 1st January 2007.

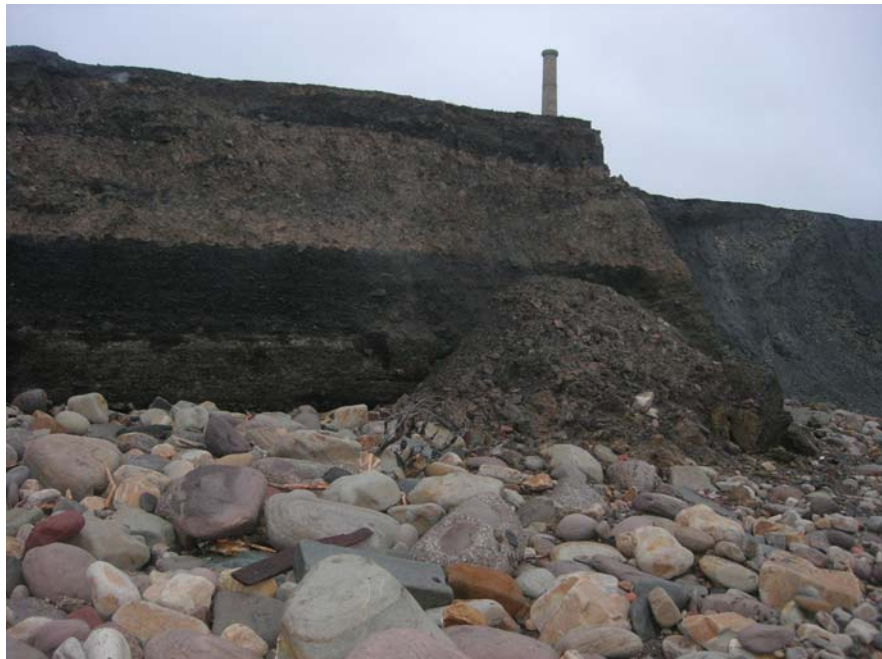
Front cover

The South Beach Landslide
(Photo: BGS, 03/01/07).

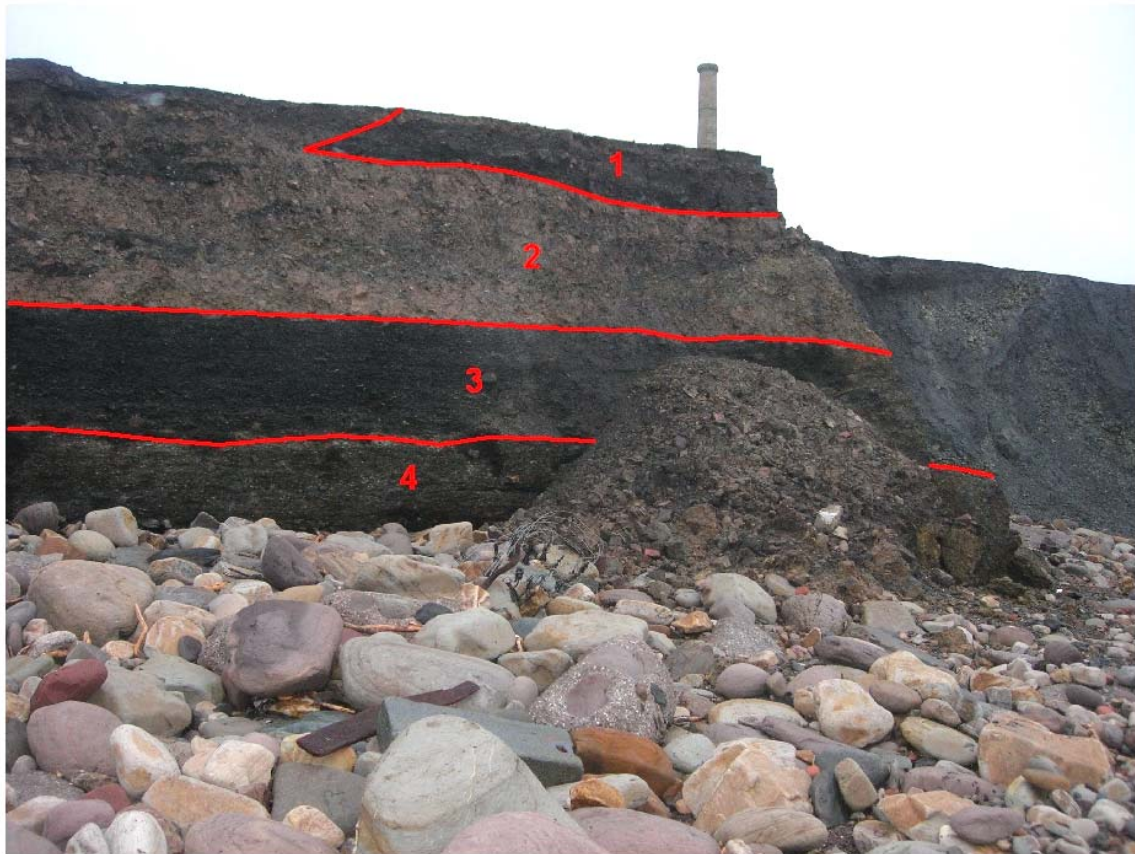
During the walkover survey to the site, a number of observations were made of the geological succession near the site. The landslide occurred in colliery spoil material, which showed a distinct stratigraphy (layering), with four identifiable units (Figure 6). Brief descriptions of each unit, based upon inspection of material at the cliff face are given in Table 1.

Figure 6. Stratigraphy of colliery spoil at landslide site (Photo: BGS, 03/01/07).

Unit	Field description
1	Dark-grey, up to coarse-gravel size, angular to sub-rounded, slightly stratified [MRCY – Land Raising Mine Fill (Colliery)]
2	Buff/light-grey/brown, loose, clasts of sandstone and colliery debris in gravel/sand/clay matrix. Up to cobble-size (250-300 mm) angular mass, slightly stratified, contains lenses of 1 [MRCY – Land Raising Mine Fill (Colliery)]
3	Dark-grey/black, semi-indurated - loose, coarse gravel-sized (60-80 mm) clasts of coal, shale, slag [MRCY – Land Raising Mine Fill (Colliery)]
4	Dark-grey/greenish-grey/light-grey, loose, coarse gravel-size clasts of shale and colliery debris, undulating stratification (tipped) to south, regular stratification to north [MRCY – Land Raising Mine Fill (Colliery)]

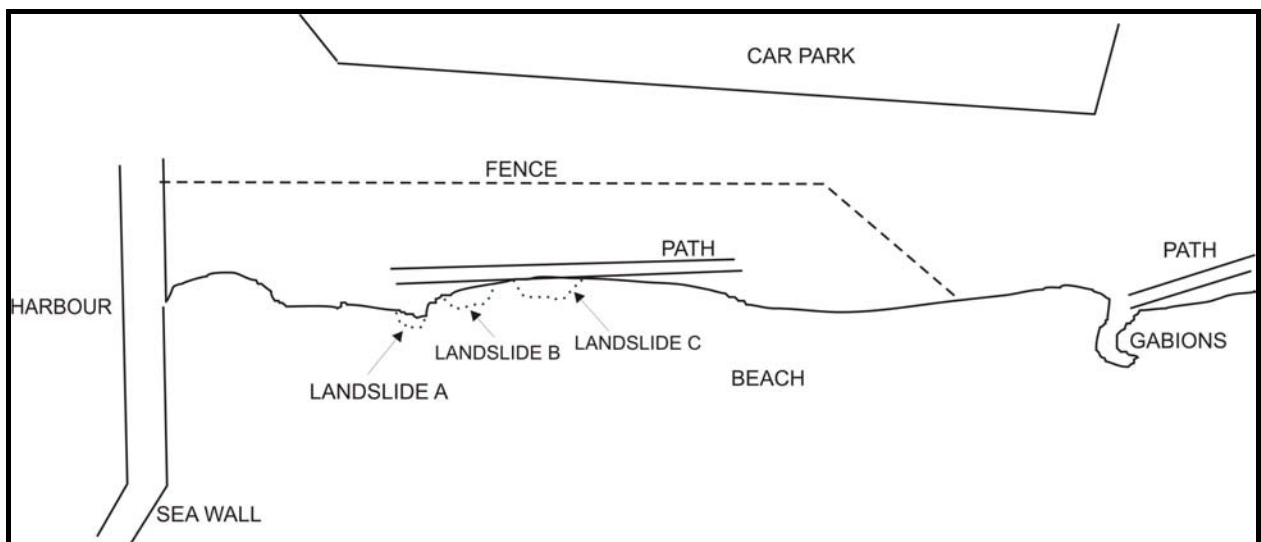
Figure 7. Sketch map (not to scale) showing main features of site (north - left, south - right).

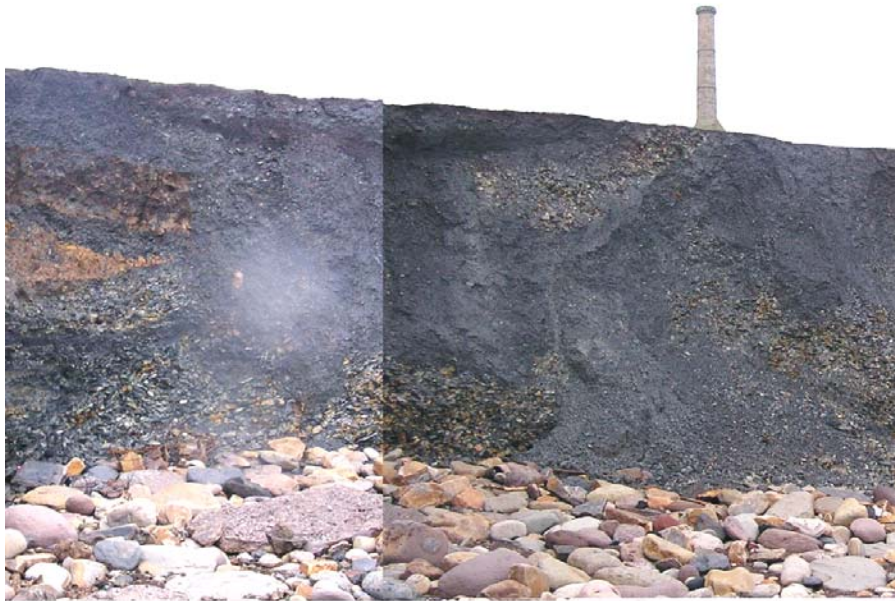
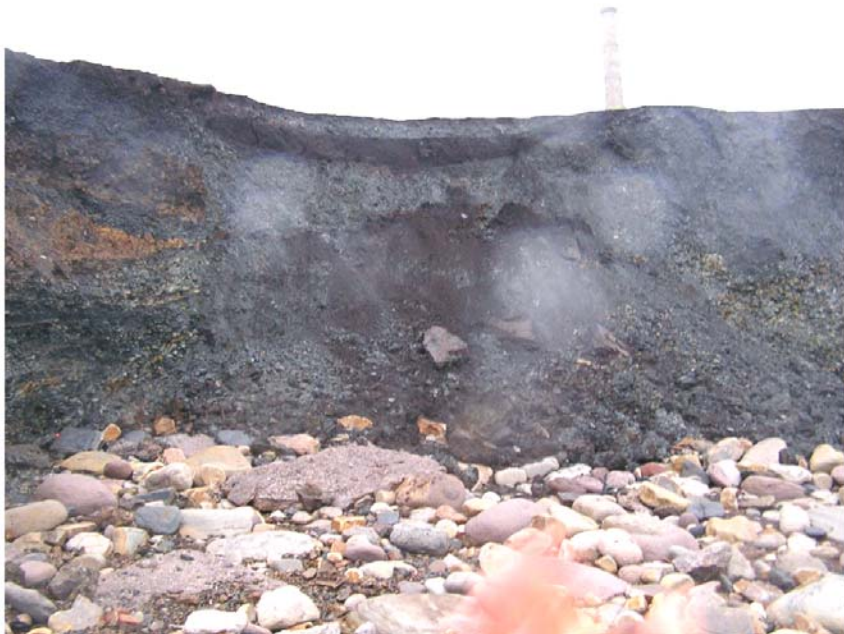
During this survey, a further landslide occurred, at NGR 296742 518372 (Landslide B on Figure 7) and was observed at close hand by BGS staff and Duncan Fyfe. (Figure 8). The landslide was approximately 4 m high x 8 m wide x 0.75 m deep and provided evidence for the style, mechanism, and amount of material involved in failures in the colliery spoil cliff.

Figure 8. Before and after of Landslide B. Top photograph taken at 14:48, bottom photograph taken at 15:26 (Photo: BGS, 03/01/07).

Due to the unstable nature of the colliery spoil material; access to the area should be prevented. This involves no public access to the beach, and at least a 5 m fenced buffer zone along the cliff top. Based on observations on the 3rd January 2007 (in particular the failure of Landslide B), it is likely that any future single cliff failure event will result in no more than 1-2 m recession of the cliff top. Constant monitoring of the cliff top is strongly recommended in order to maintain the 5 m buffer.

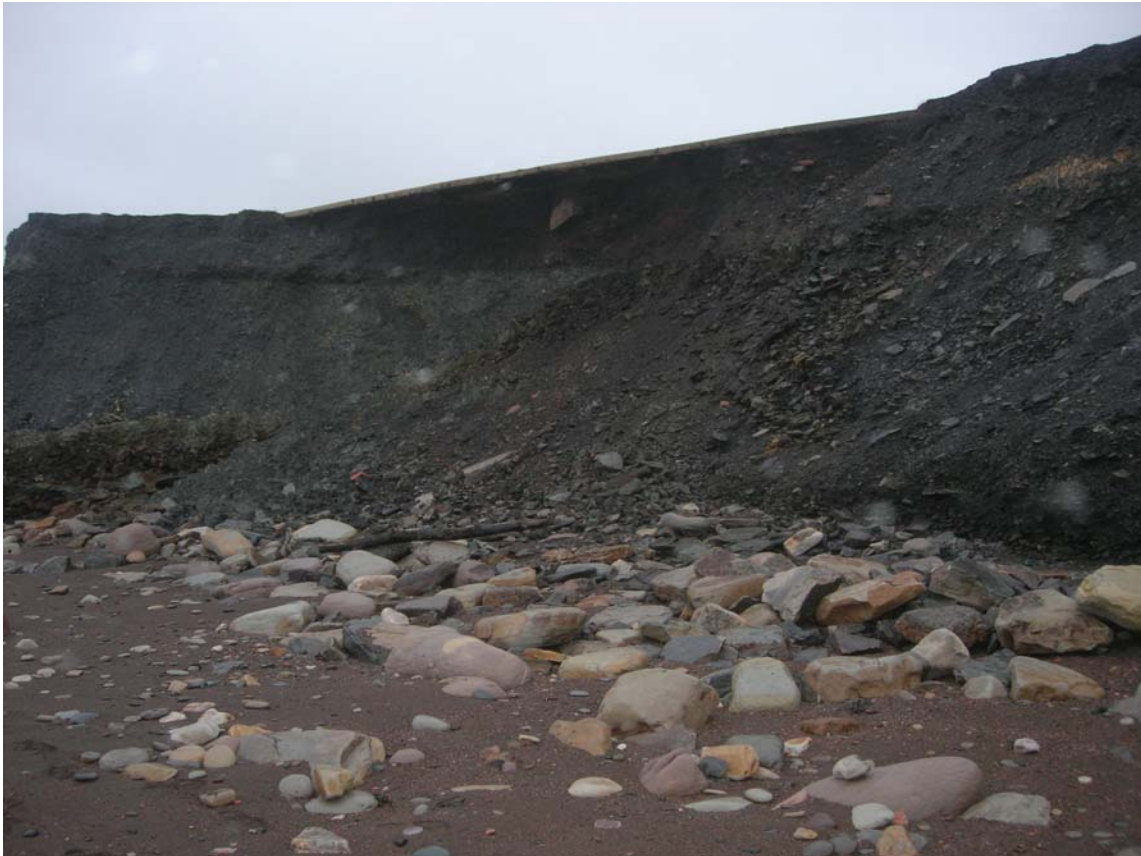
A further recent landslide was also examined at NGR 296727 518349 (Landslide C). The landslide was 4 m high x 7 m wide x 1 m deep, and had undercut the concrete path running along the cliff top (Figure 9). This landslide also provided evidence for the style and volume of material involved in failures in the colliery spoil cliff.

Figure 9. Landslide C undercutting the concrete coastal footpath at NGR 296727 518349. (Photo: BGS, 03/01/07).

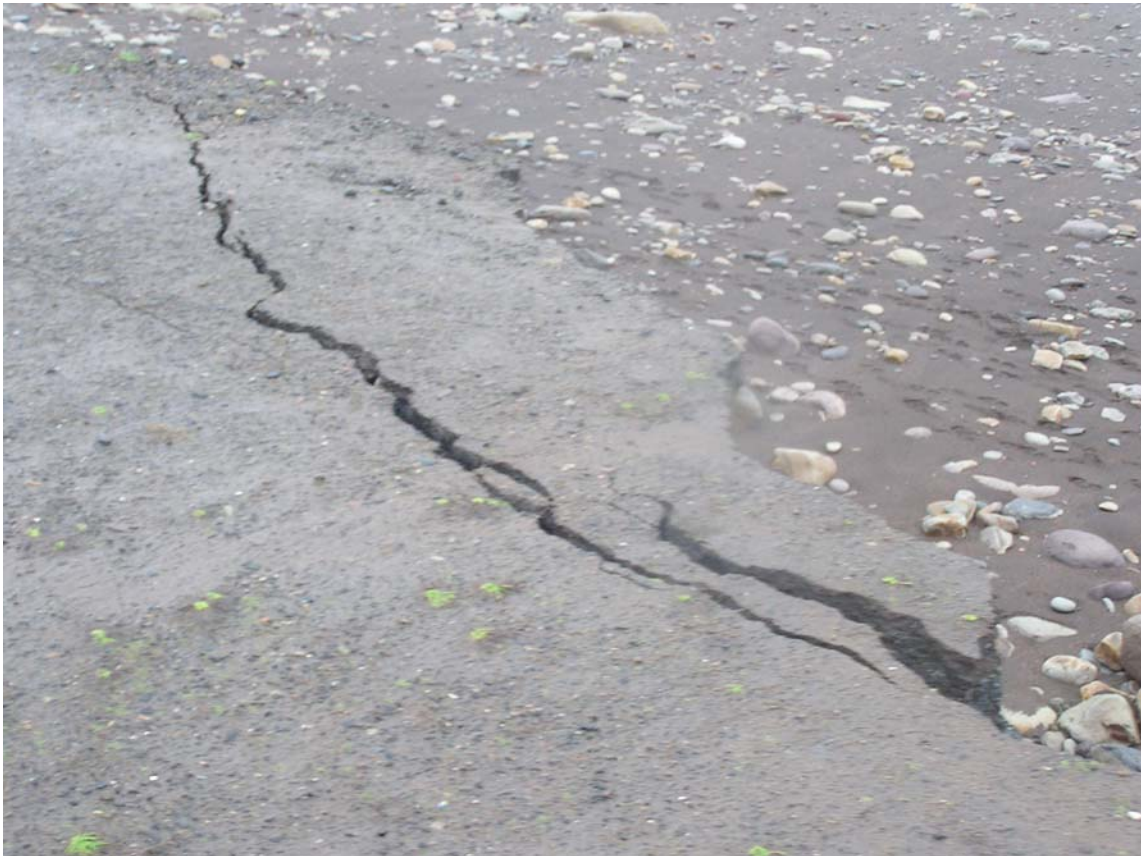
The area above the site of the landslide was also examined with particular attention to the grassed and fenced-off area at the cliff top. Although detailed measurements were not recorded, a series of fresh tension cracks were observed immediately to the north of landslide C where the concrete footpath had been undermined by previous landslide activity (Figure 10).

Figure 10. Tension cracks immediately to the north of Landslide C (Photo: BGS, 03/01/07).

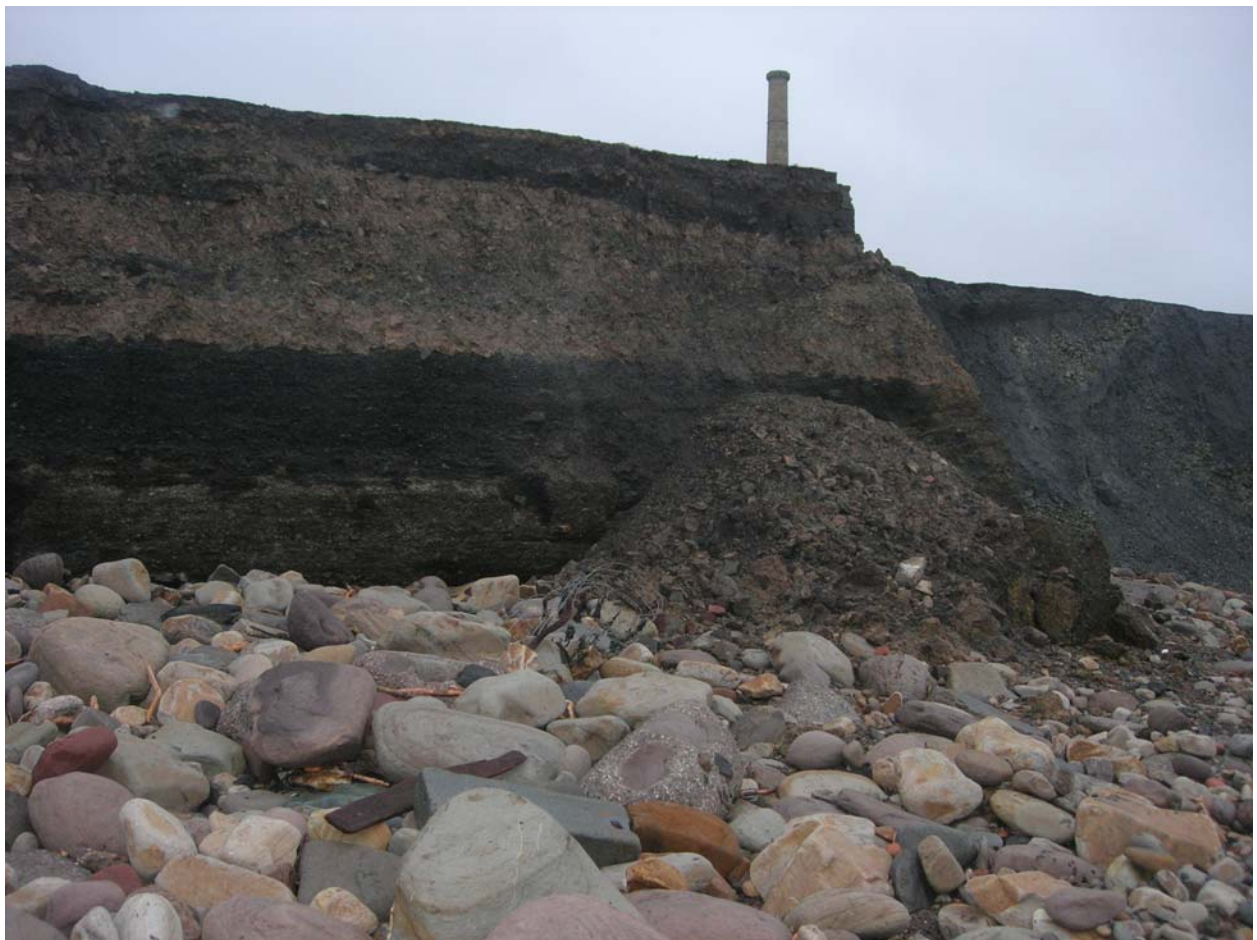
Due to the nature of the material, and the mechanism of landsliding observed in Landslide B on the 3rd January 2007, the landslide can be classified as a debris fall (Figure 11), according to the Varnes Landslide Classification Scheme (Varnes, 1978). Rainfall figures for November and December 2006 were 125 to 150% and 175 to 200% respectively above the 1961-1990 average (Met Office, 2006 & 2007). This high rainfall had saturated the colliery spoil material, increasing the pore water pressure and causing the material to become unstable. The grassed area above the cliff was observed to be flat and therefore deemed likely to provide poor drainage. This, coupled with prolonged heavy rainfall may have lead to the saturation of the spoil material. In addition, high tides and rough seas have eroded the cliff, and created a slope beyond the angle at which the material is stable (angle of repose). It is likely that this removal of support by wave action, coupled with the saturated ground has caused the colliery spoil material to become unstable and fail.

Figure 11. The fatal landslide (Landslide A) at NGR 296749 518380 (Photo: BGS, 03/01/07).

A landslide in a cliff of colliery spoil occurred at South Beach, Whitehaven, Cumbria on 1st January, 2007. The landslide resulted in a fatality. It is likely that a combination of high rainfall, high tides and rough seas had resulted in the colliery spoil material to become unstable and fail.

Signage along the cliff top and in the immediate vicinity of the car park should warn the public of the risk posed by the landslide hazard in the area.

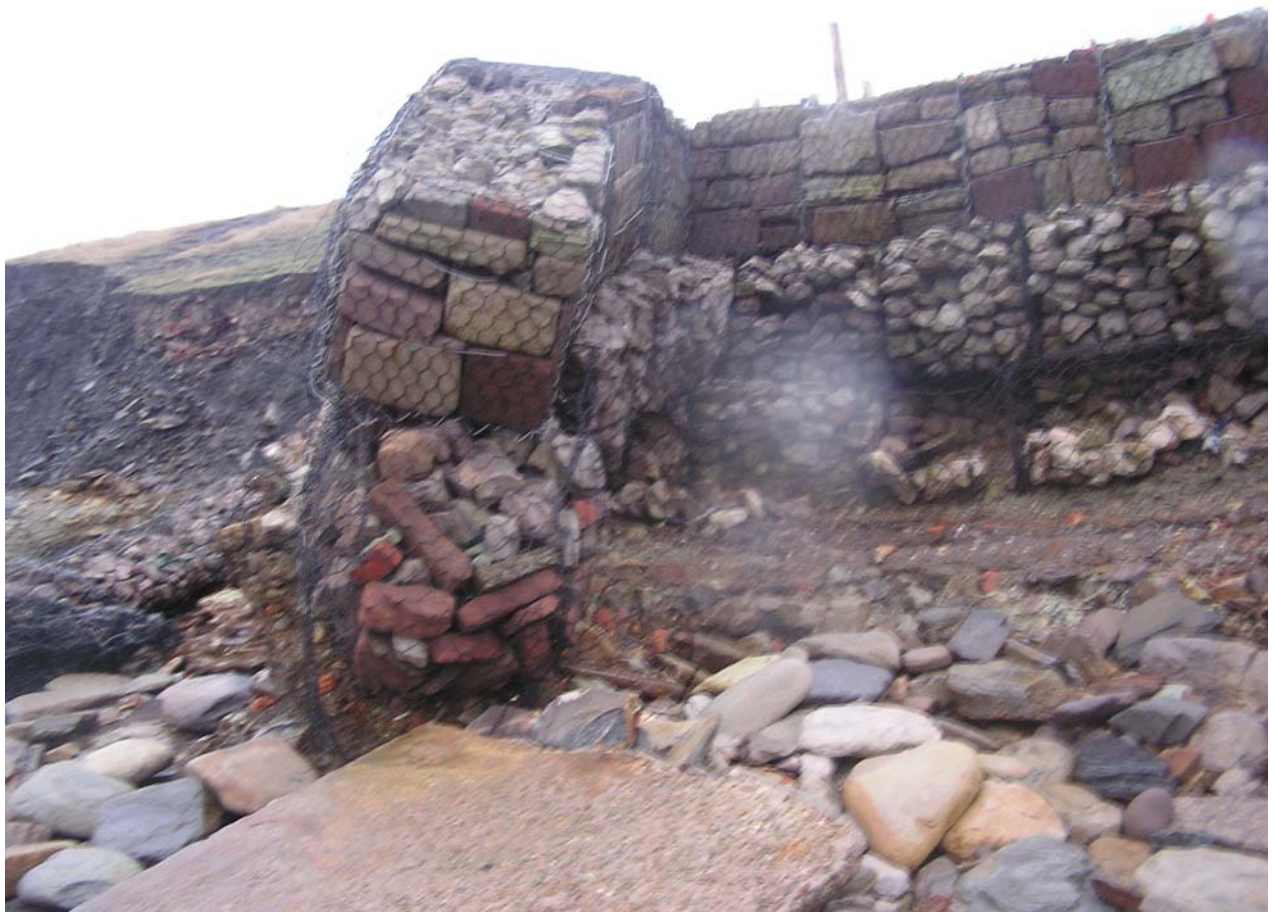
It was also noted during the walkover survey that there was considerable damage to the gabion wall at the southern end of the beach (Figure 12). The unstable gabion baskets present a risk to the public from collapse, and it is recommended that this be remediated.

Figure 12. Damage to gabion wall at southern end of beach [NGR 96696 18300] (Photo: BGS, 03/01/07).
