The Penicuik landslide, Midlothian, January 2007

Internal Report IR/07/036

M A E Browne & N R Golledge

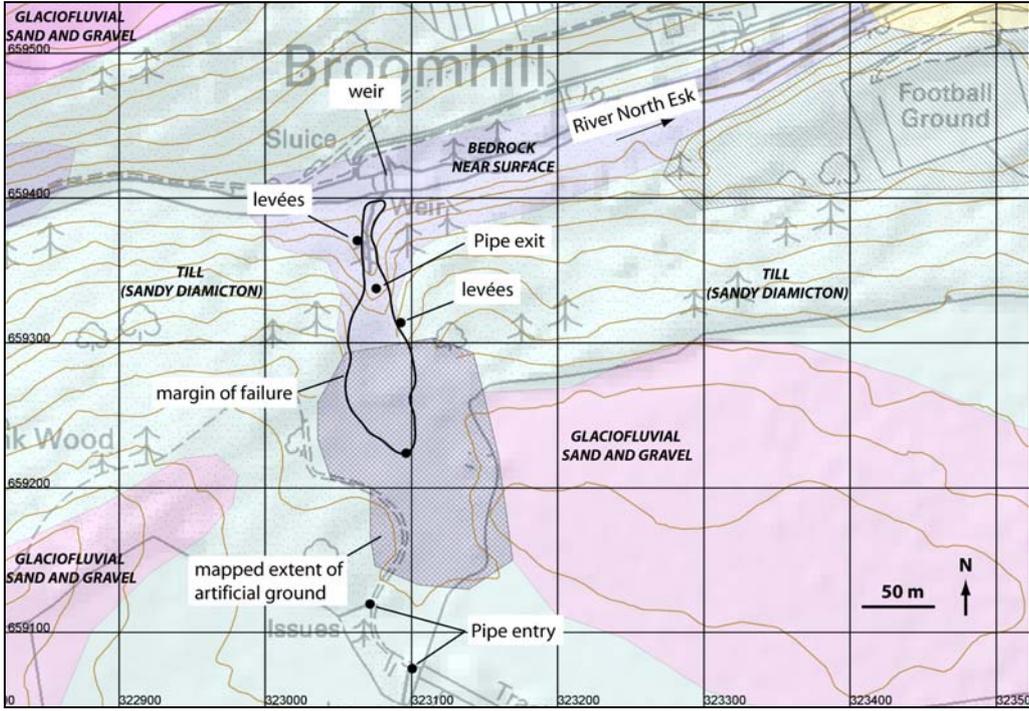
Figure 2: Geological context of failure site

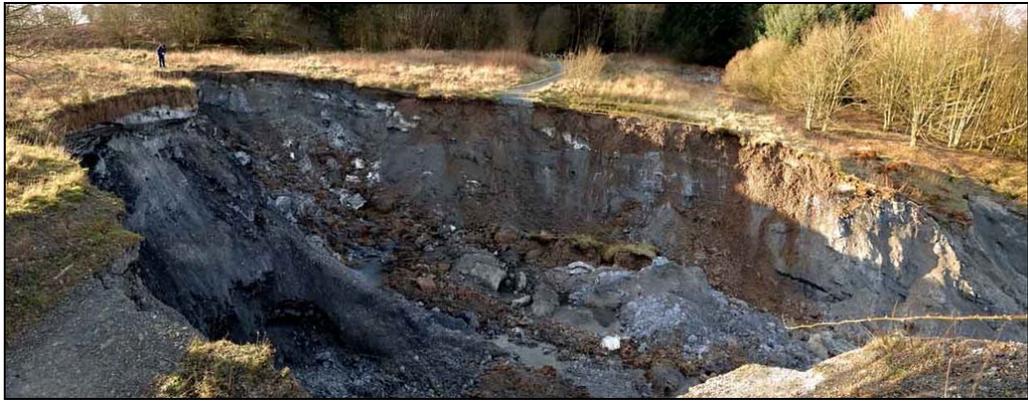
The failure site is densely wooded, and although paths exist through the wood, both upper and lower paths had been breached by the failure. The floor of the failure was saturated and appeared to be composed of industrial waste, and was considered unsafe for close investigation. Therefore, access to the slide was only possible along its sides.

Figure 3: View west across headscarp of failure, figure (left) for scale

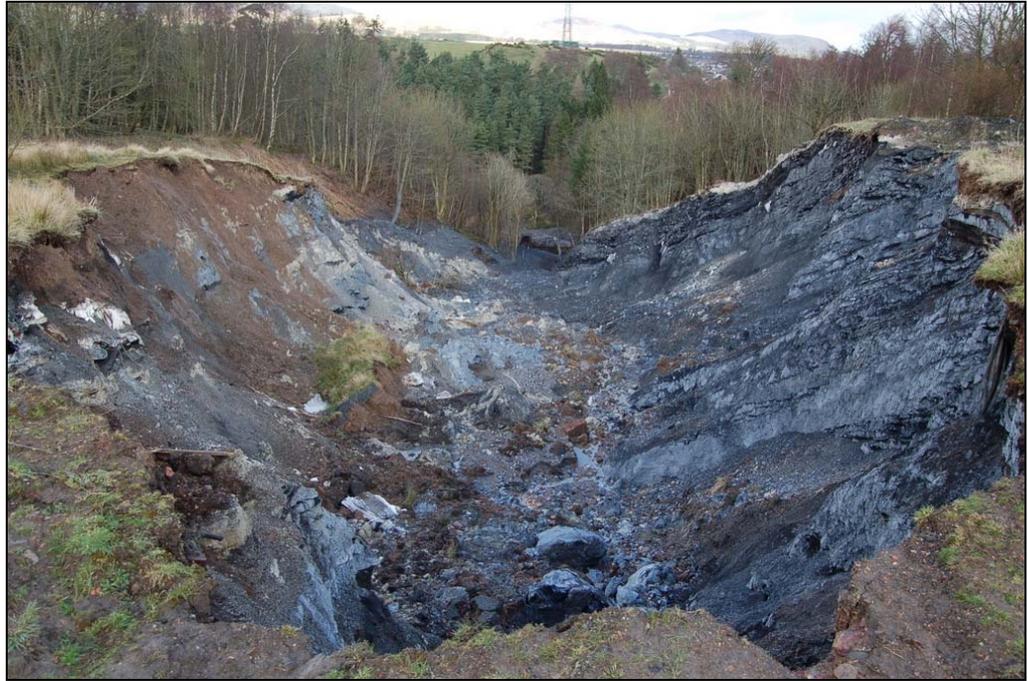
Figure 4: View north (downslope) from headscarp

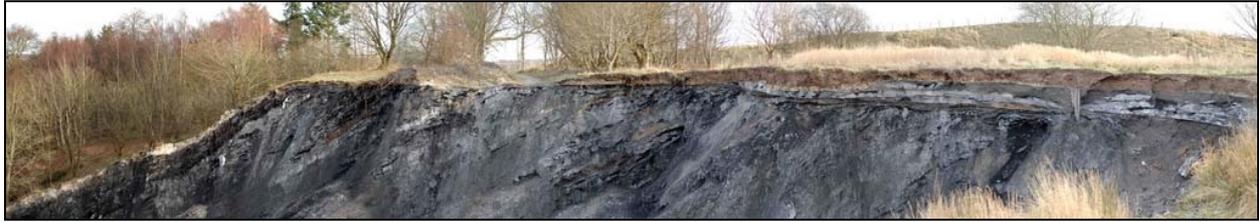
The eastern wall of the landslide displayed the stratigraphy of the landfill with steeply dipping slope-parallel fore-sets and horizontal top-sets.

Figure 5: Stratified and steeply-dipping waste in eastern wall of failure

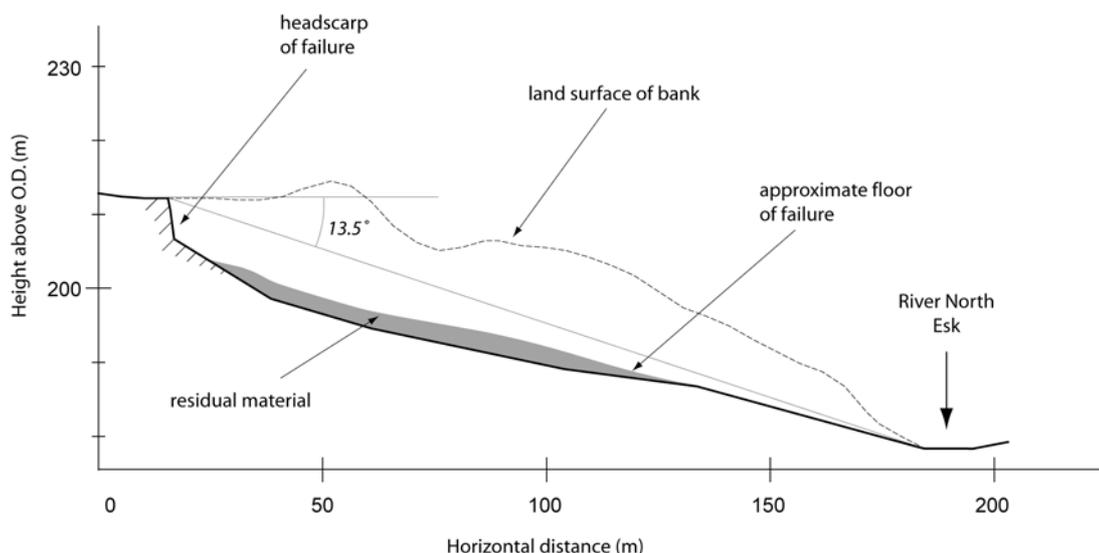
The head of the failure is located at NT 23093 59226, at around 212 m O.D. The River North Esk (at the base of the failure) is at 178 m O.D. The elongate gully produced by the collapse has a northerly aspect (358°), and occurs within landfill material as far downslope as NT 23083 59339. Below this point, the gully appears to be the pre-existing stream channel, slightly enlarged by bed erosion and bank collapse. At the most recent visit, the landslipped area measured 114 m from tip (head wall scarp) to toe (down-slope limit of slipped material), approximately 40 m across at its maximum, and up to 15 m deep.

Figure 6: Profile of failure site, based on high-resolution digital elevation data from Intermap Technologies

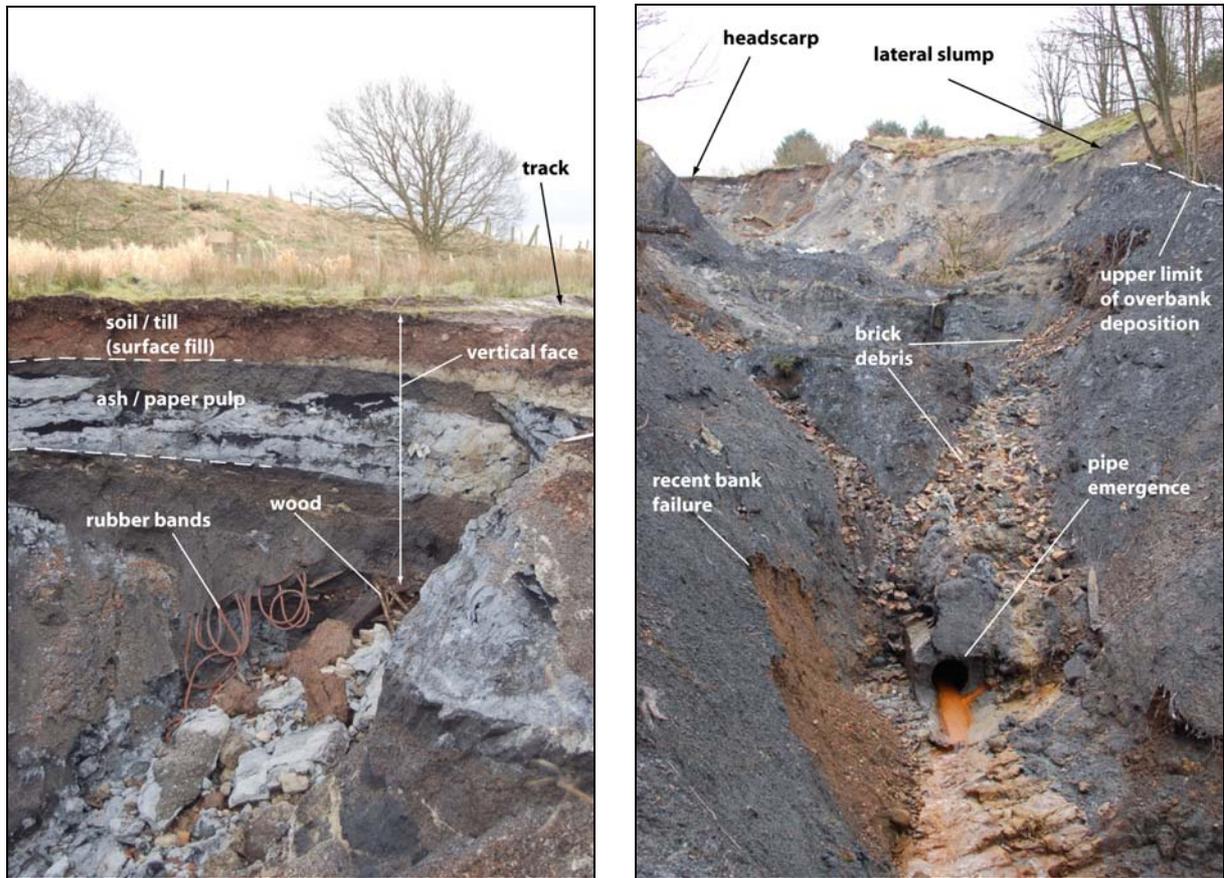
The headwall scarp is arcuate in plan, whilst in profile the exposed faces are sub-vertical (in places almost overhanging) (Fig. 7 a). The c. 350 m perimeter of the failure is crenulate, with two major lateral slump scarps along the western margin, and many subsidiary collapse scars on both western and eastern sides. On the western fringes, tension cracks and 'potholes' were observed up to 12 m from the main western failure edge. One such tension crack exposed a near-surface drainage pipe culverting surface runoff beneath the footpath.

Figure 7: a) Stratified waste exposed in vertical face of headscarp b) view up gully from toe of failure

Overbank material (reworked landfill) is present along the lower margins of the failure gully (Fig. 7b), to a width of about 40 m. There is a notable cross-gully asymmetry in the height of overbank deposition, the highest areas marked by debris levées up to 2 m high (e.g. at NT 23090 59310 on the eastern flank, and at NT 23065 59374 on the western flank) (Fig. 8). Behind these levées are hollows where the original slopes are visible, and where no failed material was seen overlying the *in situ* orange-red sandy till. The lateral margin of overbank deposition is generally abrupt and continuous (Figs. 7, 8, 10). Standing water was seen trapped in pools between the new levées and the pre-existing slopes. Failed material was also seen capping fallen tree limbs protruding the gully side (Fig. 9). On parts of the lower slopes, sub-horizontal flow lineations were observed in the overbank debris, as were flow-aligned trees (Fig. 8).

The vertical and overhanging headscarp faces suggest that catastrophic (rather than incremental) failure occurred in the made ground at the Penicuik site. Tension cracking in the substrate still visible in the surrounding area attests to tensile stresses related to extensional deformation resulting from debuitressing (slope collapse). The steep headwall, deep gully, and lack of visible slide plane at the gully base indicate that initial failure was probably rotational rather than translational. The volume of the initial failure is not known, but the very limited amount of remaining debris in the gully suggests that disaggregation and possible liquifaction occurred soon after failure, producing a cohesionless debris flow that flowed downslope and was highly effective at removing debris.

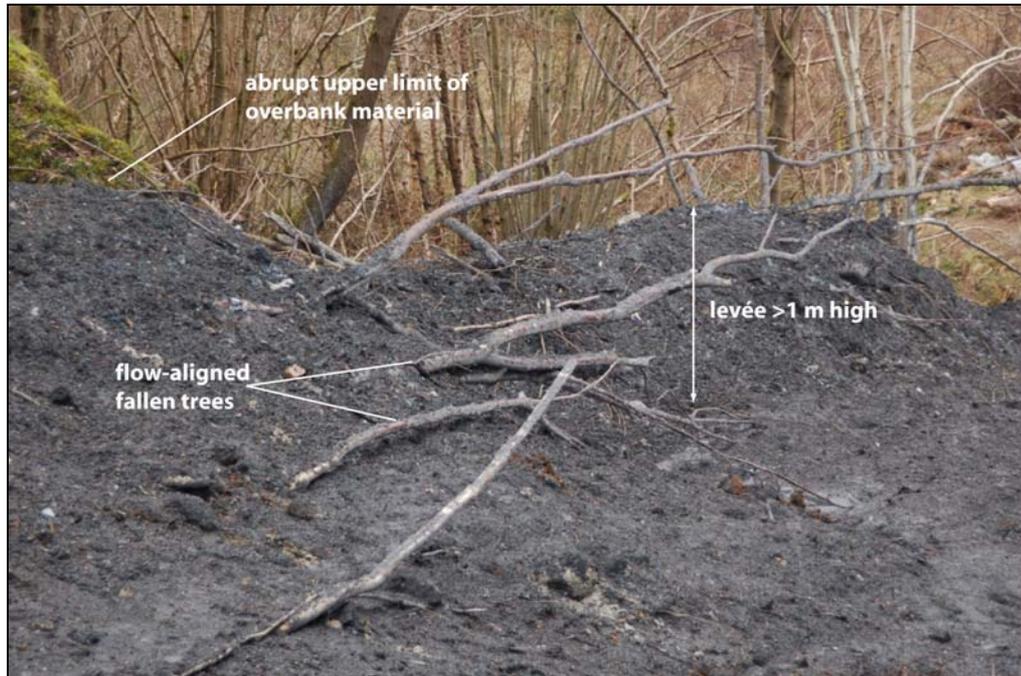
Figure 8: Levée of overbank material near base of slope, western margin

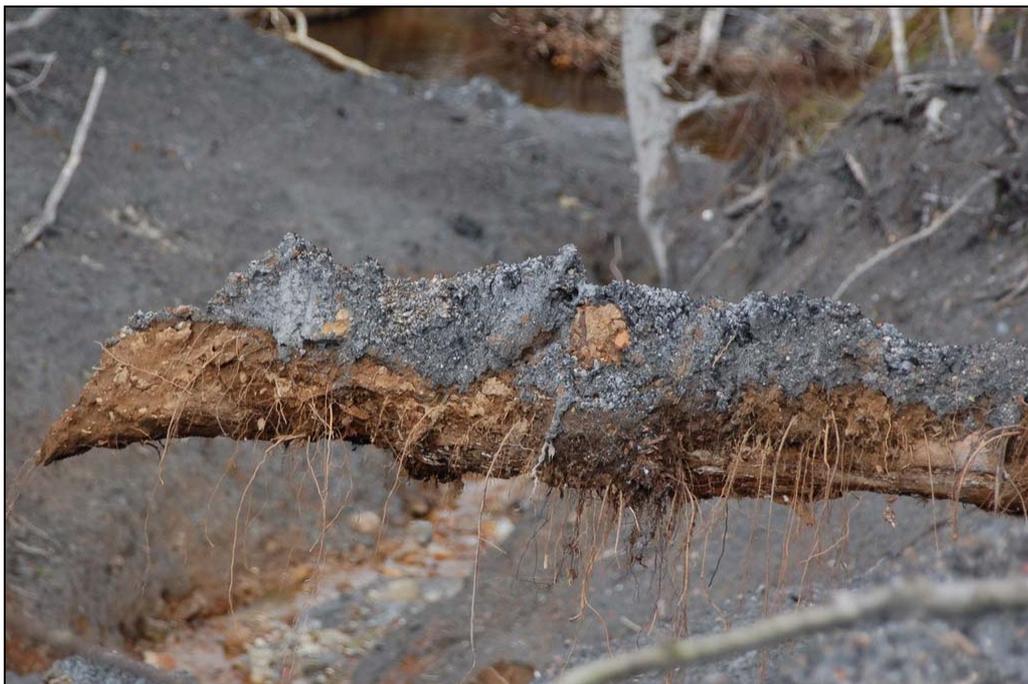
Figure 9: Debris flow material capping fallen tree limb

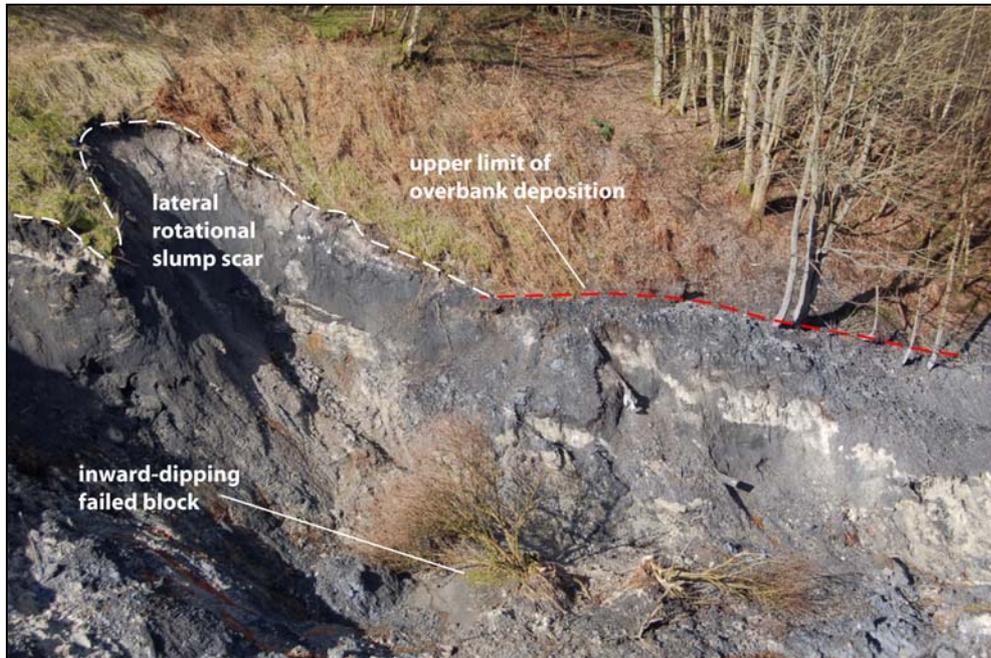
Larger lateral bank collapses are also thought to have taken place subsequent to the main failure, particularly the two arcuate slumps on the western margin. These scars truncate a clear lateral limit of overbank material, and material from them is still present at their bases (Fig. 10). The southernmost of the two slumps exposes upper fill material resembling soil and till, which supports vegetation. The inward-dipping grassy tops of slumped but intact blocks of this material show that this collapse was a rotational failure, and that it occurred after the main debris flow. Similarly, the inward-dipping block supporting an intact tree at the base of the northernmost of these two slumps suggests the same. It is likely that much of the perimeter of the initial failure has subsequently, and incrementally, collapsed, as the exposed faces attempt to readjust to a new angle of repose. This process may continue for some time.

Figure 10: Lateral slump truncating overbank deposition, western margin of failure

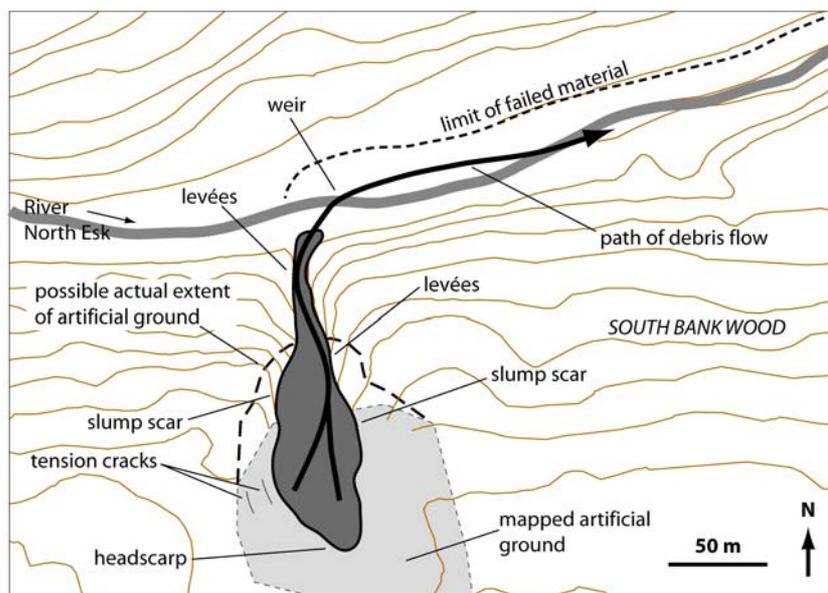
Following the initial slump, disaggregation of the material ensued, most probably aided by a high water content. This is likely to have occurred as a result of higher than normal volumes of surface runoff resulting from heavy rainfall, which also led to a locally elevated water table. The failed material (paper, pulp, ash, plastic sheets etc) was heterogeneous, stratified, and had limited cohesion. Combined with the abundant water present in the substrate that further lowered its effective shear strength, mass movement of the material produced a cohesionless debris flow that by 75 m downslope of the headscarp had breached its confines. Mass transport in this way led to the formation of levées, the deposition of overbank material, and re-alignment of fallen trees parallel to flow. It is possible that undercutting propagated further bank collapses, thereby maintaining the flow. That the height of overbank deposits and the distribution of levées is asymmetric, may hint at a slight sinuosity to the path of the debris flow (Fig. 11).

Figure 11: Schematic illustration of likely flow path of landslide / debris flow
