Birmingham Airport Link Pipeline
Environmental Assessment of Watercourse Crossings
Initial Report with reconnaissance surveys

Project leader: F.H. Dawson
Report date: 6 September 1990
Report to: RSK Environment Ltd (for Esso Petroleum Co Ltd)
Contract No: Letter of 21.5.90
IFE Report Ref: T04053s1/1
TFS Project No: T04053s1

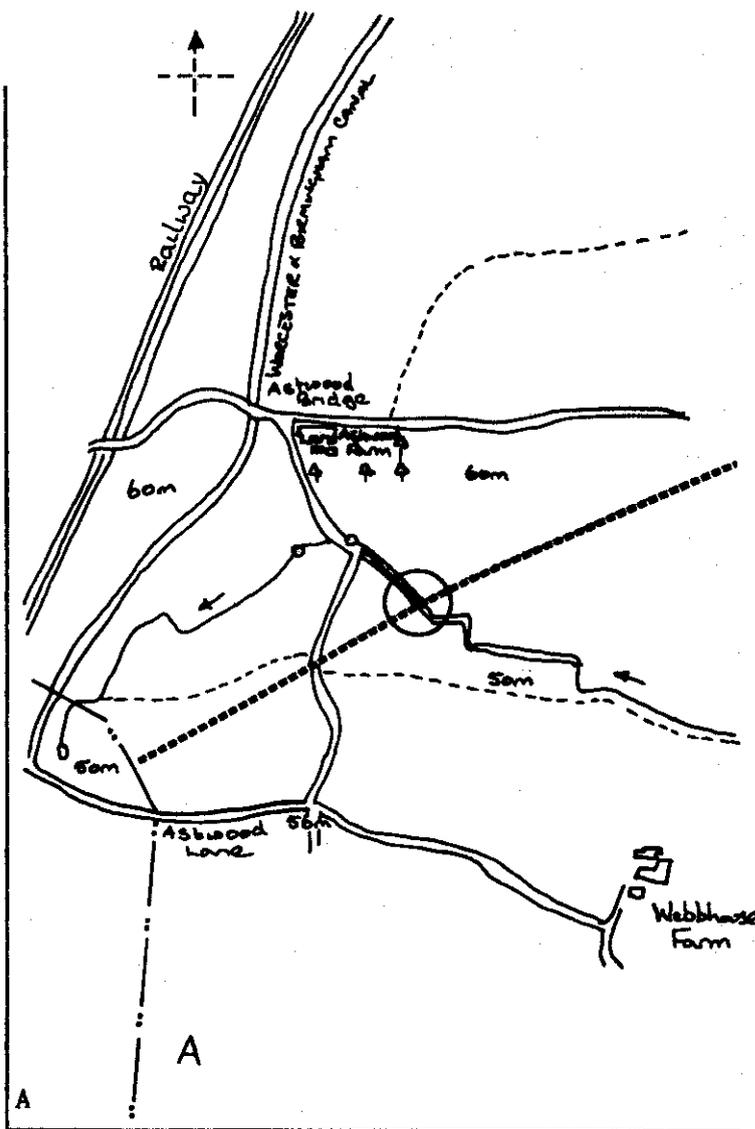
Small static water ditch with cattle drink adjacent.

- Land use grazing sheep and cattle
- Upstream -
- Downstream (Manure heap by gate)
- Maintenance occasional
- Fishery interest nil

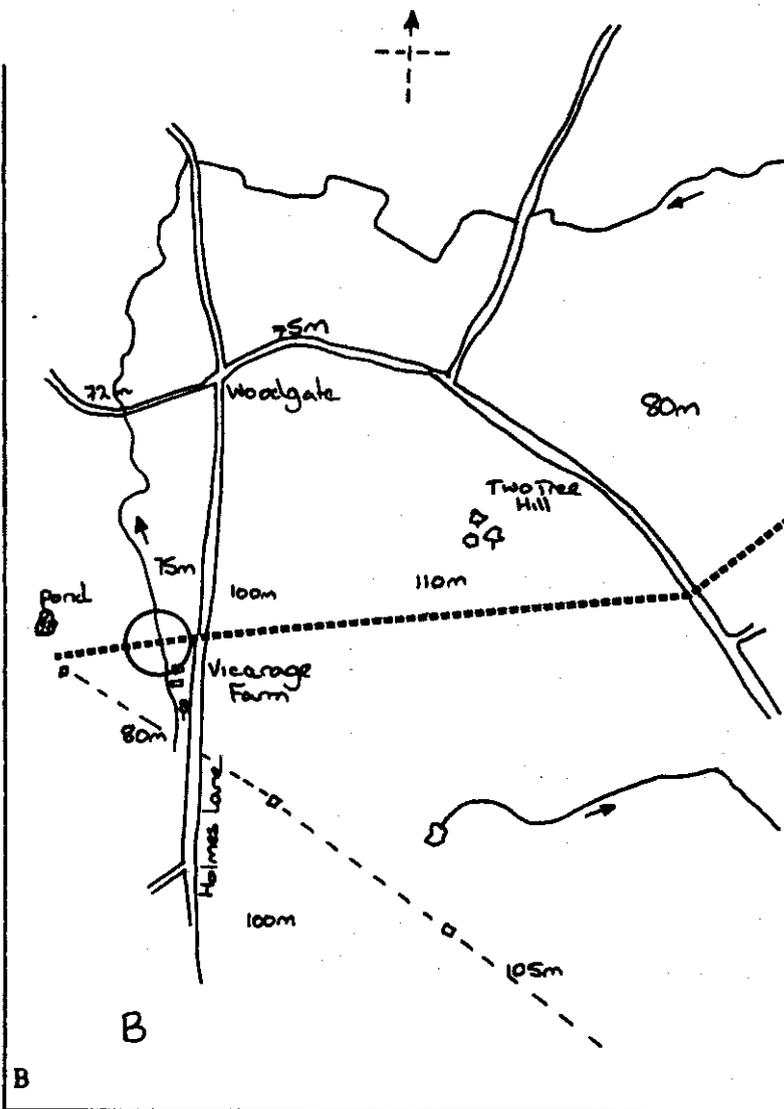
ADJACENT FEATURES etc.
 Land use farm close to old corrugated fencing
 Upstream farmyard
 Downstream sheep grazing
 Maintenance ? part fenced
 Fishery interest nil

PHYSICAL Maintenance Factor
 Static small stream of deep section with animal trodden banks and debris in stream.

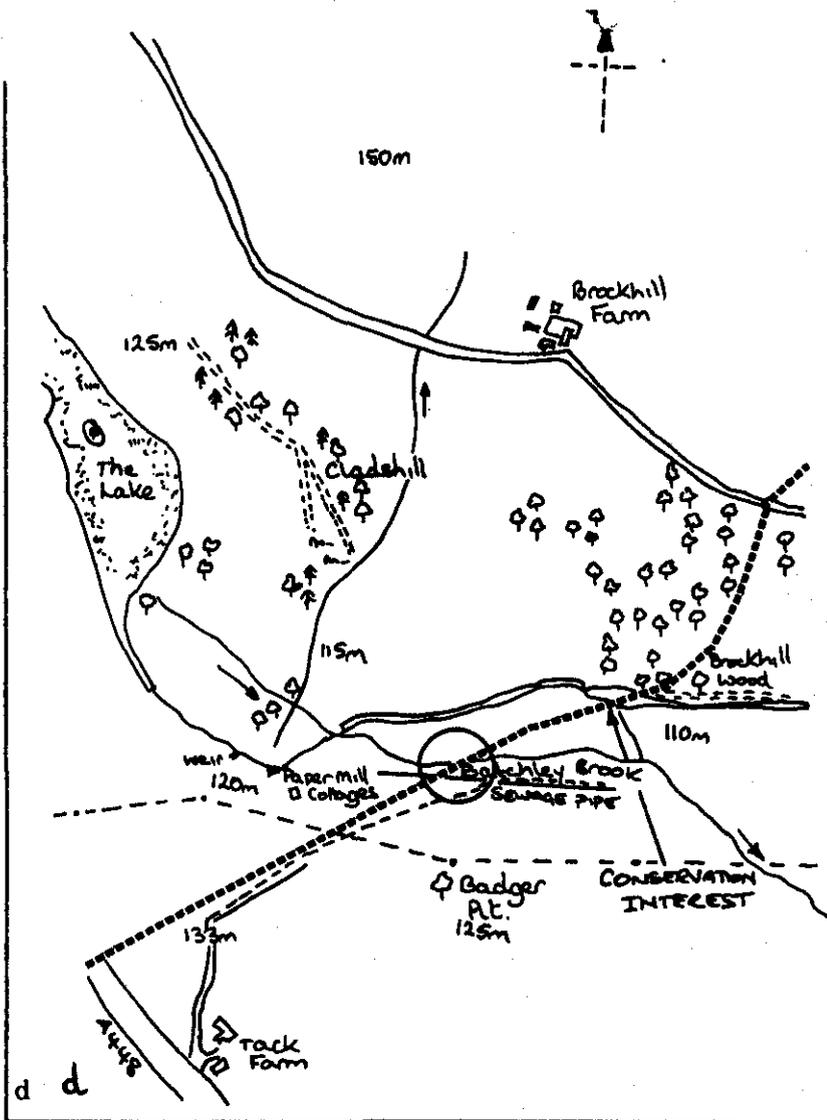
ADJACENT FEATURES etc.
 Land use poor grazing
 Upstream lake
 Downstream ditch of conservation interest
 Maintenance minimal
 Fishery interest nil

PHYSICAL
 Damp ditch/brook, south of Hewel Park Lake.

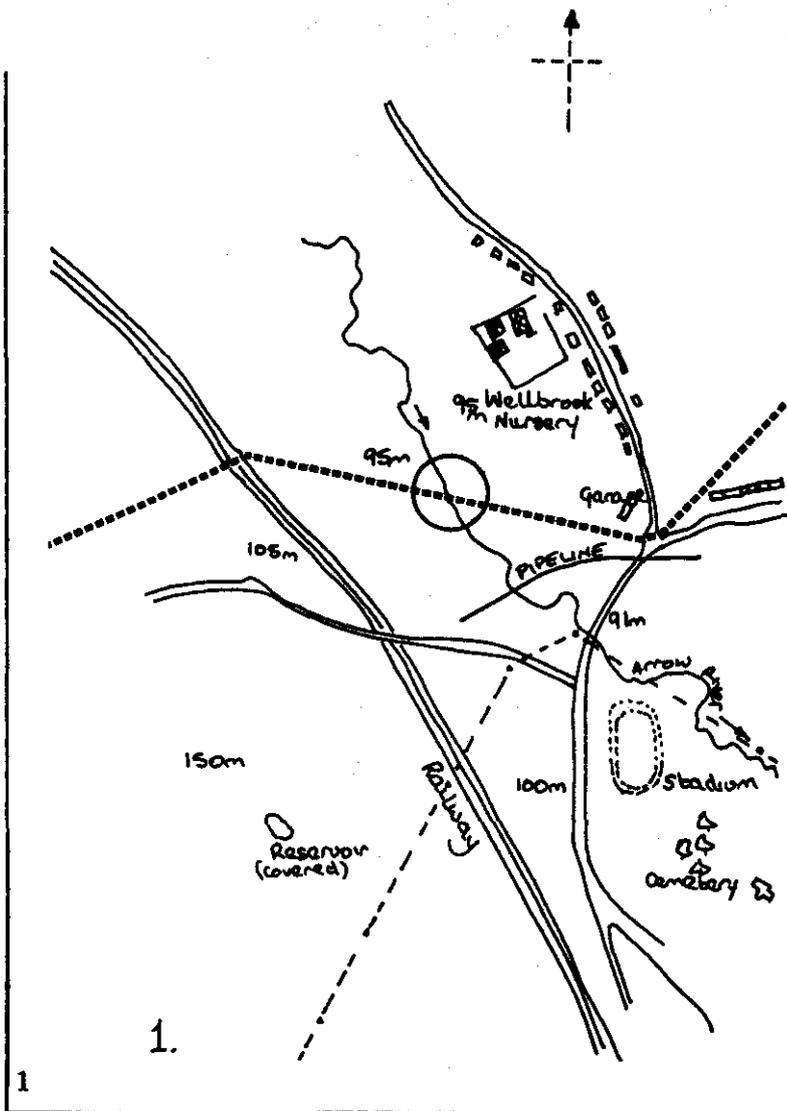
PHYSICAL oily smell.

A deep cut slightly embanked stream lined with trees.

- Land use sheep grazing
- Upstream agricultural grazing
- Downstream existing pipeline bridge 200 m d/s
- Maintenance probably regular but not extreme
- Fishery interest low-nil
- Maintenance Factor 0

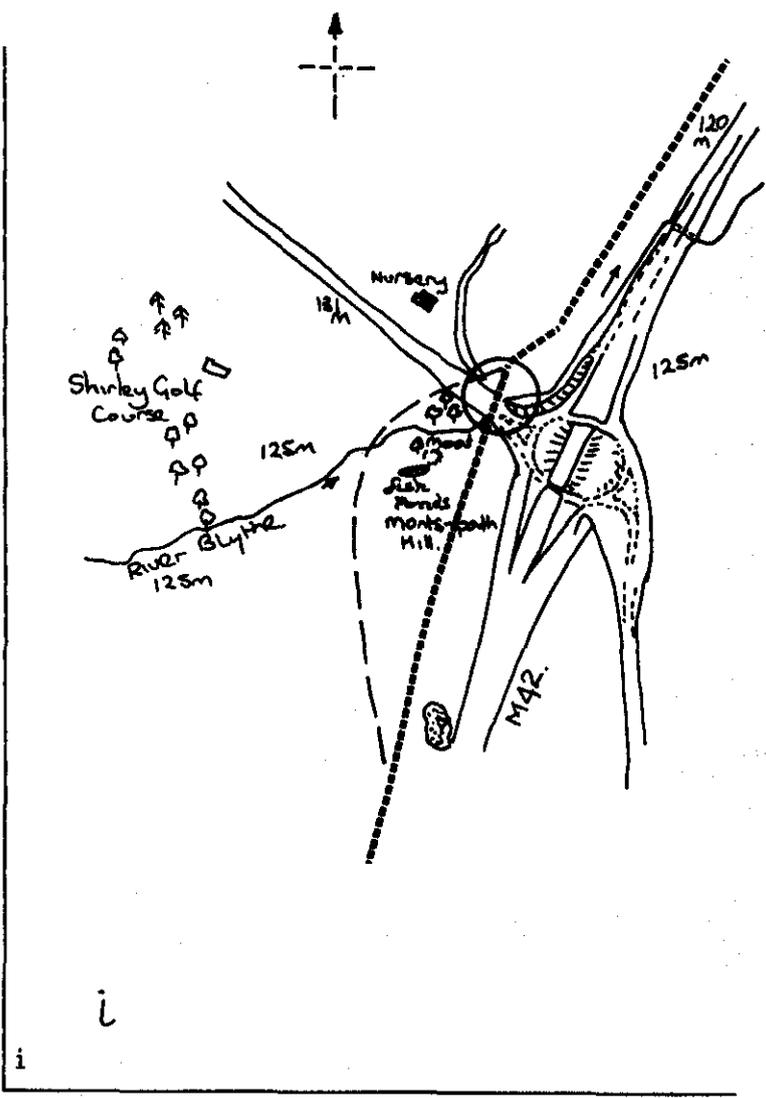
ADJACENT FEATURES etc.
 Land use motorway and access road, parkland
 Upstream Conservation river
 Downstream " "
 Maintenance
 Fishery interest medium - low

PHYSICAL Maintenance Factor
 Adjacent or under motorway access road tunnel

CONSTRUCTION Move crossing to already lined section of river.
 Avoid existing pipelines, sewers and power lines.

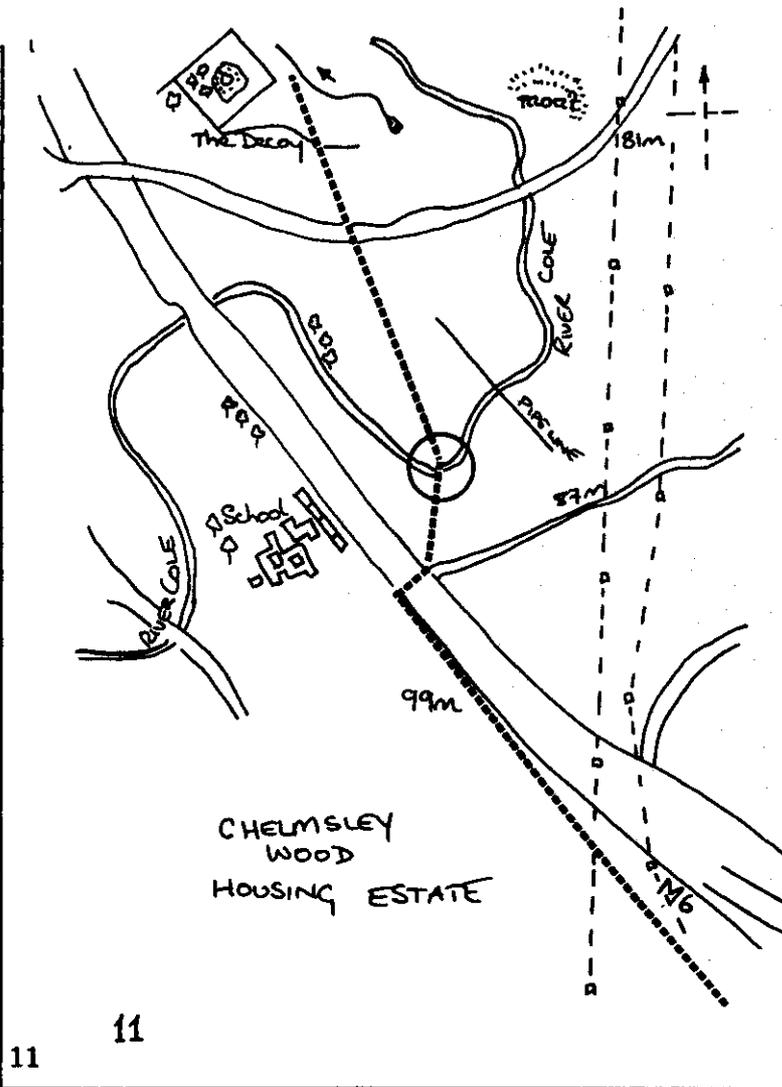
ADJACENT FEATURES etc.
 Land use rough grazing & arable, ditch to SE
 Upst. large town \with flow control strictures
 Downstream confluence with R. Tane and Blythe
 Maintenance greatly enlarged, low
 Fishery interest low

PHYSICAL Maintenance Factor -1
 Greatly enlarged and regular river; much debris in river esp. car tyres. Dried debris layer over bank vegetation to +0.5 m above water.

ANIMAL Score 3
 Only 5 taxa were found at this site. Filamentous algae covered the stony substratum. Chironomidae were extremely abundant and Asellidae was common. The sparse fauna indicates a polluted site.
