**Institute of  
Hydrology**

**Review of a proposed  
Water Management Plan,  
Pickeridge Farm Quarry,  
Fulmer, Bucks**

October 1995

## Review of Proposed Water Management Plan for Pickeridge Farm

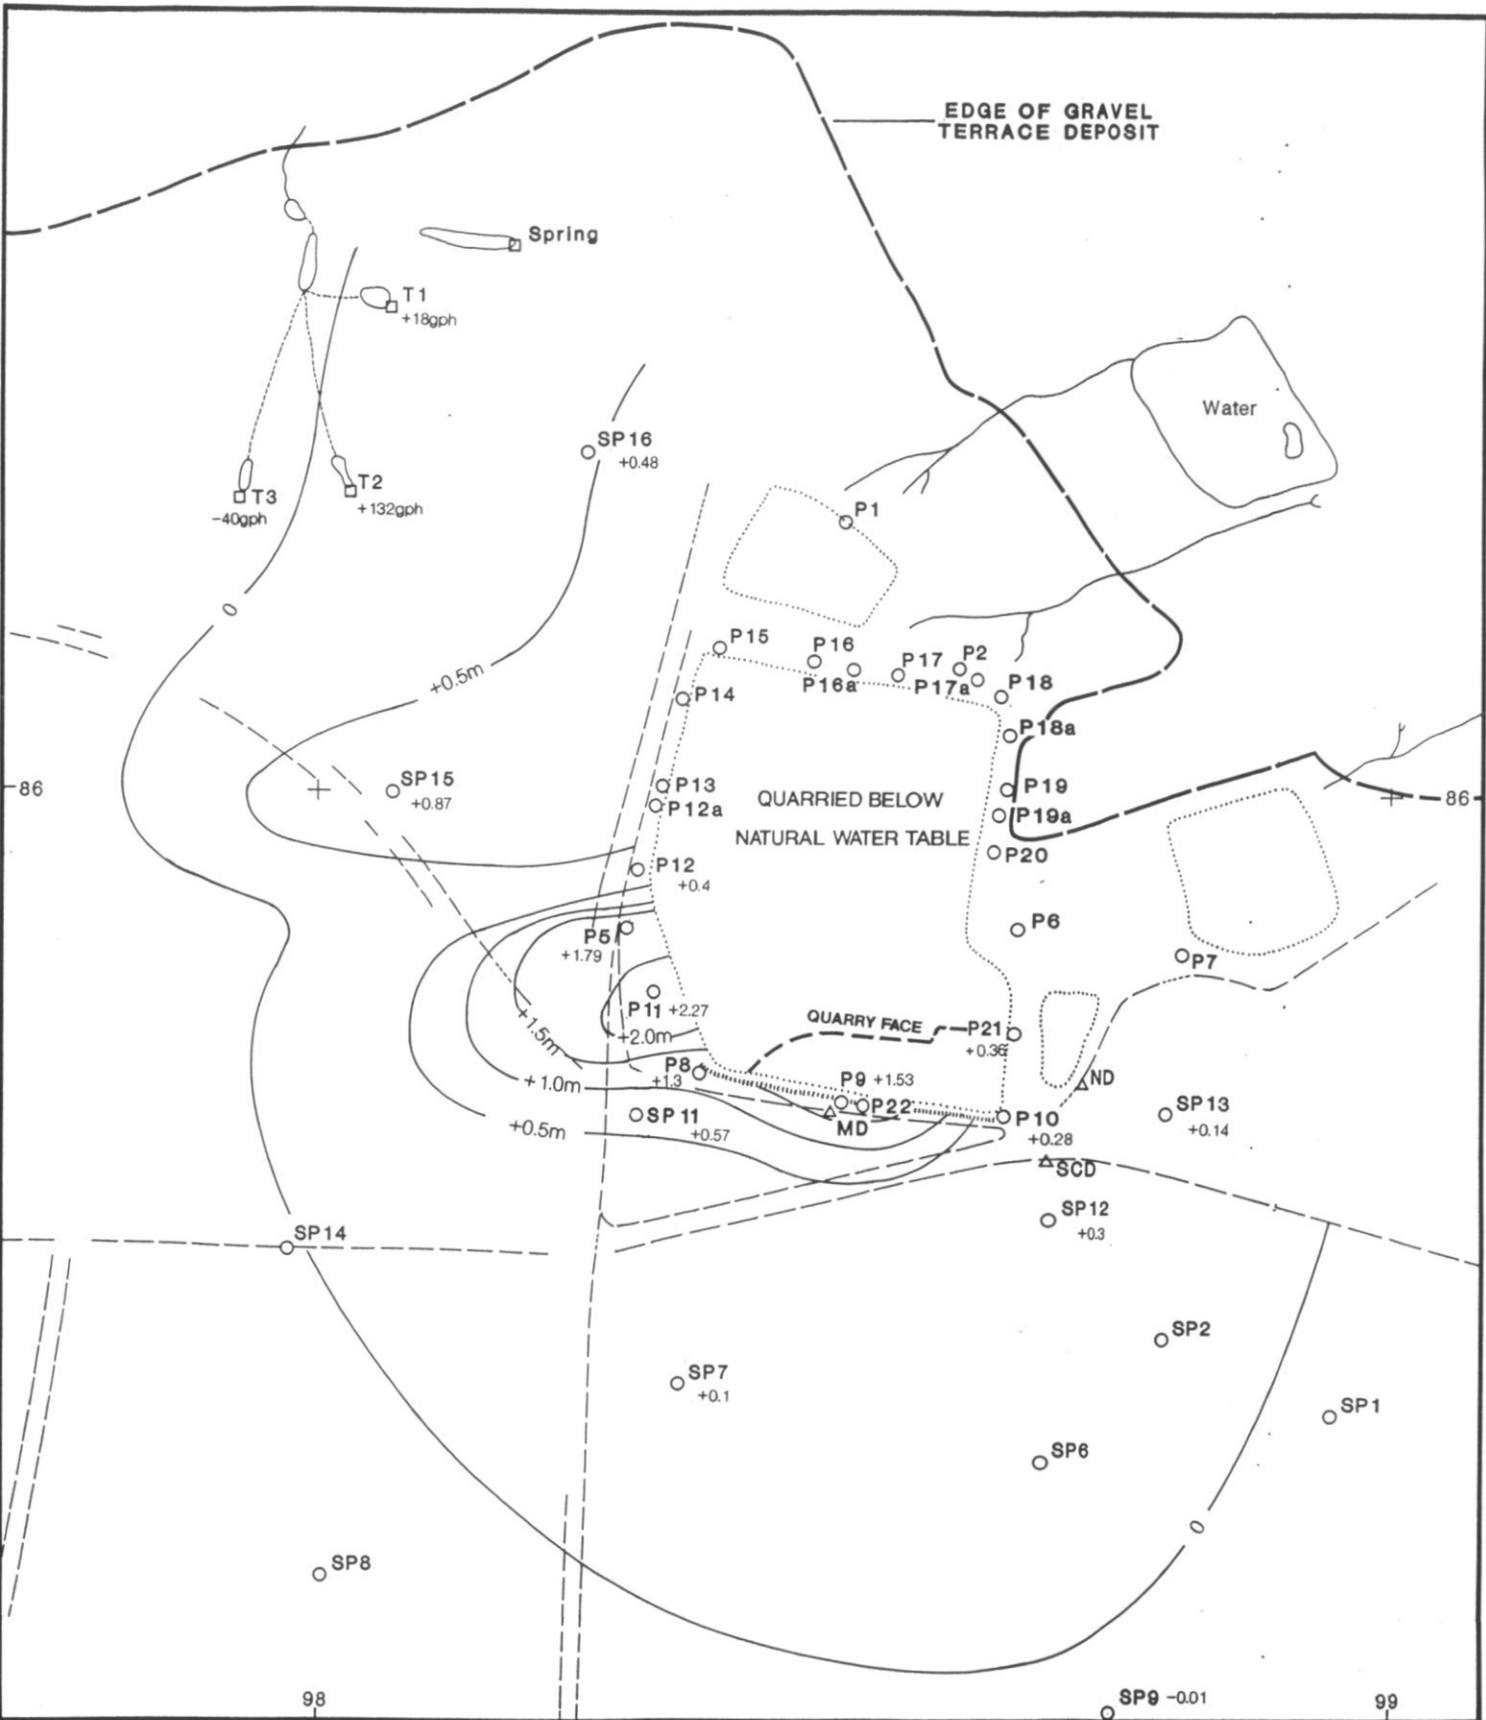
**FIGURE 2**

**WATER LEVEL CHANGE MAP**  
BETWEEN 21/03/94 and 20/03/95
