HYDROLOGICAL IMPACTS OF PROPOSED DRAINAGE IMPROVEMENT AT ARTHOG BOG SSSI, GWYNEDD

Report to Countryside Council For Wales

CCW Contract Report No. 45

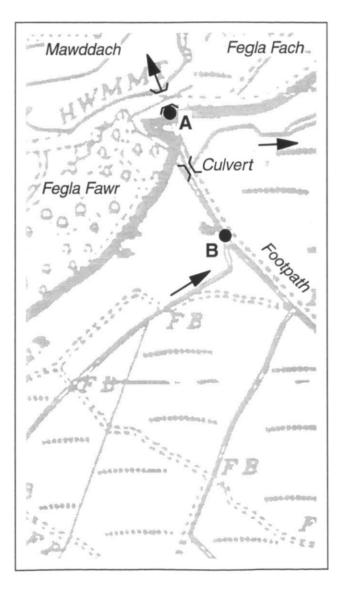
Figure 1 Arthog Bog in the vicinity of the Mawddach outfall. The SSSI boundary (bold line) follows the edge of Fegla Fawr and Fegla Fach, and the outfall is at grid reference SH 63331494. The ditch apparently draining from the culvert to the east is no longer in operation, having been superseded by the connection to the outfall.

(1) a limited amount of maintenance should be carried out, i.e. cleaning out the section AB to a depth of up to 75 cm below the present water level, with the footpath culvert being cleared either to 50 cm below water level or to its invert.

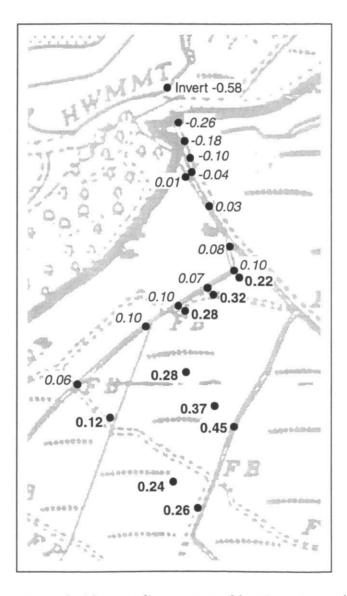
Figure 2 Levelling survey - bold text indicates ground levels, italics indicate water levels, and all levels are in m relative to an arbitrary datum 0.50 m below the top of the roof slab of the footpath culvert.

The survey, carried out using Electronic Distance Measurement equipment mounted on a theodolite, indicated that there was no measurable fall for 170 m upstream of point B, as far as the footbridge, a fall of 5 cm through the culvert and a fall of 54 cm between the eastern end of the culvert and the invert of the tidal flap outfail at point A (Figure 2). The reasons for the steepness of section AB are not difficult to determine: the ditch downstream of the culvert is narrow and crowded by sallows, and immediately downstream of the culvert silt deposition in a channel choked by growth of vegetation has caused the ditch to spread over the ground surface.
