THE INTERPRETATION OF VAN DE  
CASTEELE DIAGRAMS

G. W. LENNON

1966

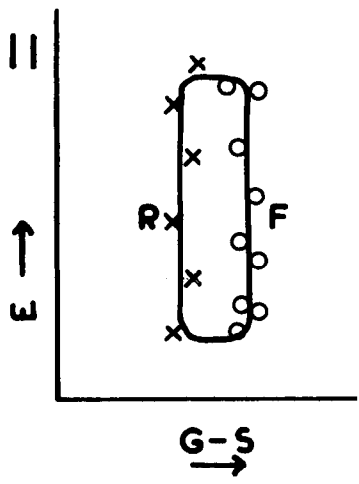
Common test result shows lag in response of gauge to water level movements in well

- due to backlash or friction in mechanism
- if gauge is remote recorder lag may be due to necessity to build up a differential at well before remote recorder can respond.
- where sounding is performed off-site (perhaps in another well) this may indicate tide gauge well orifice silted or otherwise too small.
- possibly float diameter too small.
- possibly gauge reading and sounding not simultaneous (sounding always after gauge reading).

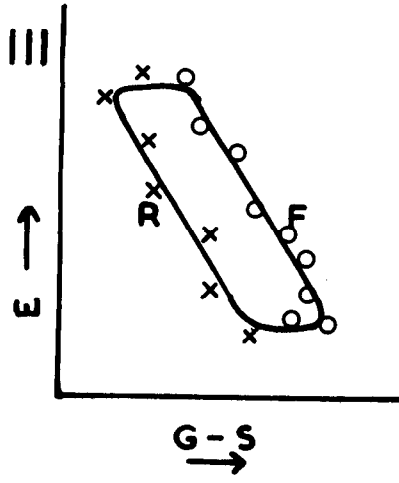
Fault is systematic non-linearity  
 Possible reasons:

- Graduations on tide gauge chart untrue either due to poor printing or to fact that operating conditions are much more humid than those which obtained at time of printing. Spacing of graduations on chart is too large.
- Float pulley too large. This may be due to the fact that too long a length of wire is attached to float so that riding turns are always present.
- Possible overriding in pen carriage movement.
- Errors in design, gears, pen carriage movement.

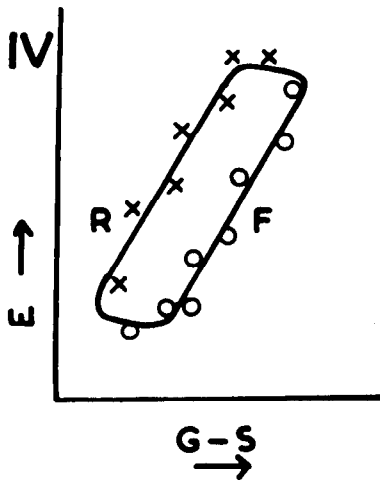
Fault is systematic non-linearity

Possible reasons:

- Graduations on tide gauge chart untrue. Spacing of graduations on chart is too small.
- Float pulley too small.
- Possible overriding in pen carriage movement.
- Errors in design, gears, pen carriage movement.

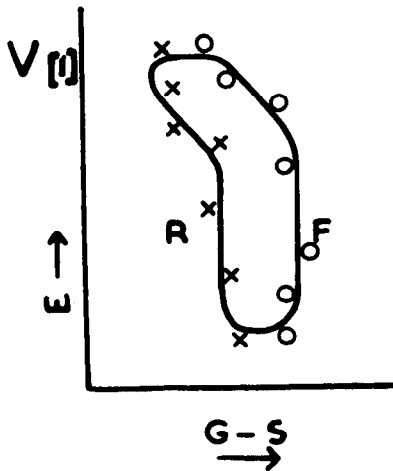
Non-linearity in higher tidal elevations.

- Classic case of riding turns in float wire.
- Riding turns in pen carriage movement.
- Since test is conducted over several hours during which drum rotates and different parts of charts are used (above might indicate that for approximately 6 hours width of chart graduations on chart have a spacing which is too large).

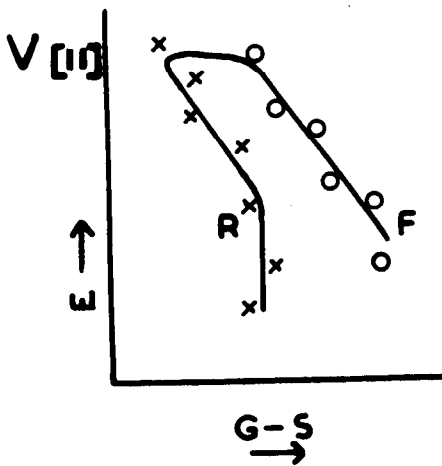
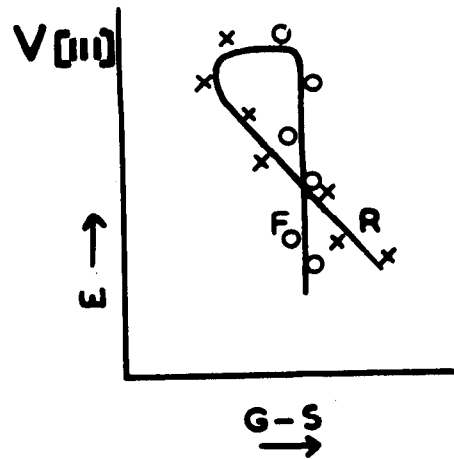
Condition (c) shows itself more commonly as follows :

also non-linearity of reverse sign is possible.

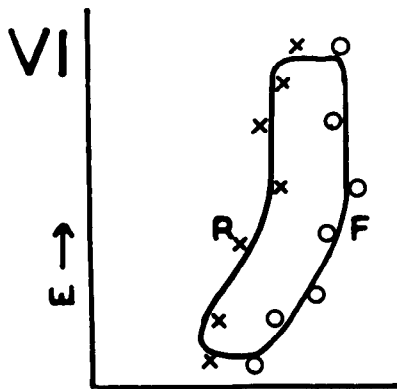
Diagram vertical at higher tidal elevations but becoming progressively negative at lower levels.

- a) Possible explanation inconsistent counterweight affecting level of buoyancy of float. Most common where float suspension is tape rather than wire and particularly where counterweight is immersed at high water.
- b) Float suspension tempered and containing kinks.
- c) Counterweight of insufficient mass, particularly if plots for rising tide are more haphazard than for falling tide.
- d) Float diameter too small particularly if plots for rising tide are more haphazard than for falling tide.

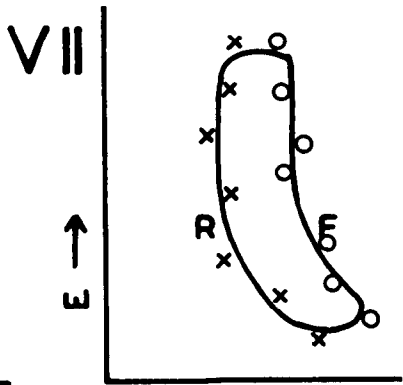
As in VI but diagram becoming progressively positive in lower levels possibly due to insufficient mass in sounding device or kinks in sounding tape.

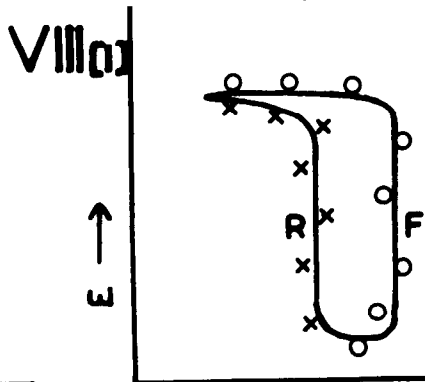
- (i) Gauge unable to register maximum levels due to :
  - a) counterweight falling too low so that it fouls an obstruction.
  - b) float or pen carriage, on rising, reaches an obstruction.

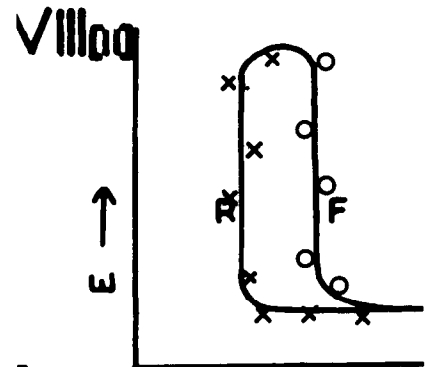
- (ii) Gauge unable to register minimum levels due to :
  - a) siltation of well.
  - b) counterweight rises too high so that it fouls an obstruction.
  - c) Float or pen carriage, on falling reaches an obstruction.

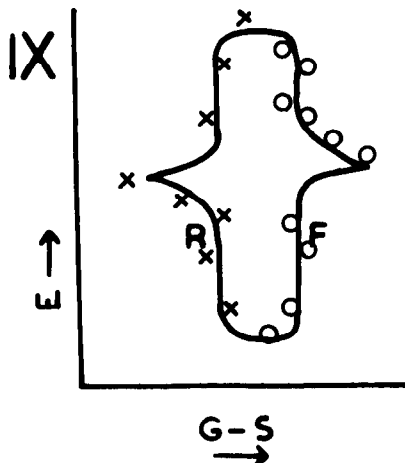
- a) Float fouls an obstruction in well on both rising and falling tides.
- b) Counterweight fouls an obstruction on both rising and falling tides.

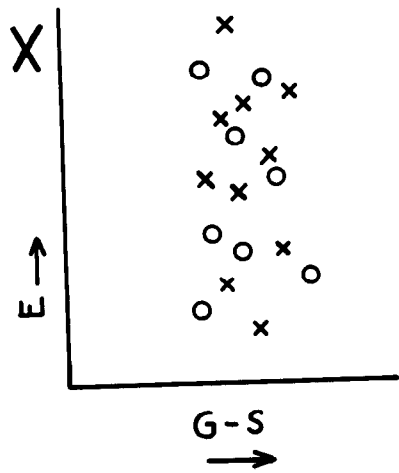
Condition : plots from rising and falling tide haphazardly distributed so that no pattern emerges. Most probably due to poor quality of soundings.

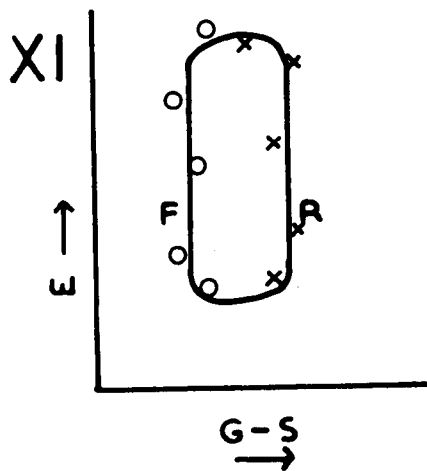
Rotation of diagram anticlockwise. Difficult to understand in terms of gauge, since it implies that gauge is anticipating movement of water in well. This is most probably due to faulty sounding equipment or procedure e.g. sounding and tide gauge reading not simultaneous (gauge reading always made after sounding).

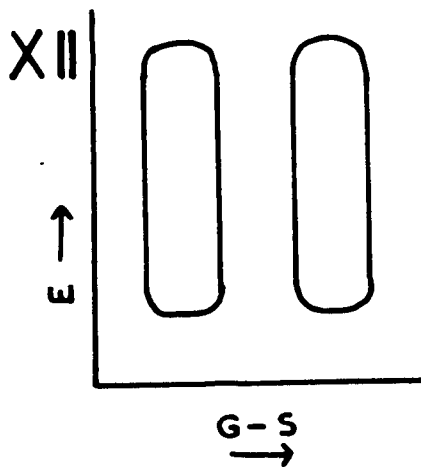
Condition : successive tests give markedly different datum - poor gauge maintenance in pen setting.
