# Nedern Brook Wetland SSSI Phase 1 hydrological monitoring

Open Report OR/15/038

Gareth Farr

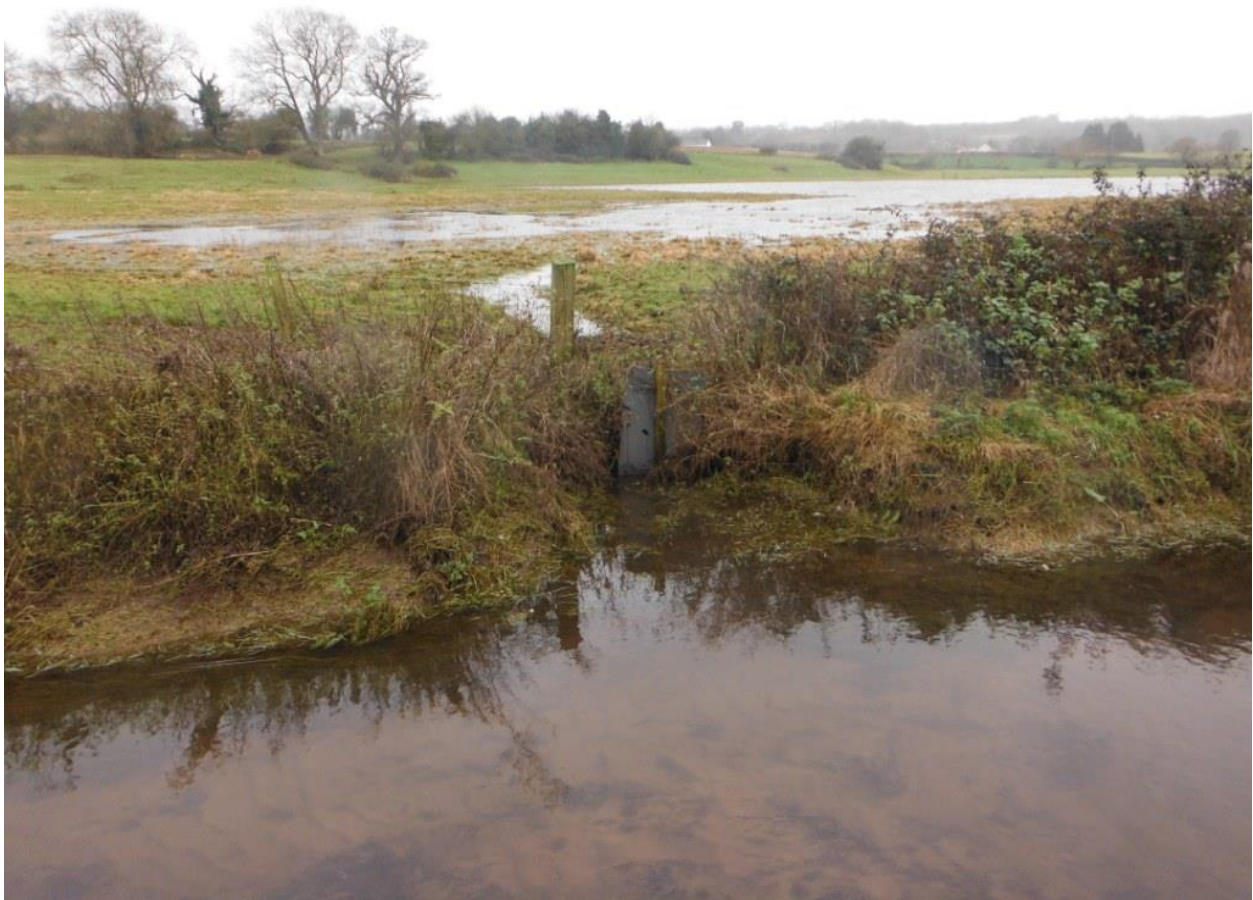
During each site visit observations were made on both water levels in the wetland and in the Nedern Brook. The key observation is that the over deepened Nedern Brook acts as a drain, taking flood waters away from the adjacent floodplain. Flooding does not appear to be of 'fluvial flooding' type and does not initiate from over topping of the Nedern Brook. Evidence for this can be seen in numerous locations, throughout the wetland, both above and below the M48 road bridge. Drains installed into the river banks (Figure 4) to take water from the floodplains into the brook, were further evidence that flooding initially occurs on the floodplain and then drains into the Nedern Brook.

**Figure 4 Flooding initiated on the banks and floodplains drains into the Nedern Brook (P915242) © BGS NERC.**

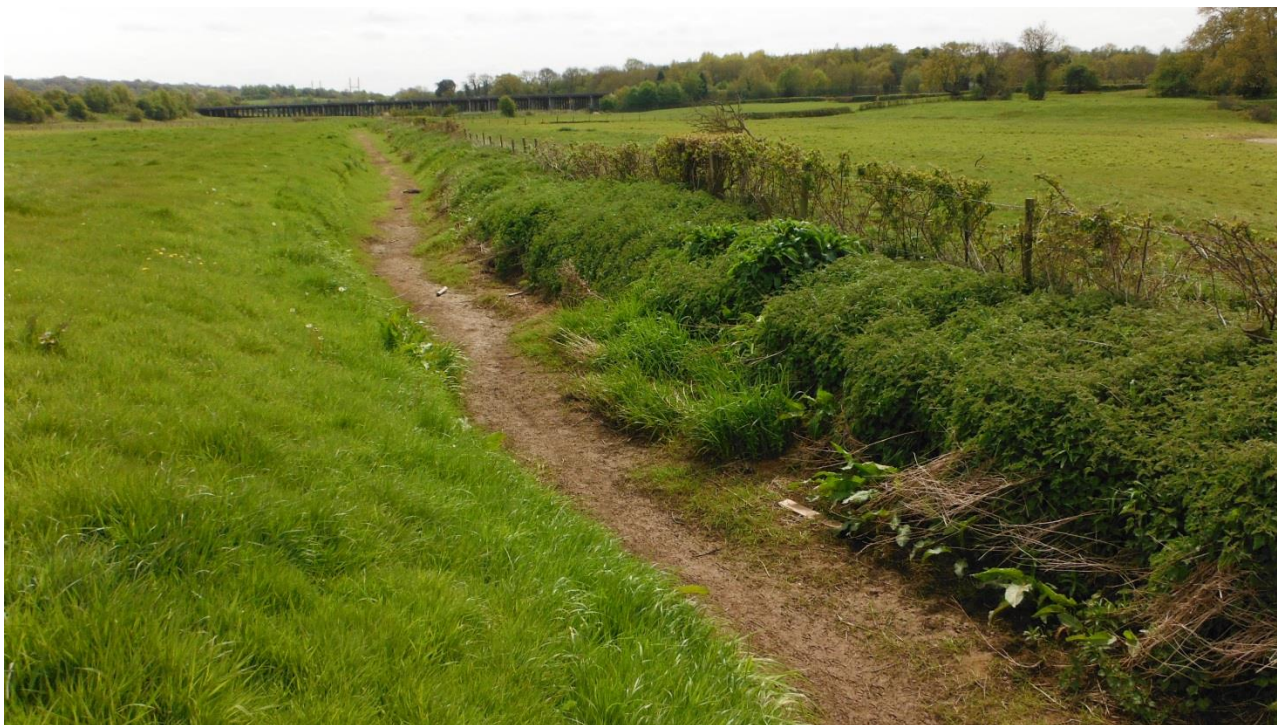
**Figure 13 Nedern Brook (dry) looking south towards the M48 road bridge 1<sup>st</sup> May 2015. © BGS NERC. P917085.**
