Report on the CSSU geological sampling programme
July-Sept 1978 using the Cape Shore

by C.D.R. Evans

WB/M1/78/015

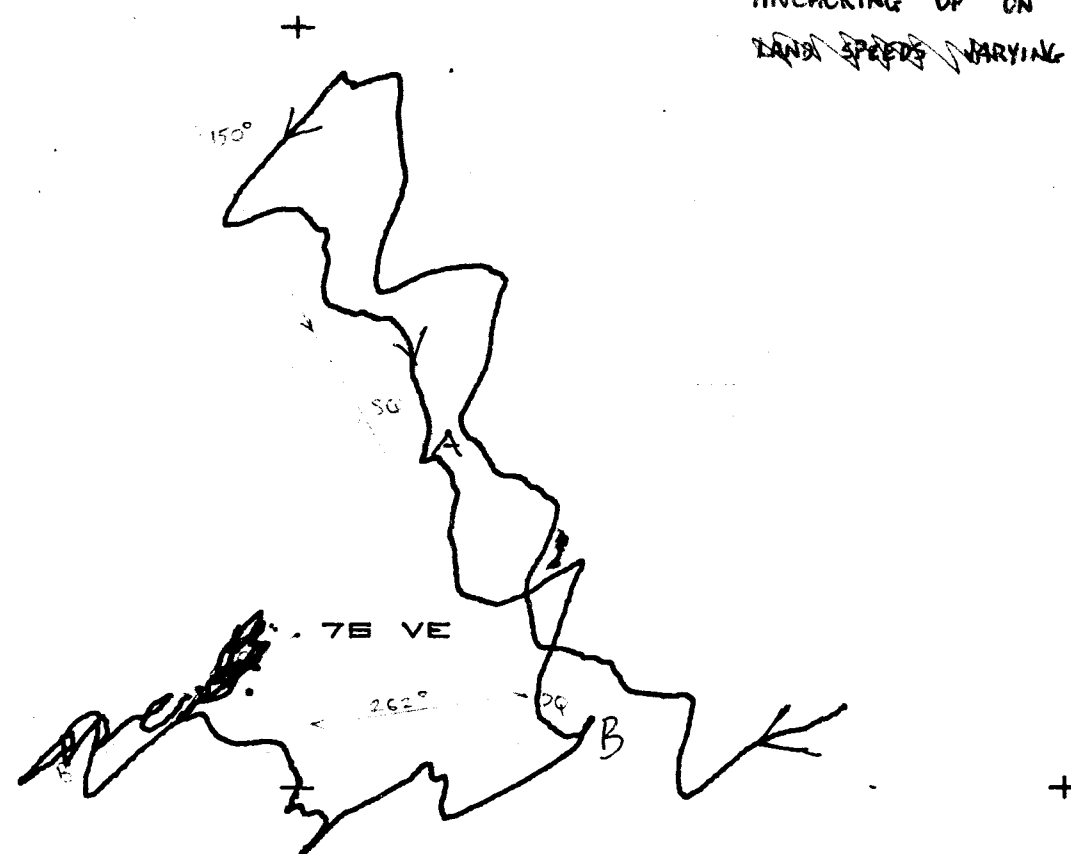
POOR VIBROCORER TRACK PLOT

The first track plot was drawn with a 500 m anchor spread and the intended anchor positions are shown as B (Bow), ST (Starboard Stern) and PT (Port Stern) on the faint circle. As can be seen from the chart ST and PT were dropped close to the intended site but B was dropped 200 m short of its intended position. The quality of the track chart is good and external fluctuations probably account for a variation of ± 40 m. This compares with fluctuations on the second chart which are approximately ± 150 m. The wandering signal of this magnitude makes anchoring more difficult though the anchors appear to have been dropped as accurately as when the navigation system was more stable. A drawback when the signal wanders is the difficulty of picking up any drift on the vessel when at anchor. A change in the lead of the anchor wires usually signals such an event but the track plotter is also useful to confirm the drift.

~~WIND SPEEDS~~ VARYING

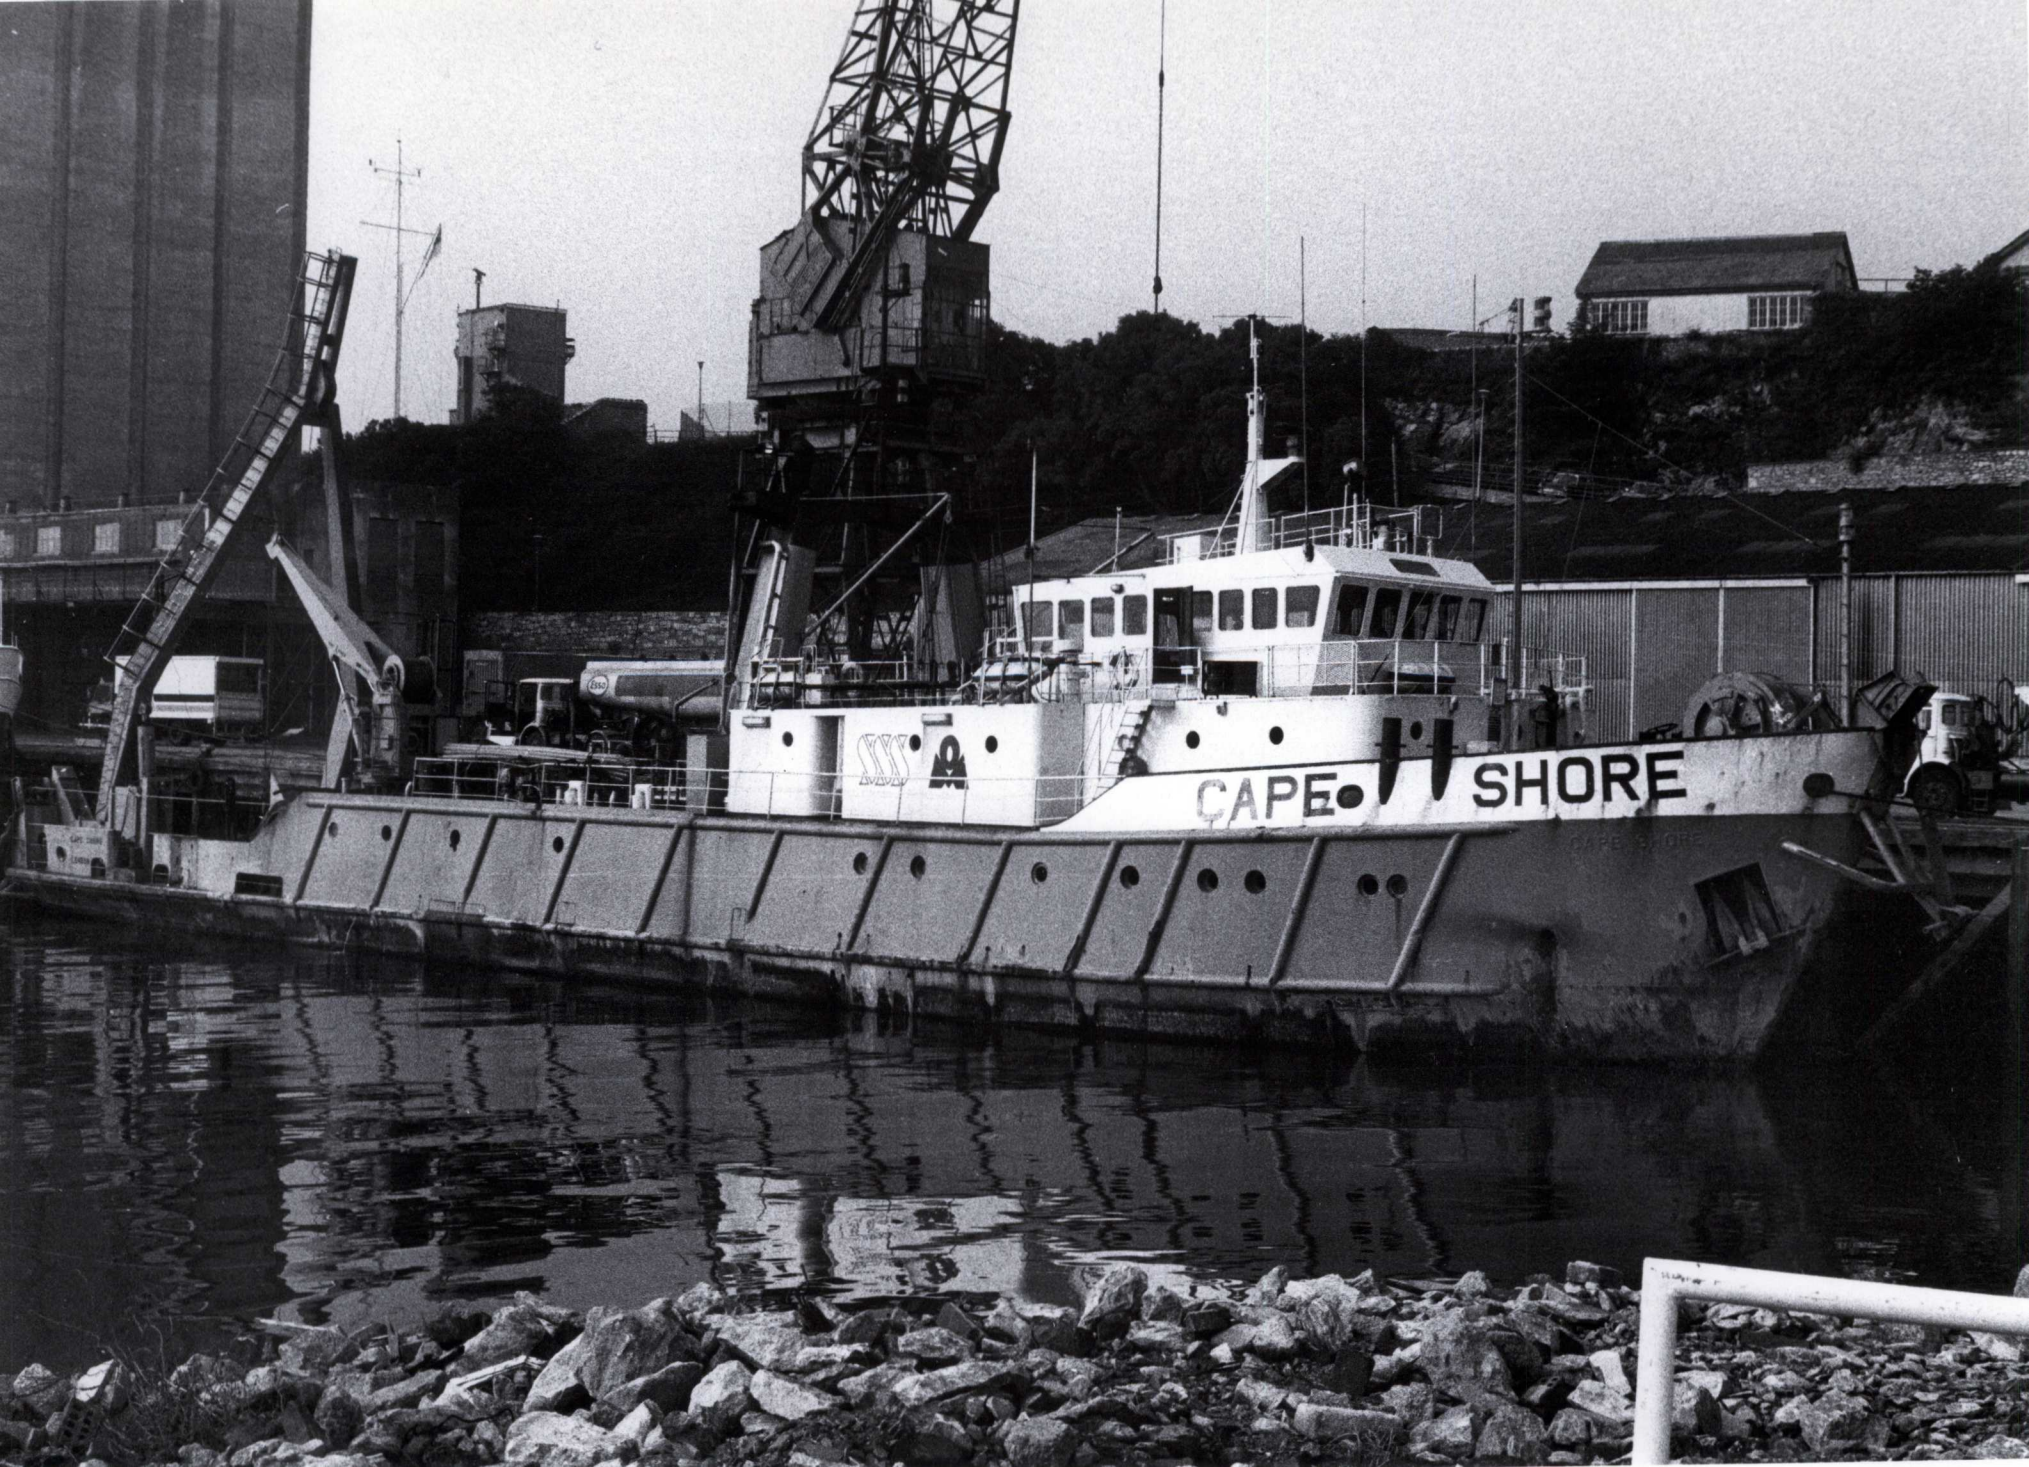
ii Anchoring system The ship laid one forward (photo 1) and two stern (photo 2) anchors for vibracoring with a spread of 300 or 500m (average water depth 150m). The first captain preferred to head the vessel into the tide but the second preferred the vessel into the sea. The latter configuration was safer and drier for launching but often resulted in having the tide on the beam. Conditions at the stern end in moderate seas became very wet (photo 6) when anchoring up into the tide and not the weather. No configuration is ideal but the direction of the sea was the most critical factor. The anchoring system worked without any recurrent major delays although Offshore Marine had to work

- 1) Cape Shore in Millbay Docks Plymouth. A frame inboard.
- 2) Cape Shore stern in Millbay Docks Plymouth. Vibracorer sitting on the stern.
- 3) Carrying the vibracorer loaded barrel to the work bench. Note wet deck, ropes and wires across the deck.
- 4) Attaching the bousing line onto the gravity corer. Position very exposed when sea washes across the stern and the ship is rolling.
- 5) View of operator on Sykes winch bringing in gravity corer. Main vibracorer electric cable in front of Sykes winch.
- 6) Lowering the vibracorer when ship moored into tide and sea coming in over the stern.

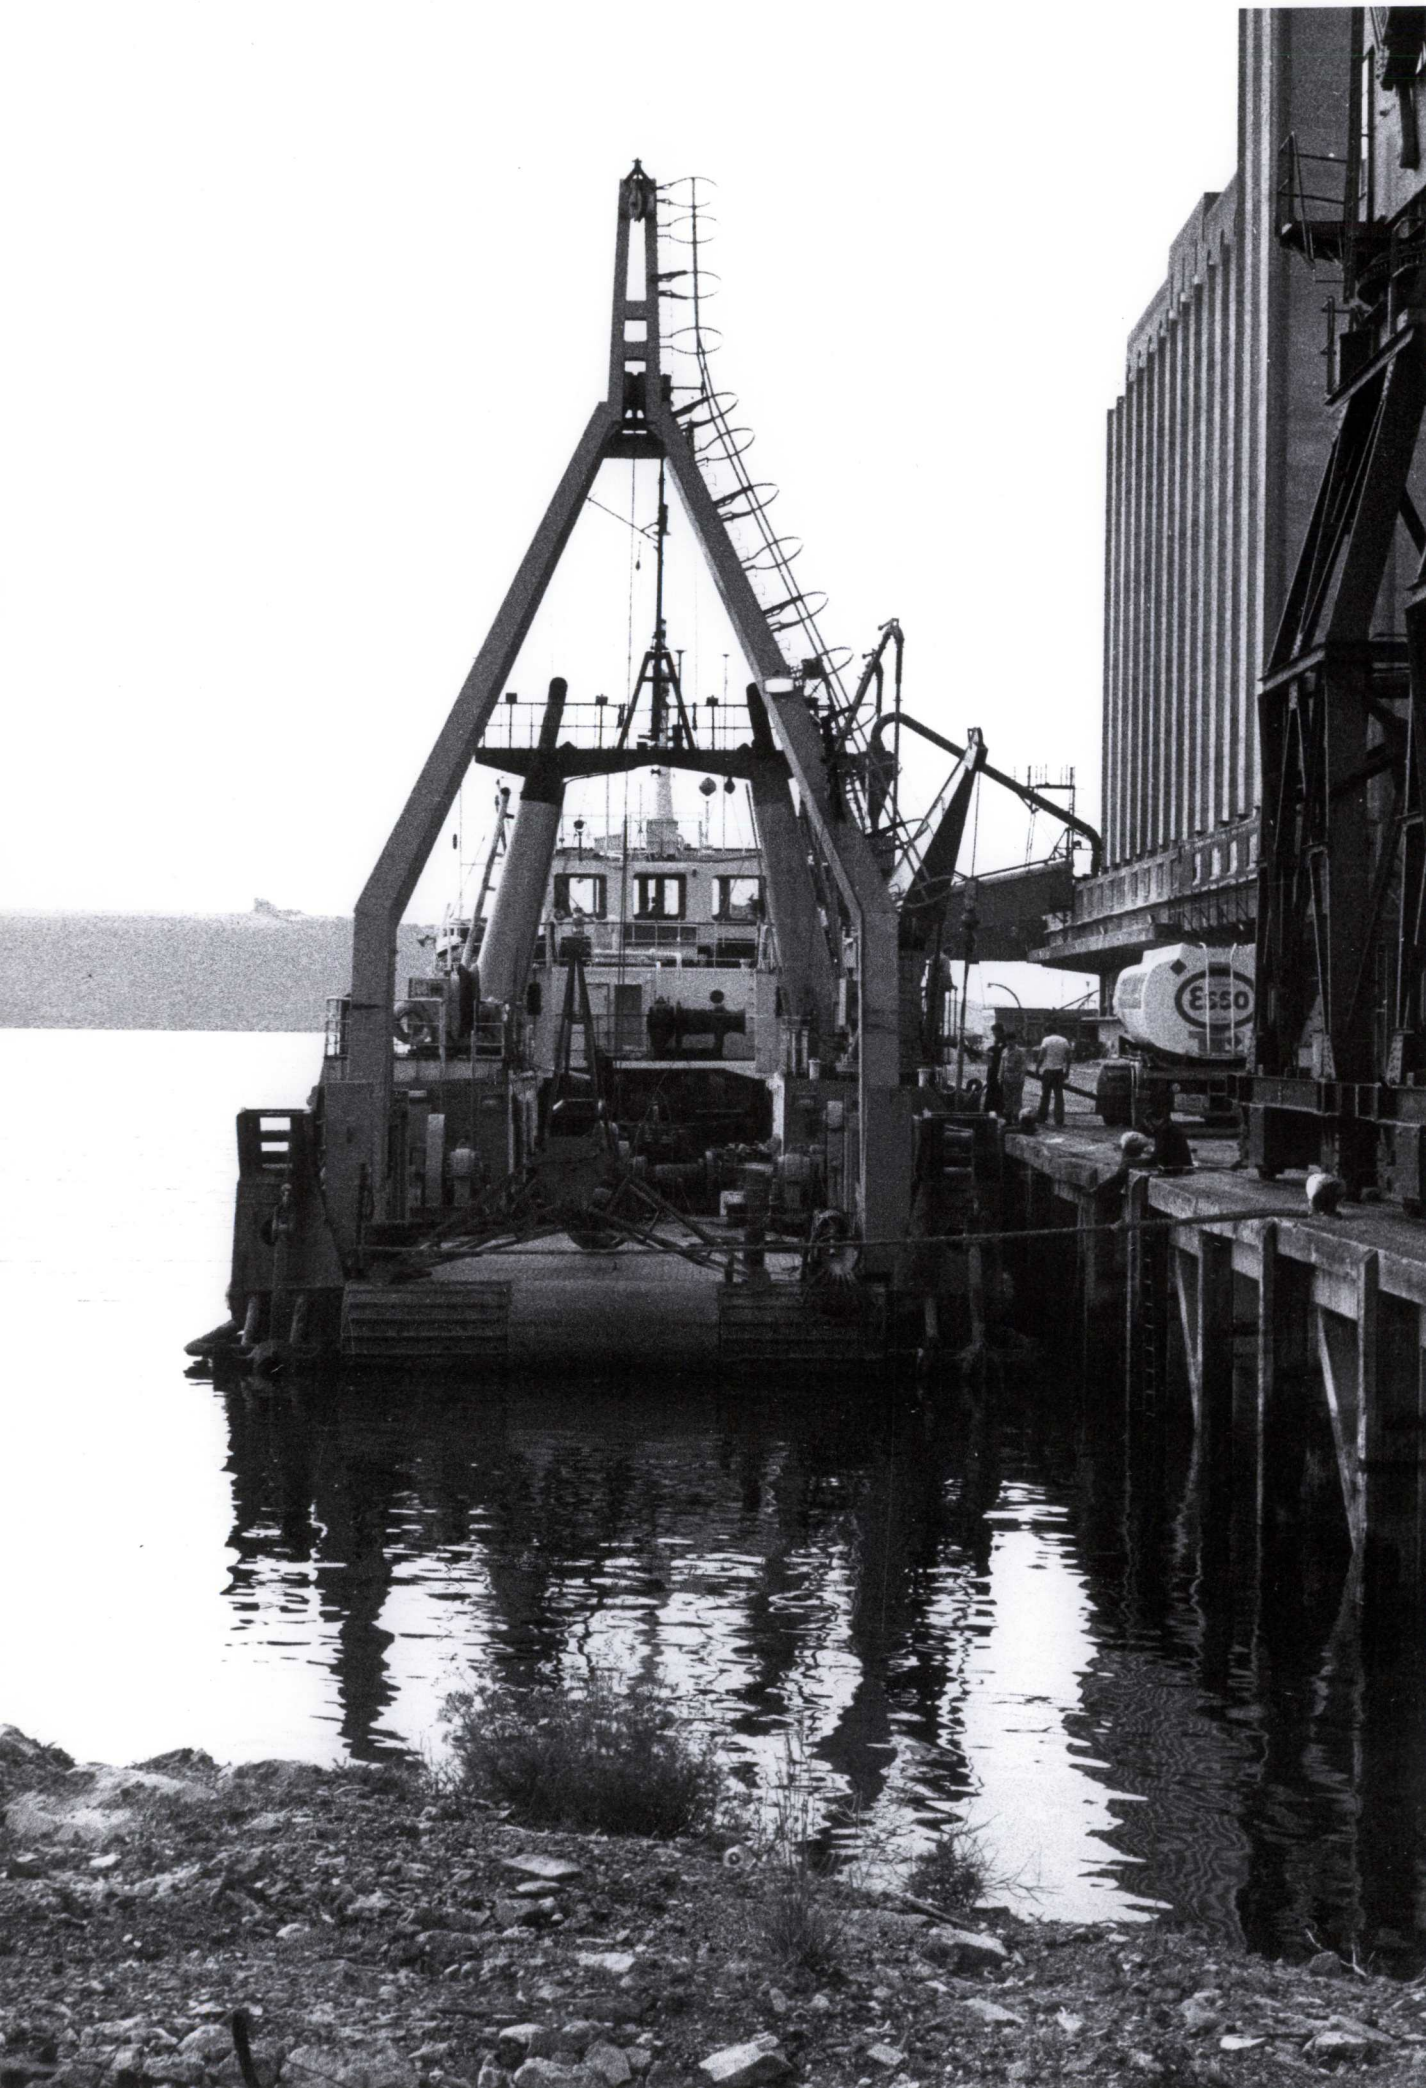
i Vibracorer The corer was pulled over the stem by the lifting cable (Photo 2) and the electrical cable was tied to the main lifting cable every 15-20m as the corer was lowered to the sea bed (Photo 5). The corer was left to vibrate for a maximum of 20 mins and then recovered: a second hauling cable and two rope guides (Photo 4) were attached once the corer was above sea level and it was then hauled inboard. The system worked smoothly and the main problem in rough weather was the releasing and attaching of the extra ropes and wires as the corer swung across the stem. CSNU used a cable hauler for handling the electric cable but CSSU preferred to tie it off and then lift it by hand during recovery. With the lightweight cables this latter system was not found to be too strenuous. Two switch boards were fitted, one in the workshop and one on the bridge. The former was used most of the time and the technician kept a constant watch on it whilst in operation.

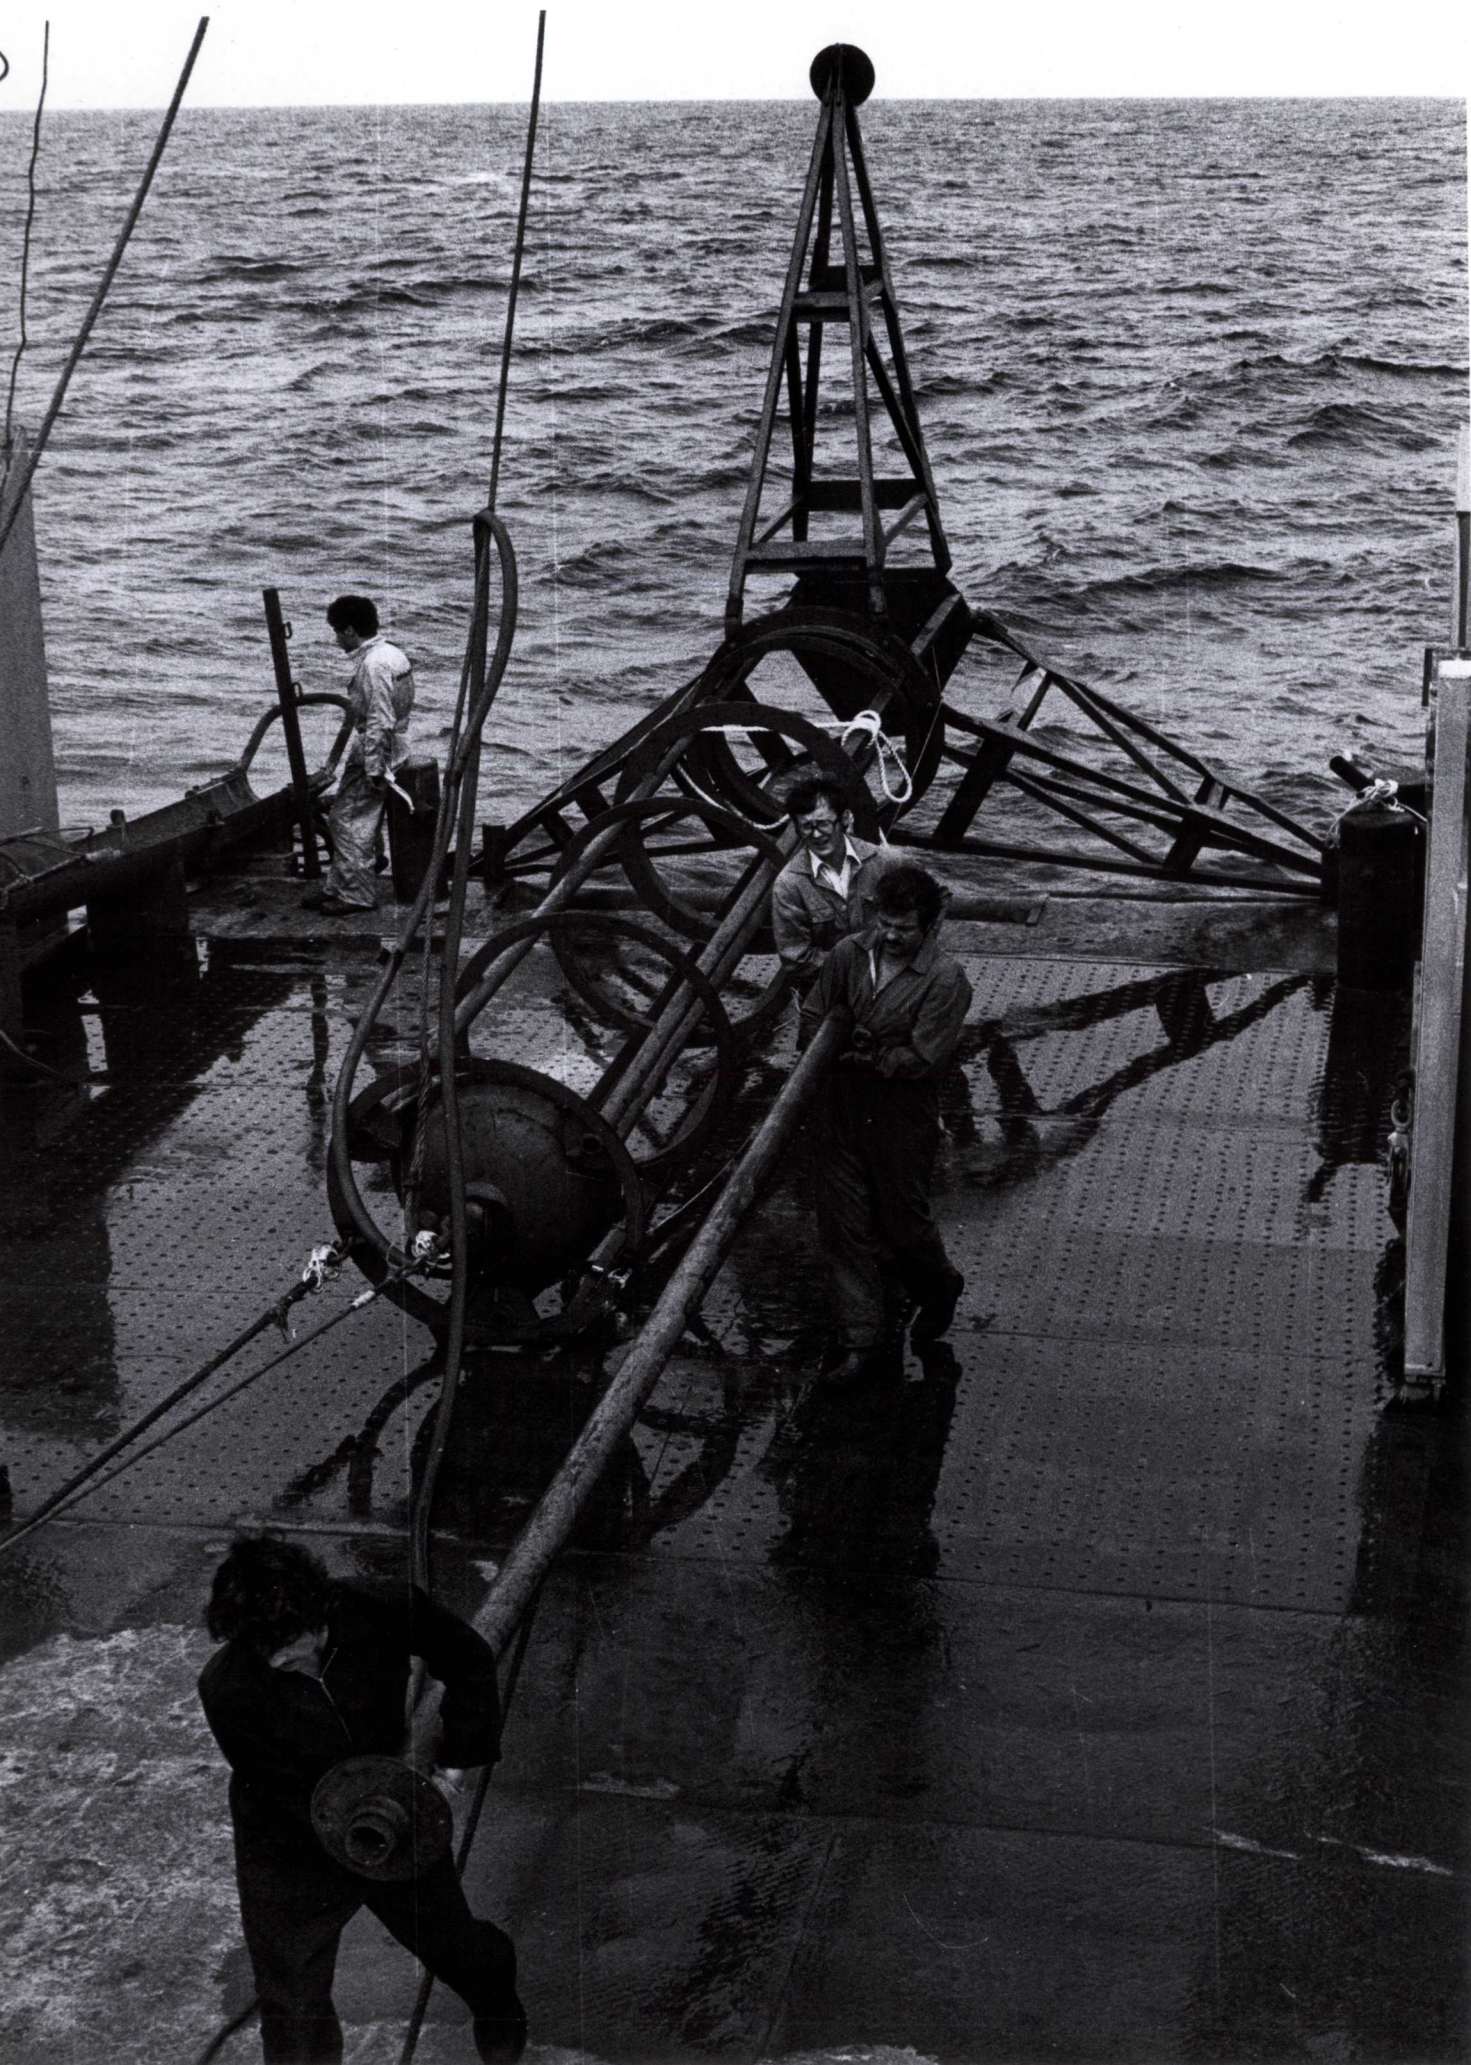
Extraction of the barrel on deck (Photo 3) was hazardous when the anchors were being lifted as was the carrying of the loaded barrel when the ship was rolling. It is suggested that next year this operation and loading the new barrel is written into the contract as part of the task of the ship's crew.

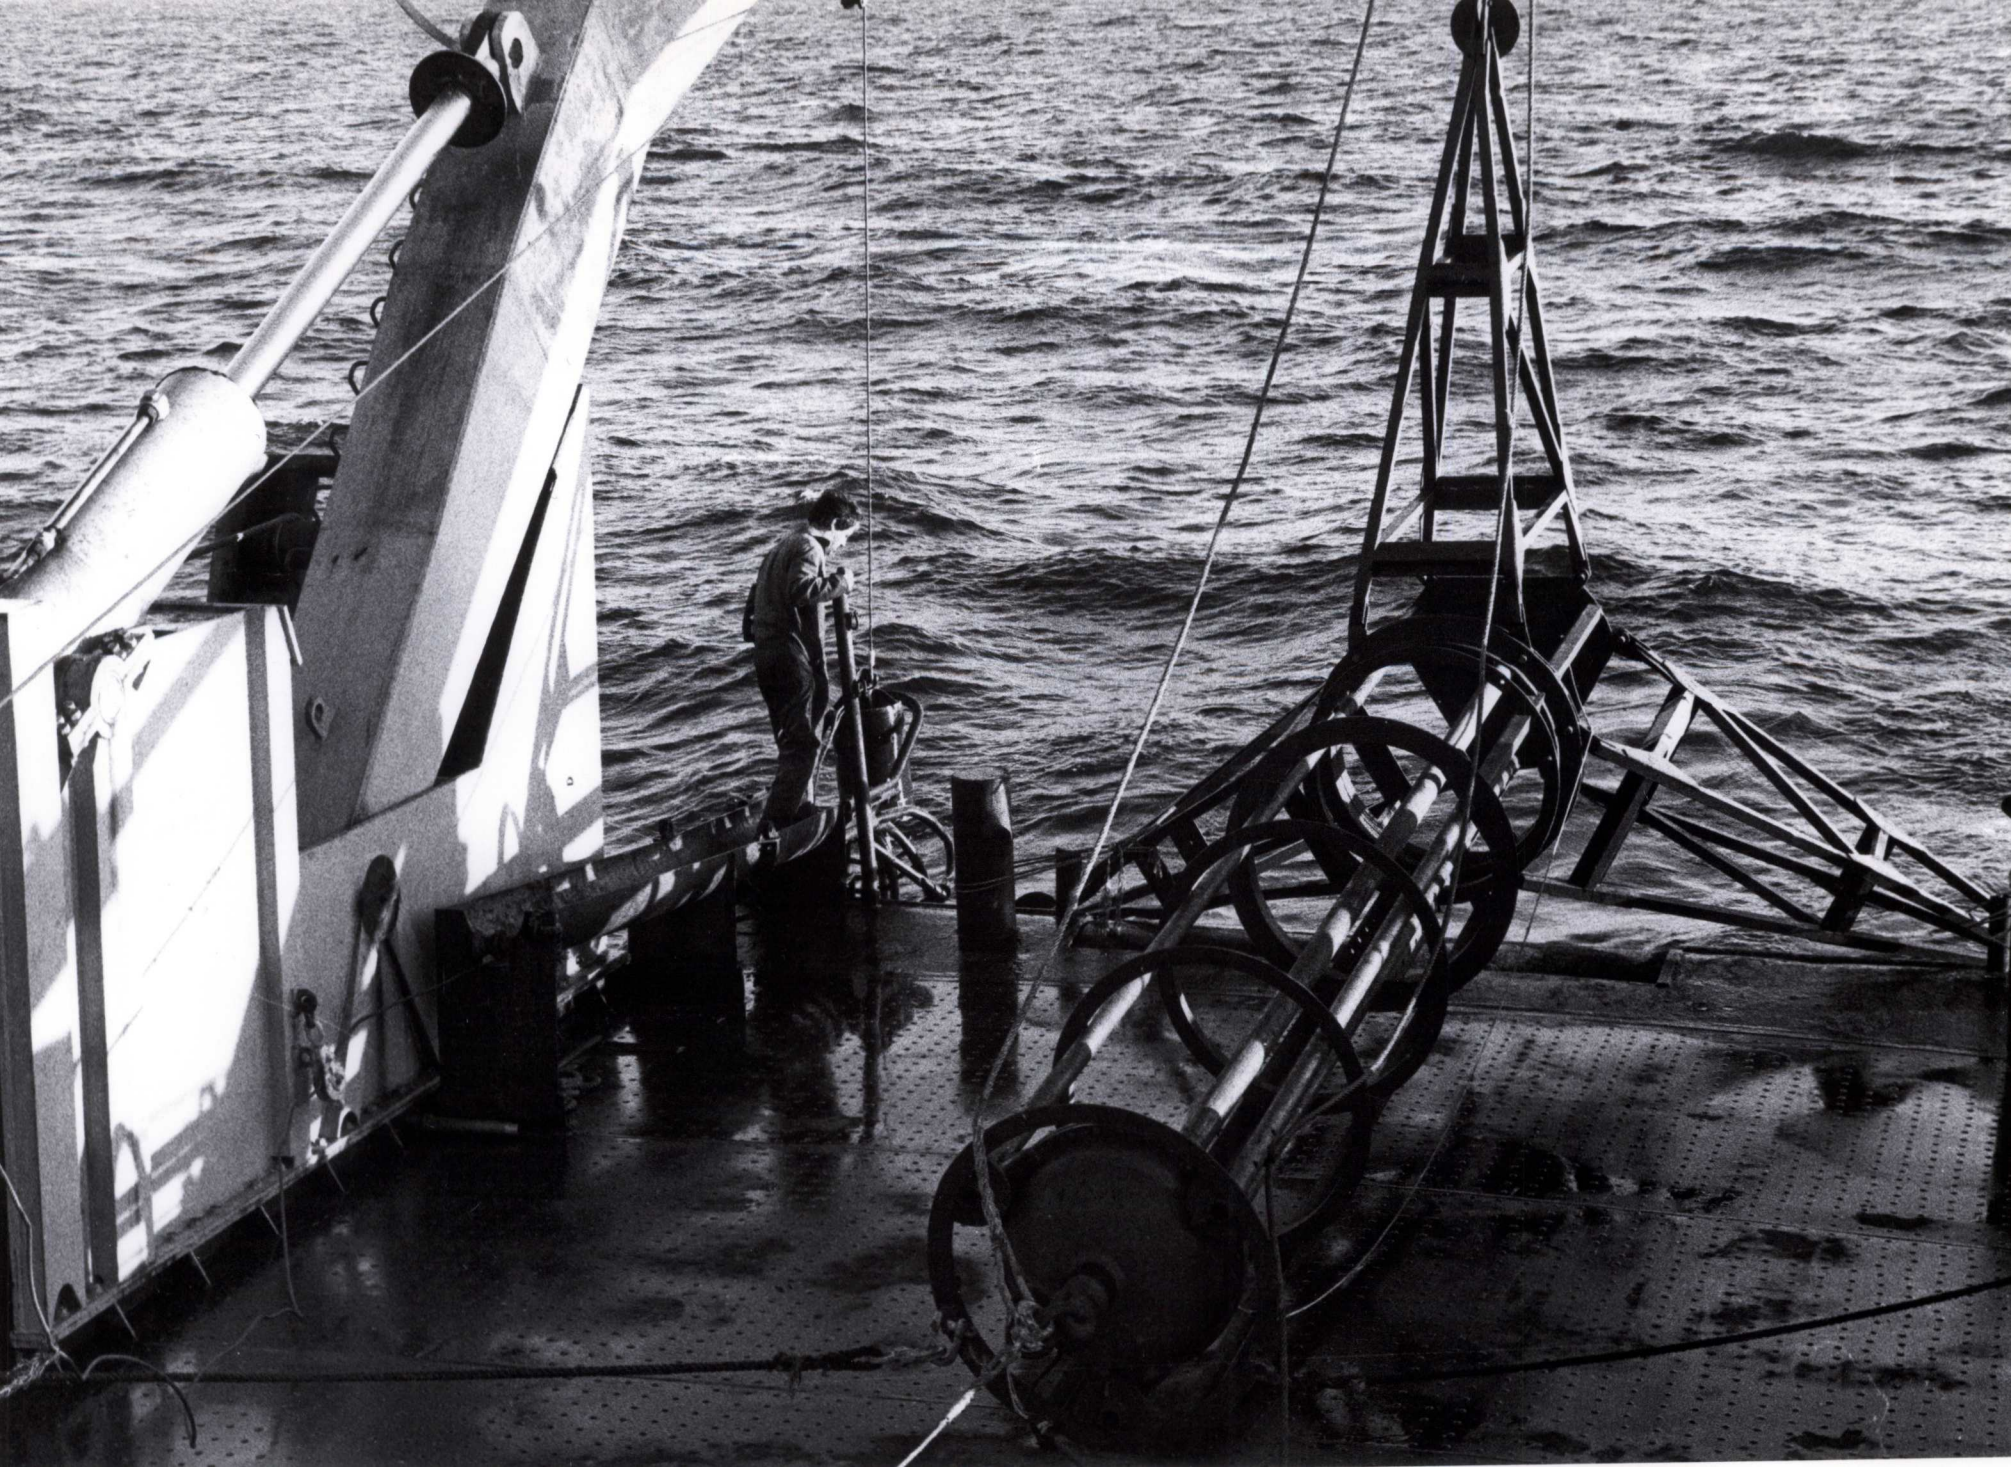
The operation worked well except that the position of the trough made the operation of attaching the bousing line (Photo 4) dangerous in moderate to rough conditions. The system was infrequently used in the Western Approaches because^{of} the concentration of effort on vibracoring and the poor results in medium to fine sands. The range of conditions between when vibracoring ceased and gravity coring had to be suspended was very narrow (see Photo 6 vibracoring conditions near limit) and when vibracoring was suspended the ship generally went onto using the shipek grab. The gravity corer was used very successfully for 4 days on the Portland sheet where the thin superficial cover was easily penetrated and 67 solid samples recovered out of 115 sites.

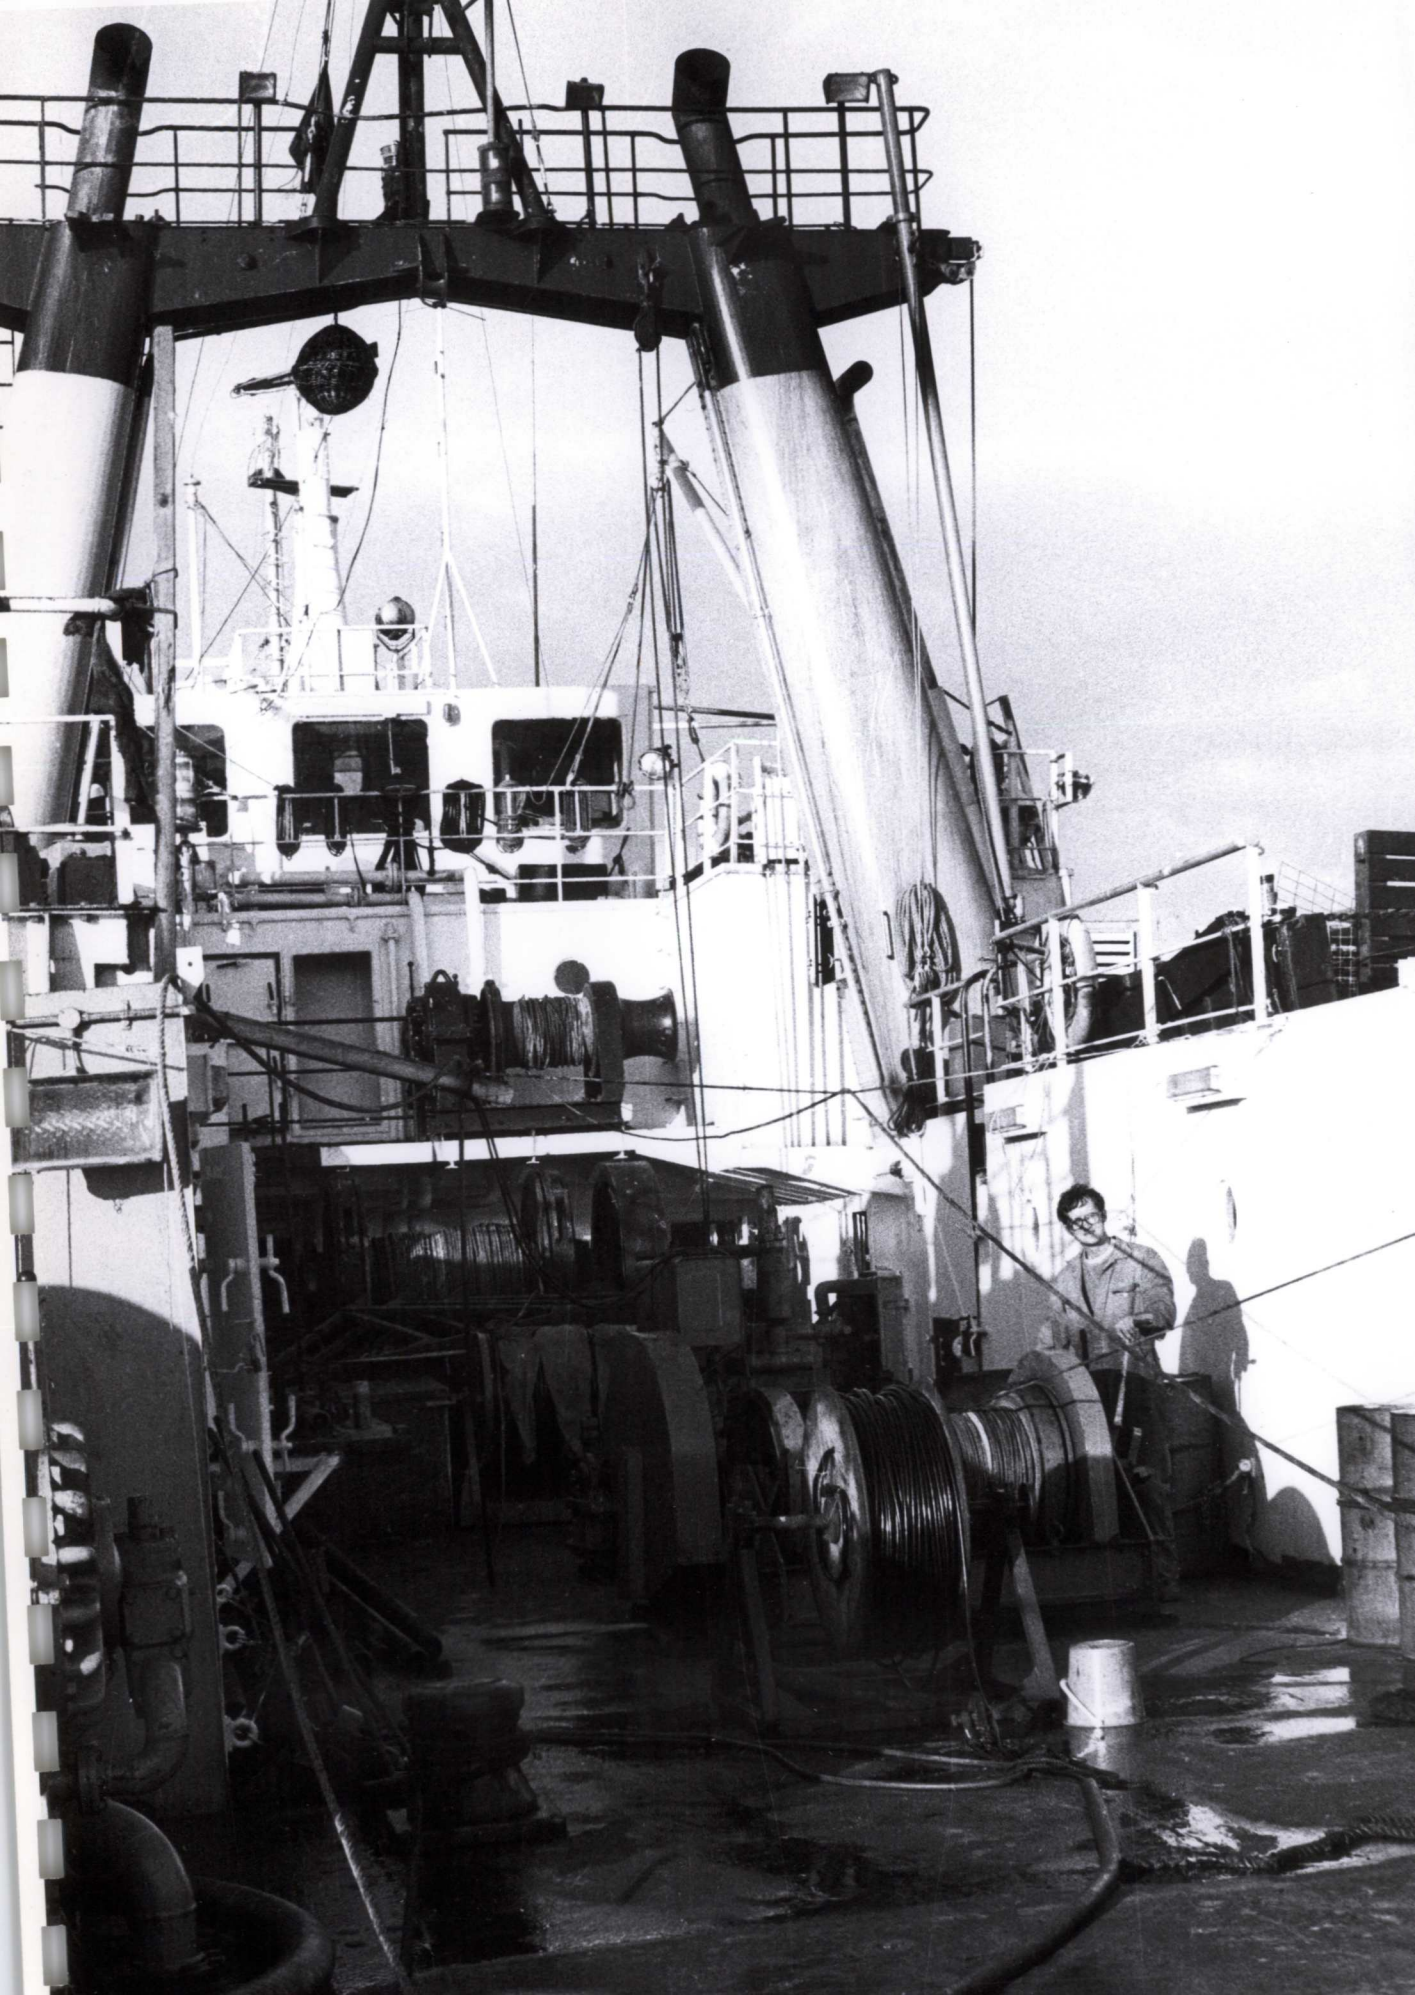
iii Gravity Corer The gravity corer trough (Photo's 2,3,4) was positioned over the starboard stern and the I.G.S. Sykeswinch (Photo 5) was used to haul the corer in and out. The ship's crane pulled the corer onto the trough and inboard. The crane was operated by the ship's crew who were often not at hand. One suggestion was for fitting a warping drum onto the Sykes winch which would then allow the whole operation to be completed using I.G.S. equipment.

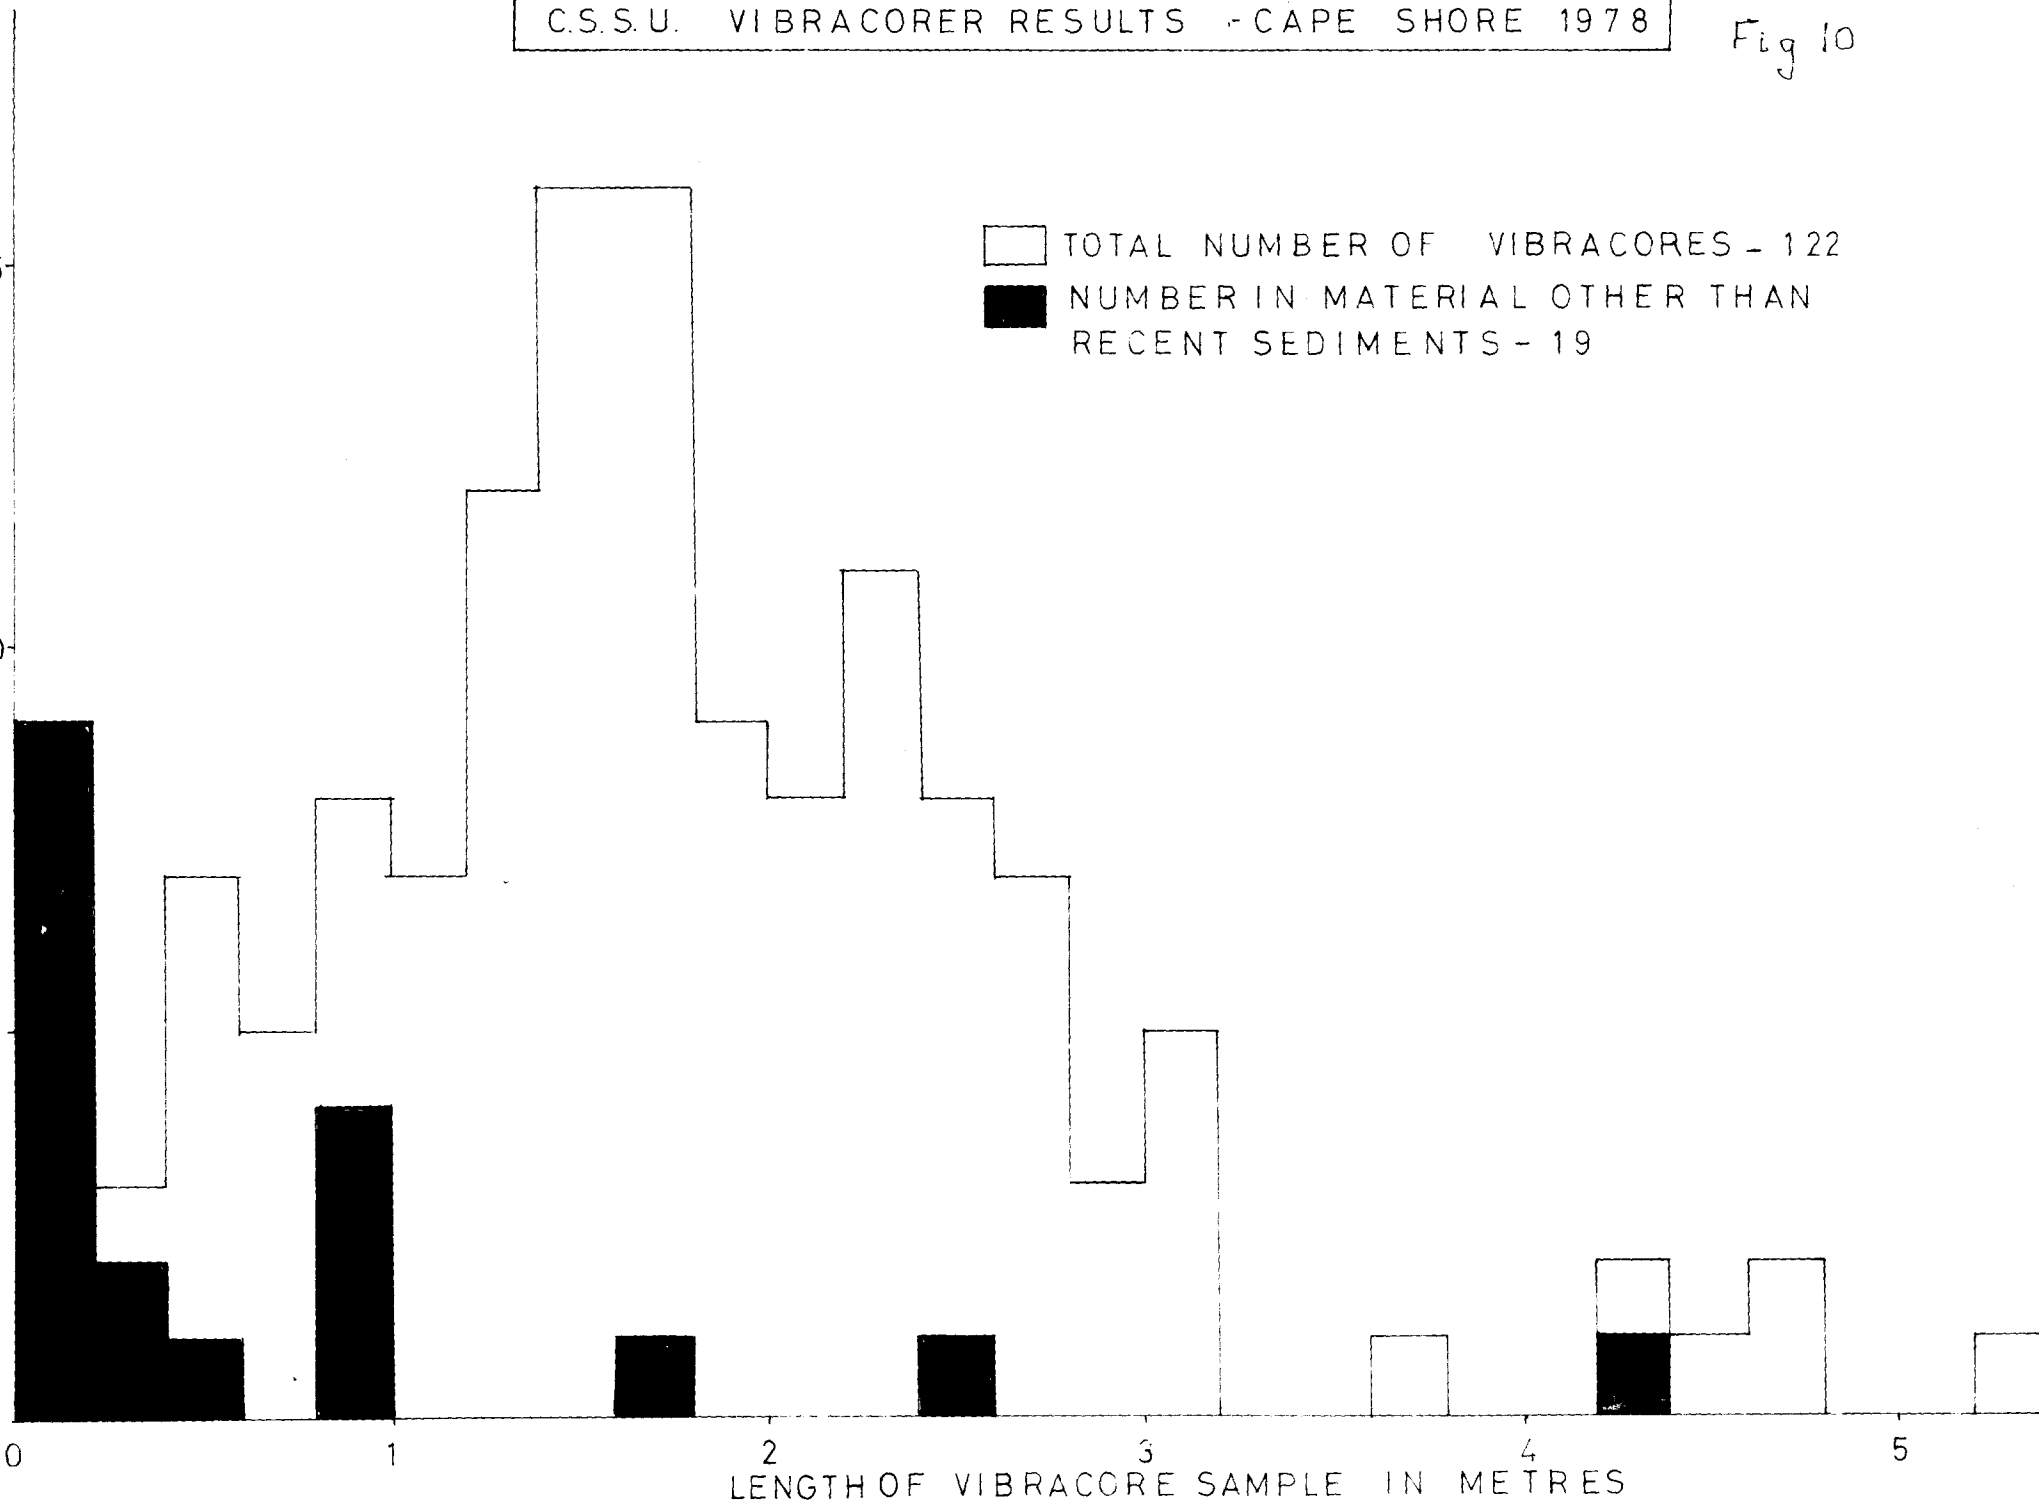
Fig 10

Recovery from the corer is shown in (Fig 10). The corer was left to run for twenty minutes unless the current started to climb when the period was curtailed prematurely. Recovery was generally disappointing but exceptions to the rule occurred and 4.3m was recovered at one site with nearly 4m of Tertiary muddy silts. On parts of the Little Sole Bank however recovery consisted of only a bag of gravel.

C.S.S.U. VIBRACORER RESULTS - CAPE SHORE 1978
