SAFEGUARDING GLASGOW'S STONE BUILT HERITAGE SKILLS AND MATERIALS REQUIREMENTS:

FAÇADE SURVEYS AND BUILDING STONE ANALYSIS

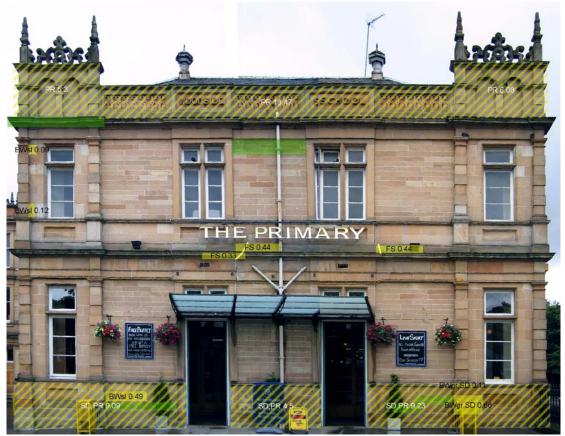
Figure 1. Example of composite facade image, corrected for distortion, scaled (georectified), showing digital overlays of stone decay types and repair requirements.

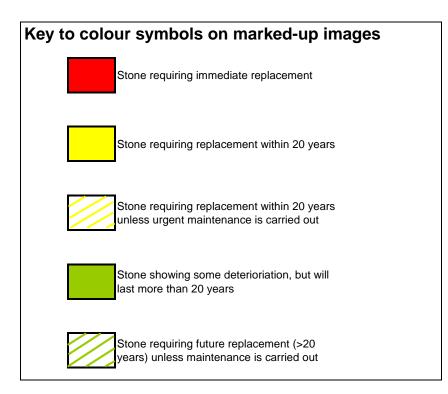
Figure 3. Colour symbols used on the digital facade images, showing categories of repair and maintenance identified.

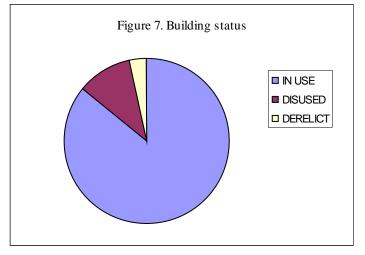
The plot showing building status (Figure 7) shows that most of the surveyed buildings were occupied or in use at the time of survey, with a relatively small proportion of disused buildings (11%). A much smaller proportion of surveyed buildings were noted as derelict (i.e. require significant repairs before capable of occupation). These figures broadly indicate that the majority of stone buildings in Glasgow are currently in use and form an important part of the city's active building stock.

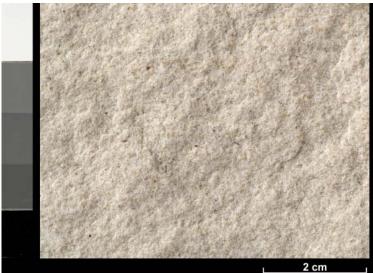
Figure 10. Sample of sandstone from one of the Giffnock quarries, typical of Type B2 sandstone with uniform texture and very pale 'blonde' colour with small specks caused by presence of small iron oxide grains.

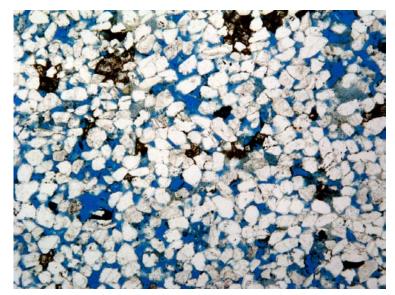
Figure 9b. Thin section image of typical Type B2 sandstone showing uniform well sorted grain distribution, with open porosity locally infilled by clay minerals, dark iron oxides and altered carbonates partially replaced by secondary iron oxides. Porosity highlighted by blue dye resin. Image is c.3 mm across. (A94 Springburn Nursery School)

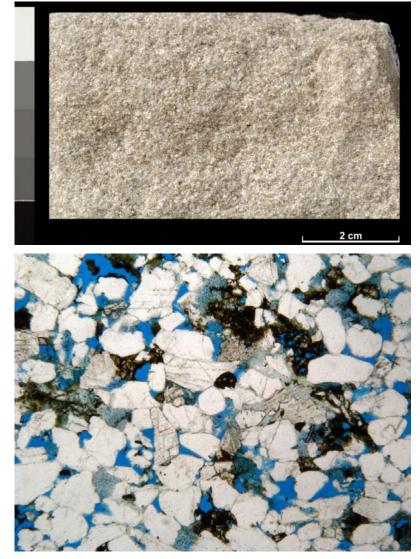
Figure 12a. Type 3 sandstone showing variable grainsize with relatively common opaque white clay minerals and some orange colouration from iron oxides and carbonate. (A103 Pollockshields Primary)

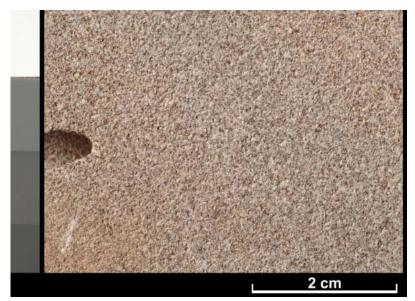
Figure 18a. Sample of Type R4 sandstone showing unusual greyish-lilac colour produced by common fine grained iron grains oxide throughout. The stone is a much stronger red colour when weathered. (B9 New Cathcart Church)
