# Multibeam trials on the Northern Lighthouse Board vessel, Polestar, 2011/2.

Internal Report OR/11/044

Nick Smart, Rhys Cooper

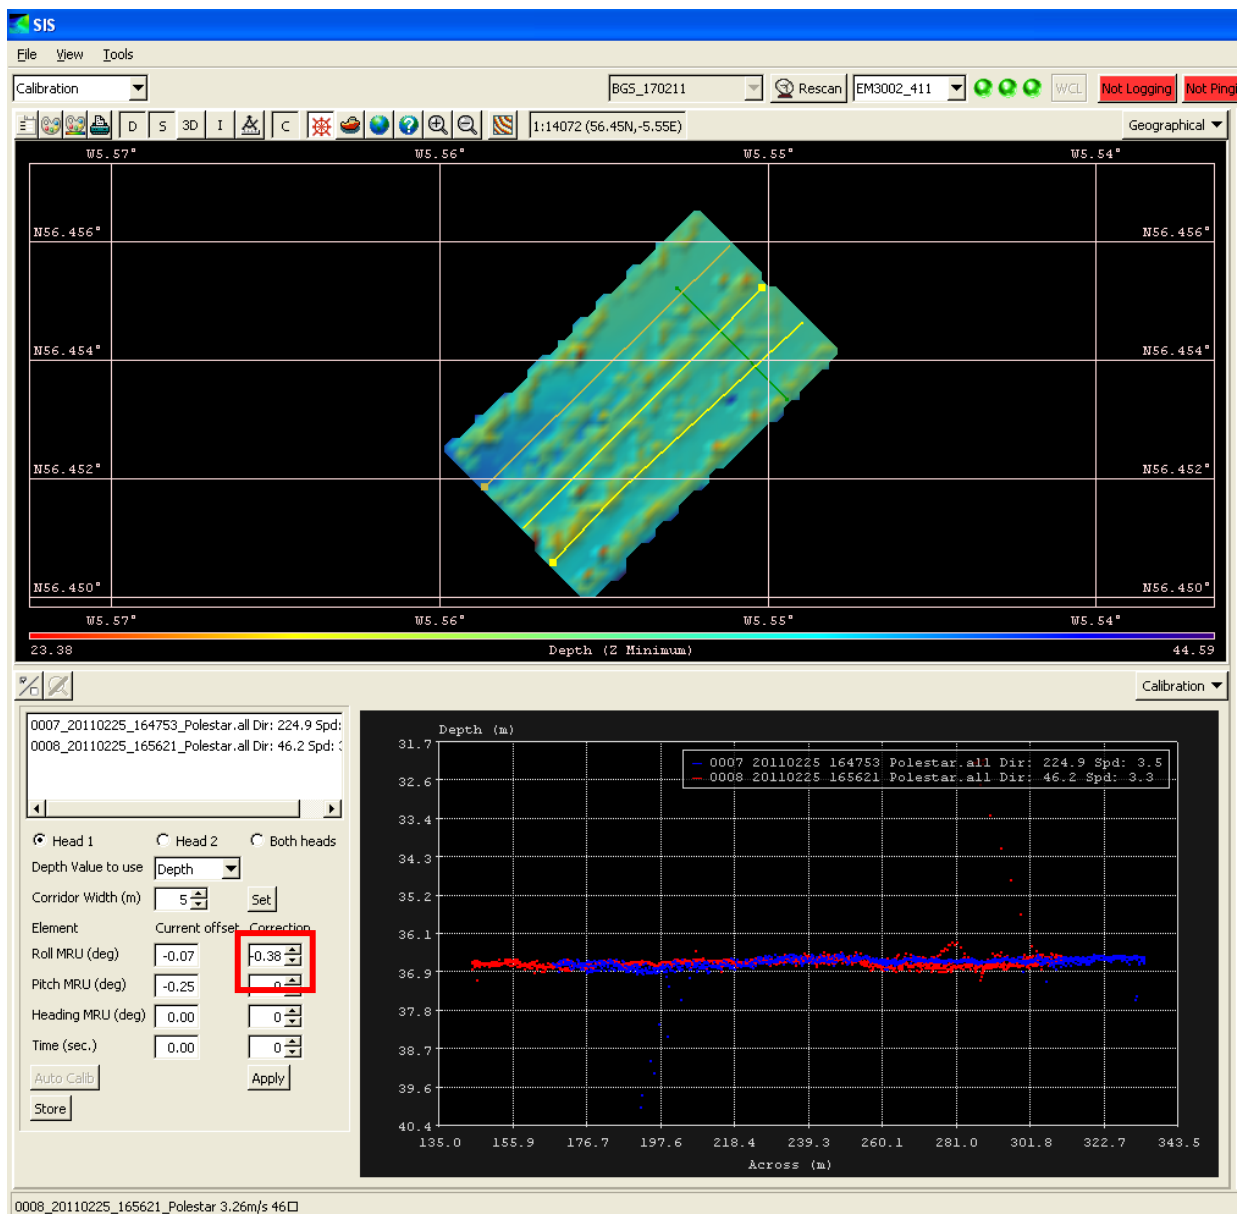
## Roll - Head 1

The results can be seen below. Roll was the only parameter that needed an offset corrected for.

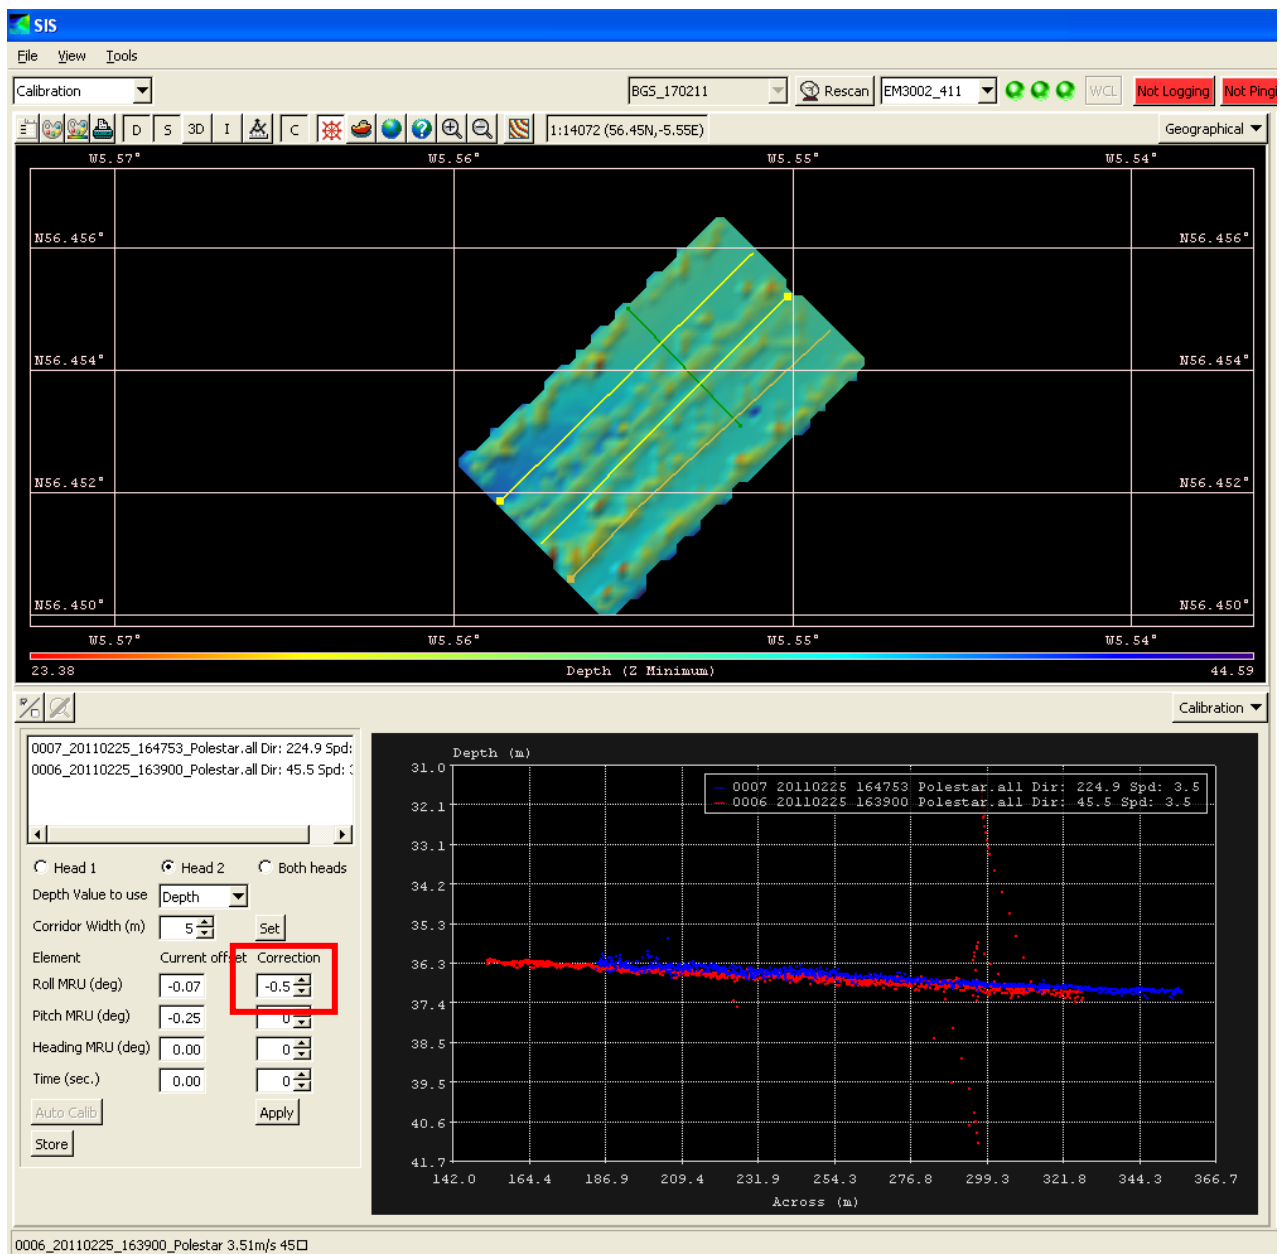
## Roll - Head 2

Head 2 installation = -38.515
