HYDROLOGICAL ANALYSIS  
OF THE TRURO FLOODS  
OF JANUARY AND OCTOBER 1988

M C Acreman

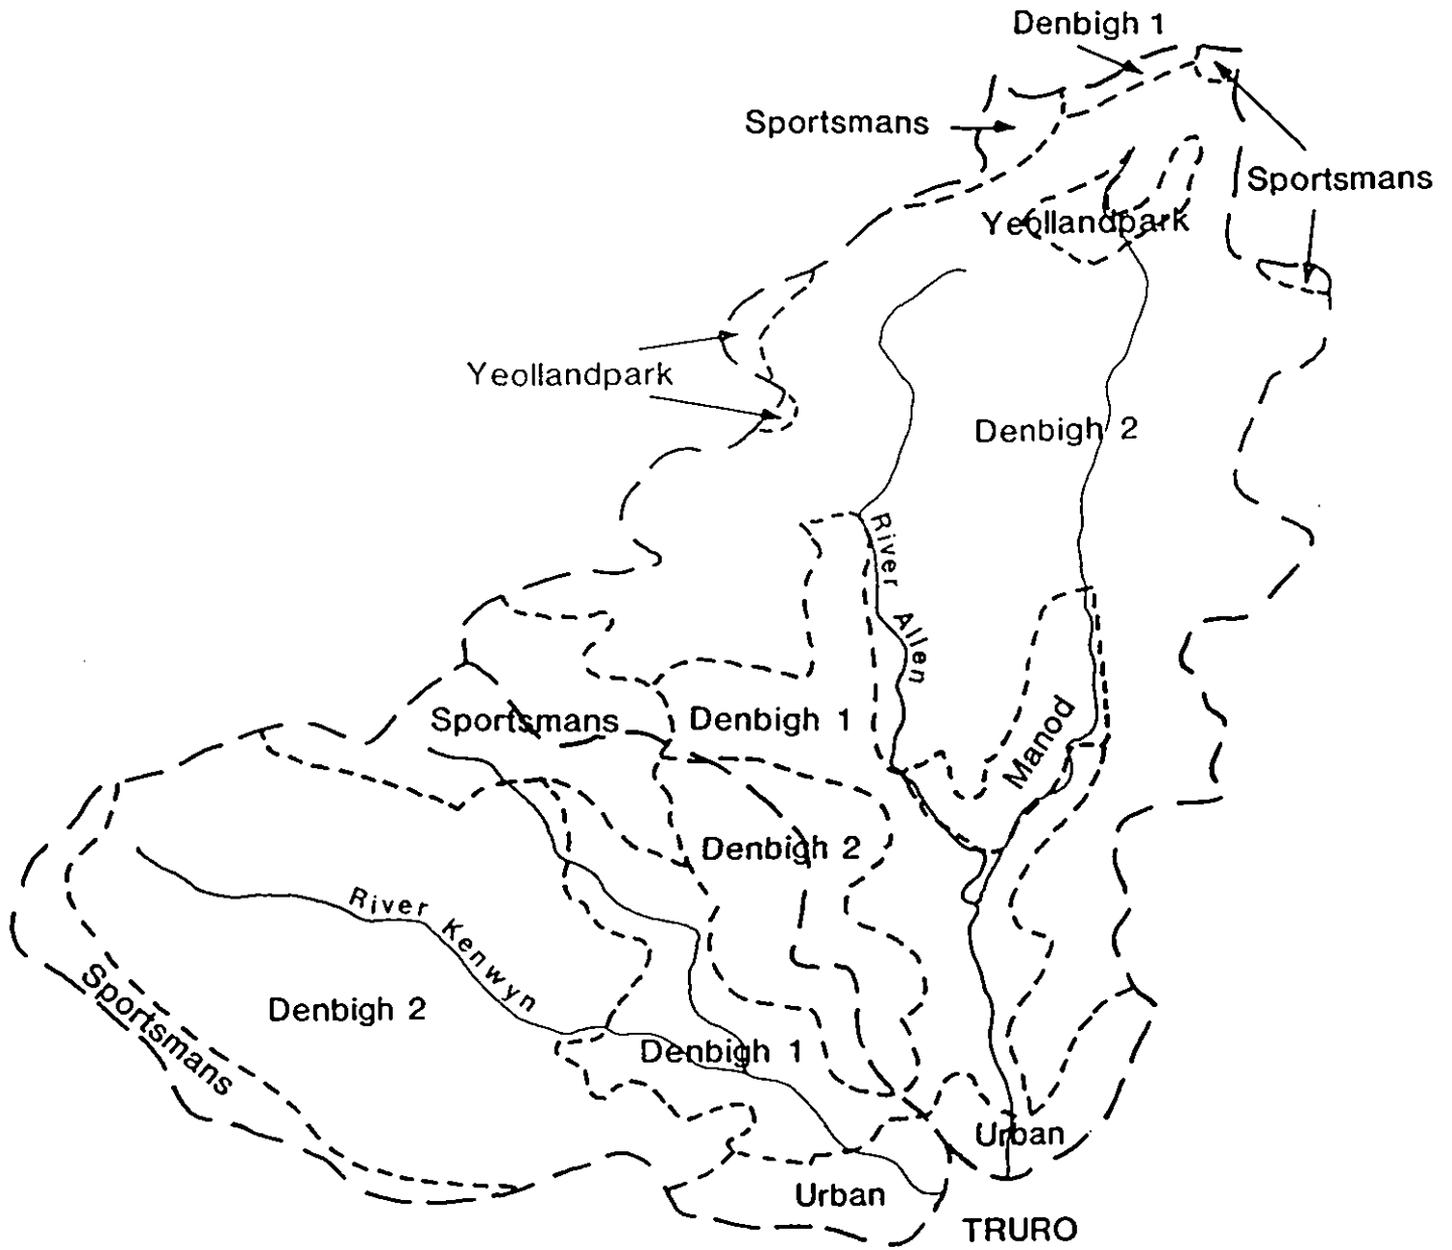
Figure 2.21 Classification of soils underlying Kenwyn and Allen Catchments

The Kenwyn and Allen catchments are underlain by rocks of Devonian age, predominantly slates and greywackes. The deposits were laid in an east-west geosynclinal trough and are known as the Gramseatho beds. Figure 2.2 shows that soils are predominantly typical brown earths of the Denbigh association (mostly Denbigh 1) consisting of brown, slightly stony clay loam (Findlay *et al*, 1984). These soils are permeable and naturally well drained and accept most winter rain. But temporary water storage capacity is limited by rock or, locally, compact drift at less than 80 cm depth which causes some runoff. Small amounts of cambic stagnogley soils of the Sportsmans association occur along parts of the watershed. These soils are moderately stony, gleyed and seasonally waterlogged.

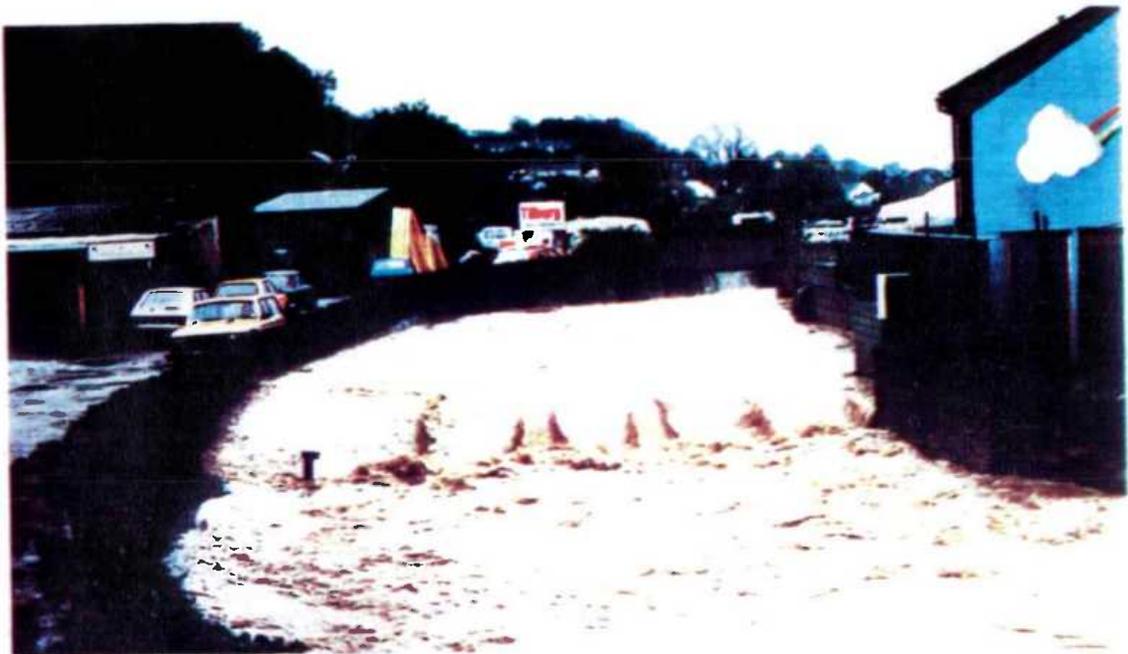
A photograph of the gauging station was taken just after the peak of the flood (Plate 4.1), showing that water levels are very high both upstream and downstream of the measuring structure. If the road culvert was producing a back-water effect and causing drowning of the weir, the estimated peak flow should be decreased. Herschy *et al*, (1977) provides a diagram from which the drowned flow characteristics of Crump weirs can be calculated given the ratio of the upstream and downstream heads. Very approximate estimates of the heads were evaluated separately for each of the three weirs by comparing the photograph with the engineering drawings of the structure. The highest ratio estimated was for the central weir at just less than 0.8. The diagram shows that even at this ratio, the reduction factor is only around 0.97. For the two side weirs the ratio is smaller. Thus there is little evidence that the peak flow should be significantly reduced. The photograph also shows that some water is by-passing the structure since the level is slightly above the wing walls. It is likely that this unmeasured quantity may compensate for any over-estimate in flow due to drowning. Consequently, given the uncertainties in the calculation, unless a full hydraulic study of the flow conditions at the peak of the flood is undertaken, the estimate should not be altered.

*Plate 4.1 River Kenwyn gauging station taken at just after the peak of the flood on 11th October 1988*

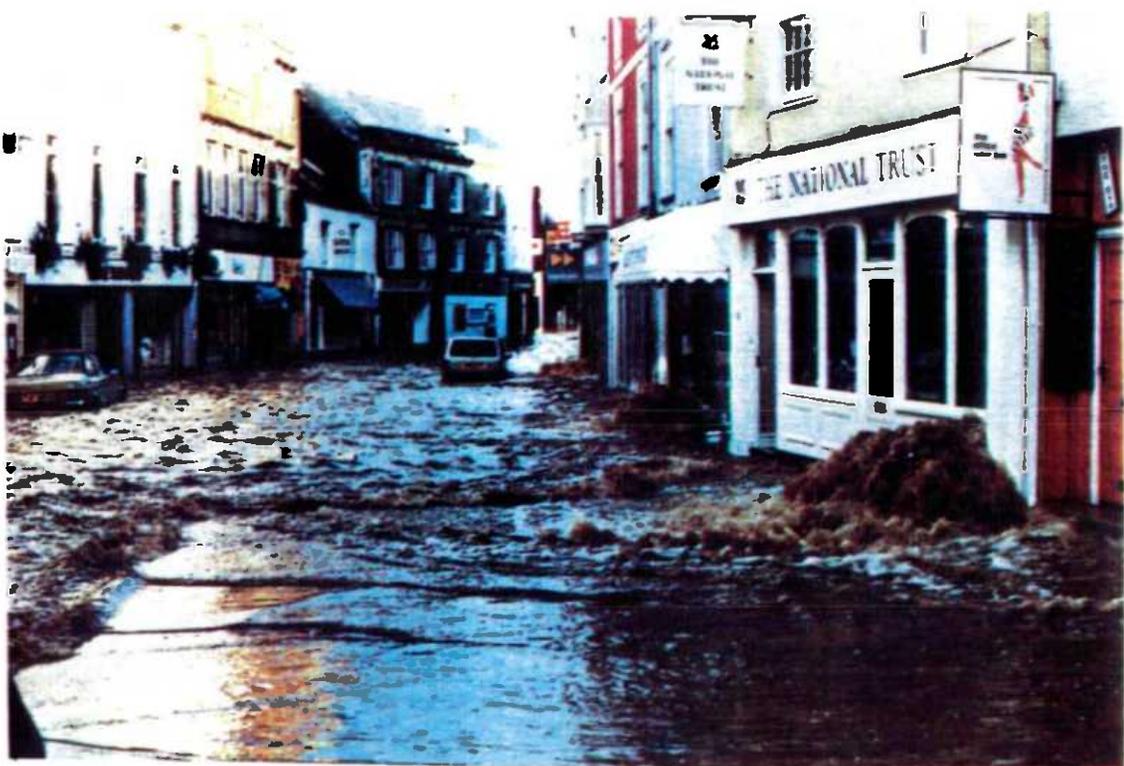
The leat sluices had been raised on the evening of the 10th after a flood warning was issued. The high river flows led to a further failure of the retaining wall behind St Georges Road, immediately downstream of section recently re-built after the January flood, and one basement property was flooded. However, other flooding in the St Georges Road area appears to be have been primarily the result of surcharging drains. As in the January event, flooding in the city centre occurred once the capacity of the culvert had been exceeded. Plate 4.2 shows the culvert surcharging through access manholes. High tide was not until 18.00 hrs by which time the river levels had dropped.

*Plate 4.2 Flooding in Truro city centre due to river culvert surcharging through access manholes*
