# Bath's 'foundered strata' - a re-interpretation

Research Report OR/08/052

P.R.N. Hobbs and G.O. Jenkins

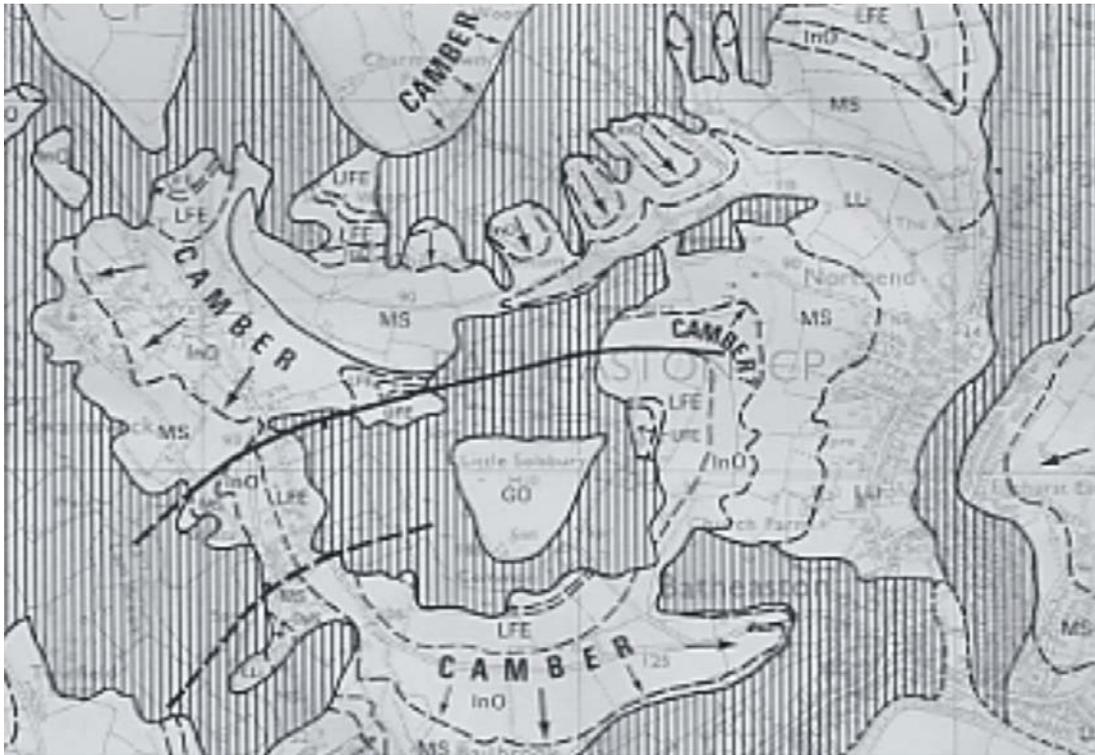
**Figure 2** Extract from R. Wyatt's map depicting landsliding and cambering (Forster et al., 1985)  
The map shows landslide deposits (vertical hachuring), cambering (arrows), and solid geology (dotted lines)

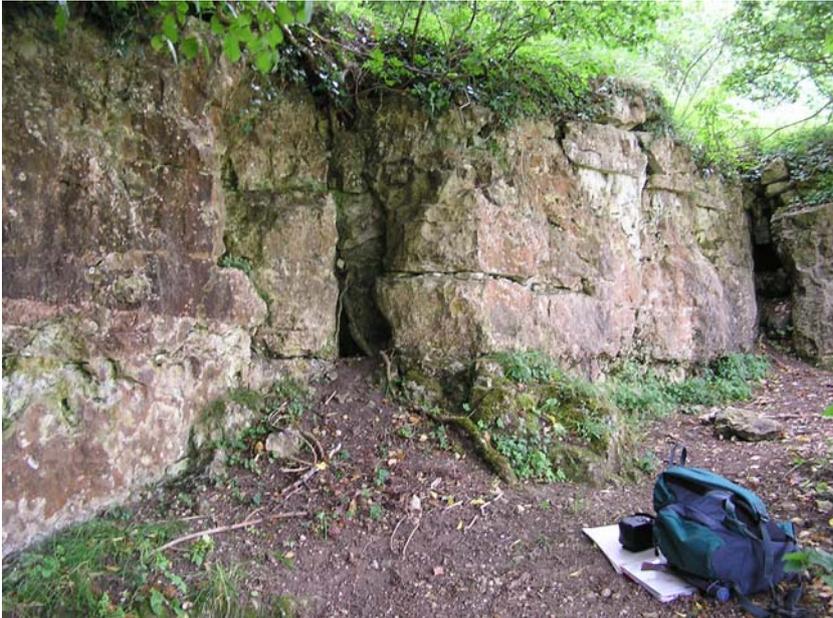
**Figure 4** Apparently uncambered Salperton Limestone Formation exposed below Soper's Wood [37480 16810].

This limestone represents the Inferior Oolite Group in the area. It consists of pale grey to brown rubbly, fine- to coarse-grained ooidal, peloidal and finely shell-detrital packstone to grainstone (Clypeus Grit Member), generally with very shelly and coarsely shell-detrital ooidal grainstone and packstone (Upper Trigonina Grit Member) at base ( [Cambering](#) tends to increase the downslope extent of the formation thus increasing its apparent thickness.

Figure 4). The formation is typically between 10 and 15 m in thickness and is generally well jointed (Chandler et al., 1976). The formation outcrops around Toghill, to the southwest and southeast of Fuddlebrook, and to the west of Tadwick, though there is little exposure in any of these locations. The presence or otherwise of cambering in the Salperton Limestone Formation is a major issue for mapping. Cambering tends to increase the downslope extent of the formation thus increasing its apparent thickness.

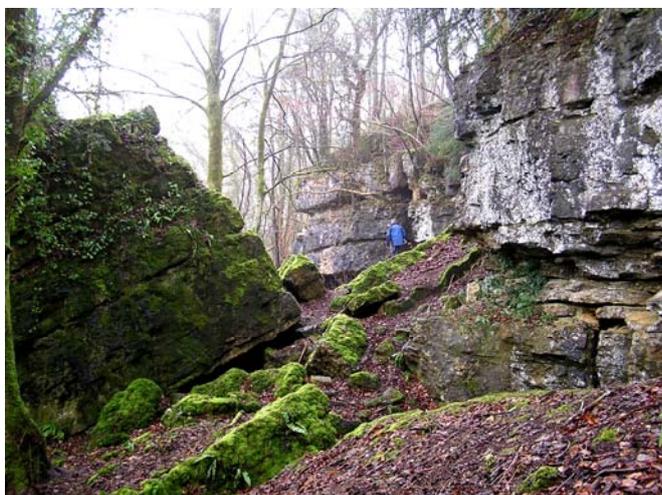
**Figure 8 Camber ‘hinge’ at Rowbarrow Wood, Monkton Farleigh**

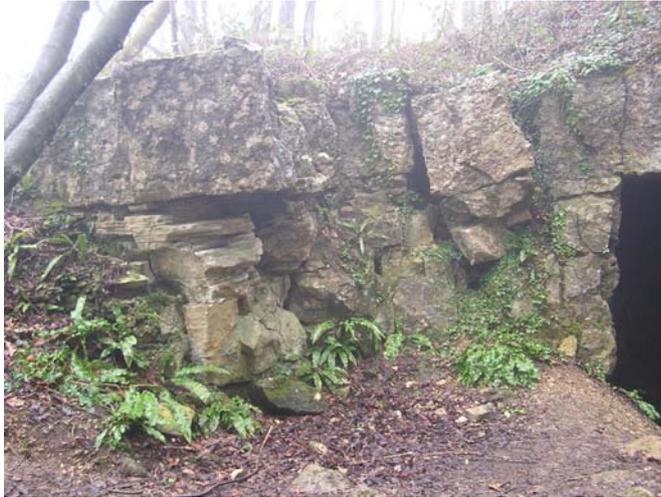
**Figure 9 Possible dip & fault profile – Rowbarrow Wood, Monkton Farleigh**

An alternative back-rotation profile is shown in [Figure 7](#). This occurs when individual cambered blocks are subject to rotational landsliding. Such processes were probably separated in time from the cambering itself, and being active have probably tended to degrade the original cambered profile. An example of the ‘hinge’ part of the cambering drape is shown in [Figure 8](#). A possible example of the ‘dip & fault’ process is shown in [Figure 9](#).

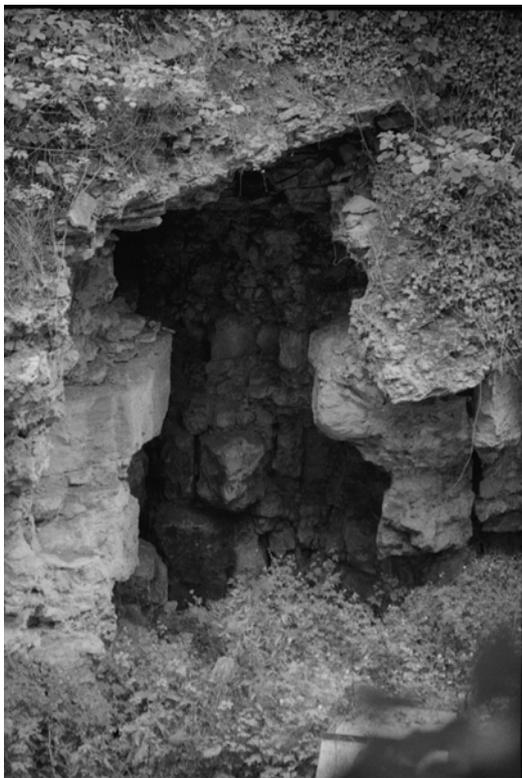
**Figure 10** Bridged gull cave, Great Oolite, Brassknocker Hill, Monkton Combe [ST779628] ([Hobbs, 1980](#)) Note: slope from right to left

An example of a bridged gull, visible in the south wall of a small (former) quarry, is shown in [Figure 10](#). This may form part of a gull cave system similar to that at Gully Woods, Monkton Farleigh (see section 0), although the slope at Brassknocker Hill has a characteristically cambered profile ([Hobbs, 1980](#)), unlike that at Gully Woods.

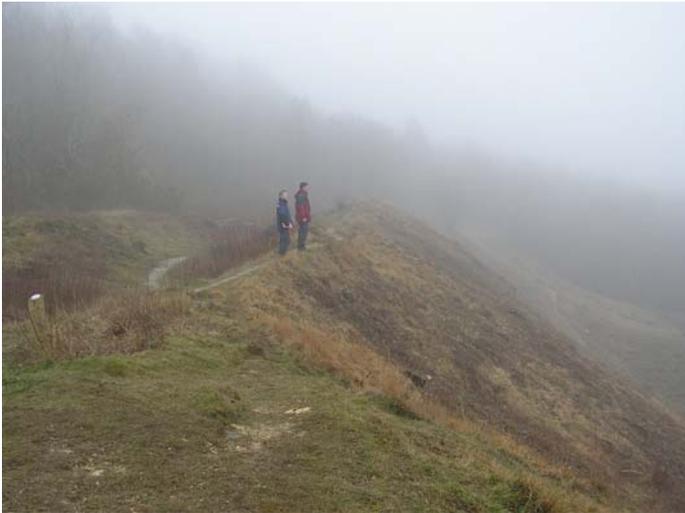
**Figure 11 Cambered block of Great Oolite, Bathford Hill - March 2004 [37940 16136]**

An example of a large cambered block of Great Oolite limestone is found in a clearing in the woods on Bathford Hill, on the east side of the Limpley-Stoke valley (Figure 11). Here the limestone has dips of  $20 - 30^\circ$  downslope (westward).

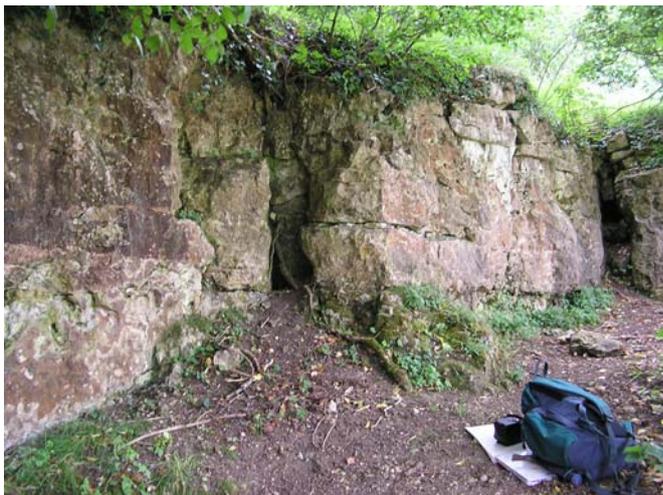
Figure 14 Apparently uncambered, though open-jointed, Salperton Limestone Formation (Inferior Oolite Group) below Soper's Wood [37480 16810].

In contrast to the Little Solsbury Hill area on the east side of the Swainswick Valley, described above, the limited outcrops of the Inferior Oolite suggest that cambering has not occurred universally; for example, on the west side of the Swainswick Valley below Soper's Wood (Figure 14).

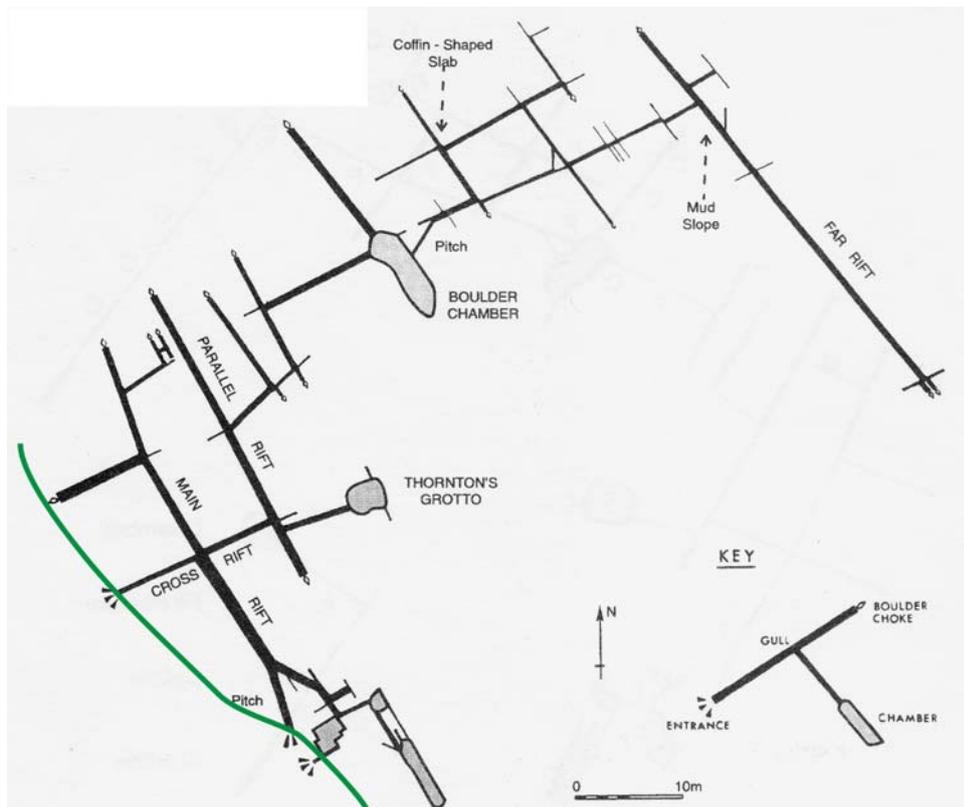
**Figure 21** Map of gull caves at Sally's Rift, Gully Woods, Bathford (Self, 1995)  
Green line = plateau edge

The cave system resulting from these processes (Figure 21) is distinctly angular in both plan and cross-section, and maps out as a trelliswork of open, en-echelon rifts parallel and perpendicular to the local valley crest (NW/SE and NE/SW, respectively). The rifts are 10 to 12 m high and 30 to 60 cm wide (Self, 1995). Apparently none of these features has any expression at ground surface. The contact between the Great Oolite limestone and the Fuller's Earth clay in the cave floor is highly irregular and poorly defined, due at least in part to a build-up of debris. Self (1985) reported that an analysis of rift volumes and polar directions indicated that net movement had been to the west (i.e. valleywards) at some point in the process, rather than solely south-west as might be expected from the polar directions alone. The rifts decrease in width away from the valley, but are still negotiable (by a caver) at a distance of 60 m at which point the cave roof is approximately 25m below ground. Self (1985) has identified two phases of mass movement, based on cave geometry and deposits, with net lateral movement of 20%. These range in age from >350,000 years BP (possibly as much as 500,000 years BP) and 78,500 years BP. Self (1985) also describes a similar cave system (Henry's Hole) to the northeast of Box (Wilts.) which is outside the study area.

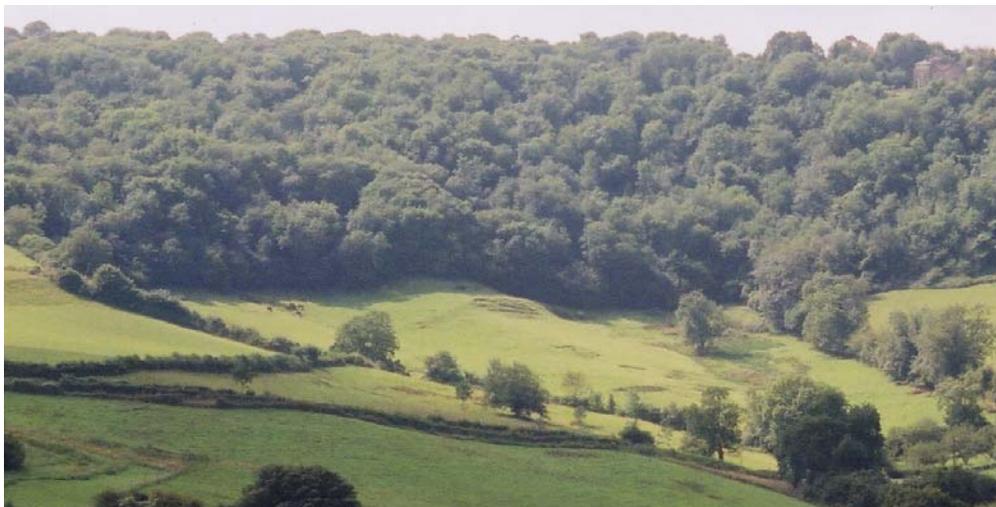
Figure 24 Debris flow emerging from Soper’s Wood, Swainswick Valley (west side)

*Debris flows* are found particularly in the tree-covered upper slopes. These usually derived from deep-seated rotational or translational landslides upslope (for example, Figure 24).

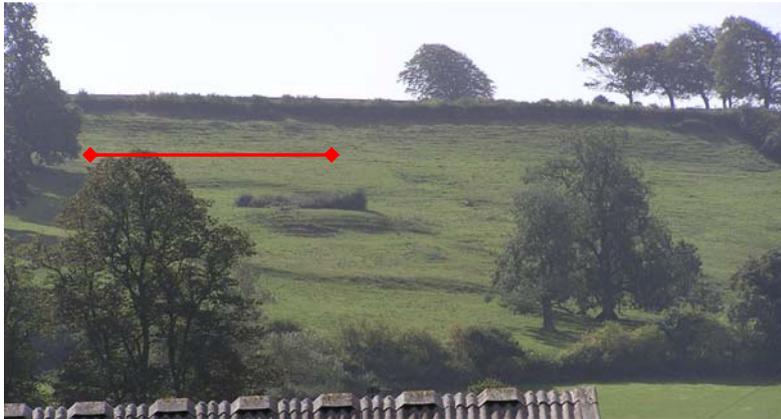
**Figure 27** Recent mudslides at Freezing Hill viewed from Toghill Farm (Sep 2005)

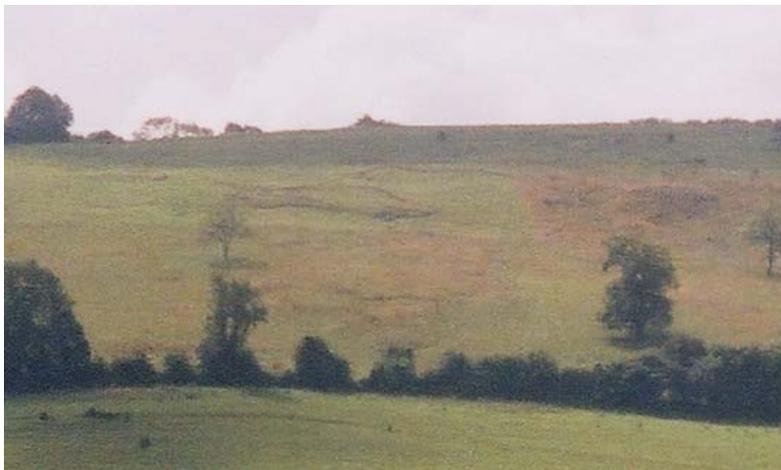
**Figure 28** Shallow landslides at Soper's Wood, Swainswick valley (west side)

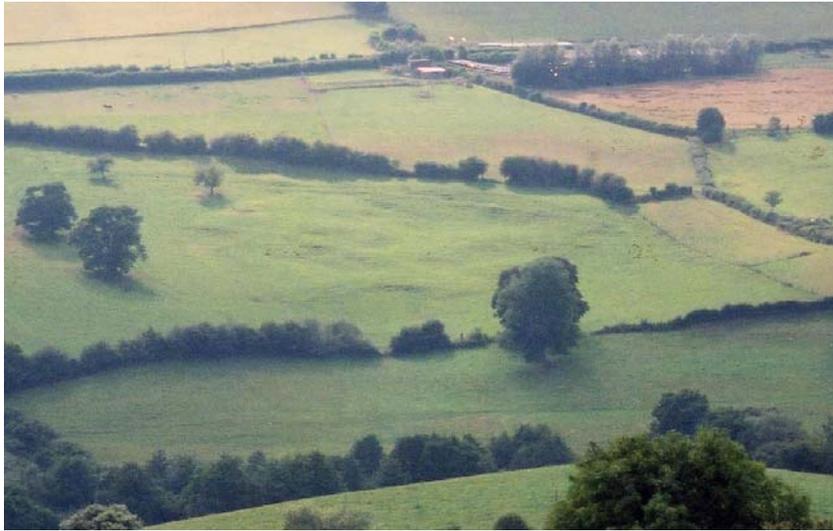
**Figure 33** Shallow landslides on the lower slopes at Twinfield Farm, Swainswick Valley (west side)

With the exception of a small number of other deep-seated landslides (refer to [Appendix 1](#)) the lower slopes are either unslipped or are covered by shallow landslides (for example, [Figure 33](#)), some of which have developed from landslides initiated in the upper slopes (see [section 3.3.1](#)).

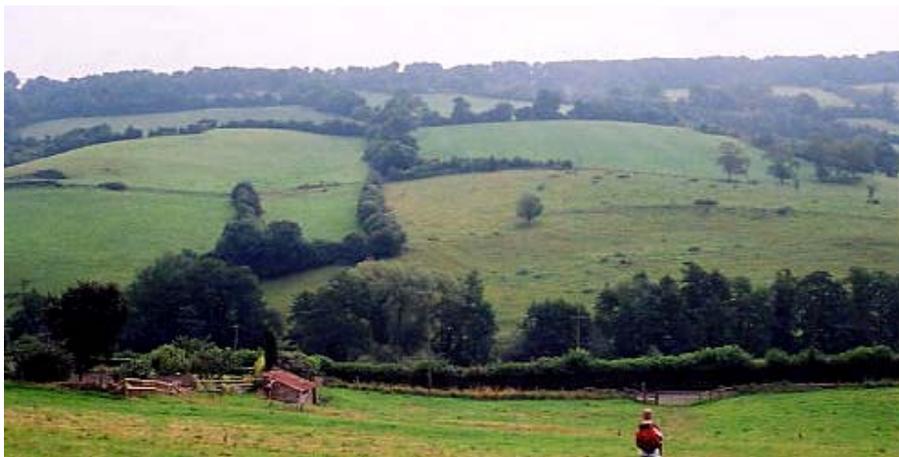
**Figure 35** View eastward toward Bannerdown from Upper Northend Farm, Aug 2002 [37817 16907]  
 Note: Northern edge of Luccombe Farm landslide (right)

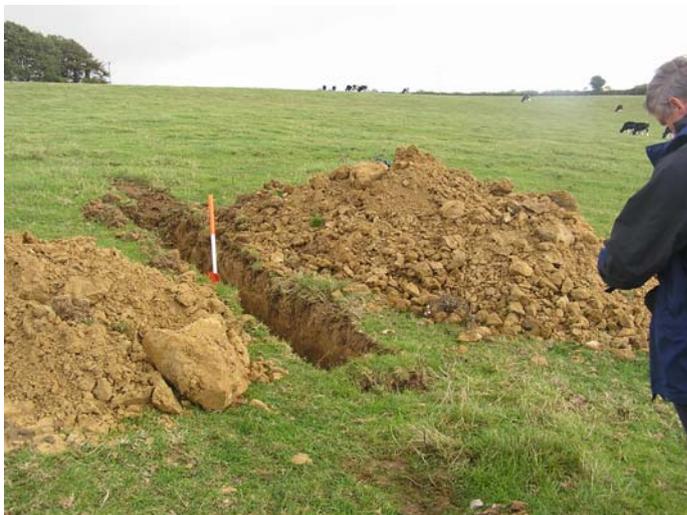
Figure 41 Trial pit TP3, Toghill Farm

[Figure 40](#). Trial pits (TP1 to TP4) were excavated to a maximum depth of 2 m using a hydraulic backhoe ([Figure 41](#)) the results of which are summarised in [Table 8](#). In addition, ultra-lightweight penetrometer tests were carried out at the trial pit locations, the results of which are shown in [Figure 42](#).
