National Oceanography Centre
Research & Consultancy Report No. 06

NOC turbulence glider deployment report
for the OSMOSIS Project

C Balfour, P Knight & D McLaughlin

2011

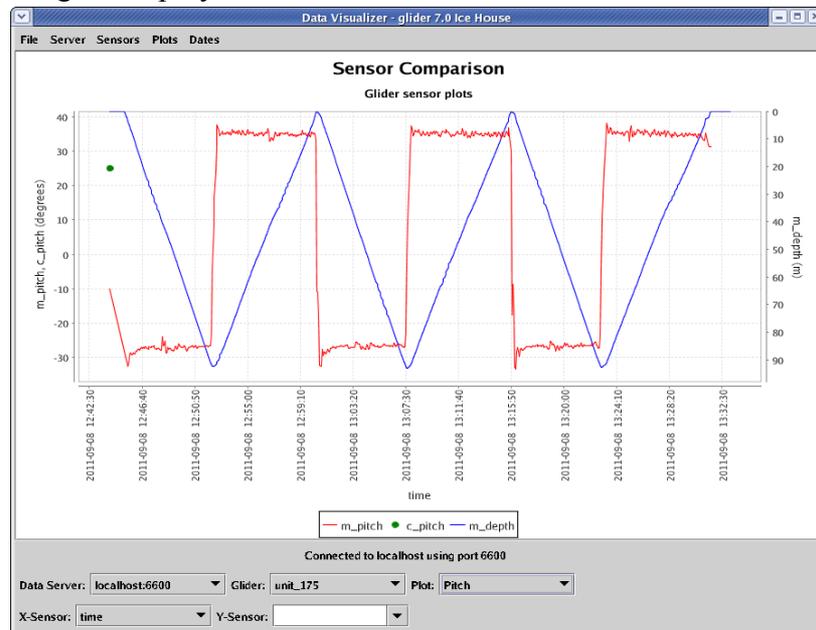
Fig. 5. Data Visualizer Plots of the Glider Dive and Climb profiles

The MR_Serv1 Mission using fixed pitch battery positions produced a 26° dive angle and a 35° climb angle as required

- The results from the 'mr_test' mission were then used to decide what pitch battery positions should be used for the local deployment site conditions to dive at 26 degrees (ideal) and climb at 35 degrees (steeper to improve the microstructure measurements). A fixed pitch motor position of +0.25 inch was used for dives and -0.1 inch was used for climbs based upon the results from the 'mr_test' mission described in 2 above. Fixed pitch motor positions are used to limit the noise (mechanical and electrical) generated by the glider that is likely to interfere with microstructure measurements. An 'mr_serv1' mission was then run to dive to 90 metres and then climb near the surface for a period of 45 minutes to evaluate the glider performance. This mission was completed successfully at 13:33 and the required dive angle of ~26 degrees and climb angle of ~35 degrees had been achieved, as shown in Fig. 5. Microstructure measurements and glider CTD data had been recorded successfully during climbs as required. During the mr_serv1 mission over the side CTD calibration data was generated by a Seabird Microcat, SN 4966 (with a strain gauge pressure sensor installed). Calibration casts to approximately 10 metres were also undertaken with a Castaway CTD during the glider deployment.

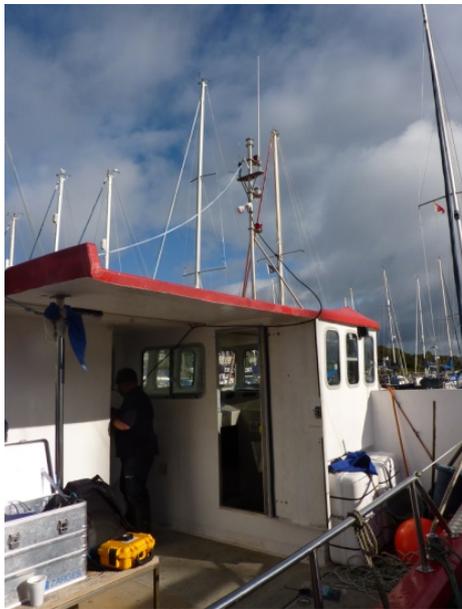
Dive Boat FreeWave Short Range Glider Communications Setup

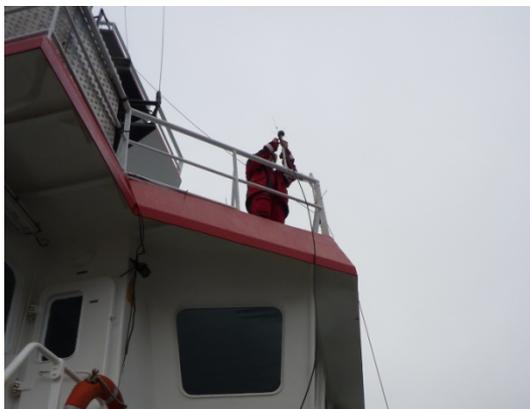
FreeWave Short Range Glider to Ship Antenna Installation on the Upper Deck of the RV Prince Madog at Tarbert Port

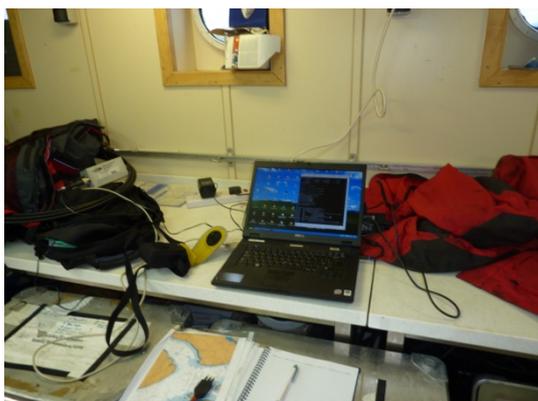
Arrangement for the Initial Testing of the Glider Using FreeWave

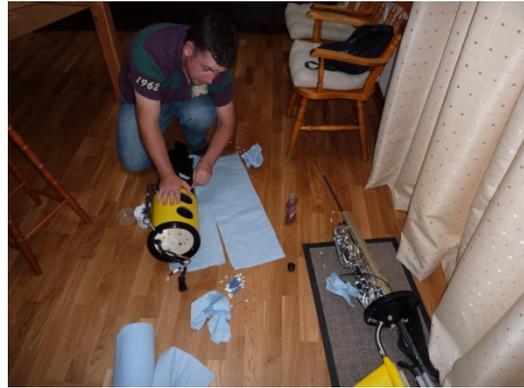
Removal of Seawater Ingress from the Glider

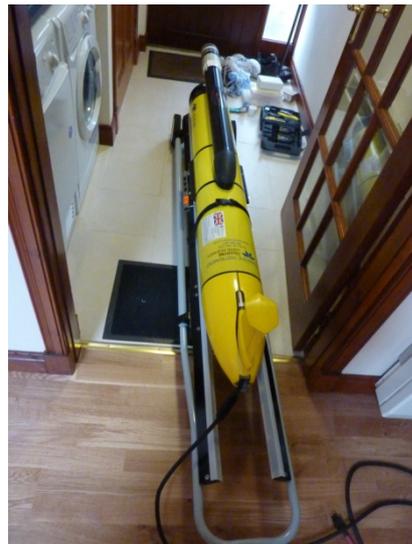
Testing of the Repaired Glider and micro-Rider by Running a Mission Simulation with the Glider Connected to an External Power Source
