Tracer test feasibility assessment: Frongoch Mine Tailings Lagoon

Open Report OR/12/035

This report was commissioned by the Environment Agency to provide information in support of the design of a remediation scheme for Frongoch Mine near Devil's Bridge, Ceredigion, Wales. The report assesses the feasibility of tracer testing at the site to provide an improved understanding of the hydrogeology of an area of mine tailings.

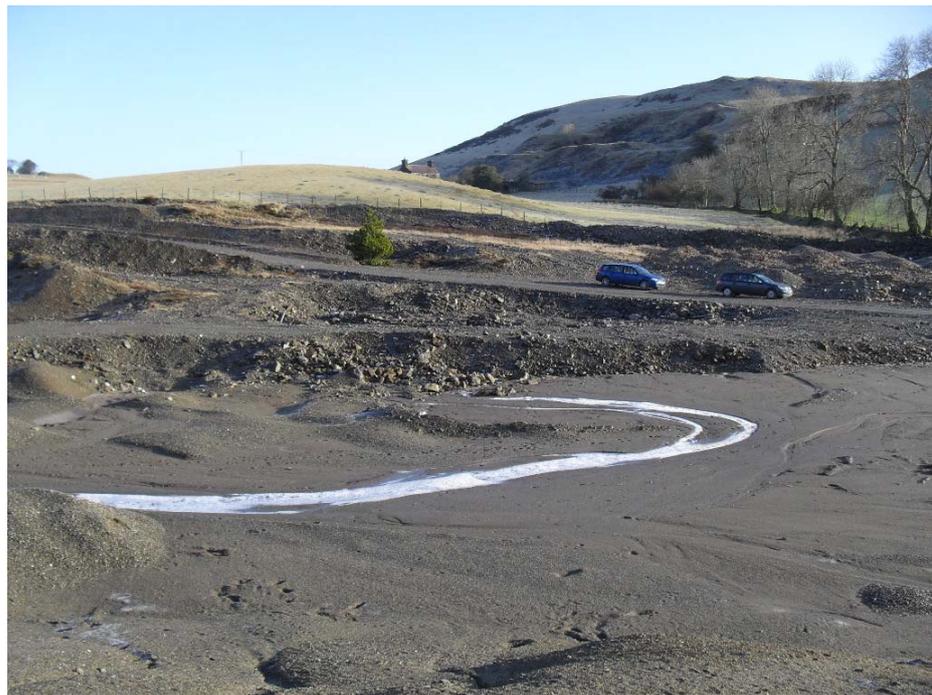
Front cover

Frozen stream sink on tailings area, Frongoch

The most obvious tracer injection point is the sinking stream on the tailings area (Figure 2.5 and Figure 2.6). On 6 February 2012 the surface stream had a flow of ~ 1–2 l/s and the water was sinking into three distinct points in the ground, approximately 50 m from the culvert and at a higher elevation than the culvert. However, the area around the stream sink appears to pond in wetter conditions and it would not be possible to carry out a tracer test if the water is ponded or the stream sink is frozen. It is possible that under different hydrological conditions there would be other distinct stream sink points that could be used as tracer injection points.

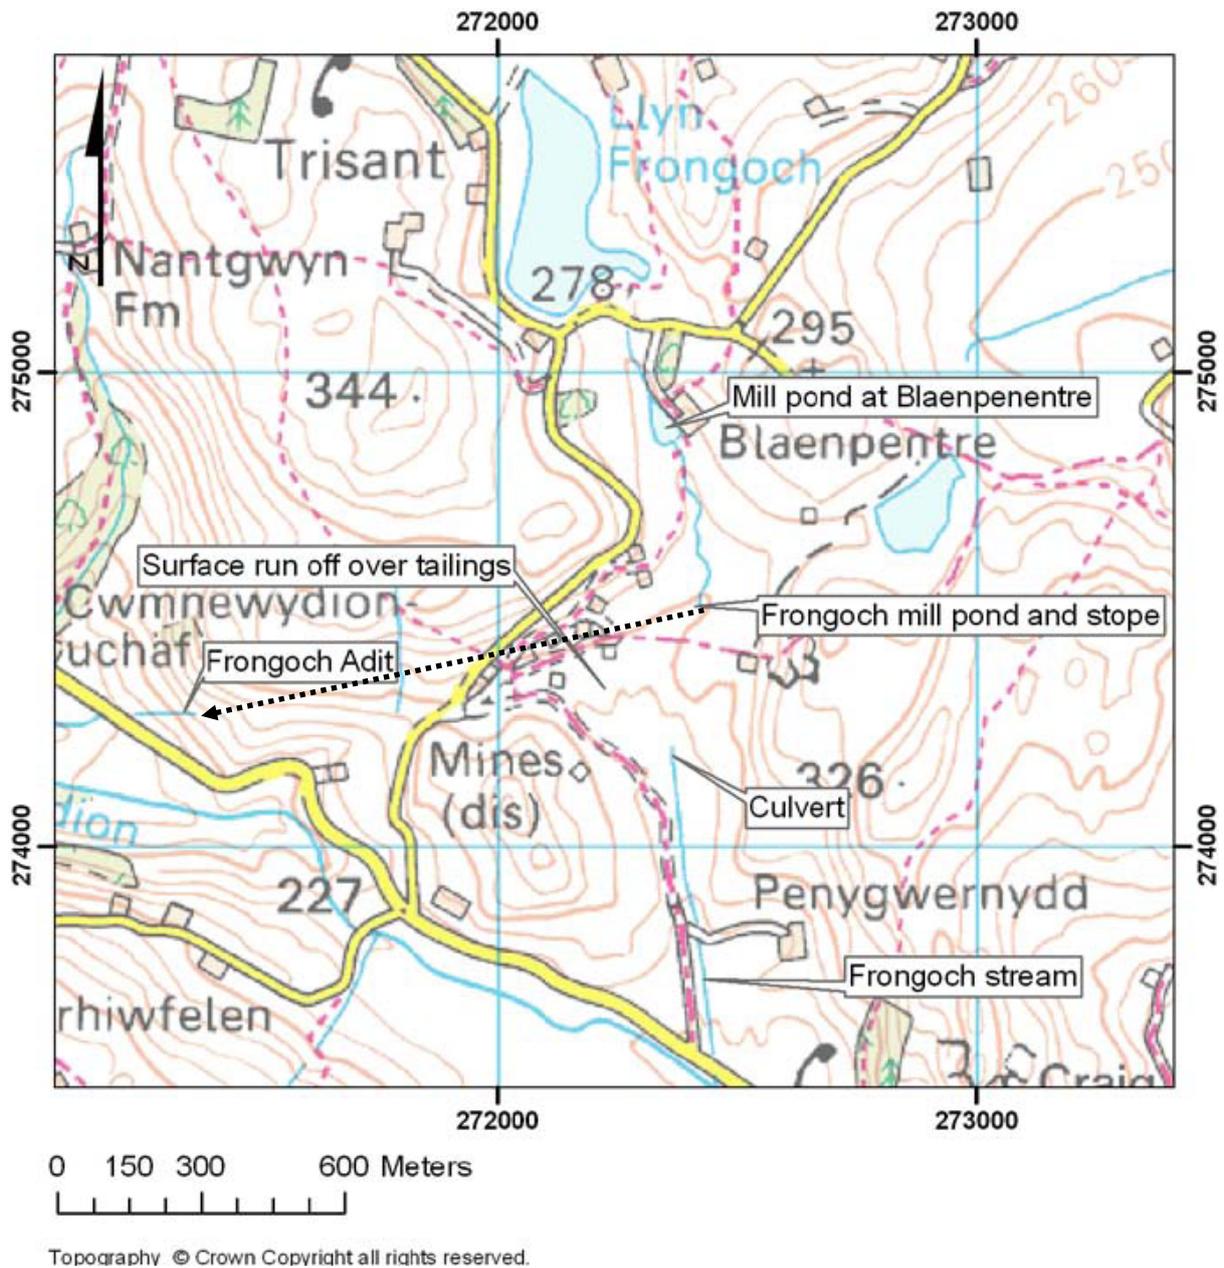
Figure 2.1 General topography and drainage in the vicinity of the Frongoch Mine site.

The arrow indicates the previous subsurface route of water from the Frongoch Stope to the Frongoch Adit which has subsequently been diverted southwards over the surface into the Frongoch Stream.

Surface water from Llyn Frongoch to the north of the Frongoch Mine site previously entered the Frongoch Stope to be discharged approximately 1.2 km to the west-south-west through the Frongoch Adit (Figure 2.1). A newly constructed lagoon prevents the surface water entering the Frongoch Stope, and the surface water is now diverted along the eastern perimeter of the Frongoch Mine site, emerging from a culvert to become the southwards flowing Frongoch Stream (Figure 2.2). Upstream of the Frongoch Mine site the surface water is unpolluted but as it passes the area of mine tailings the Frongoch Stream becomes contaminated with metals, in particular Fe, Al, Ni, Zn, Pb, Cd (Bearcock et al., 2010). It is understood that the main source of contamination is a small culvert that drains the area of mine tailings and enters the Frongoch Stream at point A on Figure 2.2. There is a gauging station on the Frongoch Stream downstream of the Frongoch Mine (point B on Figure 2.2), which EA staff reported had a flow of approximately 50 l/s at the time of the field visit. The flow in the culvert (point A on Figure 2.2, for picture see Figure 2.3) was not measured, but was estimated at ~ 3 l/s. The Frongoch stream flows along the eastern side of a road that also has a drainage channel running along its west side. At the time of the site visit a very small flow emerged into the base of this drainage channel at point C on Figure 2.2 and flowed slowly (less than 0.2 l/s) for a few metres before seeping back through the base of the drainage channel. The drainage channel was then dry until a second small spring that emerged over several metres and formed a channel of approximately 1–2 l/s that is culverted under the road at point D on Figure 2.2 and enters the Frongoch Stream.
