# Instability mechanisms affecting cultural heritage sites in the Maltese Archipelago

**Abstract.** The superimposition of geological formations with marked contrast in geotechnical properties presents one of the most critical environments for slope instability due to the different response of the materials to the applied disturbances. Moreover, the above-mentioned geological setting is often associated with high risk conditions, since many isolated rock slabs located at a higher altitude than the surrounding countryside have been sites of historical towns or buildings.

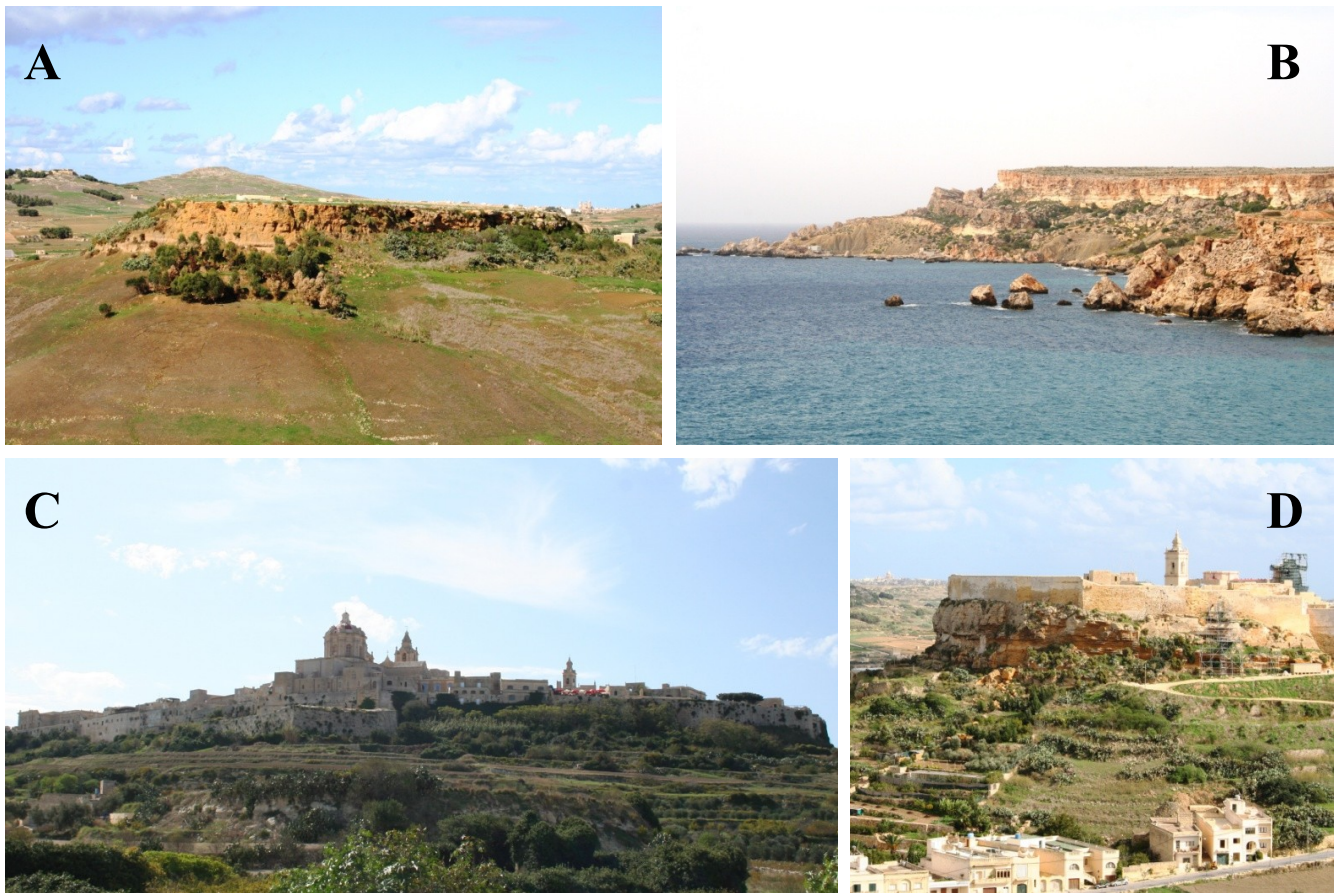
**Fig. 3.** Panoramic views of UCL slabs overlying BC exposed in Gozo (A) and Malta (B), and of the investigated sites of Mdina (C) and Citadel (D).

UCL hillcaps and plateaus overtopping BC gentle slopes are the dominant feature in the landscape of north-western Malta and north-eastern Gozo (Fig. 3a, b). Therefore, the geological and geomorphological features of the latter areas are deeply influenced by the geological characteristics and mutual interaction of the above-mentioned formations (Magri et al., 2008; Devoto et al., 2011), while GS, due to its limited thickness, can only affect the form of the land surface locally.

stability. Furthermore rainfall washes away the easily erodible BC causing the overtopping limestone caps to break away and collapse into blocks of various sizes (Fig. 3d) (Pedley et al., 2002).

Mdina, the former capital of Malta, is a fortified town located in the central – western sector of the Island on a rise constituted by the UCL (Fig. 3c). Thanks to its strategic position, over the past centuries the city has been influenced by many cultures. In 1693 it was extensively damaged by the Val di Noto (Sicily) earthquake (Galea, 2007), and most of the buildings and bastions were constructed afterwards (De Lucca, 1993). The city is built on a thin UCL plate (maximum thickness: 6 m) with a rhomboidal shape and a total surface area of about 55 000 m<sup>2</sup>.

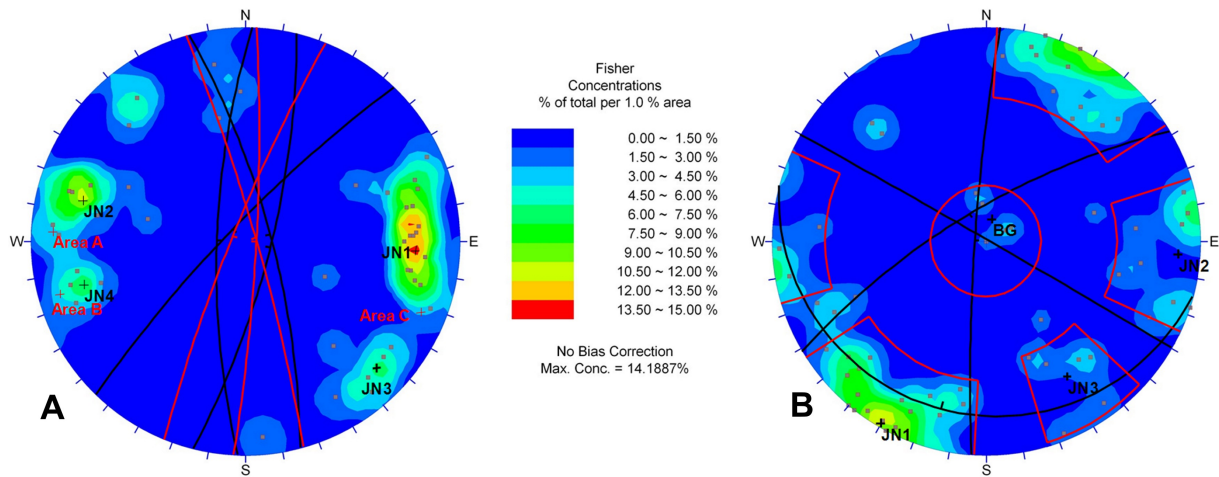
**Fig. 8.** Discontinuity poles, contour lines and modal planes of the main discontinuity sets collected at Mđina (A) and Citadel (B). The mean buried rock-slope orientation of the Mđina areas investigated is also reported (red major planes).

The Vilhena Palace area (Area A) shows the most complex fracture pattern, probably due to the thin and heavily fractured underlying rock mass, and the intrinsic structural problems linked to the different construction phases (Fig. 6). In the Cathedral area (Area B), a predominant translational displacement with an E-SE direction is associated with considerable vertical component. This behaviour is in accordance with the geological setting, as the Despuig bastion was constructed directly on the stratigraphic contact between the UCL and the BC (Fig. 6). The Curtain Magazine area (Area C) is characterized by an intense concentration of fractures, most of which show displacement vectors with a sub-horizontal direction and apertures of up to 20 cm (Fig. 11a). These displacements are compatible with the differential behaviour of the materials underlying the structure, and can be emphasized by the presence of a relevant ancient landslide, which is probably responsible for the local rock plate indentation (Fig. 6). All the instability processes within the investigated areas are also magnified by the presence of unfavourably orientated discontinuity sets with respect to the main instability mechanisms affecting the rock mass (Fig. 8A). The constant dip kinematic analysis (Fig. 14)

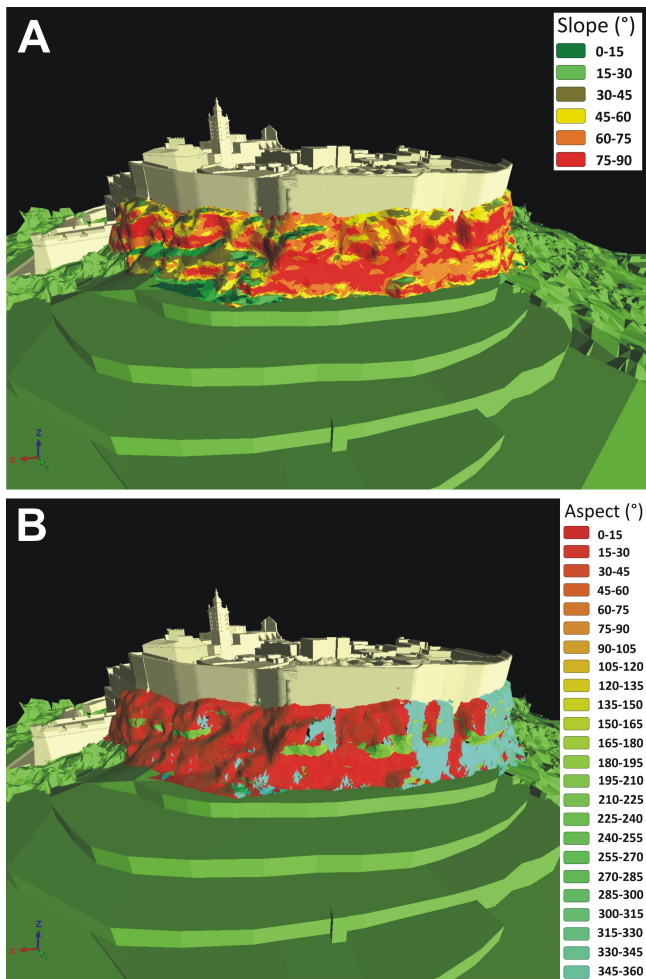
**Fig. 12.** 3-D maps of slope steepness (A) and aspect (B) of the Citadel rock mass.

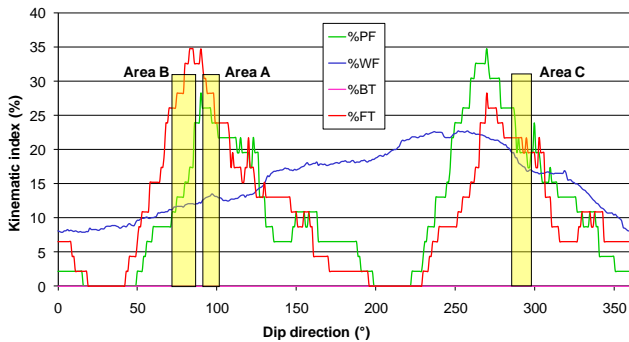
**Fig. 14.** Constant dip quantitative kinematic analysis for Mдина. Yellow rectangles indicate the dip direction range for each investigated area. (PF: plane failure; WF: wedge failure; BT: block toppling; FT: flexural toppling).

The employed quantitative approach considers a fixed slope dip (80°); the kinematic hazard index for each instability mechanism is then calculated by varying the slope dip direction from 0° to 360°. Given a certain slope dip, it is therefore possible to identify the most unfavourable slope orientations for the main instability mechanisms.

confirms that all the study areas are oriented unfavourably with respect to all the mechanisms analysed (with the exception of block toppling), with high kinematic hazard indices (ranging from 12 % to 35 %).

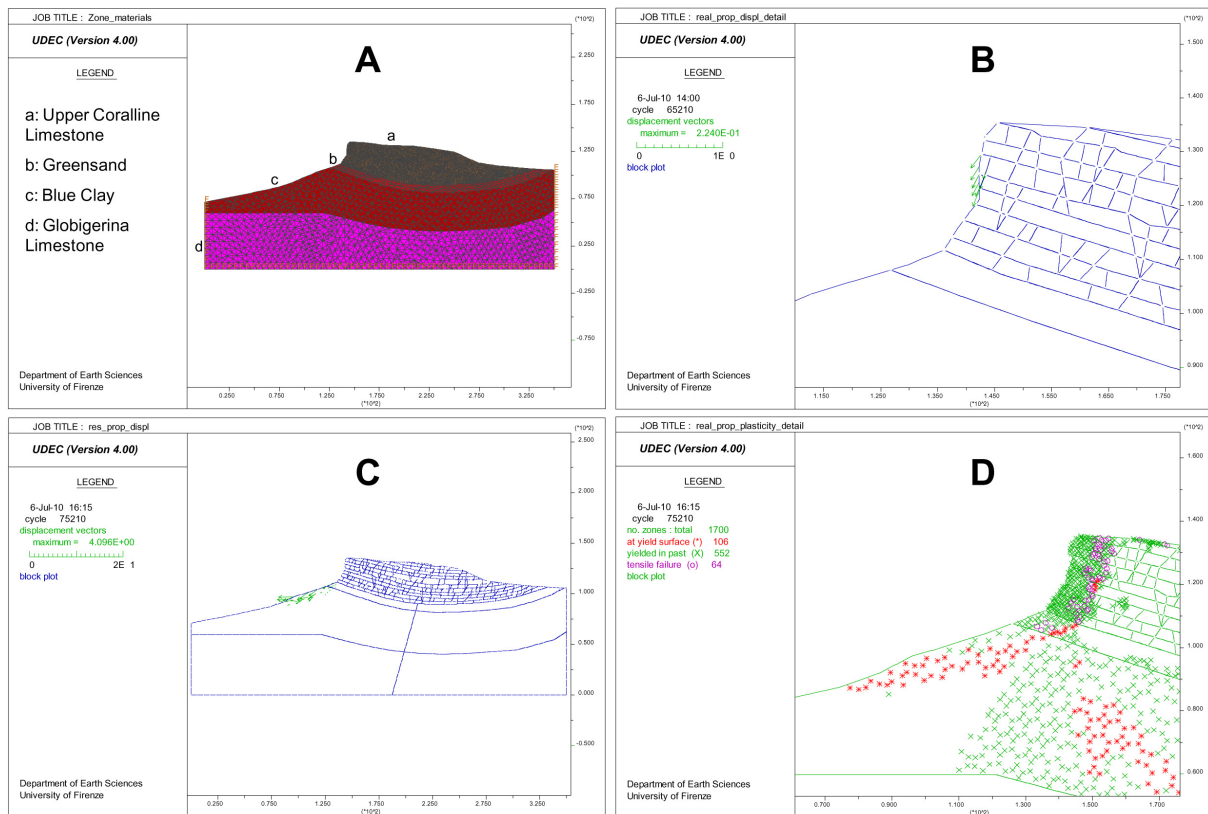
**Fig. 15.** Numerical modelling results. (A): Initial model; (B): Block displacements (third step); (C): Displacement vectors (fourth step); (D): Zone state (fourth step).

Fractures were generated within the UCL layer, according to the apparent orientation of the discontinuities surveyed (Fig. 15a). Each block was subdivided into a mesh of finite-difference elements, and each element was assigned a Mohr Coulomb constitutive model.

For the last stage (fourth step), falling blocks were removed, to restore the model to a stable state, and residual strength properties were assigned to the shallow part of the BC region, in order to simulate the eventual processes of decay of these materials, favoured by the poor conditions of the Citadel retaining terrace walls. Due to this modification, a shallow landslide is triggered in the numerical model (Fig. 15c), and mixed shear-traction sub-vertical fractures are induced throughout the whole upper rock plate by the resulting undermining action (Fig. 15d).

The numerical modeling, besides confirming these superficial instability mechanisms, also displays the possibility of a deeper involvement of the rock mass, in case of shallow landslide or undercutting within the underlying clayey unit (Fig. 15d). Such phenomena are clearly visible on the boundary of the UCL rock plate at Gelmus Hill, near Citadel (Fig. 17), where the clay slopes are not terraced, and shallow landslides can take place. The distance from the cliff face of the observed fractures seems however slightly lower than that of the numerical modelling, probably due to a low spatial resolution of the model caused by a coarse meshing. These kind of processes, however, do not seem to be presently affecting the Citadel rock plate, where the instability phenomena are mainly constituted by rockfalls along pre-existing structural discontinuities; the latter are enhanced by the intense weathering conditions of the rock walls. Probably this is due to the concave setting of the hill (Fig. 7), caused by the solution collapse structure, which prevents the concentration of high stress at the base of the cliff, thus limiting plastic deformations.

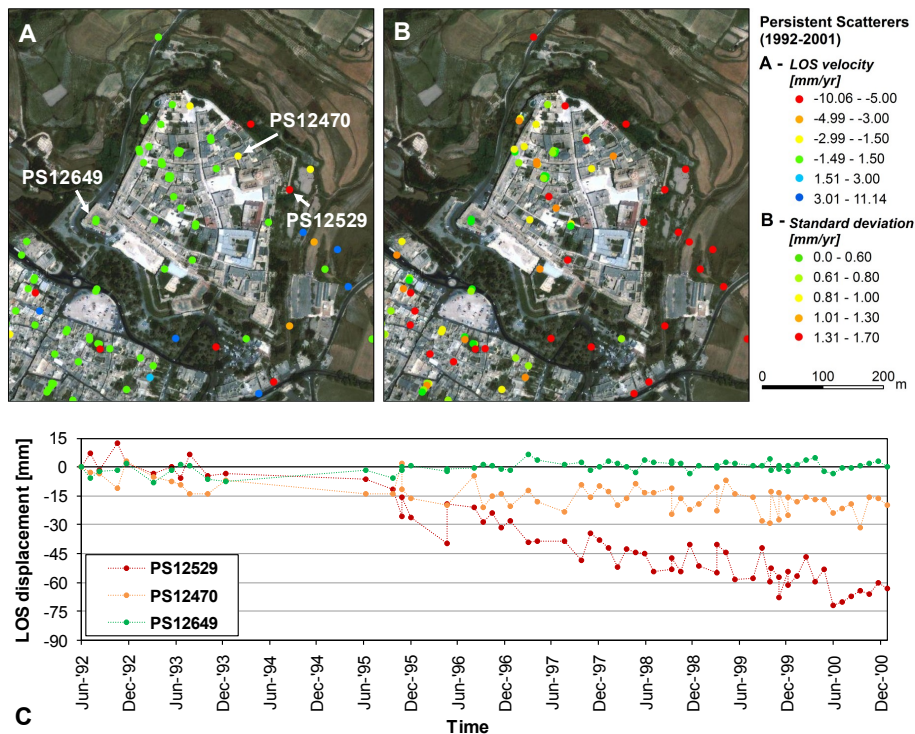
**Fig. 16.** (A): LOS displacement velocities measured between 1992–2001 for the ERS1/2 Persistent Scatterers identified in the area of Mdina. Negative velocities indicate movements away from the sensors, while positive values indicate movements toward the sensor. (B) Standard deviations of LOS velocity of the identified PS. (C): Deformation time series of selected PS. For graphical purposes, the temporal reference for the time series was shifted from the master images (30 March 1998) to the first SAR acquisition (5 June 1992).
