**National Oceanography Centre**  
**Research & Consultancy Report No. 24**

RRS *Discovery* Cruise D381B OSMOSIS Project  
Turbulence glider operations report  
September 2012

C Balfour

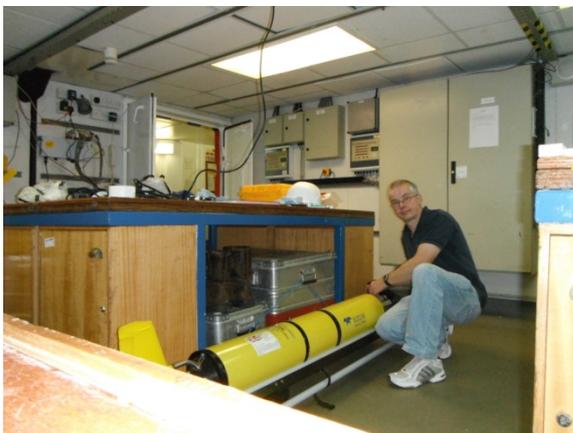
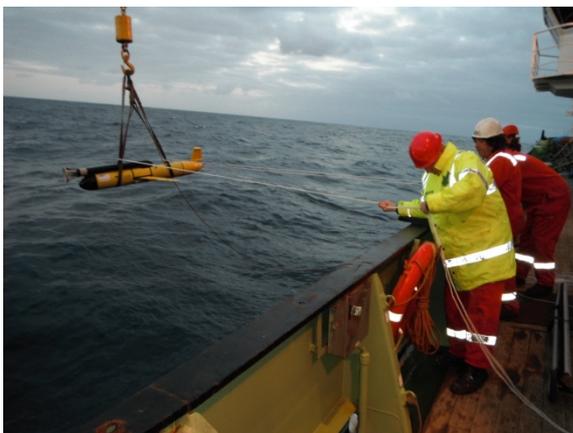
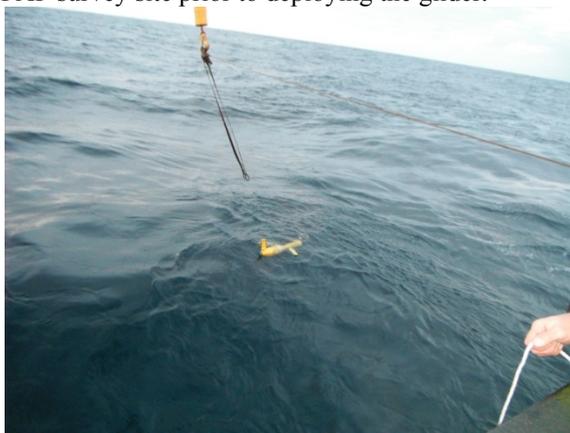
### Fig. 3. Turbulence Glider Preparation and Deployment

a Glider preparation in the wet lab of RRS *Discovery*

b A portable tank was used to test the turbulence glider ballasting with near surface seawater from the PAP survey site prior to deploying the glider.

c Lowering of the glider towards the sea surface

d Glider deployment. The sea surface swell is evident in this picture

A safety pin and pull line was installed to prevent a premature release of the hook from occurring. This safety pin was removed from the release hook once the crane had positioned the glider over the side of the ship. As the glider was lowered to the sea surface the stay lines were then removed. The turbulence glider was deployed at a GPS location of 48° 46.731’N, 16° 22.816’W on Monday 17<sup>th</sup> September at 19:14 GMT at a water depth of approximately 4800 metres. The selected deployment location was approximately 14km to the west of the wave rider buoy at the northern part of the OSMOSIS moorings at the PAP survey site. A sequence of pictures that illustrate the glider deployment operations are shown in Fig. 3.

Once the glider was buoyant at the sea surface the release hook was then operated and the crane lifted the strops away from the glider to complete the deployment. A sea surface swell occurred during the glider operations that caused the deployed glider to move vertically on the sea surface relative to the ship. Before the crane lifting arm could be retracted the release hook impacted with the rear plastic cowling over the glider air bladder and below the tail section. No damage was evident to the cowling although this does illustrate the potential risk of using this type of deployment mechanism in anything other than a flat calm sea state. Two long fending off poles were on standby to prevent the glider from straying too close to the outer hull of RRS *Discovery* during the early phases of the deployment. When the glider was approximately 300m to 500m from the ship the pre deployment glider dive testing operations commenced. These tests were then undertaken using FreeWave wireless communications to the glider from an antenna mounted on the ship at an elevated position close to the CTD winch.

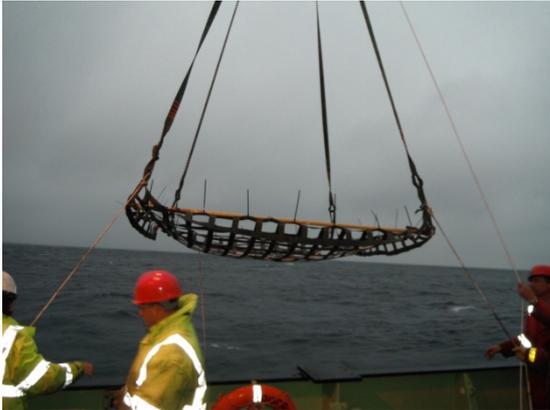
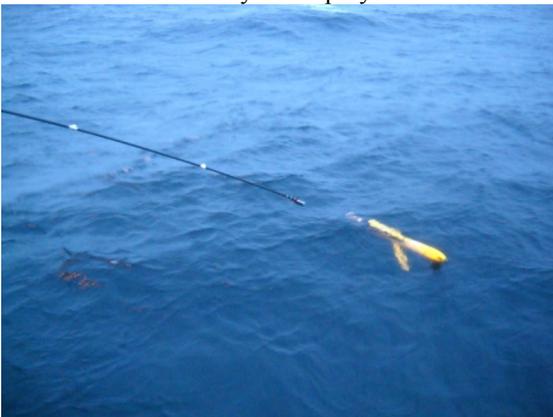
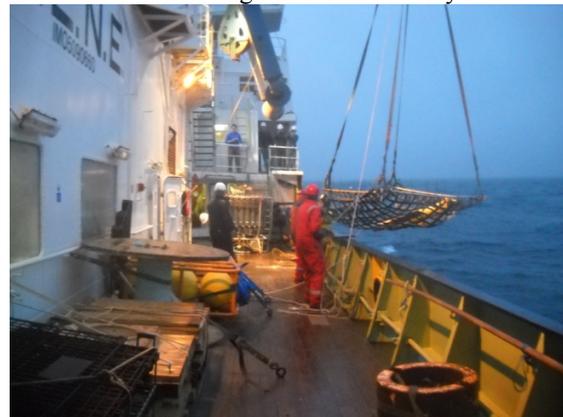
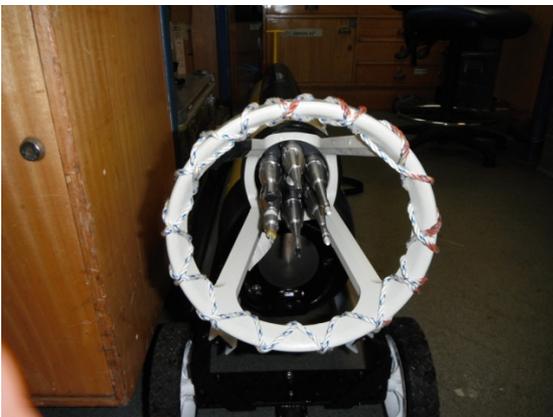
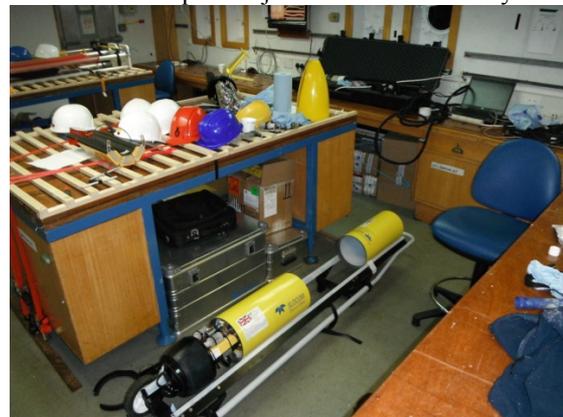
**Fig. 7. Turbulence Glider Recovery Operations**

attempt was made. A sequence of photographs of the turbulence glider recovery operations are shown in Fig. 7. During the first recovery attempt the glider snagged one of the stay lines and then overshot the recovery net. Further attempts to drag the glider back to the net resulted in the loss of the port wing. RRS *Discovery* was re-aligned with the glider and during the second attempt the glider was manipulated onto the recovery net. The sea swell made this operation very difficult and precarious. Long fending off poles were used to hold the glider in the net until the crane on the side of the ship could lift the glider clear of the water and back onto deck.

a Recovery net deployment

b Glider alignment for recovery

c Port wing lost after first recovery attempt

d Glider recovery. The sea swell and white cap can be seen in this picture just below the recovery net

e Turbulence probes clean and intact after the recovery

f Servicing of the recovered glider

The glider was successfully recovered at 18:46 GMT on Thursday 27<sup>th</sup> September at a GPS location of 48° 43.274'N, 16° 07.023'W. After the recovery the glider was washed down with fresh water, dried and returned to the wet lab. An initial inspection revealed that there was no significant damage to the glider hull or main components although both wings were lost or damaged during the recovery. The micro-Rider was de-mounted and initial tests showed that the correct volume of data had been recorded. Preliminary tests also showed that the glider was operational and the internal vacuum had been sustained. This indicated that no significant damage or seawater ingress had occurred during the recovery process. The glider was then subsequently disassembled and the hull seals were cleaned and re-greased. A copy of the flight and science data recorded by the glider was then made. Following this a preliminary assessment of the glider science data was, undertaken as summarised in appendix C. Initial checks showed that the micro-Rider had recorded 7.27GB of science data and that all of the microstructure probes had been working correctly throughout the 10 day deployment. A preliminary evaluation of the glider CTD data showed that a problem with the science computer had caused the loss of approximately 1.5 days of CTD data. While this was disappointing, more than 8 days of precision CTD measurements had been recorded by the glider. The general feedback from the turbulence data scientists is that the micro-Rider turbulence data can be adequately calibrated with the existing data set to compensate for the interruption in the main glider CTD recording. This loss of glider CTD data occurred between day 8 and day 9 of the 10 day glider deployment (am on Wednesday 26<sup>th</sup> September to around midday on Thursday 27<sup>th</sup> September).

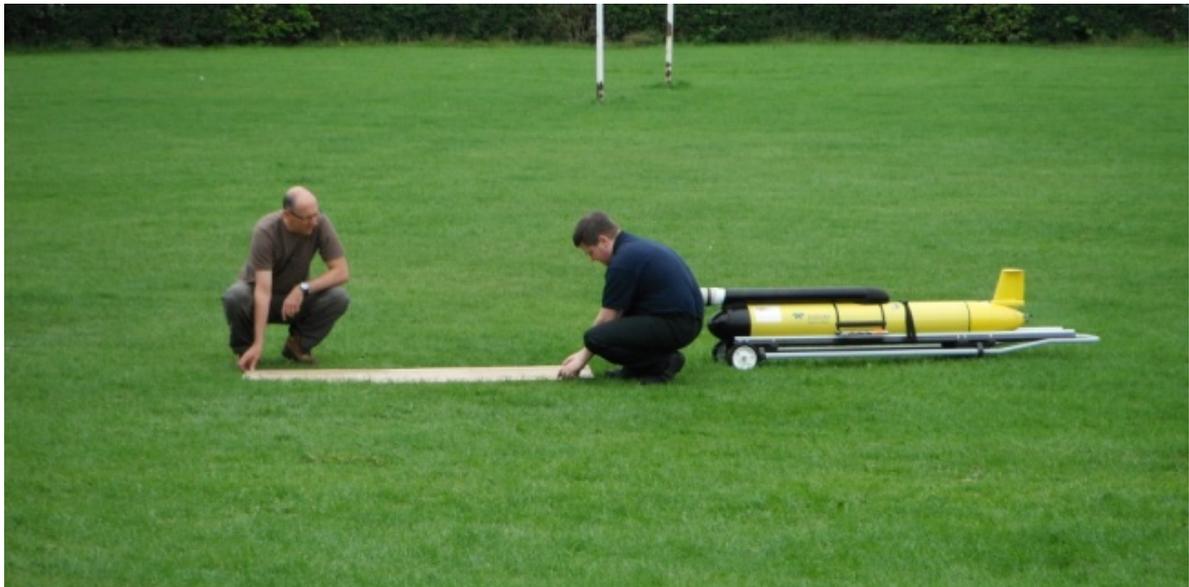
**Fig. A1. Turbulence Glider Electronic Compass Check for the OSMOSIS Deployment**

To configure the turbulence glider for the OSMOSIS deployment a set of lithium primary expendable batteries were installed. This was required to provide the capability of running the required glider science sensors at their maximum recording rates for extended periods of time of weeks in duration. Any disturbance in the glider configuration such as the installation of new batteries or sensor drift over time can compromise the operation of the glider internal electronic compass. To ensure the integrity of the compass measurements in the glider a compass calibration was undertaken before the OSMOSIS glider deployment. This involved taking the glider to an open space free of stray electrical or magnetic fields, calibrating the compass and then verifying the result of the calibration. During this process the glider is reoriented through a series of positions involving changes to pitch, heading and roll while the internal compass samples the external magnetic fields. Provided that a satisfactory spread of glider movements is achieved with the required time frame of typically 5 minutes the glider compass can then self calibrate. If successful the electronic compass module nulls the effect of any static fields that are introduced by such factors as changes in the internal glider components. The result of this is to improve the accuracy of the compass. To check the integrity of a compass calibration the measurements of the glider electronic compass are compared to measurements from a hand held magnetic compass. The glider is basically rotated horizontally through 360° in a series of iterations. At each of these iterations of normally 22.5° the glider heading measurement is compared to readings from a magnetic compass. Although this is a practical procedure and subject to experimental error the process provides a basic check that a glider compass calibration has been performed satisfactorily. A selection of images of the turbulence glider compass calibration process is shown in Figs A1 and A2.

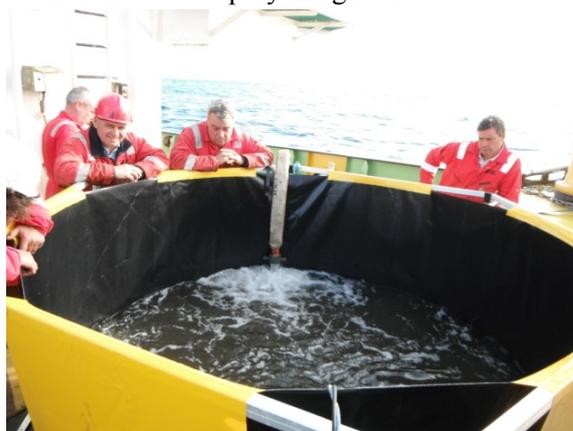
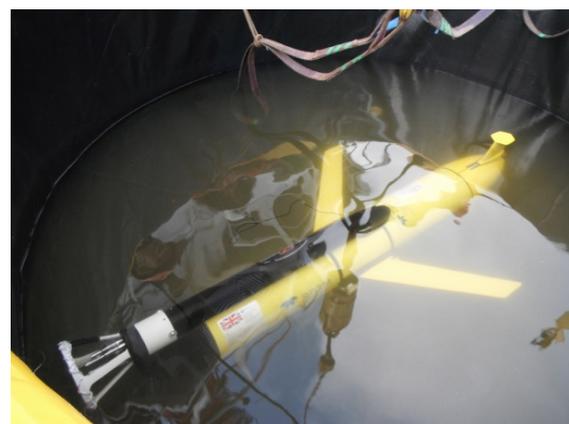
**Fig. B2. Turbulence Glider Ballasting Tests Onboard RRS *Discovery***

After the glider was placed in the tank and purged of any trapped air pockets, bubbles and so on the glider was well ballasted and floated just below the water surface in the tank. The glider, micro-Rider turbulence probe and guard assembly were also level, with minimal parasitic pitch and roll. This indicated a good setup of the glider had occurred and that the UOLHL ballasting has produced settings that are lighter than expected by several tens of grams. Figure B2 shows photographs of the turbulence glider ballasting tests onboard RRS *Discovery* using a portable tank. Considering that the glider buoyancy pump has a capability for mass changes of approximately ± 250 grams the decision was then made to deploy the glider.

a Filling of the portable tank with near surface seawater from the Celtic Sea PAP survey site

b The turbulence glider was confirmed as being correctly ballasted during the tank test
