Application of Engineering Geology to Surface Mine Design, British Gypsum, Newark Nottinghamshire

Sunday 1st April 2007

Engineering Geology through the Centuries

A Joint Meeting of the Yorkshire Geological Society and the Engineering Group
of the Geological Society: (Part of the celebration of the bicentenary of the
Geological Society of London, under the Society's "Local Heroes" initiative for
the bicentenary)

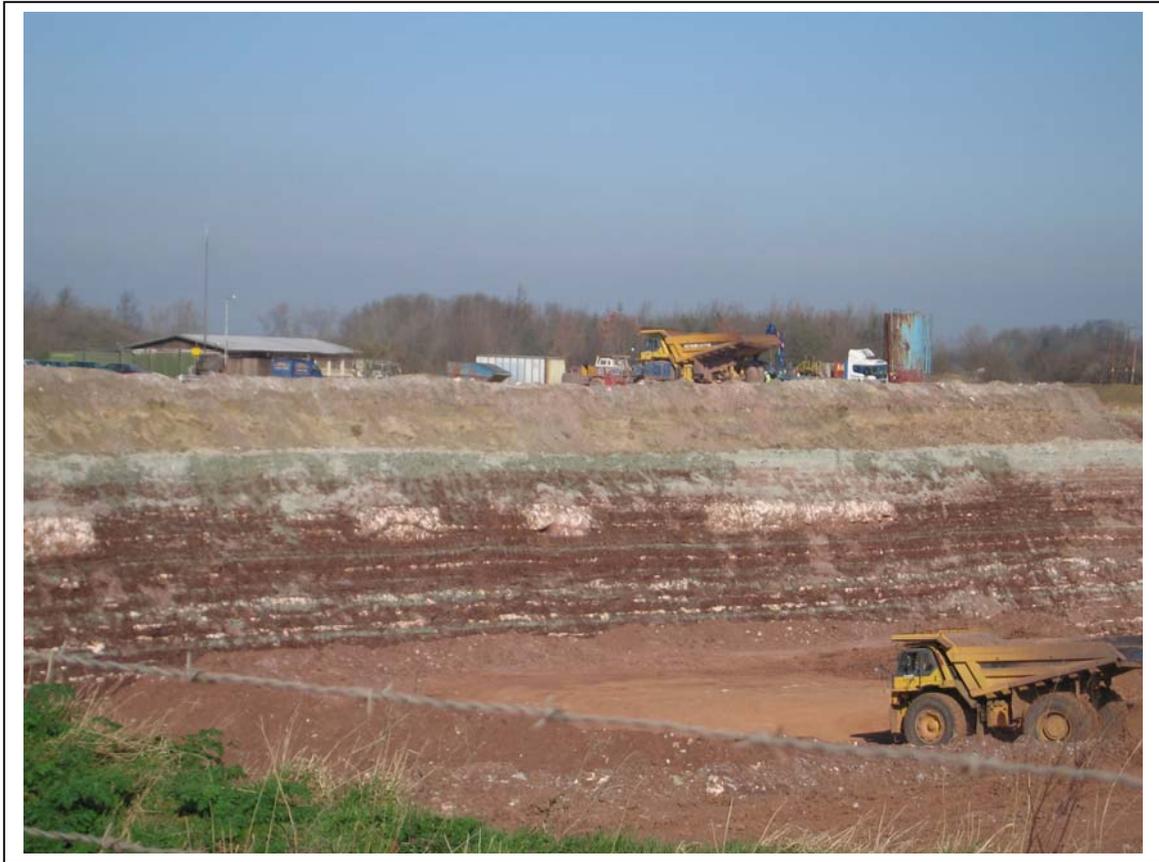
Kilvington Mine looking westwards. The overburden layers comprising alluvium (tan coloured), Blue Anchor Mudstone (grey) and Cropwell Bishop Formation (red brown). The first gypsum seam, the 'Grey Rock' is prominent and represents a thick but discontinuous layer and deposited sub-aerially in a sabkha setting.

The mine access road affords an extensive view showing the sequence of opencast mining operations. The mine is worked in a series of rectangular shaped cuts that are excavated through the overburden layers to access the first gypsum seam. These cuts are typically 50 m wide and contain a series of benches that accords with each of the gypsum seams and inter-burden. Transport within the excavation is effected by a series of ramps constructed to allow the movement of materials; these are designed at gradients of 1 in 10 for main haul roads and up to 1:6 for inter-seam working areas. Slope angles of the excavation are constructed at overall 1 in 1.

Overburden, comprising the Blue Anchor Formation and Alluvium layer is currently being stripped down to the first seam, the 'Grey Rock', using excavators and dumper trucks. This material is then back-cast behind the working area. At this site the

The current working area is adjacent to the River Devon and the outcrop of the saturated zone of the Cropwell Bishop Formation is evident in the south facing side-wall of the excavation. Karstification of the highest gypsum seam has occurred and water flows through these cavities into the excavation.

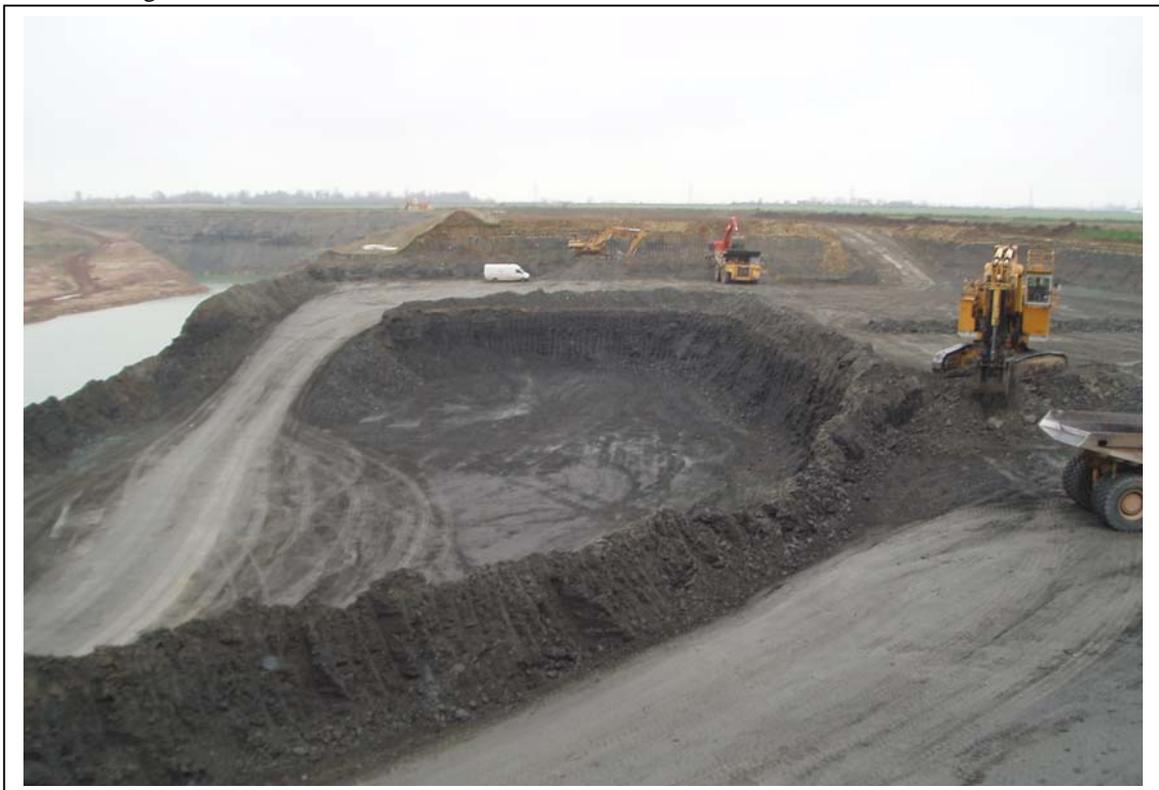
Bantycok Mine stripping operations for the new cut in the Westbury Formation. The Cotham Member (brown) is evident in the mid ground.

Excavation of overburden in the new cut at Bantycok Mine has been underway for approximately 2 months and a new 50 m wide cut is approaching the base of the Westbury Formation at the time of writing.

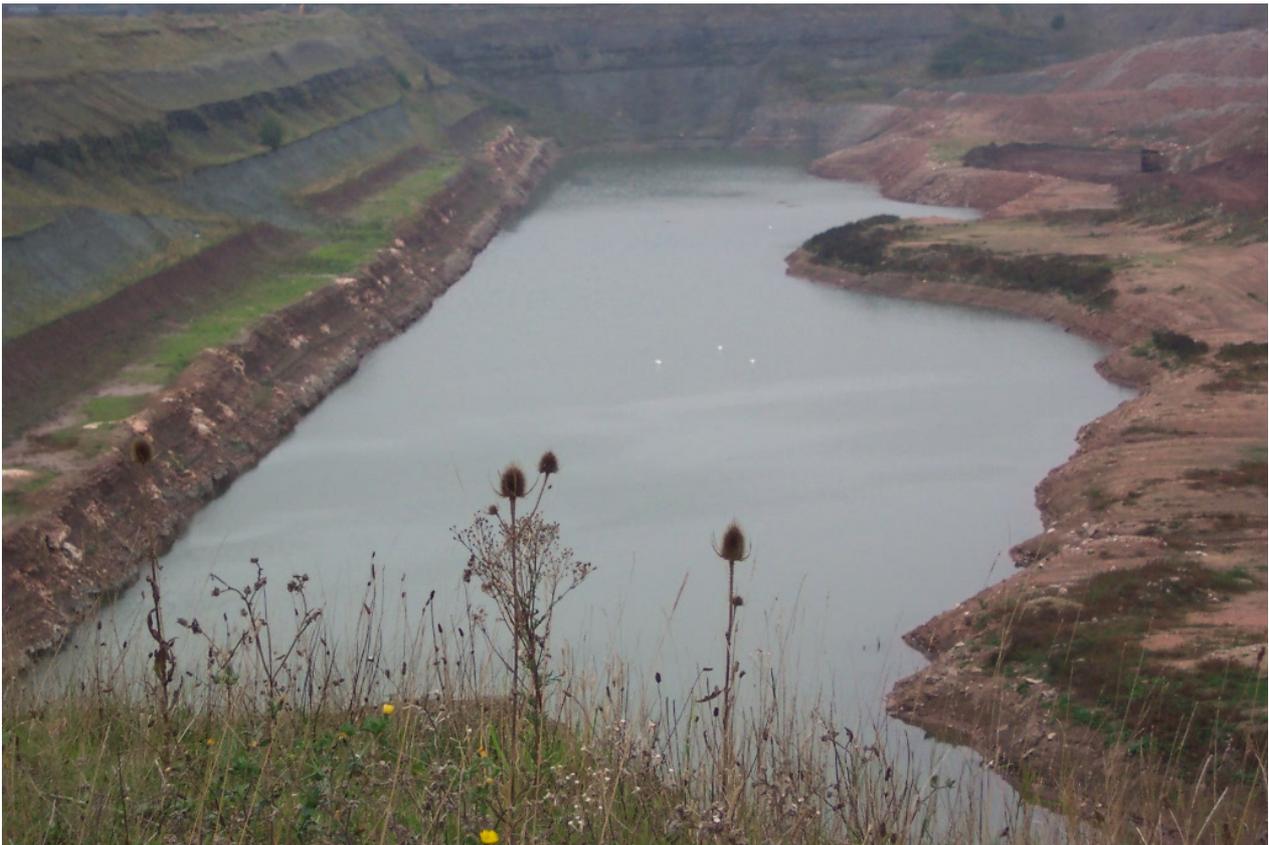
Bantymock Mine undergoing dewatering. The geological layering comprising from the base, Cropwell Bishop Fm with gypsum beds, Blue Anchor Formation, Westbury Formation, Cotham Member, and Lower Lias.

The mine works in a similar geological sequence as Kilvington but seam thickness is greater at over 3 m, however overburden thickness is generally 25 m and the overall excavation depth attains 50 m. The overburden comprises, Blue Anchor Formation, overlain by Penarth Group strata including, the Westbury Formation overlain by the Cotham Member of the Penarth Group and limestone and shales strata belonging to the Lower Jurassic.
