Sustainable development framework for the Gogar Burn – River Habitat Survey analysis

Project Leader: P. Scarlett
Report to: Scottish Institute of Sustainable Technology
CEH Project No: C02813
Date: May 2006

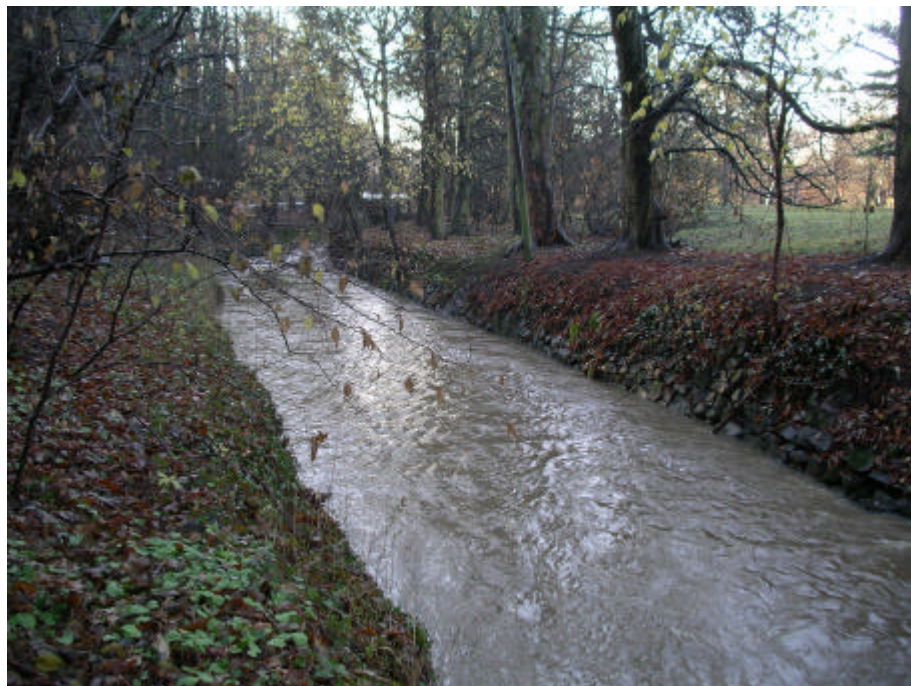
Figure 2 Bank reinforcement and resectioning near the RBS headquarters (site 2)

The banks at both the airport and RBS sites are extensively engineered with resectioning, reinforcement and embankment (figure 2). The introduction of artificial meanders or the use of soft engineering materials would enhance habitat quality. Eroding cliffs were recorded at site two, suggesting that the banks are beginning to recover from past engineering.

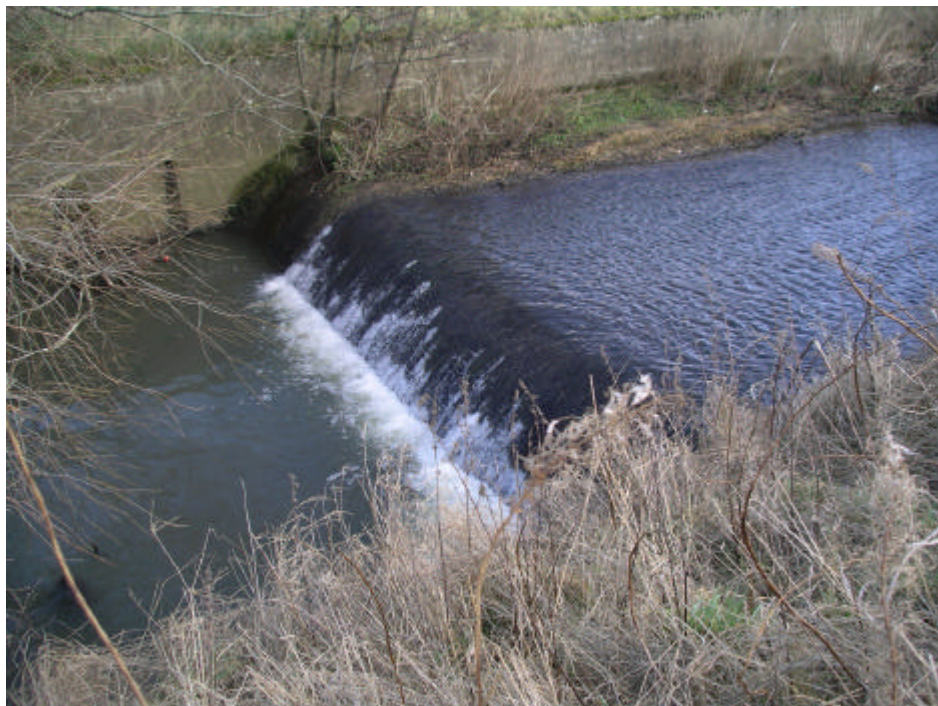
A full length weir is present at the RBS site, which may act as a barrier to migratory fish (figure 3).

Figure 3 Weir at Turnhouse (near Edinburgh airport)

High flow levels during surveying are likely to have altered flow patterns at the airport and RBS sites, so comparison with the reference sites may be misleading. However, it would seem likely that there is poor diversity of flow at both of the airport and RBS sites, mainly due to historical engineering of the channel. The introduction of artificial riffles, backwaters or refuges for fish (e.g. boulders) would increase this aspect of the habitat quality of the site, though care must be taken to ensure that these are feasible in such an engineered channel.
