# RIVER HABITAT SURVEY IN THE ARDÈCHE AND CÉVENNES AREAS OF SOUTH-EASTERN FRANCE

R E S U L T S F R O M 2 0 0 7

A report by Paul Raven<sup>1</sup>, Nigel Holmes<sup>2</sup> and Hugh Dawson<sup>3</sup>

December 2007

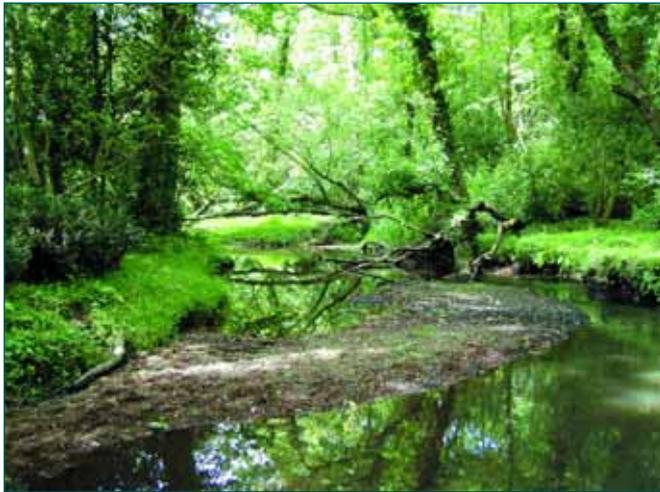
Diversity of natural in-channel, bank and riparian habitat produces a high HQA score.

**Habitat Quality Assessment (HQA)** is a broad indication of overall habitat diversity provided by natural features in the channel and river corridor. Points are awarded for the presence of scoring features such as point, side and mid-channel bars, eroding cliffs, marginal tree roots, woody debris, waterfalls, marginal reeds and floodplain wetlands. Additional points reflect the variety of substrate, flow-types, in-channel vegetation, and also the extent of trees and semi-natural land-use adjacent to the river.

Points are added together to provide the HQA. In contrast to HMS (*see below*), the higher the score, the more highly rated the site. The diversity and character of features at any site is influenced by natural variation and the extent of human intervention both in the channel and adjacent land. The RHS database allows HQA scores to be compared using sites with similar physical characteristics (e.g. slope, distance from source) and geology. Features determining habitat suitability for individual species such as European otter (*Lutra lutra*), or dipper (*Cinclus cinclus*) can also be selected, thereby providing a more ecologically-specific context for comparing sites<sup>8</sup>. Carrying out RHS and macrophyte surveys at specially selected good quality sites provides the necessary calibration of HQA for a range of river types in the UK. These special surveys have been extended to mainland Europe, including Finland, Norway, Poland, Slovenia, Bavaria and the Tyrolian Alps. This visit to south-eastern France represented another special survey. Comparison of various habitat assessment methods has also been part of this European-wide initiative<sup>9</sup>.

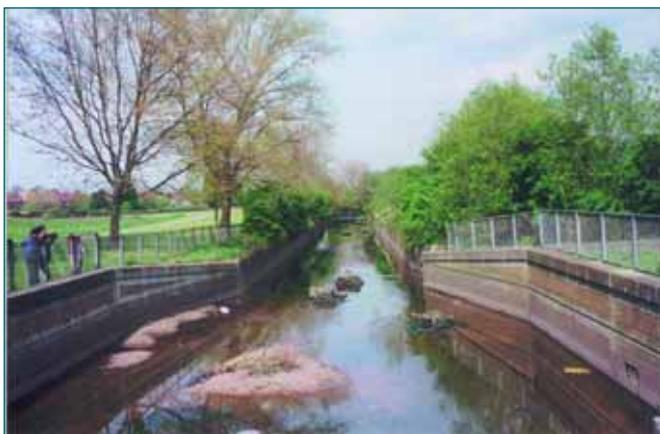
Artificial reprofiling and reinforcement of the banks and channel produce a high HMS score.

**Habitat Modification Score (HMS)** is, by contrast, an indication of modification to the river channel morphology. To calculate HMS for sites, points are awarded for the presence of artificial features such as culverts, weirs, current deflectors, and bank revetments. Points are also awarded for modifications to the channel such as re-sectioned banks or heavily trampled margins. The more severe the modification, the higher the score. The cumulative points total provides the Habitat Modification Score (HMS). A Habitat Modification Class (HMC) has been developed which allocates a site into one of five modification classes, based on the total score. In contrast to HQA, higher scores reflect more intervention and modification of the river channel within the site.

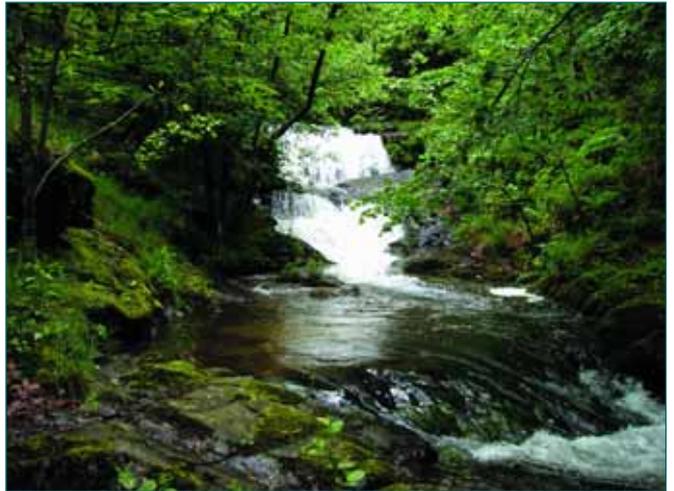
For JNCC macrophyte surveys, vegetation in the channel and along the water's edge is recorded.

When undertaking special RHS and macrophyte surveys on UK and European rivers, two methods are normally used in tandem. The Joint Nature Conservation Committee (JNCC) method records aquatic and marginal plants in the same 500m as the RHS survey. Species from the river channel and the margins/base of the bank are recorded separately on a three-point scale of abundance. A check-list of species is used to aid recording. Data are held on a JNCC database, and field data can be used to classify the plant community<sup>2</sup>.

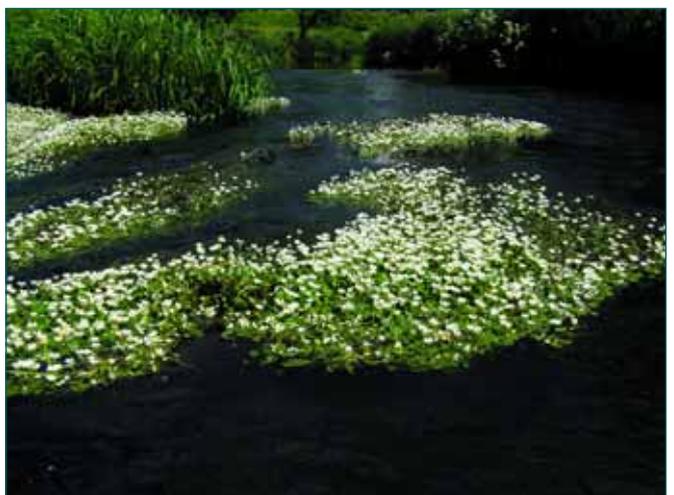
For the MTR method, plants growing in the water are used to calculate scores.

The second type of macrophyte survey normally carried out is the Mean Trophic Rank (MTR). This records only aquatic taxa, again using a check-list of species, but within a 100m length of river. Each species is assigned a trophic rank of 1-10, depending on its tolerance to eutrophication (1=tolerant; 10=intolerant). Cover abundance of species is estimated on a scale of one to nine and the combination of cover values and trophic rank enables a MTR score to be derived. This provides an indication of the level of nutrient enrichment of the sites surveyed<sup>3</sup>.

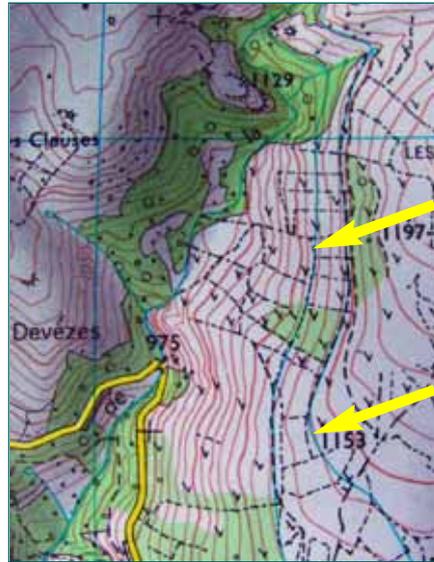
Levadas in the Brouse River catchment, shown by arrows.

Another notable feature in several valleys was construction of levadas for irrigation purposes. Dilapidated and primitive irrigation in the Ardèches contrasted with well-functioning modern levadas in several catchments.

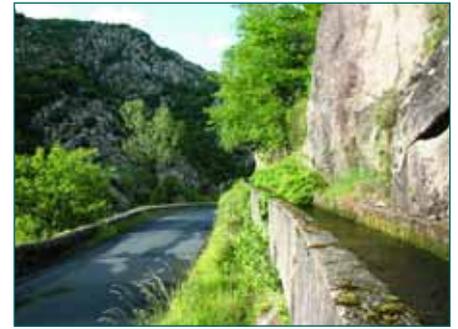
A functioning levada in the Borne valley.

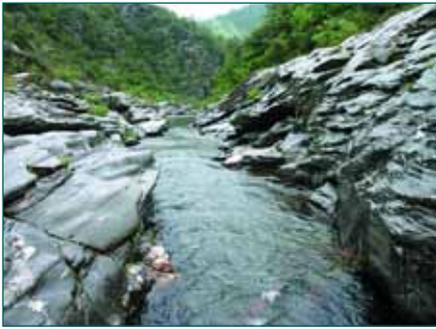
The scouring effect of flash floods leaves bedrock channels virtually without vegetation.

In bedrock channels the exposed rocks were often scoured bare up to the trashline, with some sapling alders (*Alnus glutinosa*) colonising cracks and crevices in boulder-sized vegetated bar material.

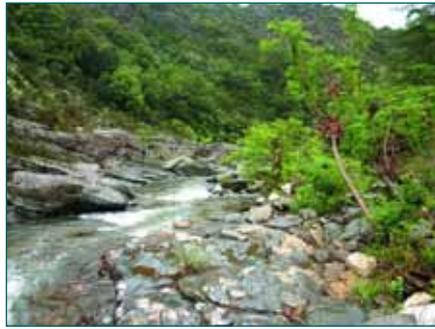
Cracks in the bedrock can provide footholds for some shrubs; Luech River.

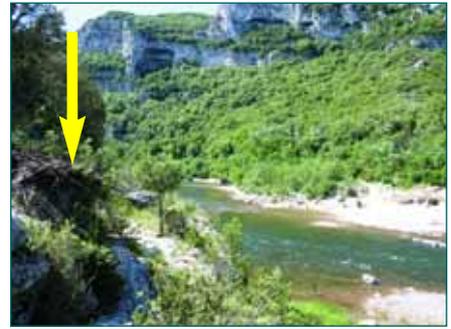
Trashline at 40m – evidence of a spectacular flash flood; Ardèche gorge.

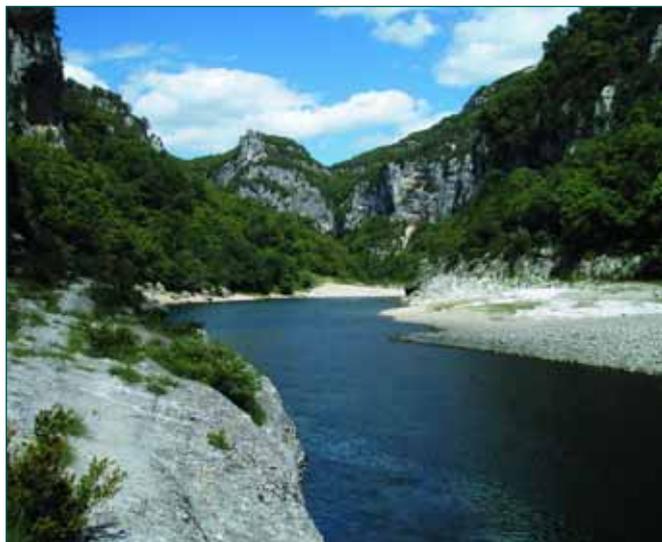
Sparse aquatic and bankside vegetation; Ardèche gorge.

The flora recorded from the 13 sites varied significantly, with the shaded sites having rich bryophyte communities growing down the banks to the water’s edge. Sites on the Ardèche River within the gorge had virtually nothing present due to either extreme bed instability, where pebbles, cobbles and boulders were the dominant components of the substrate, or where bedrock is scoured clean by the force of torrential floods. At the margins of the Ardèche, clinging in cracks in the rocks, were several non-native taxa, some of which do not have a great affinity to rivers.

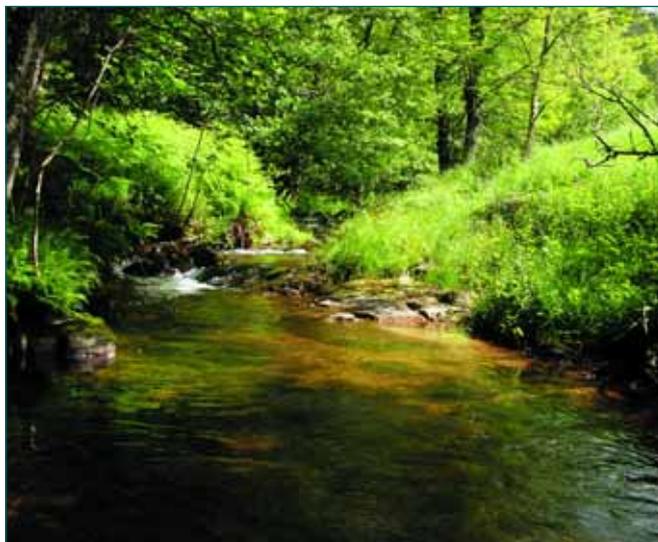
Good macrophyte growth in the Doux tributary; FRA-1.

The moss-dominated flora is typical of a community found in a shaded upland stream on slightly acidic rock in the UK. Indicators of acid rocks include *Racomitrium* and *Scapania* but the dominance of *Rhynchostegium*, with *Chiloscyphus* also common, clearly reflects a community type close to neutral rock chemistry. There is good moss productivity both below water level and at the margins where woodland taxa (e.g. *Plagiochila*, *Orthotrichum*) are present alongside the wetland and aquatic species.

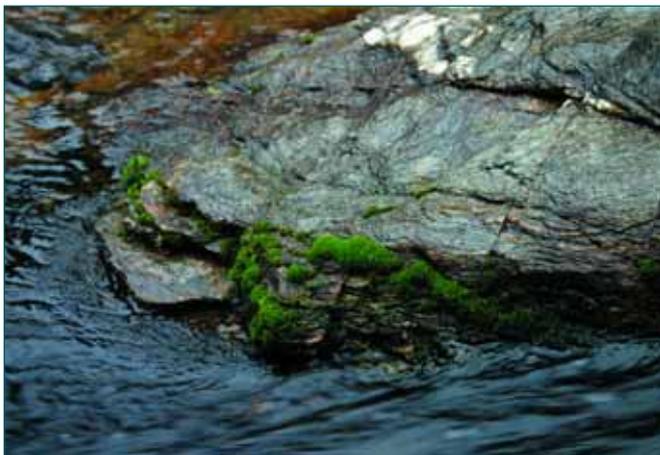
*Bryum dichotomum* growing in almost permanently submerged conditions; FRA-10.

Macrophytes in the channel, and often the bank margins too, were generally dominated by bryophytes. *Bryum dichotomum* (*B. bicolor*) was a frequent colonizer of rock fissures in several of the rivers surveyed, extending down the inundation zone lower than where true aquatics such as *Fontinalis* or *Cinclidotus* were found. This vertical distribution has never been observed in UK rivers. Several sites contained bryophytes indicative of base-rich rock (e.g. Ardèche, Brousse).

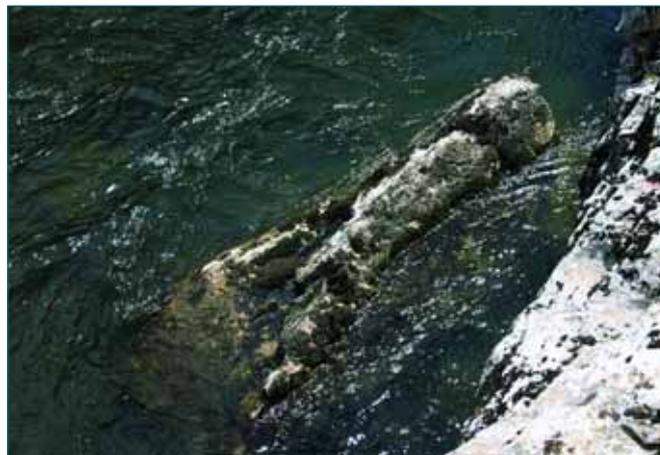
Mosses such as *Cinclidotus* were rare and largely confined to rock fissures; FRA-6.

forming the rapids provide the only foothold for several bryophyte taxa, with *Cinclidotus* and *Bryum dichotomum*, the most hardy, found closest to the water level on the bankside. The total amount of perennial rooted vegetation was close to 0.1%, with the dominant in-channel taxon being the filamentous red alga *Lemanea*. Fissures in some flat pavements on one bank in FRA-10 provided suitable rooting habitat for marginal higher plants such as spike-rush (*Eleocharis*), common reed (*Phragmites*) and yellow loosestrife (*Lysimachia vulgaris*). A major concern is Japanese knotweed growing throughout the reach.

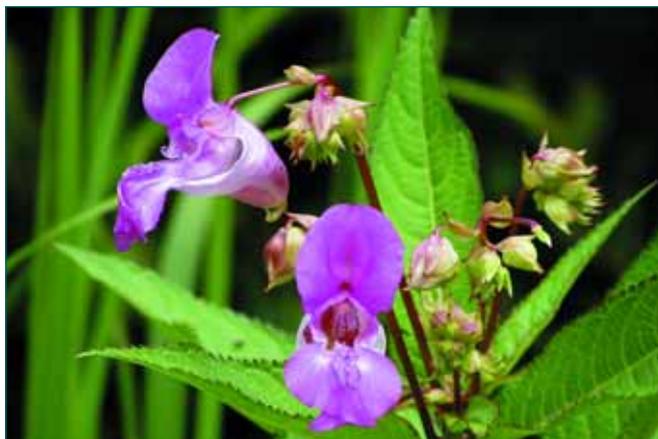
Himalayan balsam in the Ardèche; FRA-4.

Non-native species are recognised as a 'pressure' that could prevent water bodies achieving "good ecological status". Non-native plants, and Japanese knotweed in particular, are a problem along waterways in several parts of Europe. We recorded Japanese knotweed on the Ardèche and Luech (FRA-5, 10, 11) but it did not always extend down to the water's edge; Himalayan balsam (*Impatiens glandulifera*) was present in the Ardèche sites. In the UK, Japanese knotweed occurred at 8.6% of RHS baseline survey sites and Himalayan balsam at 14.4% of sites during 1994-96. Both have undoubtedly spread since then.

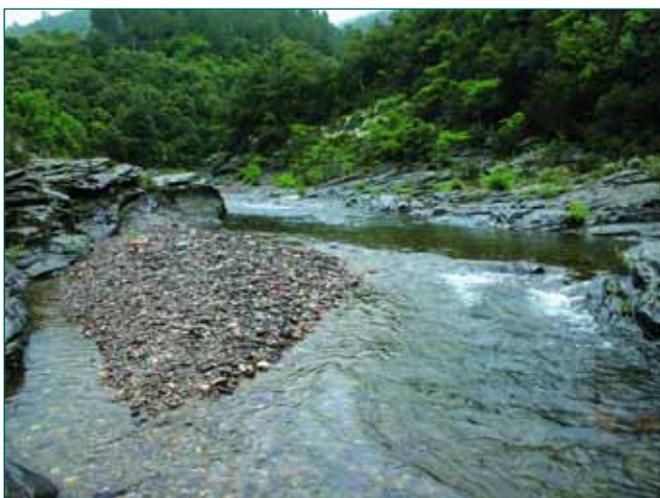
Unstable substratum and bedrock scoured clean prevents macrophytes being used to assess water quality; FRA-11.

Ten MTR surveys were carried out on the eight rivers we visited but, as with sites surveyed in the mountains of Slovenia<sup>10</sup> and the Alps<sup>11</sup>, too few UK taxa were found within the channel to give confidence in the results being a good indicator of water quality. In the Ardèche and Luech, taxa were exceptionally sparse, and the lowest MTR scores were noted for these rivers (48, 55, 58), but these do not reflect the near pristine water quality of these rivers. The other rivers had higher scores, but again, probably lower than would be expected given the purity of the water. Use of MTR using the UK check-list of taxa for water quality determination is therefore not recommended for such rivers, but may be adapted in the future if the taxa list is extended to include species more widespread in Europe as a whole. Even with an extended list, water quality cannot be assessed using macrophytes in sites such as the Ardèche and Luech where cover is so sparse, and the diversity so low.

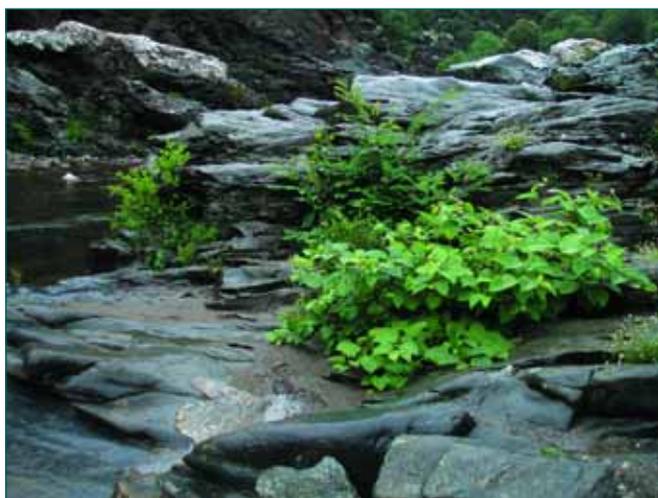
Japanese knotweed on the Luech River; FRA-10.

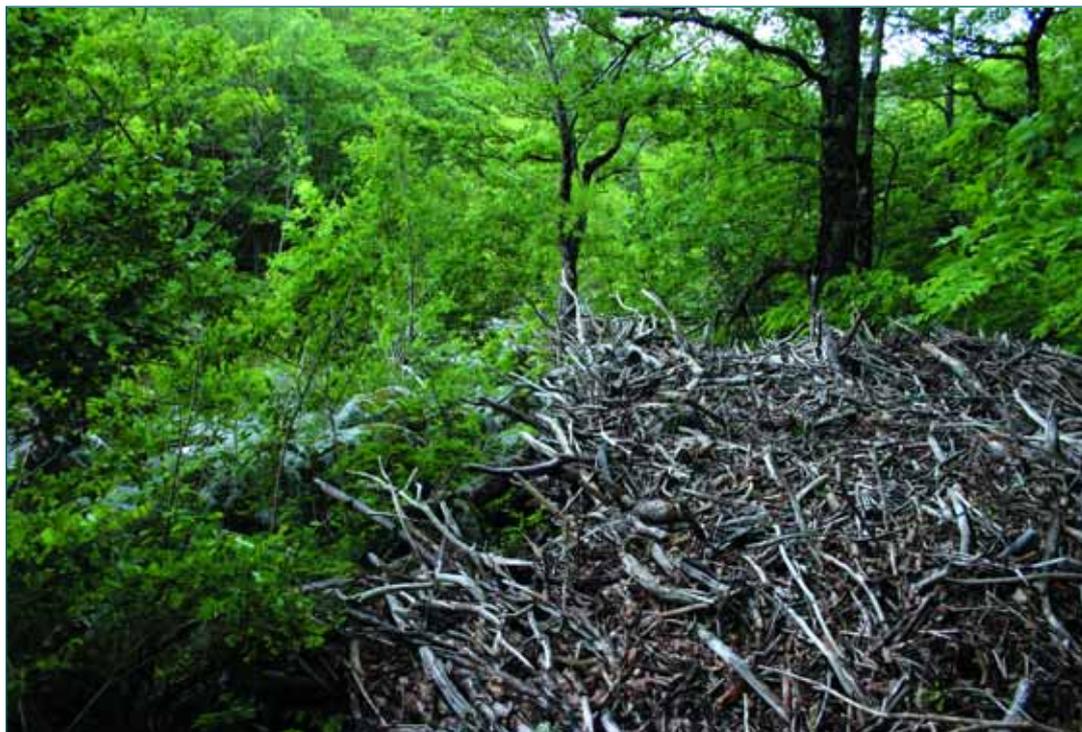
Flood debris trashline on the Tarn River; FRA-13.

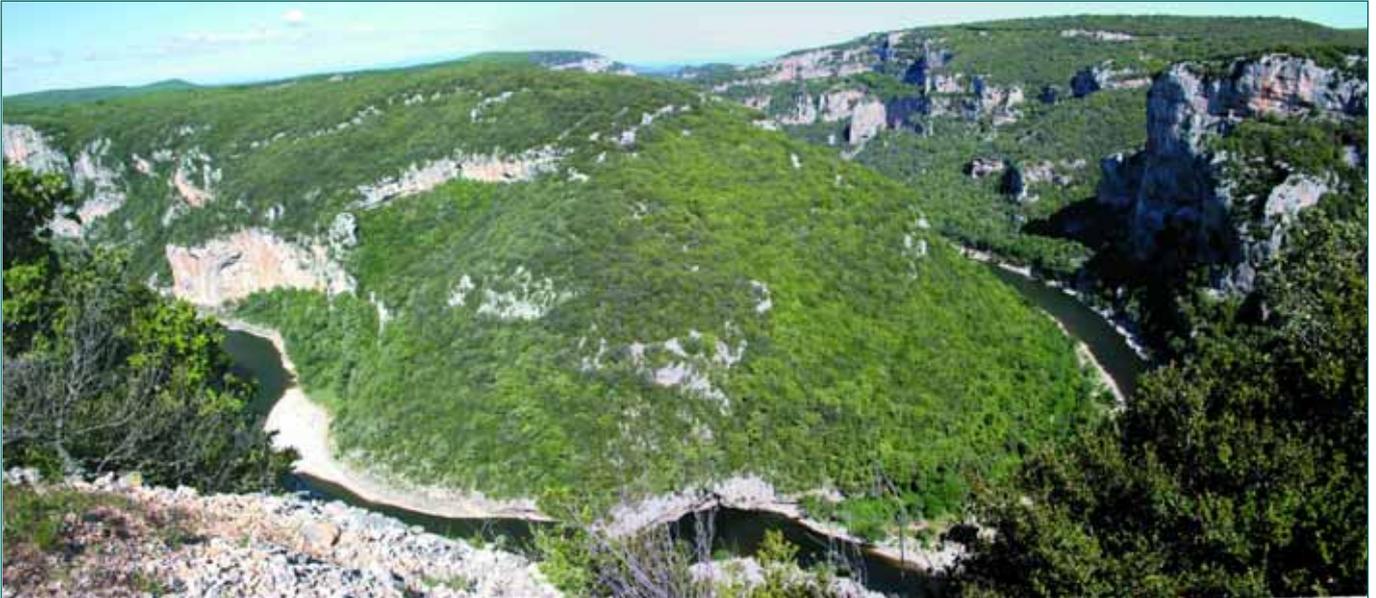
Some gorge reaches are inaccessible by foot. Aerial photographs and canoes need to be used for river habitat assessment.

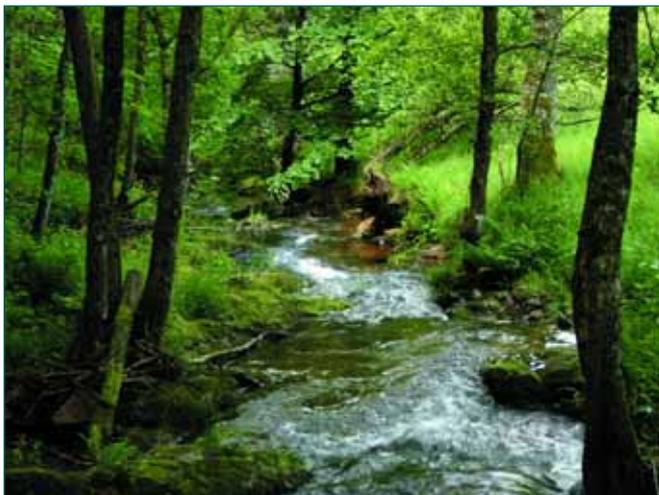
Good aquatic and water's edge bryophyte flora; FRA-1.

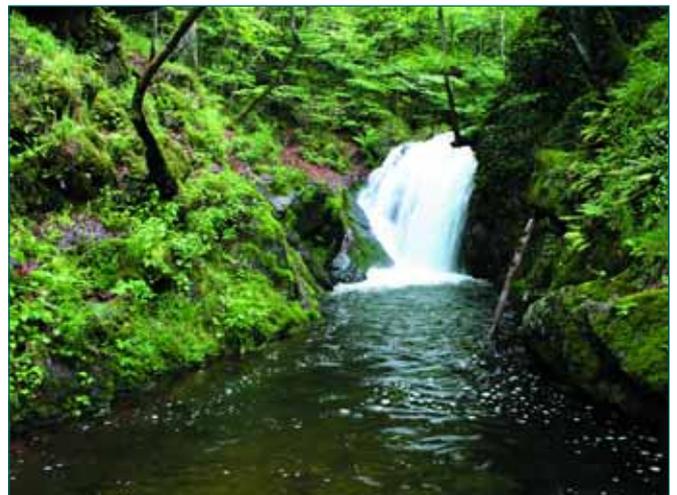
Distinctive step-cascade and pool sequence; FRA-2.

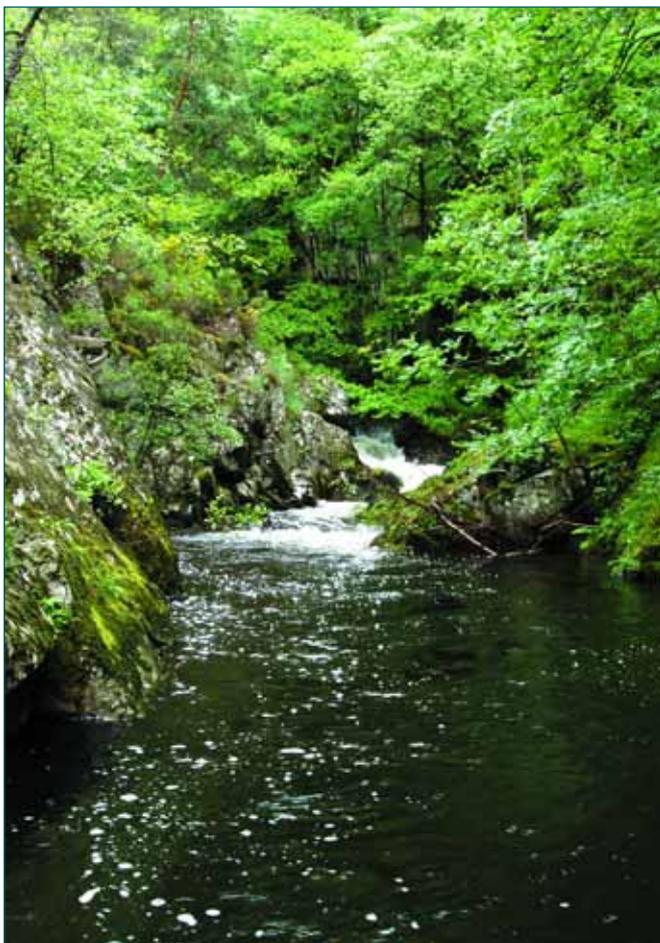
Plentiful bryophytes along the well-shaded Eyrieux; FRA-2.

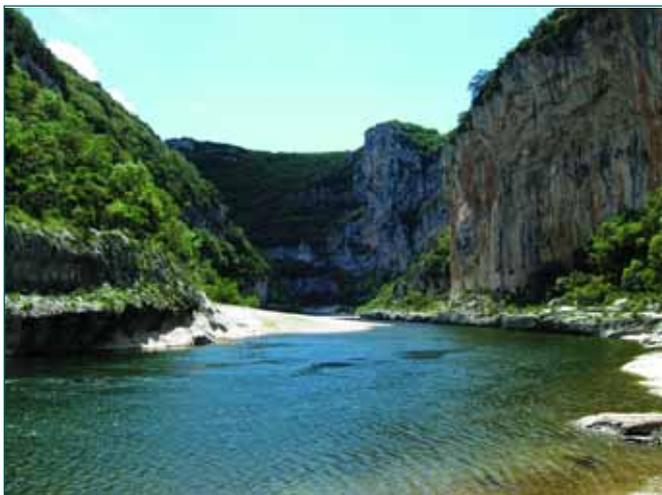
Sheer gorge rock-face; FRA-5.

The narrow gorge and bottleneck constrictions caused by tight meander bends mean that the erosive force during spate flows each year must be enormous. This has produced a complex bankface/banktop structure akin to a coastal wave-cut rock platform. There are several strandlines ranging between 15m and 40m above summer water level, the latter probably associated with a catastrophic flash flood in September 2002. Difficulties in determining the banktop/face are discussed in Appendix 7. There are point and side bars, riffles, pools and rapids, and the river is very popular with canoeists. Broadleaf woodland dominates the steep valley sides, with bare rock-face where the gorge-profile is sheer. The whole gorge is managed as a nature reserve.

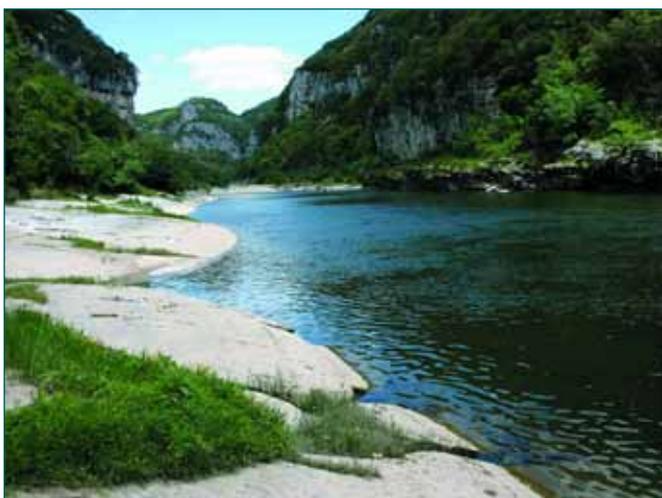
Marginal macrophytes such as *Rorippa sylvestris* were confined to cracks in the limestone bedrock; FRA-5.

such as *Amblystegium fluviatile* and *A. tenax* this indicates base-rich rock. In some cracks higher plants were present, the commonest being creeping yellow-cress (*Rorippa sylvestris*) and yellow loosestrife (*Lysimachia vulgaris*). A glance at Appendix 10 shows that many taxa were present at this site that were absent from others, and vice versa. Notable species here, but not other surveyed sites, included water-crowfoot (*Ranunculus*) in the most stable parts of riffles, whilst water-milfoil (*Myriophyllum*) and curled pondweed (*Potamogeton crispus*) were found in rock pools and backwaters protected from the scouring force of flash floods.

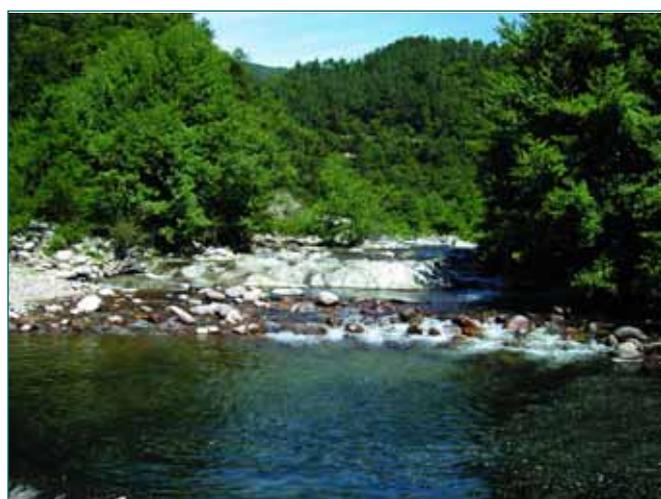
The bedrock channel and wooded valley of the Drobie River; FRA-8.

Located on the River Drobie, about six km north-west of Joyeuse, FRA-7 and 8 represent a meandering bedrock channel in a deeply incised wooded valley. The upstream site (FRA-7) is dominated by bedrock platforms sculptured in the schist bedrock, whilst FRA-8 has a slightly greater channel gradient. Both sites have a diverse channel substrate and extensive vegetated shingle/cobble deposits forming vegetated side bars which support an alder-dominated riparian zone. A small summer house dwelling in FRA-8 is typical of the minor development in the river valley, whilst there is some terracing for vine-growing further upstream.

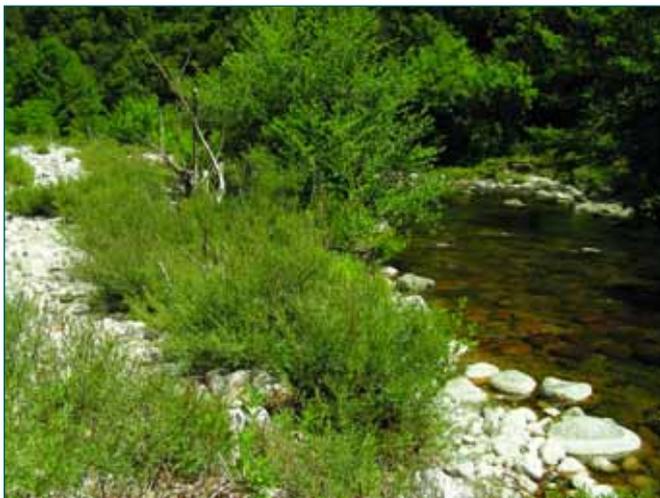
Sapling willows and alders colonising side bars; FRA-8.

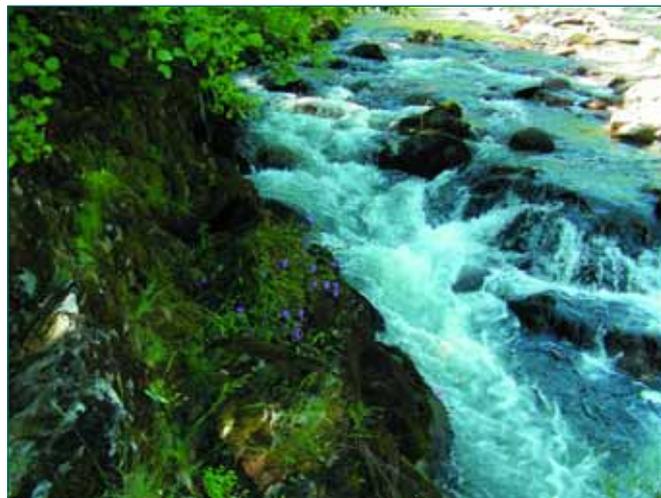
Shaded bedrock with plenty of bryophytes; FRA-8.

The Drobie had the most macrophyte taxa recorded of any of the rivers surveyed, reflecting a rich bryophyte flora on some stable boulders, and in the fissures of the bedrock that was present in only some of the reach. The most abundant species indicated neutral, or slightly basic rock chemistry, but some rocks had *Racomitrium* present, suggesting that some more acidic boulders had been washed down from upstream. Several types of higher plants were recorded on shallow gravel margins, reflecting a diverse structure of the flora. On some gravel bars just away from the river, American pokeweed (*Phytolacca americana*) was found.

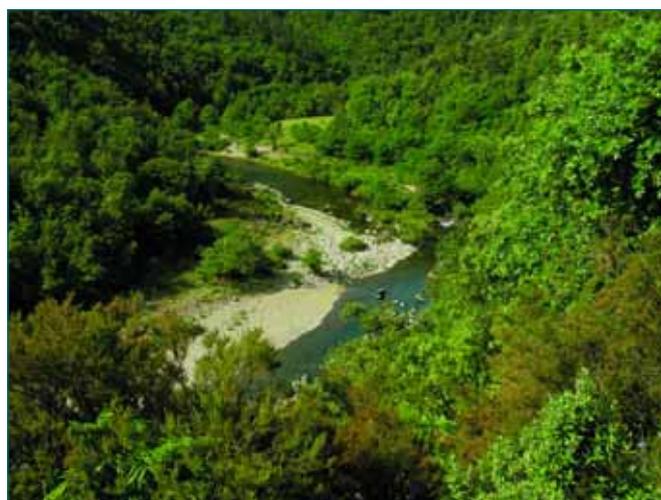
Bar deposits in FRA-8 contrast with bedrock channel; FRA-7.

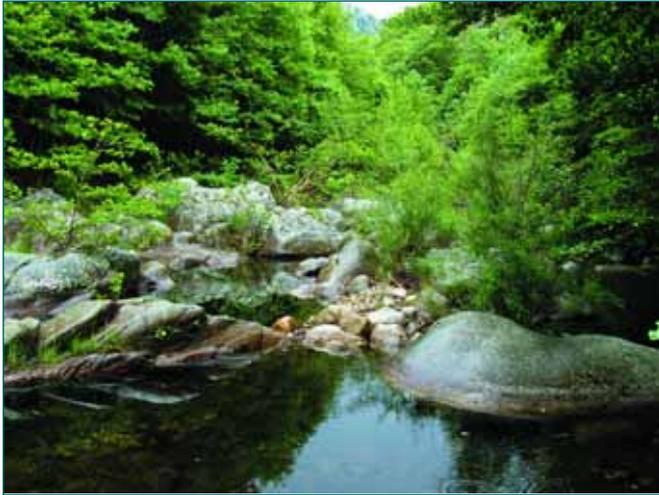
Saplings colonising rock crevices and deposits; FRA-9.

FRA-9 has the characteristics typical of a high energy mountain river, including very large boulders. What is unusual, compared with equivalent reaches not affected by hydropower, notably the Leuch River near Chamboredon, (see FRA-10 and 11), was the dense growth of alders along the margins, vegetated side bars and colonisation of rock

crevices and boulders in mid-channel by saplings. The even-aged structure of the alders provides a clue to the timing of construction of the Barrage de Roujanel, a major dam 2 km upstream. Extensive coarse woody debris snagged by the alders in the channel also suggests that the peak flood event is artificially attenuated because elsewhere it would be scoured out and transported downstream, as in FRA-10 and 11.

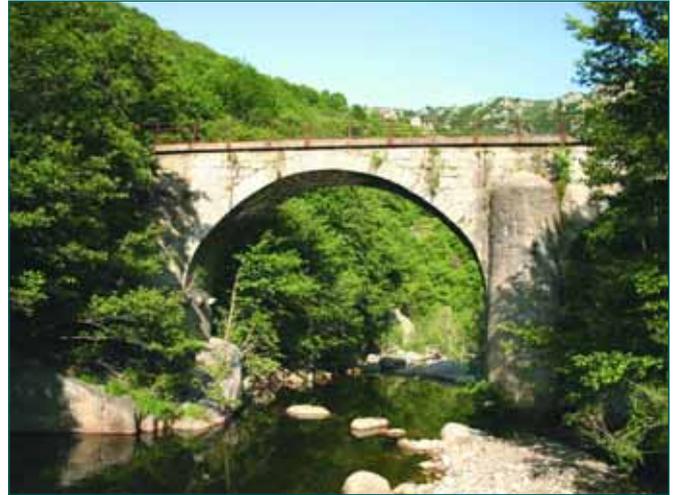
Bridge arch indicates height of floods before dam construction 2km upstream; FRA-9.

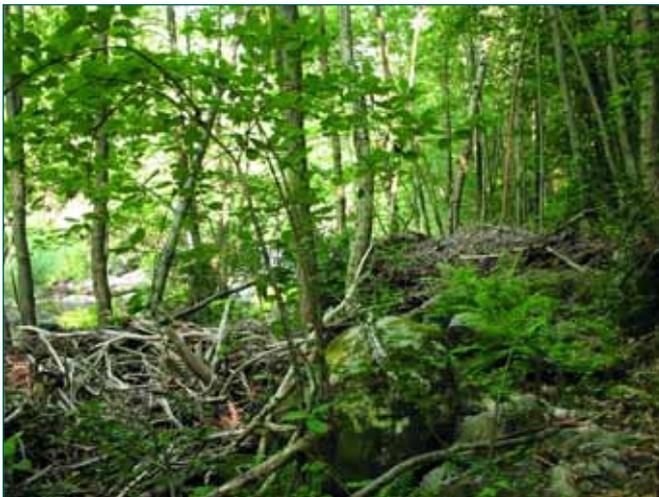
Saplings and woody debris indicate infrequent scouring; FRA-9.

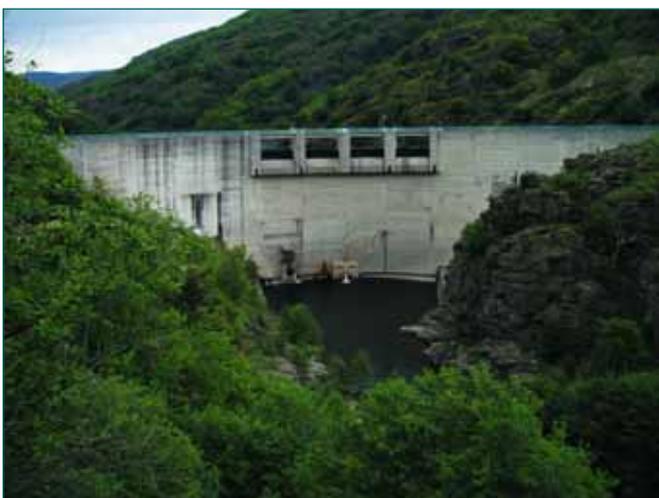
Barrage de Roujanel, 2km upstream from FRA-9.

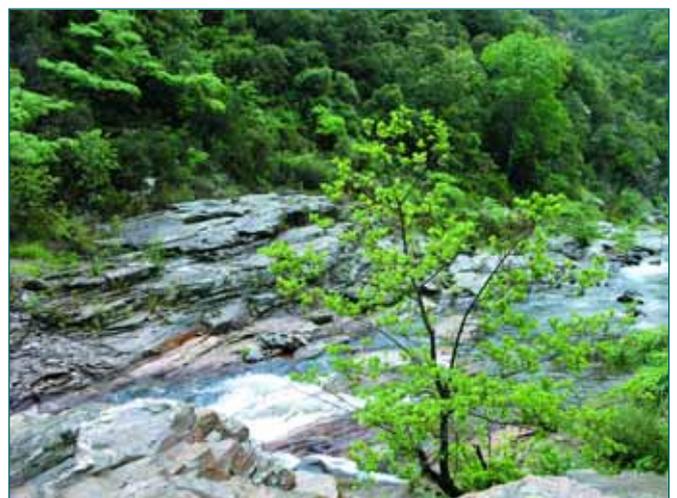
Scoured bedrock and no woody debris on the Luech River; FRA-10.

Numerous small alder saplings grow from crevices but do not grow higher than about 1m because of the scouring action and also beaver (*Castor fiber*) damage. There is virtually no coarse woody debris, again probably reflecting the force of spate flows. This contrasts with the regulated flow of FRA-9 (River Borne) which has abundant large woody debris and vegetated rock/boulder features (see FRA-9).

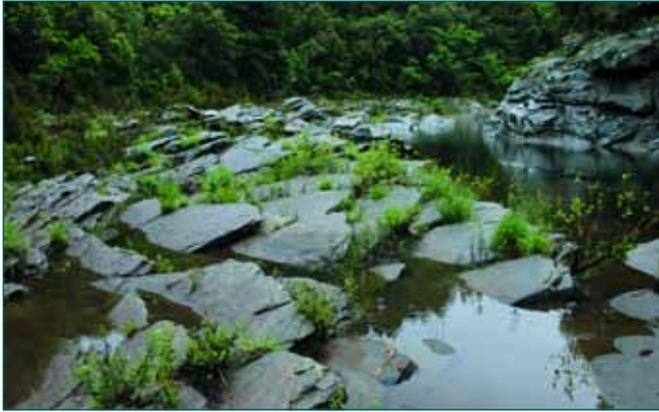
Rock pools and crevices in the bedrock; FRA-10.

A meandering bedrock channel in a deeply incised (70m deep) valley about five km west of Bessèges. The bedrock bankface (defined by the trashline, and varying from 3.5m to 6.0m depending on channel profile) is predominantly bare, scoured clean by intense spate flows. The layered schist bedrock is angled and provides a diverse variety of crevices and 'rock pools' scoured into the surface. These crevices, pools and large deposits of sand and gravel provide a rich variety of temporary habitats. Rock pools are scored as a special HQA feature.

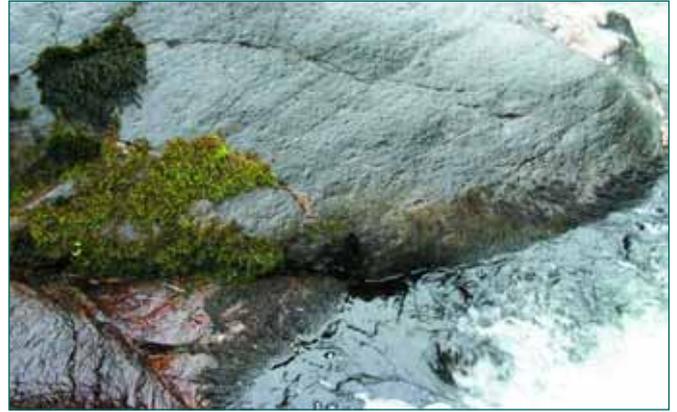
Crevices provide the only footholds for mosses in the scoured bedrock; FRA-11.

The immense scouring power of floods means that perennial aquatic taxa are rare. Cracks in the bedrock

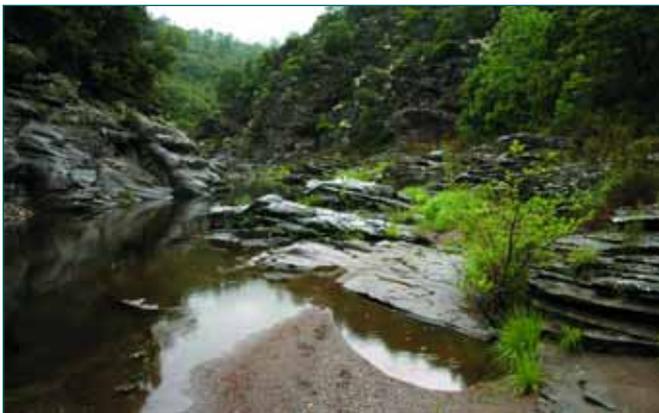
Marginal deadwater and gravel deposits add contrast to the scoured bedrock; FRA-10.

FRA-10 has a very diverse range of substrates, a good riffle-pool sequence and several bar deposits. The character of FRA-11 is different, reflecting a steeper gradient, and is dominated by a 300m long, narrow bedrock chute. Overall, there is a very diverse channel and bank habitat.

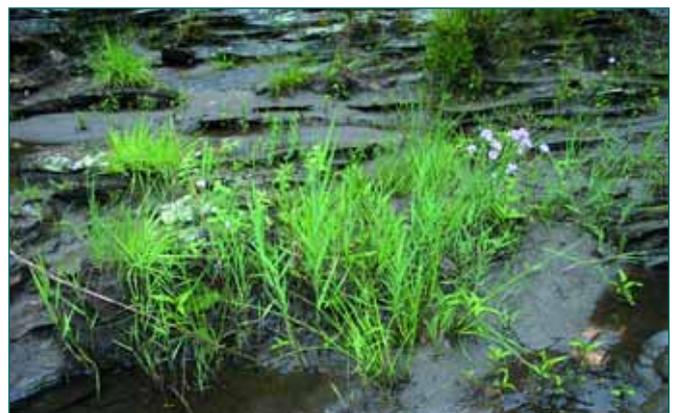
Discrete sand deposits are colonised by reeds; FRA-10.

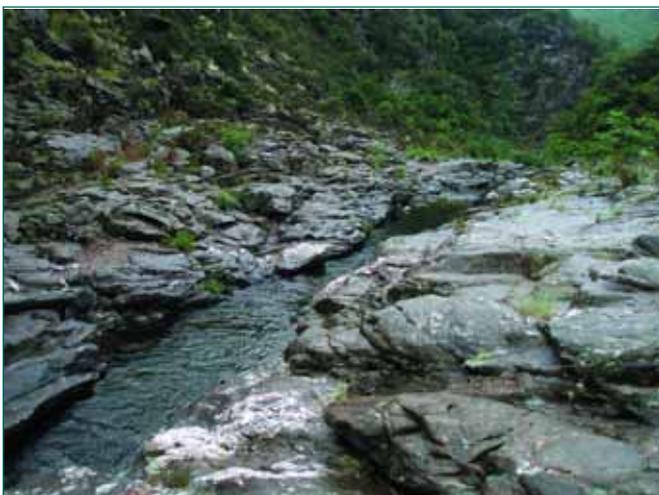
Narrow bedrock chute; FRA-11.

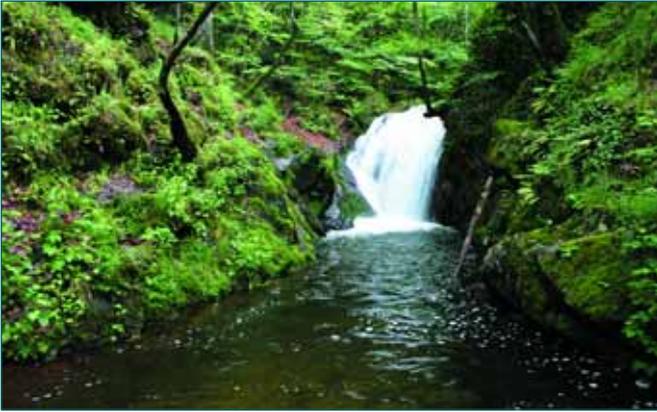
One of several cascades and waterfalls; FRA-12.

The Brouse is a short (10 km), steep stream that rises two km west of Mont Lozère. FRA-12 is located in a deep wooded valley, about 750m from where it flows into the River Tarn (see FRA-13). The site is dominated by 14 substantial cascades and two large (>5m) waterfalls. It was specifically selected because of its granite catchment, so that the macrophyte flora could be compared with that in streams surveyed on schist geology. The excellent woodland is dominated by oak, (*Quercus*) and sweet chestnut, with alders frequent along the water's edge. Further upstream from the site, the habitat changes to sub-alpine heath. Two levadas have been constructed about 2.5 km upstream from the site.

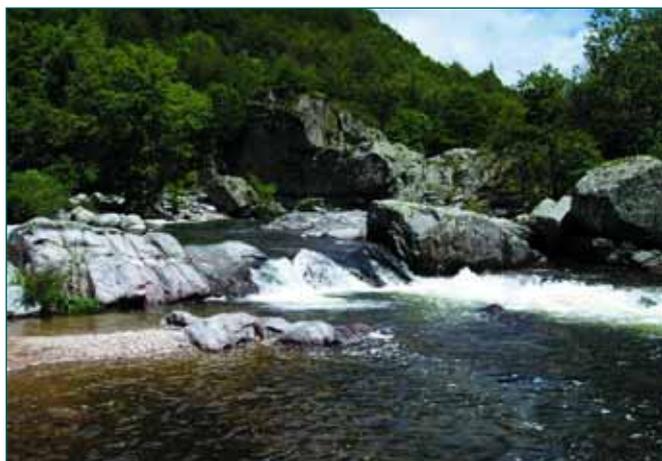
Diverse flow-types and channel habitat; FRA-13.

A typical bedrock-boulder dominated section of the upper Tarn, eight km east of Florac and flowing in a deeply-incised valley. There is granite geology on the north side (see FRA-12) and schist geology to the south, a geological mixture reflected in the different types of boulders, cobbles and pebbles comprising the side bars and discrete sand and gravel deposits which are notable features of the river margins. Trash lines at 2.5m and 3.5m above normal water level indicate the impact of flash floods.

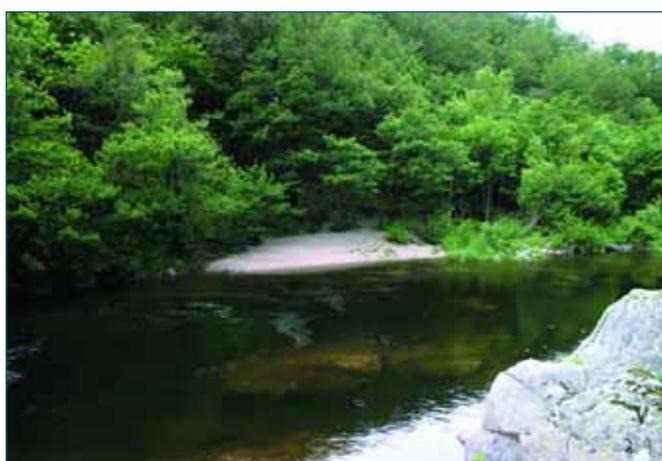
Bedrock bank, huge underwater boulders and sand bar deposit; FRA-13.

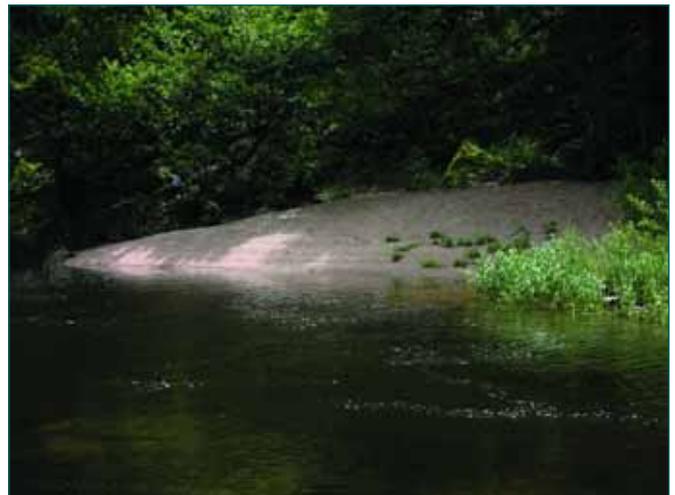
Scale will determine whether large discrete deposits are side bars; FRA-13.

*Recommend* a better explanation in the RHS manual over the difference between side bars and discrete silt/sand/gravel deposits and how to record them.

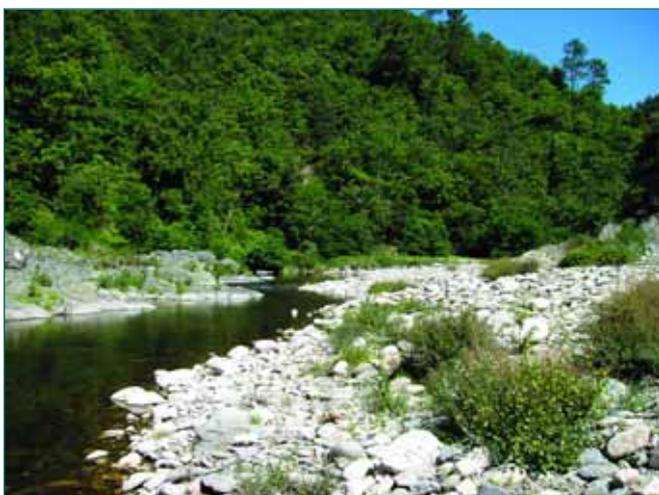
Point bar deposit covering the bank face (not visible).

*Recommend* requiring an explanation where not visible ('NV') is to be used as an entry for bank material when side or point bar material entirely covers the bankface (Section E). The manual needs to be more explicit about how to record this.

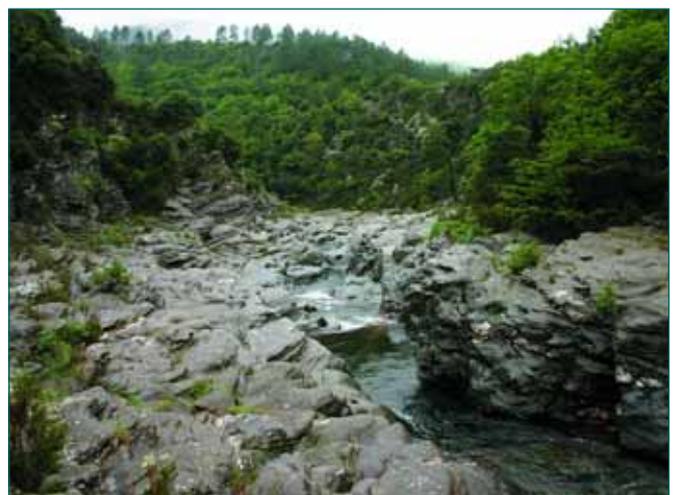
Composite bank profile in bedrock provides variety of habitat niches; FRA-11.

*Recommend* an explanation that composite bank profile (Section I) includes bedrock platforms scoured by the force of water.

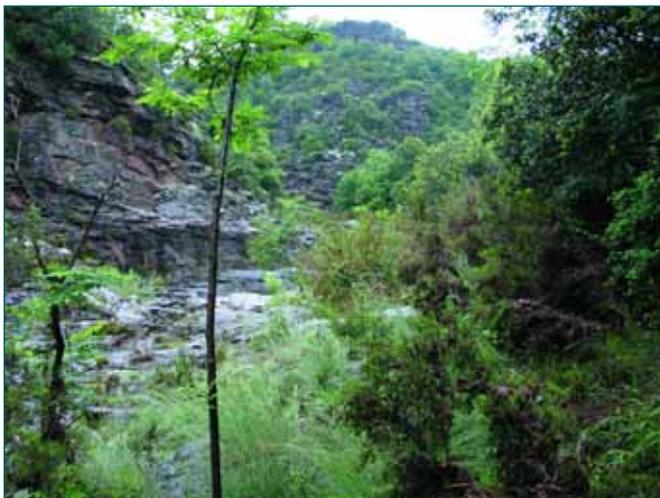
Coincident trashline and scoured bedrock mark the 'banktop' in deep vee valley; FRA-10.

*Recommend* that in deep vee valleys, an obvious scour-level coincident with trashline height is used as the surrogate "bankface/banktop" boundary for recording vegetation structure at spot-checks.

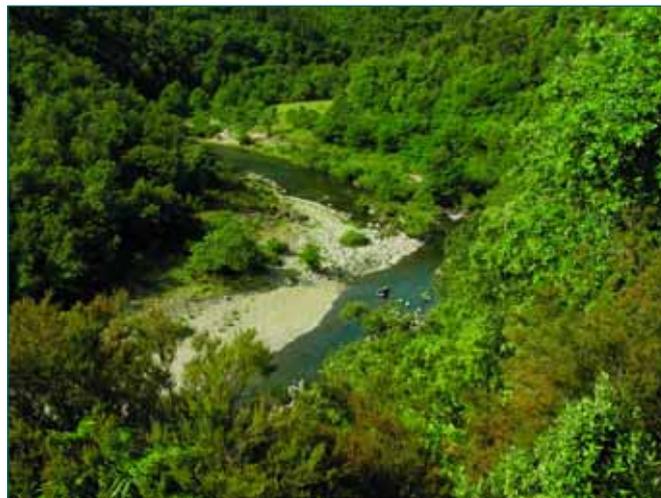
Determining tree distribution in vee-shaped valleys can be difficult.

*Recommend* a more explicit definition of how to record bankface/banktop tree cover in deep vee and gorge valleys.

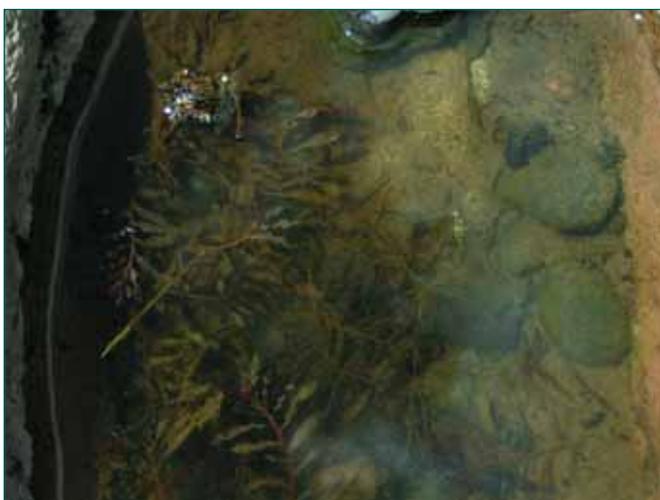
Rock pool in limestone bedrock pavement, Ardèche River.

*Recommend* an analysis of 'other' special features and impacts recorded to update the current list in Section M. For example, bedrock platform, and "rock pools" as special features and levadas as a modifying feature were generated by this survey visit.

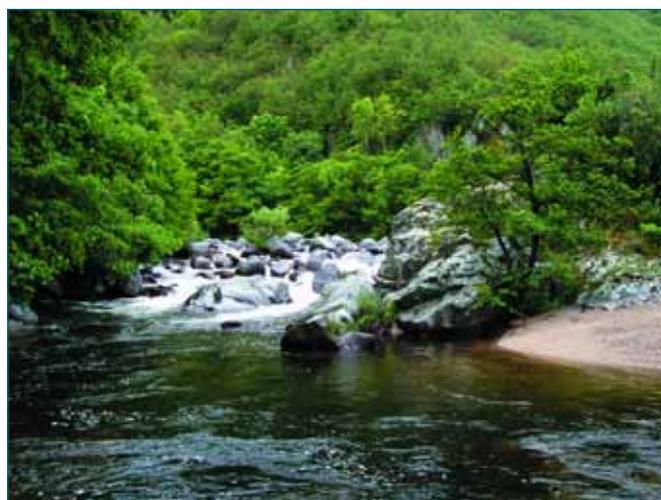
Discrete sand deposit – more of a bank associated feature? FRA-13.

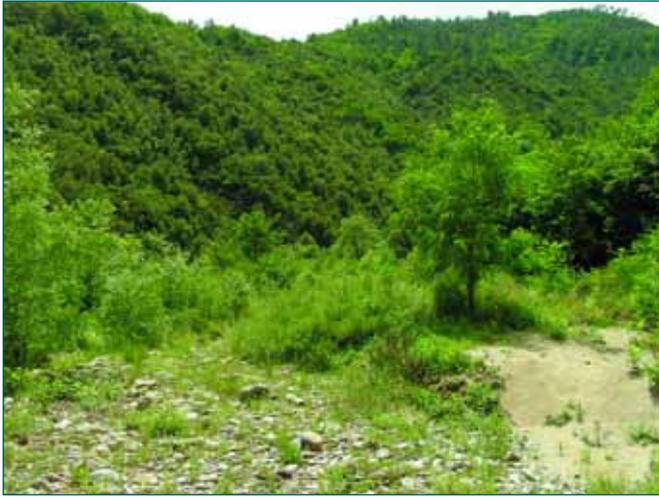
Discrete sand deposits on side bar; FRA-8.

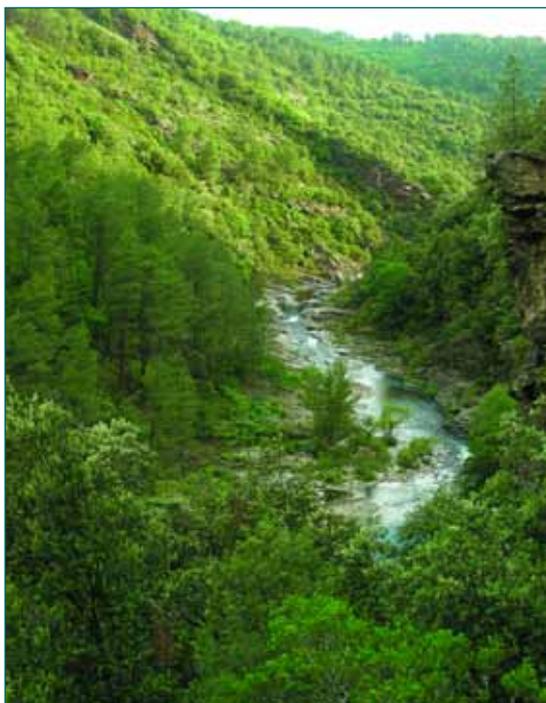
Shading in deep, gorge-like valleys could influence channel vegetation; FRA-10.

*Consider* encouraging surveyors to note the occurrence of natural shade (such as caused by narrow gorge profile) in addition to tree-related shade (Section J).
