Our crumbling buildings

stone decay, and calculate the volumes of replacement stone that are required for repairs. The project, 'Safeguarding Glasgow's Stone Built Heritage', is intended to produce hard facts and figures to help the city to maintain its built heritage in the future.

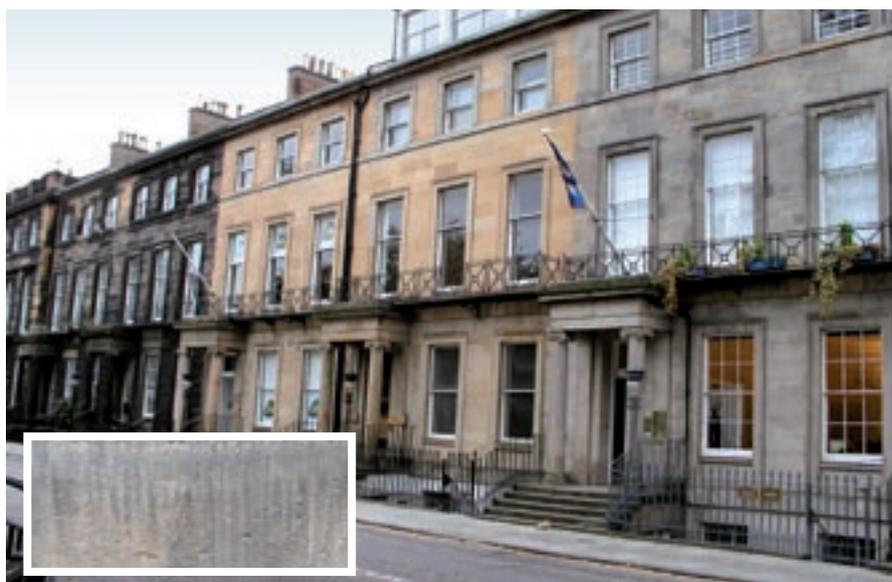
Typical sandstone buildings showing variable appearance due to the use of different stone cleaning techniques. All the buildings are constructed from the same stone type. Inset shows damage to stone masonry surface due to the application of corrosive cleaning chemicals.

Significant damage to sandstone buildings has been done by stone cleaning, where the action of corrosive chemicals and abrasive methods

has removed the external protective hard patina, exposing weakened underlying layers of stone which are prone to relatively rapid weathering. The introduction of expansive salts, during chemical cleaning, into the pore structure of sandstone has resulted in irreversible damage to the fabric of many stone buildings. New research is being targeted to determine the detailed damage mechanisms and to understand the effects of increased rates of decay on damaged stone in the face of climate change. The BGS has initiated two Ph.D. studentships specifically to investigate these issues.

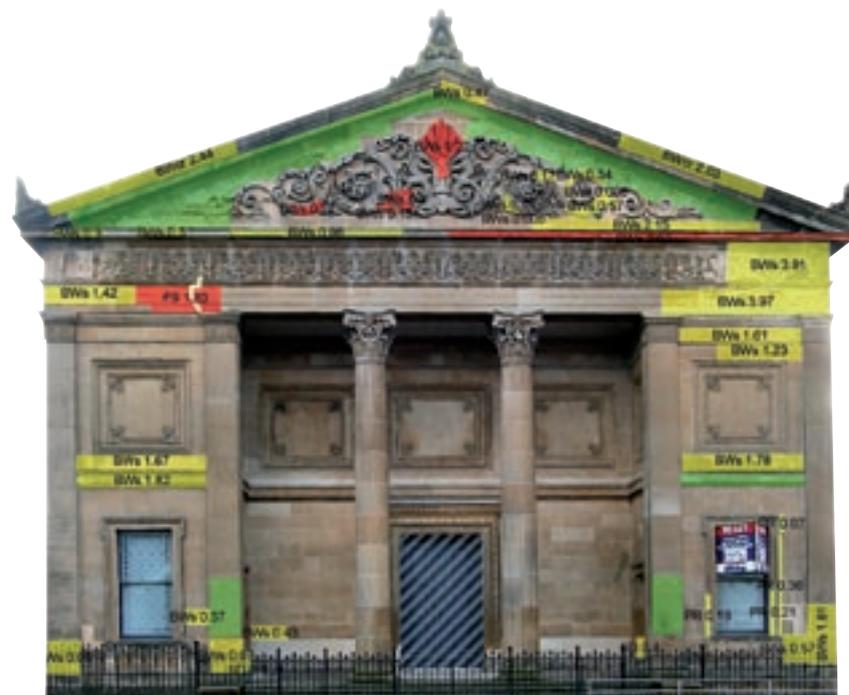
Rectified image of a listed building in Glasgow digitally overlain with coloured areas highlighting different types of stone decay. This methodology has been developed to allow a rapid assessment of the stone condition of historic buildings.

in Glasgow and develop a methodology for rapidly assessing building façades. The results will provide quantitative estimates of the amount and severity of

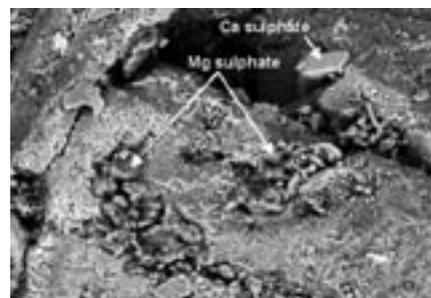
Scanning electron microscope image of a building sandstone, showing magnesium sulphate salts on the surface of individual quartz grains as a result of contamination from chemical cleaning. These salts can expand resulting in the break-up of the sandstone, rapidly increasing the rate of stone decay.
