## **The classification, recording, databasing and use of information about building damage due to subsidence and landslides**

*Quarterly Journal of Engineering Geology and Hydrogeology*, 2008. Vol. 41 (3).  
409-424. 10.1144/1470-9236/07-223

**Anthony H.Cooper**

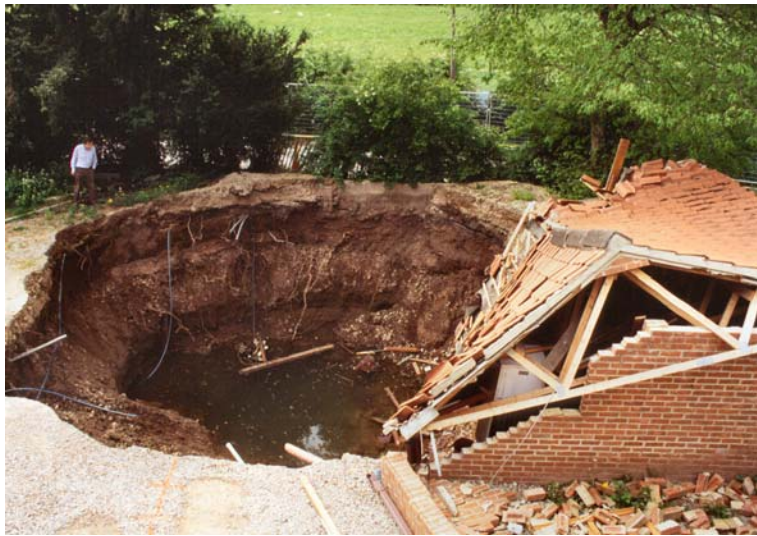
Figure 2. Category 7 building damage at Ure Bank Terrace, Ripon. The damage here has been caused by gypsum dissolution and collapse with loss of support under most of the building (Cooper, 1998).

The lowest 1-5 categories of the damage scheme have previously been successfully used to record building damage in Ripon, North Yorkshire (Figures 2 and 3; Griffin, Unpublished MSc thesis, Newcastle University, 1986; McNerney unpublished BSc thesis Sunderland University, 2000). The same methodology has also been applied to the historical city of Calatayud in Spain (Figures 4 and 5; Gutiérrez et al., 2000; Gutiérrez and Cooper 2002). After these studies and in the light of more recent work, it became apparent that the NCB (1975) scheme required additional classes to enable more severe damage to be recorded. Extension of the recording into more open land was also possible. The extended scheme with classes 1-7 was instigated for use in the British Geological Survey karst geohazards database (Cooper et al., 2001).

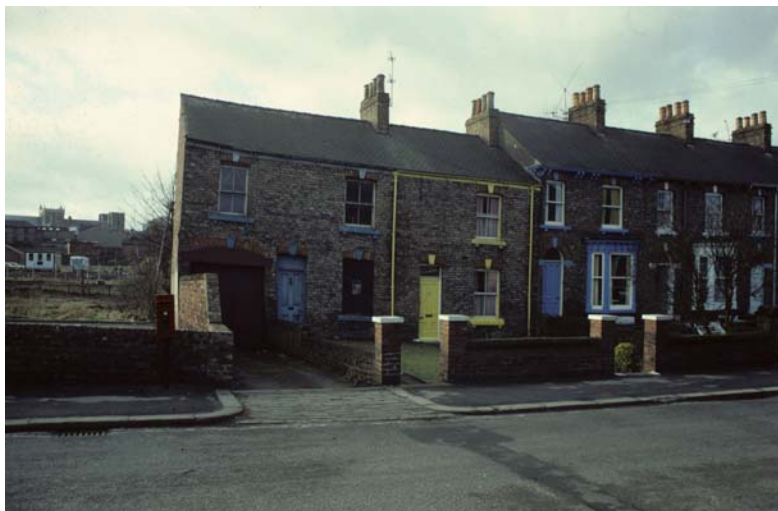
Figure 3. Sagging building damage Category 5 caused by gypsum dissolution and associated settlement on peat deposits, Princess Road, Ripon (Cooper, 1998).

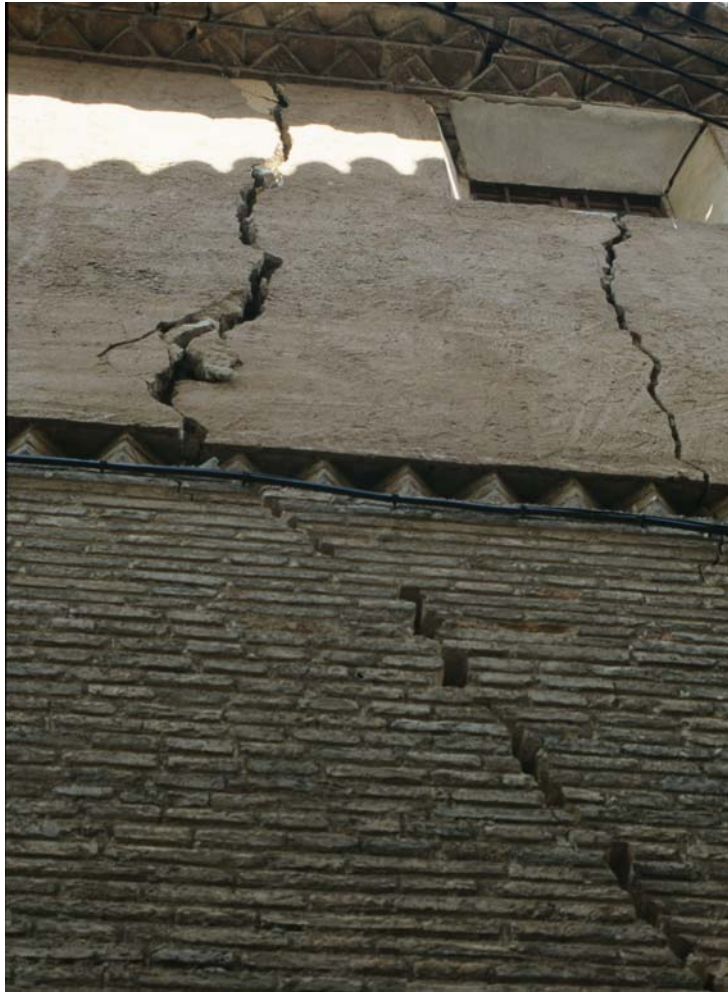
Figure 5. Cracks in historic building of Colegiata Sta. María La Mayor in Calatayud, Spain, here the cracks are up to 30 mm wide, others on the building are larger and the degree of damage merits a Category 5 classification, (Gutiérrez and Cooper, 2002).

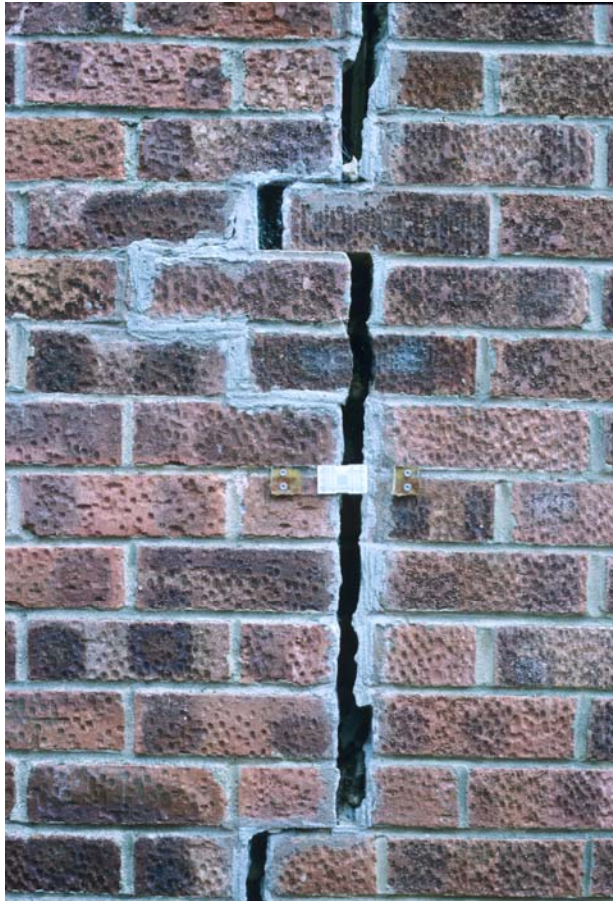
Figure 6. 18 mm crack in wall of house at Hutton Conyers near Ripon, damage caused by subsidence at side of large doline formed by the dissolution of gypsum. Category 4 damage formed by loss of support and rotation of the floor slab.

Of necessity, the surveys in Ripon and Calatayud could only be undertaken from outside the properties (Figure 6) and usually remotely from roads or public land. Consequently, only the more severe levels of damage (above category 2) could be surveyed. The surveying techniques involved walking around the towns noting the damage ratings on topographical maps and making additional notes in notebooks. Since then, the British Geological Survey karst geohazards database has been established with direct input of data to a database using a GIS interface (Cooper et al., 2001). Initially proformas were developed to duplicate the database fields and allow information to be collected in loose-leaf notebooks (Figure 7). Other loose-leaf sheets were also printed for recording springs, dolines, stream sinks and natural cavities (Cooper et al., 2001). Recent developments of rugged waterproof mobile tablet personal computers and the development of the British Geological Survey digital field mapping system allow the gathering this type of data directly into a GIS in the field in the form and structure that the centralised database requires.
