Photographic Feature

Subsidence caused by gypsum dissolution at Ripon, North Yorkshire

Anthony H. Cooper¹ and Antony C. Waltham²

Published 1999 in *Quarterly Journal of Engineering Geology*, Vol 32, 305-310

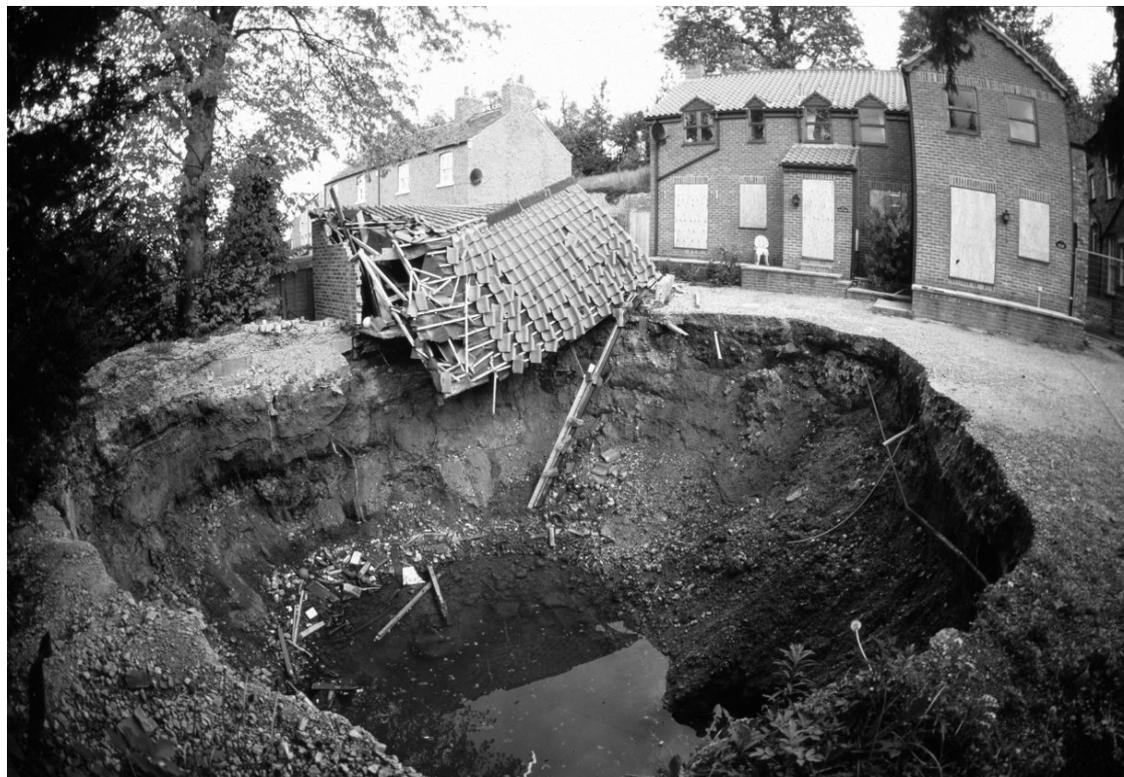
FIG. 1. The new sinkhole at Ure Bank Terrace, Ripon, looking north-east. The hole formed in April 1997, and measured 10m across and 5.5m deep. It was caused by collapse over a cave formed in gypsum of Permian age. Photograph by Tony Waltham.

Overnight its sides collapsed inwards, so that the hole had doubled in size by the next morning (Fig. 1). The sinkhole was then 10 m in diameter, and was 5.5 m deep to a choke of debris covered by water 1 m deep. Its sudden appearance was of considerable concern to the occupants of the adjacent house, and the event was widely reported in the national press and media.

There is no simple remediation for a major sinkhole collapse like that in Ure Bank (Fig. 1). Filling the subsidence crater merely creates temporary support for the sides of the collapse; long-term stability of the fill cannot be guaranteed, and many older holes that have been filled in this way have collapsed again. A subsidence sinkhole over limestone may be repaired by excavation to rockhead, placing chunkrock too large to enter the bedrock fissures, and backfilling to ground level. Many of the Ripon subsidences are in drift too deep to excavate to bedrock economically, and breccia pipes of large diameter can render this approach unreasonable. Geogrid mattresses sunk within the collapse zone or placed across at ground level can offer only temporary respite in an active sinkhole, before it is ultimately undermined.

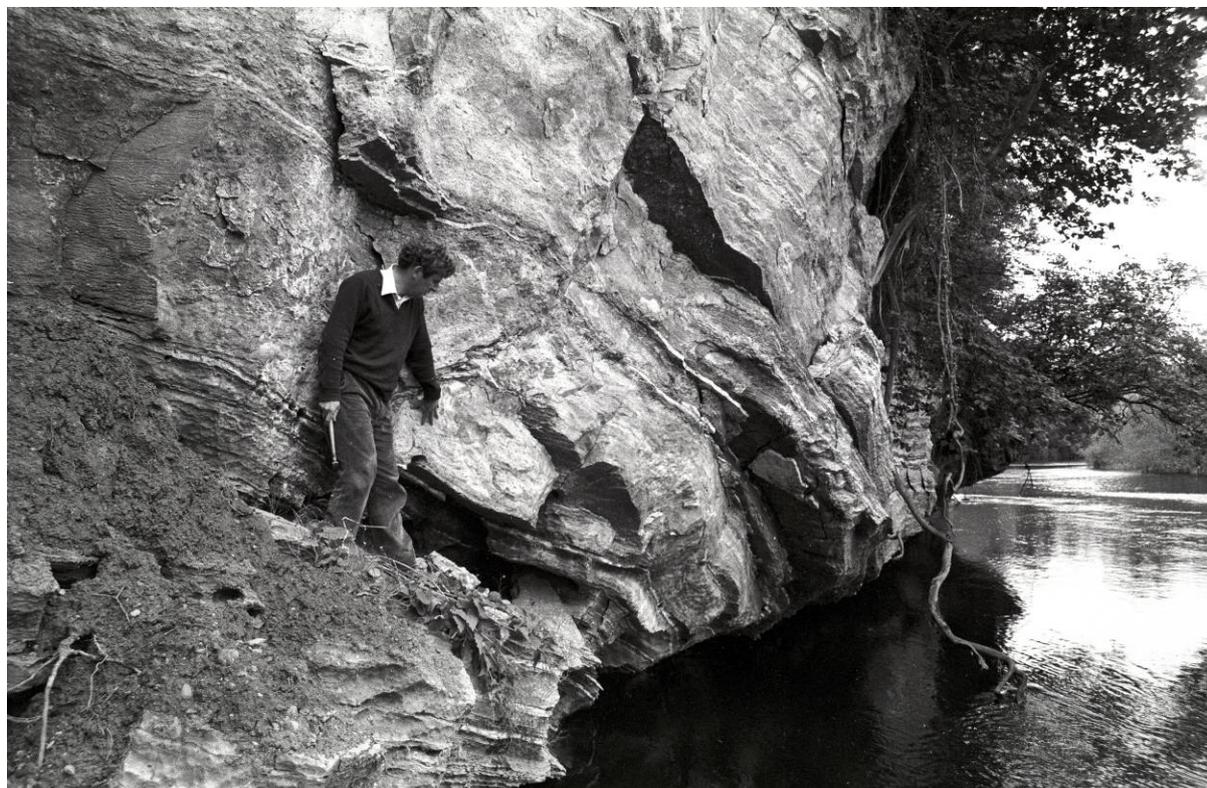
FIG. 3. River cliff developed in the Edlington Formation gypsum at Ripon Parks, 3.5km north of Ripon. This photograph was taken in 1980 when the face was undercut by about 1.5m. By August 1989 the undercut measured about 6m, and the full flow of the river passed through it, before the face collapsed some time later that year. Photograph by Anthony Cooper.

Gypsum dissolves very rapidly under flowing water, and normal river flow of about 1 m/s can dissolve up to about one metre of gypsum per year. This rate of dissolution has been verified by many years of observation of the low cliffs (Fig. 3) along the River Ure at Ripon Parks, 3.5 km north of Ripon (James *et al.*, 1981); around 6 m of undercutting of the cliff has taken place inside 9 years, before the face collapsed into the river.

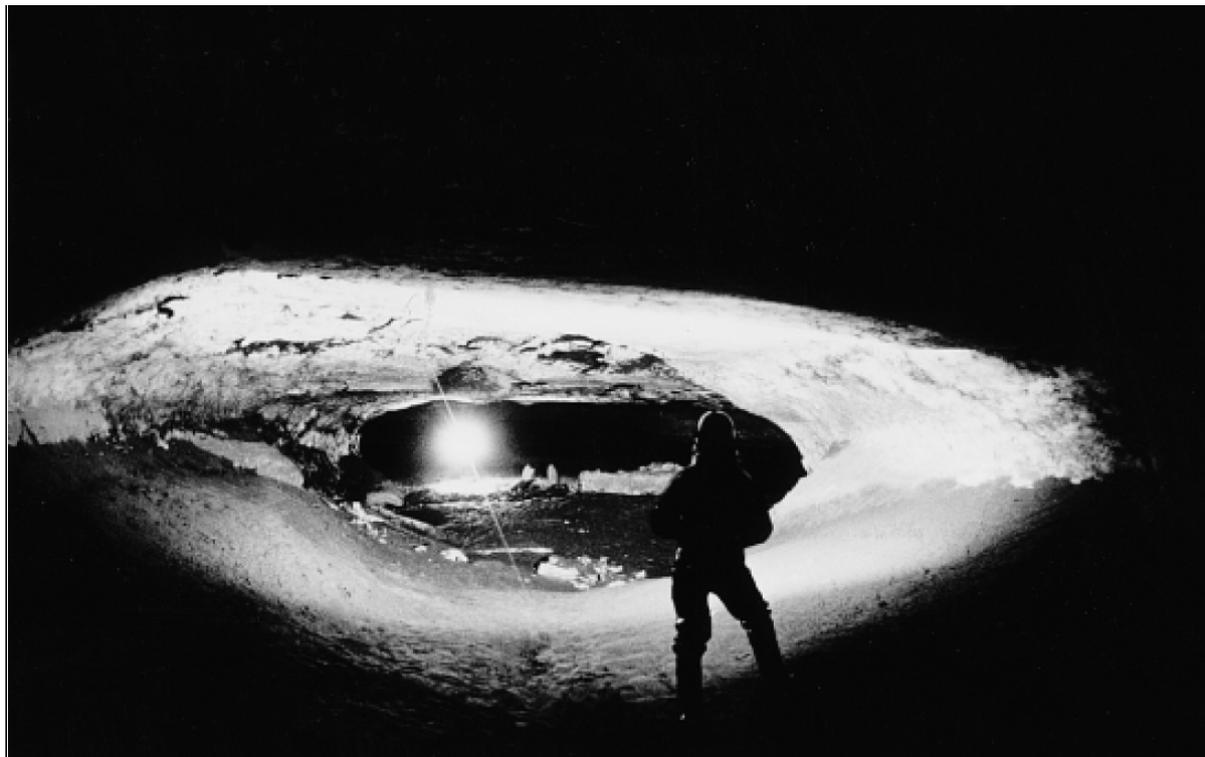
FIG. 4. Cave passage within a bed of Permian gypsum at Pinega, Russia. The cave was enlarged partly by subglacial or proglacial meltwater in an environment which may be compared to that of the Ripon area during the Devensian. Photograph by Tony Waltham.

These high rates of dissolution create a significant potential for the rapid development of cave systems where there is throughflow of groundwater within the beds of gypsum. Caves are known in gypsum throughout the world (Klimchouk *et al.*, 1996). In dolomite/limestone and gypsum sequences, their most common morphology is a rectilinear maze in two dimensions, due to dissolutional opening of intersecting joints within a the gypsum confined between the sequences of other material. Such caves are normally formed by slowly moving water in the phreatic environment. Passage widths in these maze caves are generally only 1-3 m, but in some mazes the gypsum bed has been removed across more than half of its area, in the manner of a pillar-and-stall mine. Larger linear cave passages are formed where groundwater flows are high (Fig. 4). In karst terraines of low relief, this can occur where melting glaciers provide massive flows of subglacial water; gypsum dissolution is not restricted by low temperatures (Waltham, 1994).

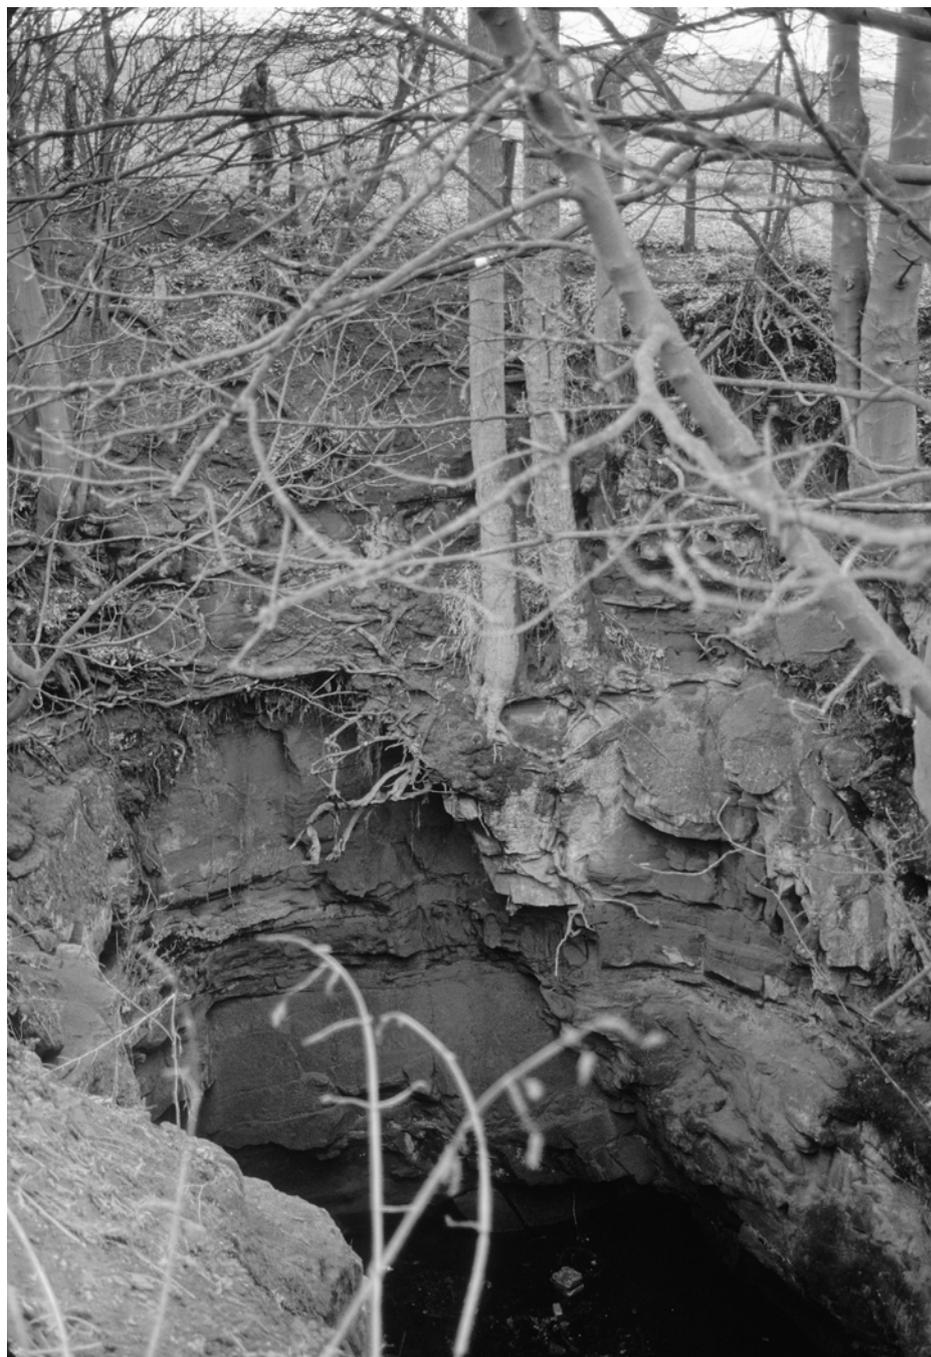
FIG. 6. Vertical shaft that formed by a drop-out collapse in July 1834 near Ripon railway station. The cylindrical sinkhole is 14m in diameter and 15m deep with red Sherwood Sandstone exposed in its sides. Photograph by Anthony Cooper.

The breccia pipes commonly reach through considerable thicknesses of solid rock above buried gypsum horizons, to create sinkholes in outcrops of insoluble rocks. One hole formed near Ripon station in 1834 and remains open today; it is 11 m across, and exposes solid Sherwood Sandstone in its sides down to a depth of at least 15 m (Fig. 6). A borehole near Ripon penetrated undisturbed drift and then solid rock to a depth of 24 m, before descending through 4 m of unconsolidated cave sediments containing housebricks. There is no doubt that the gypsum caves are active, and are continuing to swallow material from above.

The presence and threat of these sinkhole collapses is significant for urban development in the Ripon area, and provides special problems in site investigation. For example, if a typical site investigation borehole was drilled close to the rim of the station sinkhole (Fig. 6) it would prove solid red sandstone to a depth of over 15 m, but only a few metres away there is a catastrophic subsidence. Complete assessment of the subsidence hazard at a site in Ripon could demand large numbers of closely spaced boreholes, which may have to reach depths of 60 or 70 m. This is clearly an uneconomic proposition for most development. Geophysical surveys by microgravity (Patterson *et al.*, 1995) or resistivity tomography have potential to identify anomalies in such areas and reduce the dependence on boreholes; however, these techniques have limitations in their depth penetration, their decrease of resolution with depth and the interference caused by the edge of the River Ure buried valley.

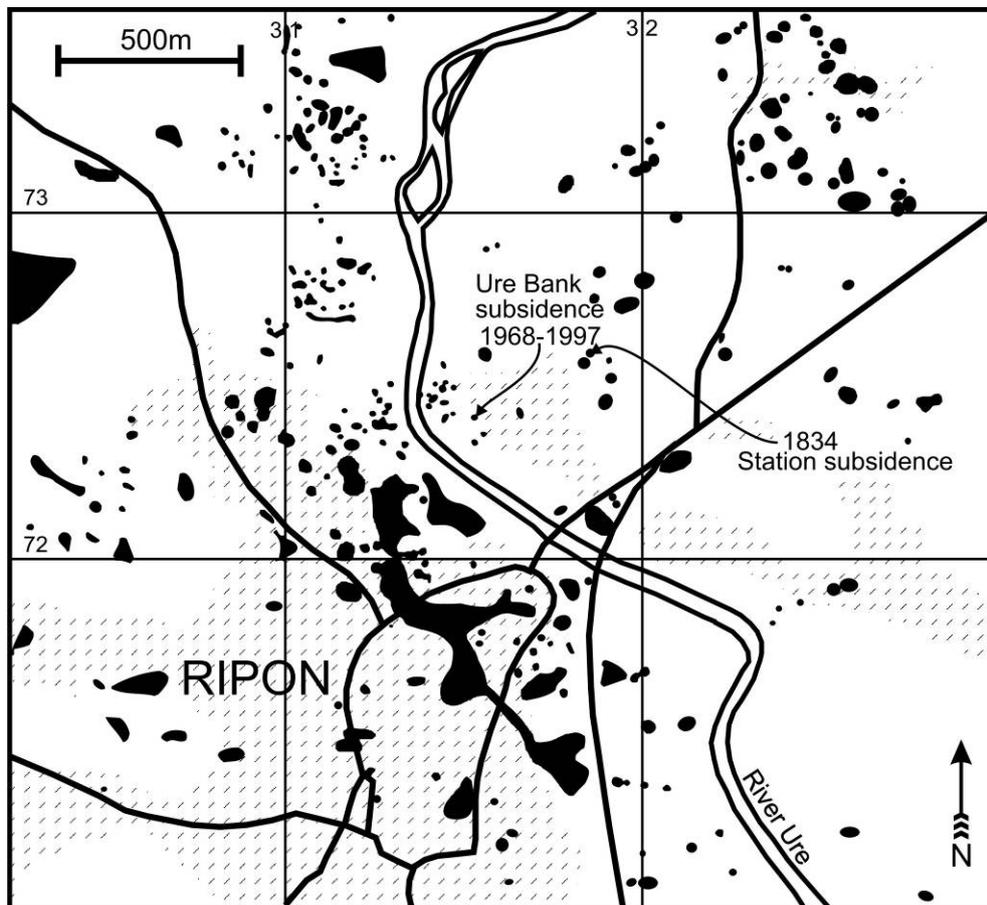
FIG. 7. The distribution of sinkholes and subsidence hollows (both shown in black) in the Ripon area, whose built up area is shown stippled. Dates of the subsidences are given where known, and the named sites are referred to in the text.

Within the subsidence-prone area of Ripon, one precaution that is practicable is to avoid development on known sites of current or historical instability (Fig. 7). To these should be added exclusion zones around unstable features, and these may need to be 20 m or more wide; once a collapse has occurred dissolution can continue in the adjacent gypsum to cause another collapse, and in areas of thick drift, sinkholes can enlarge laterally as soils slump into narrow pipes. Because of the problems of liability it is also important not to leave known sites of potential instability within private gardens. House insurance covers the properties, garages and structures, but does not include the land; householders with subsidence hollows on their land could be held responsible for peripheral damage or threat to neighbouring property. Since these holes may be difficult, expensive or impossible to remediate, they are very undesirable to own.
