### **Research & Consultancy Report No. 39**

NOC Liverpool report for the UK-IMON Project  
April-June 2013 Unit 194  
Glider deployment

C Balfour & M Palmer

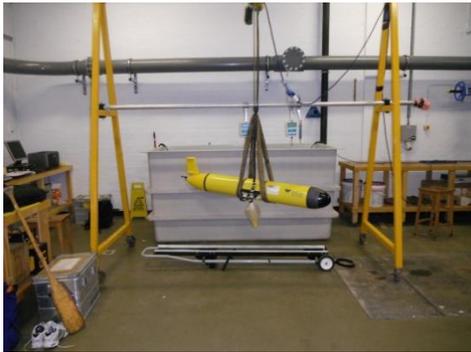
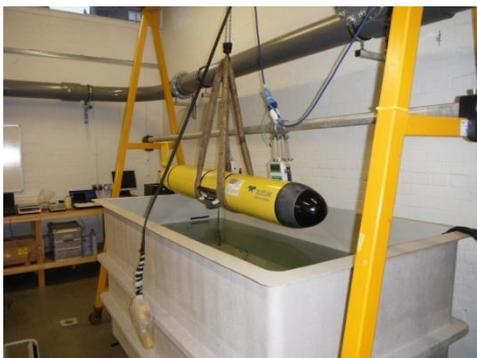
**Fig. A1. Unit 194 Glider Preparations for the UK-IMON Irish Sea Survey**

Glider preparatory area, lifting gantry, glider transportation trolley and saltwater test tank

Preparation of the glider for ballasting testing

The intended deployment conditions were simulated in the test tank and the glider ballasting was verified

The glider was taken apart to visually inspect the status of the glider internal components after shipment to Liverpool and assess the scope for making ballasting adjustments. When an attempt to separate the forward hull section and watertight o ring seals was made this proved to be difficult to accomplish. As the seals eventually separated under load one of the internal electrical connectors was damaged. The plastic retaining latch from one of the connectors between the forward science bay area (just forward of the centre of the glider) and the pitch battery position control assembly in the front of the glider was damaged. After consulting the glider manufacturer TWR a replacement connector was ordered, delivered to Liverpool and installed to rectify the problem. Visual inspection had shown a set of ballasting steel plates, lead strips and plastic bottles with lead shot had been used to ballast the forward section of the glider. One of the plastic ballasting bottles in particular, fitted around the outer casing of the buoyancy pump assembly, was compressed against the lower part of the internal carbon fibre composite hull. This tended to offer resistance to taking the glider front sections apart

and the fastening cable tie was relatively loose. Photographs were taken of this arrangement and the glider was carefully reassembled for ballasting testing. The unit 194 glider ballasting setup was tested in a saltwater ballasting tank in the University of Liverpool (UOL) Hydraulics Laboratory (Fig. A1). The estimated mean deployment conditions were simulated in the test tank by mixing the solution of synthetic sea salt in the ballasting tank to the required density. The elevated temperature of the tank in a laboratory environment, when compared to the likely seawater temperature at the intended glider deployment location in the western Irish Sea, was also taken into account. When the anticipated deployment conditions were simulated in the laboratory based tank the correct ballasting of the glider was confirmed. The unit 194 glider was determined to be approximately 20g too light when it was tested in the tank. This small offset was comfortably within the range of the unit 194 glider buoyancy pump. When deployed, a coastal (up to 200 m depth limit) Slocum glider standard buoyancy pump has an approximately  $\pm 250$ g mass change capability from the neutral (with the pump in its mid range position) ballasted configuration. The H distance or distance between the centre of buoyancy and gravity in the glider was also tested and confirmed to be within manufacturer's guidelines.

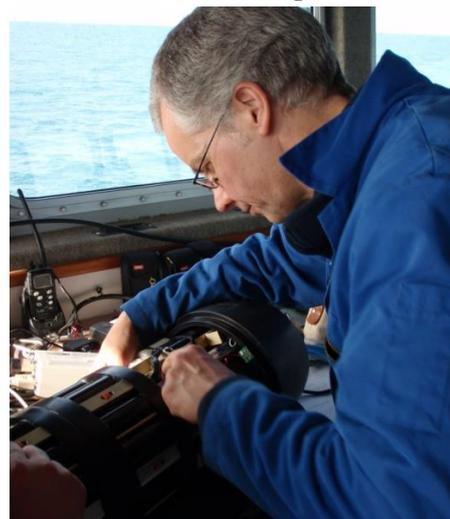
**Fig. C3. Slocum electric glider repairs onboard FPV *Barrule* on 6<sup>th</sup> April 2013**

Repairs to the internal cabling around the front buoyancy pump assembly in the enclosed bridge area of FPV *Barrule*

Rerouting of the repaired altimeter cable

During disassembly it transpired that one of the internal ballasting bottles (containing lead shot) was held in place with a cable tie that was close to the internal altimeter power, ground and signal cable assembly. This ballasting bottle was not securely fastened and it is likely that movement of the cable tie during glider ballasting and testing operations (assembly and disassembly, addition of ballasting weights etc) and subsequent transport of the glider had damaged this cable. The red lead (altimeter power) had been severed and a repair was implemented by rejoining the cable and adding some insulation around the repair.

The repaired cable was then rerouted away from the ballasting bottle area. Two new cable ties were then carefully positioned inside the glider, on the outside of the buoyancy pump assembly, to securely fasten the problematic ballasting bottle in position. The glider hull seals were then serviced by cleaning the sealing faces plus o rings and applying silicon grease and reassembling the seals. The glider was then carefully reassembled and an internal vacuum was generated using an external pump in line with manufacturer's guidelines. A series of onboard tests then verified the glider was operating correctly. The repaired glider was then deployed again using the ship's RHIB. A series of vehicle status checks and test dives of incremental depths were undertaken before committing to a series of full depth tests that will rely on the integrity of the glider altimeter to operate correctly. Downloading and subsequent data plotting of the glider sensor data onboard FPV *Barrule* demonstrated that the glider was

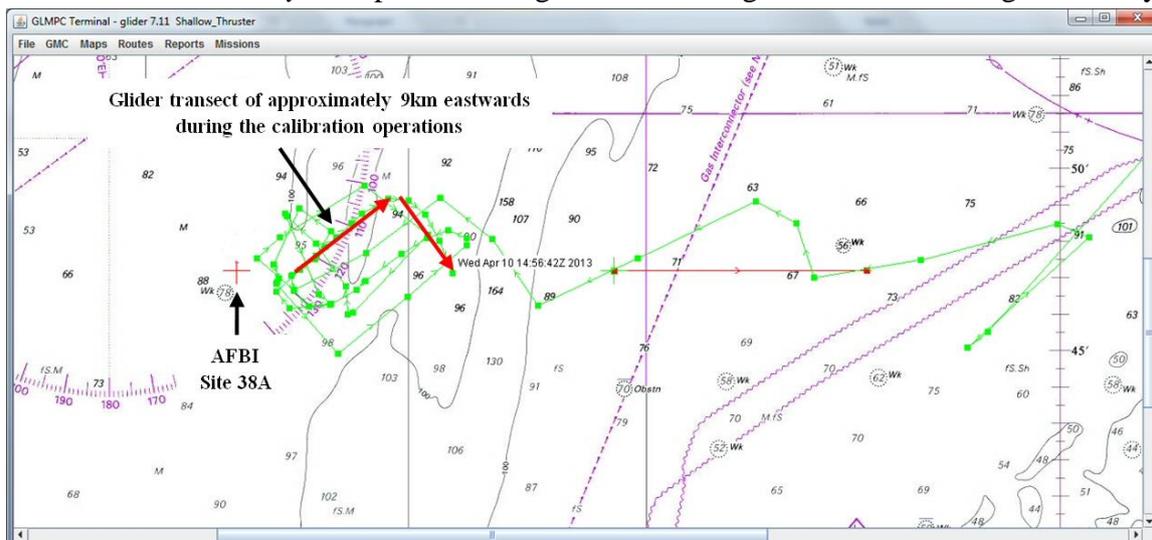
**Fig. D3. Unit 194 Glider Transect during the RV *Corystes* based sensor calibration cruise**

As indicated in fig D3 the glider navigated approximately 9km eastwards during the survey. The green squares represent the reported glider positions and the path of the glider is also indicated using the red arrows. An AIS plot is shown of the position of RV *Corystes* during the sensor calibration operations is shown in Fig D4.

The glider had travelled approximately 9km east during the day along a curved transect from the starting position close to Site 38A in the morning. The curvature of the glider transect was caused by the influence of tidal currents as the glider navigated underwater. It was noted that there was an approximately 1.5°C temperature difference between the first surface and bottom samples taken at Site 38A at the start of the RV *Corystes* survey. This temperature difference reduced during the day as the calibration sampling progressed. This provided an indication that some level of differences in the water column properties occurred during the procedure, as the glider and ship travelled eastwards. Changes in the water column properties were required from a scientific measurement perspective in order to provide sensor calibration information while studying varying water column conditions.

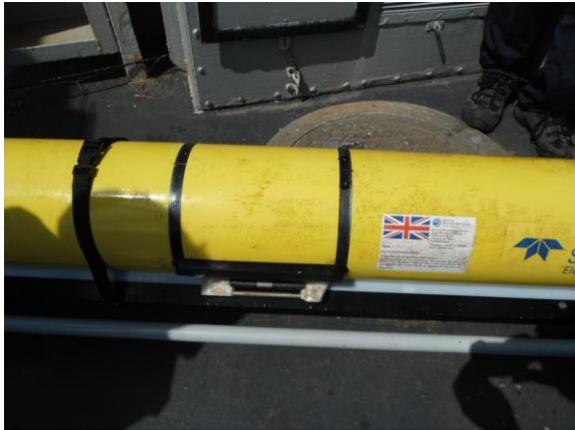
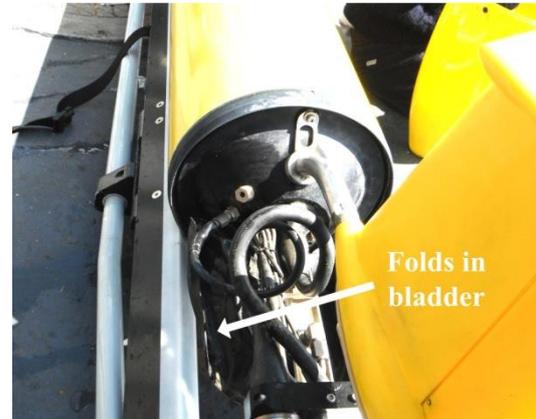
glider are shown in Fig. G4. There was some evidence of minor corrosion and outer surface biofouling during the initial unit 194 glider evaluation. There was also an accumulation of fine sediment inside the rear tail cowling that may have provided opposition to the uniform inflation of the rear tail section bladder.

Minor hull/sensor biofouling in the form of an apparent algae plus sediment deposit

Slight hull corrosion (white spots/deposits) on the metal inter hull sections

Rear tail mounting corrosion and rear zinc anode degradation

Some folds were apparent in the rear tail elevation bladder that is inflated during glider surfacing

The sacrificial zinc anode to the rear of the glider had degraded during the deployment. Rapid anode degradation has been previously observed and it is something that tends to regularly occur with coastal instrumentation. After a very brief review of the recovered glider status it was apparent that the glider was in good condition after a challenging survey of almost 2 months in duration. The glider was first washed down with fresh water and dried. All of the glider hull seals, with the exception of the forward hull seal just behind the nose cone section were opened, cleaned, re-greased and reassembled. This occurred during the internally recorded data recovery process onboard FPV *Barrule*. It was also noted that at the end of the deployment the total number of glider underwater inflections were reported as being in excess of 20,000 (20792 was the last reported value during the glider survey). In line with TWR guidelines it was recommended that a routine replacement of the buoyancy pump rolling diaphragm for the unit 194 glider should occur before the next deployment.
