# Development of a risk assessment tool to assess the significance of septic tanks around freshwater SSSIs

Phase 1 – Understanding better the retention of phosphorus in the drainage field

First published 03 February 2015

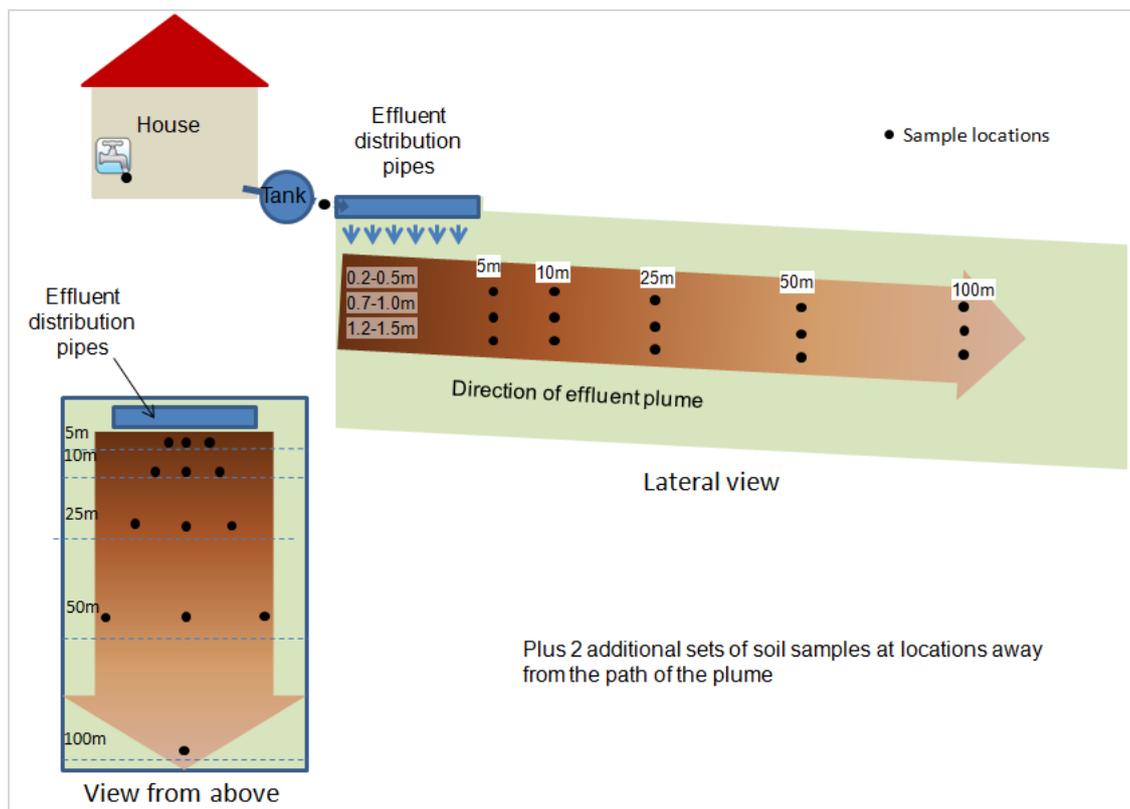
**Figure 1** Outline sampling strategy for collecting tap water, septic tank effluent, and soil and porewater samples from the soakaway

Soil samples from within the soakaway were collected at various and increasing distances from each tank (i.e. approximately 5 m, 10 m, 25 m, 50 m, 100 m), and along the most likely direction of travel of the effluent plume (Figure 1). This direction of travel was determined, initially, from the surface topography using Ordnance Survey® maps. However, minor modifications to the overall sampling regime were necessary at most sites to take account of local conditions and issues relating to access. In addition, at OXON3, sampling was focused on an area below the effluent distribution pipes to investigate downward, rather than horizontal, movement of the effluent plume at this site.

Soil cores, approximately 0.3 m in length, were collected with a standard auger (Plate 1) at approximately 0.5 m depth intervals, where possible, across the drainage field (Figure 1). These samples were collected to provide information on changing soil P status and porewater P concentrations with depth and distance from the source. In many cases, sampling and subsampling strategies had to be modified to take account of local site conditions, such as soil structure and the depth of the underlying bedrock material. At the Hampshire sites, it was not possible to take samples close to the tanks as these were situated in inaccessible private gardens.

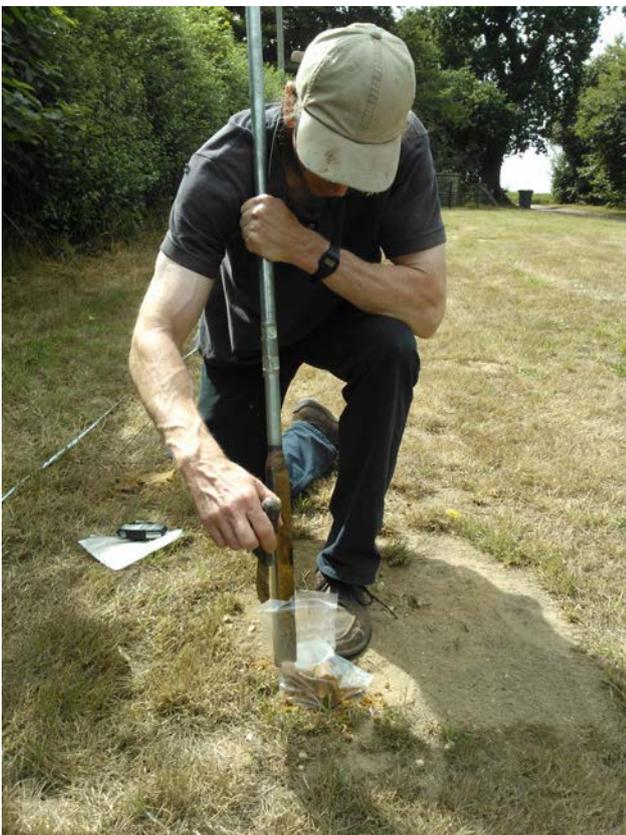
**Plate 1** Soil coring with an auger

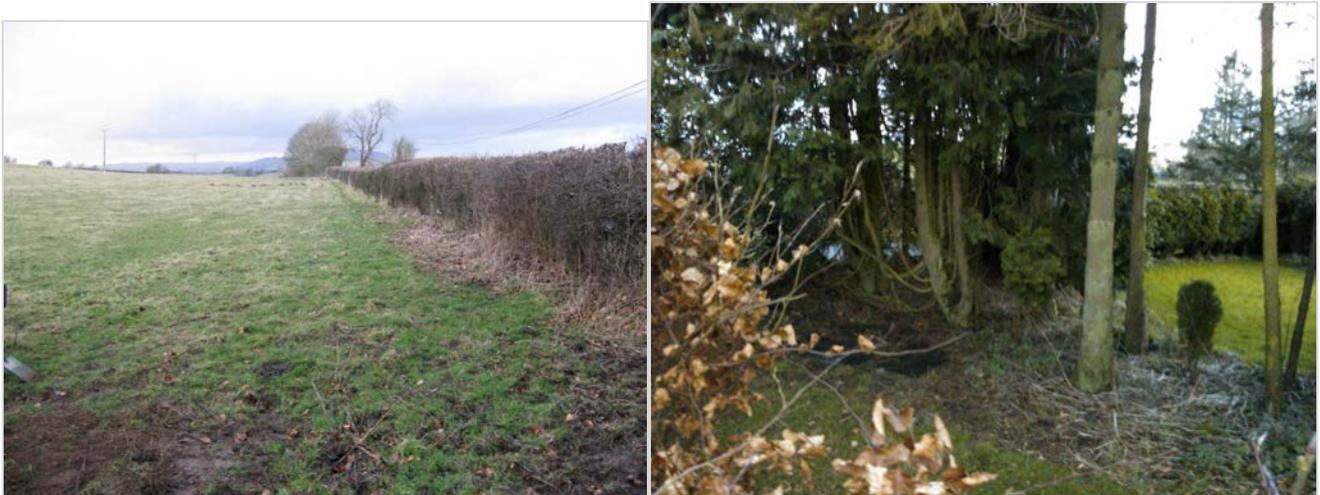
**Plate 2** Septic tank location (left) and drainage field (right) at site CLUN1

The septic tank at this site was estimated to be about 45 years old and was constructed of brick. It was not in a good state of repair and presented a health and safety risk to the field team. In particular, the manhole cover was so badly corroded that it could not be lifted. So, no tank samples could be taken at this site. However, it was possible to collect a water sample from the kitchen tap and a full set of soil samples from the drainage field, albeit to a rather shallow depth.

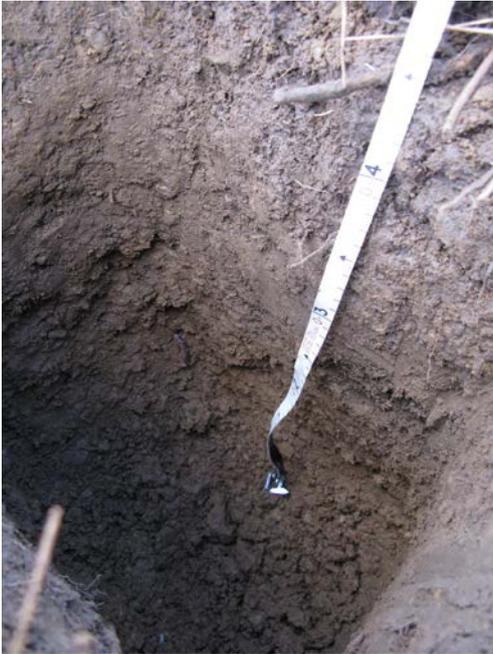
**Plate 3** Soil profile within the drainage field at site CLUN1

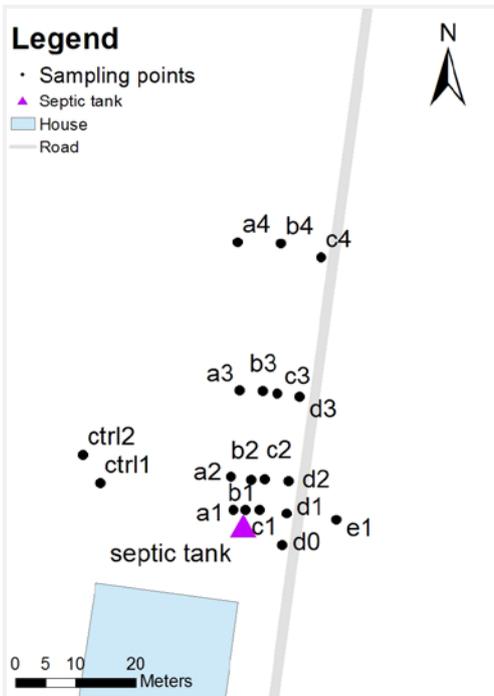
**Figure 3** Distribution of sampling points at Site CLUN1

The distribution of sampling points for this site is shown in Figure 3. The soils in the drainage field were silty, slightly red in colour and very stony beyond about 0.4 m depth (Plate 3). The bedrock (sandstone) was situated at about 0.5 m and 0.7 m below the surface, so most of the drainage area could be sampled to a depth of 0.2 – 0.5 m, only. In some locations, sample depths of up to 0.8 m were possible. Most of the samples taken near the septic tank had a maximum depth of about 0.5 m.

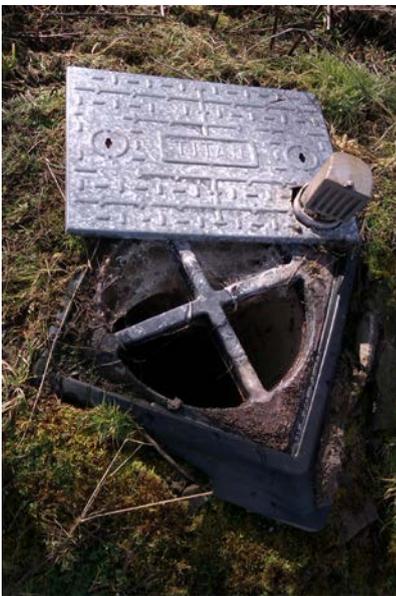
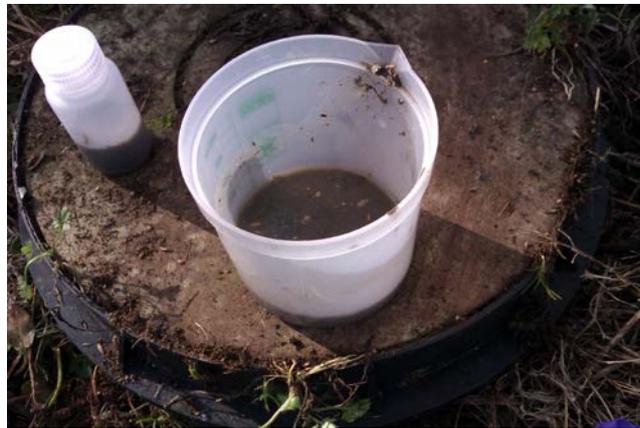
**Plate 4** Septic tank access point and sludge collected from the storage tank at CLUN2

The septic tank serves holiday accommodation with seasonally varying occupancy and, at times, remains unused for long periods. It was readily accessible (Plate 4, left) but, at the time of sampling, the effluent was covered by a very hard surface crust. Although this was broken using soil augers, the volume of liquid effluent below the crust was small and was grossly contaminated by the solid crust material (Plate 4, right). So, no representative sample of the effluent plume could be collected at this site.

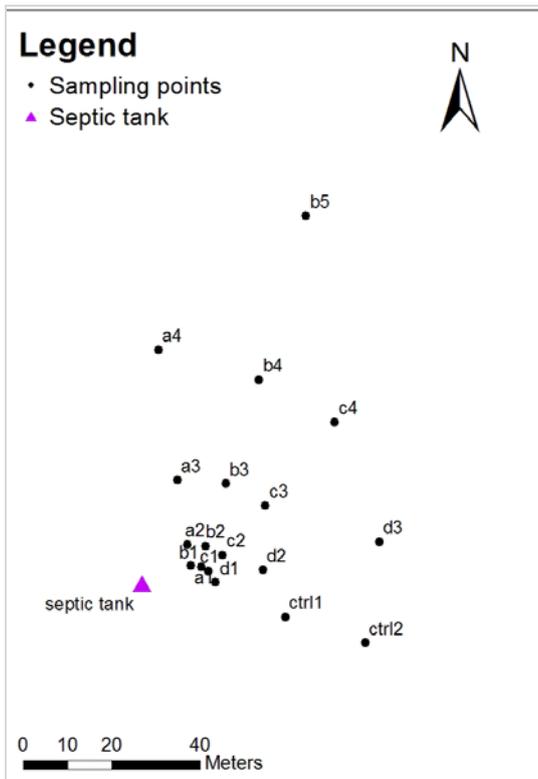
**Figure 4** Distribution of sampling points at site CLUN2

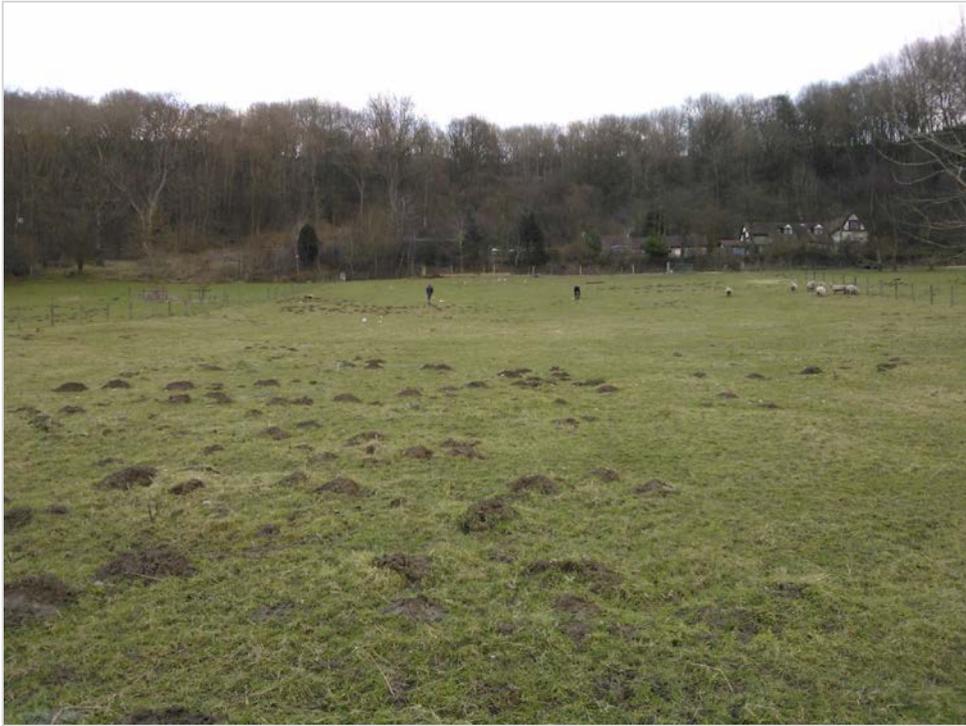
**Plate 5** Septic tank drainage field at CLUN3

The septic tank at this site was built of concrete and estimated to be about 21 years old. It discharged to a soakaway. The tank and the immediate seepage area around it were on a raised area close to some houses. Further away, the seepage passed under a small road and then down a very steep bank (5 m drop) into a sheep grazing field (Plate 5). Overall, the slope from the tank to the most remote sampling point was estimated to be about 26%. The tank was in a good state of repair and was readily accessible for sampling.

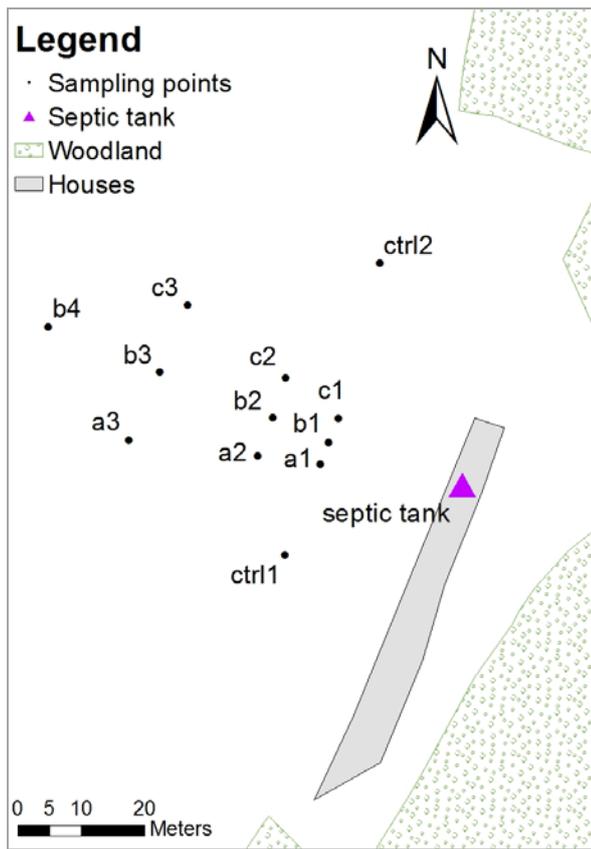
**Figure 5** Distribution of sampling points at site CLUN3

The distribution of sampling points for this site is shown in Figure 5. The soil in this area was silty clay with few stones, making sample collection much easier than at the other Shropshire sites. Most locations were sampled to a depth of 150cm. It was noted that a manure heap was situated close to site C1.

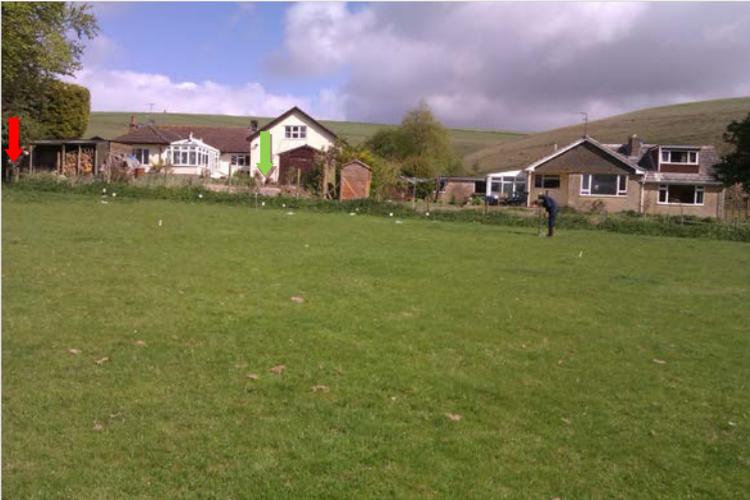
**Plate 6** Septic tank drainage field at WYLYE1 (red arrow) and WYLYE2 (green arrow)

These sites were next door to each other and it was determined that any potential discharge plume would probably flow downhill into the field to the rear of the properties, which was used for grazing horses (Plate 6). The sampling team was unable to gain access to the houses or gardens in this area. So, it was not possible to sample the tanks or tap waters, or collect completed questionnaires, at these sites. However, the householders did indicate the approximate position of their septic tanks to the sampling team. These are marked in Plate 6.

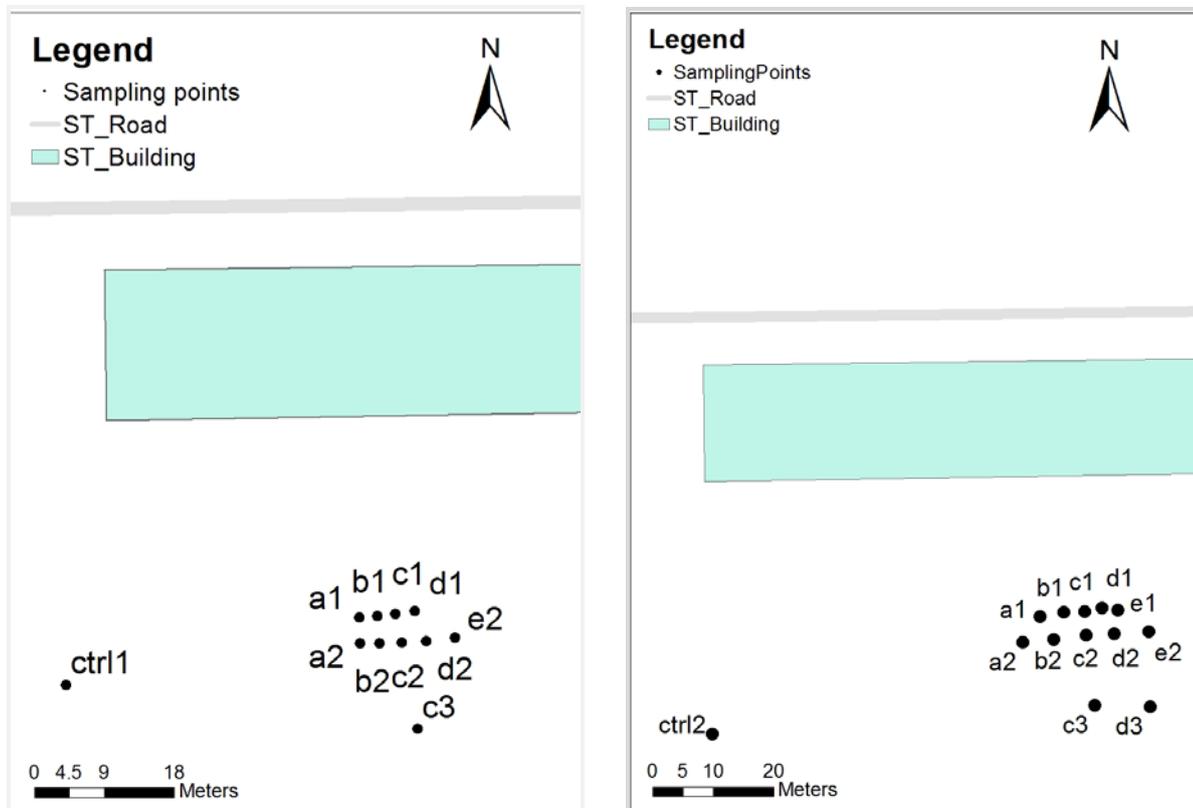
**Figure 6** Distribution of sampling points at sites WYLYE1 (left) and WYLYE2 (right)

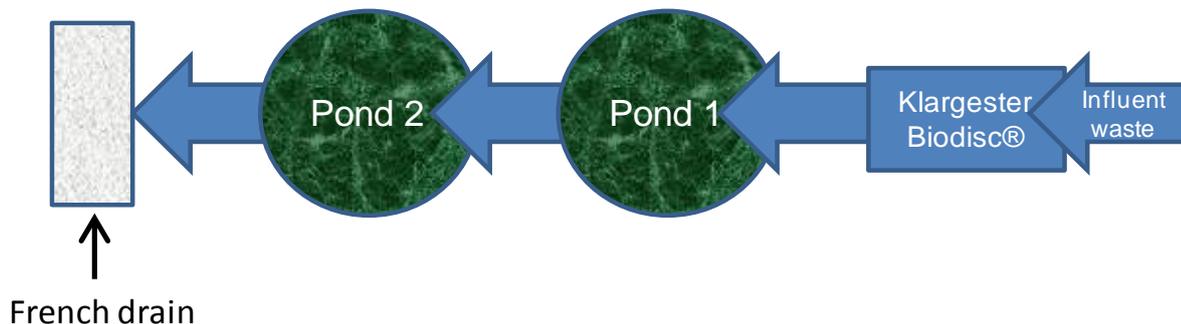
**Figure 7** Schematic diagram of the Klargester Biodisc®, ponds and French drain at OXON1

In contrast to the tanks at other sampling sites, the tank at OXON1 was a Klargester Biodisc® system (<http://klargester.com/products/BioDisc-BA-BD.htm>), not a simple septic tank. Klargester Biodisc® systems use a rotating biological contactor to encourage the formation of an active biofilm that improves sludge aeration and, consequently, the efficiency of wastewater treatment in the tank. As this improves effluent quality in line with European legislation (EN-12566) these systems are often permitted to discharge directly to a watercourse. However, it should be noted that this improvement in water quality only applies to biochemical oxygen demand (BOD), suspended solids and ammonium concentrations. Because there is no legal requirement to do so, the quality of the effluent in terms of P discharges is not regulated or tested.

It has been suggested that effluent quality from these types of tank can be improved prior to discharge to a drainage field or watercourse by incorporating a reed bed filtration into the system. In line with this recommendation, the installation at this site includes the tank itself and two treatment ponds (e.g. Plate 6). These are lined, to prevent seepage, and connected, in series, by a sealed pipe

that delivers treated effluent to a 'French drain' (Figure 6). The 'French drain' is 1 m wide, 1 m deep and filled with limestone. It discharges to a soil soakaway.

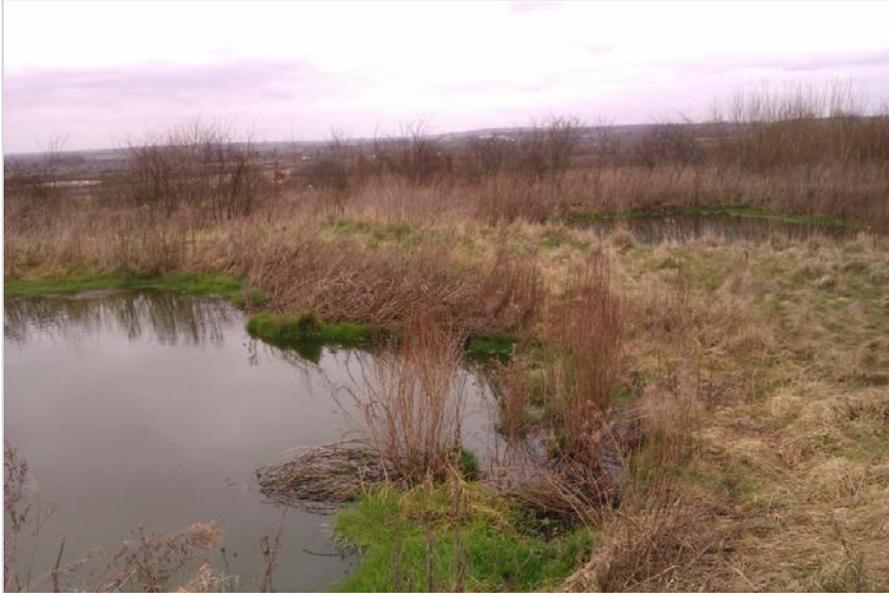
**Plate 7** Effluent processing pond at OXON1

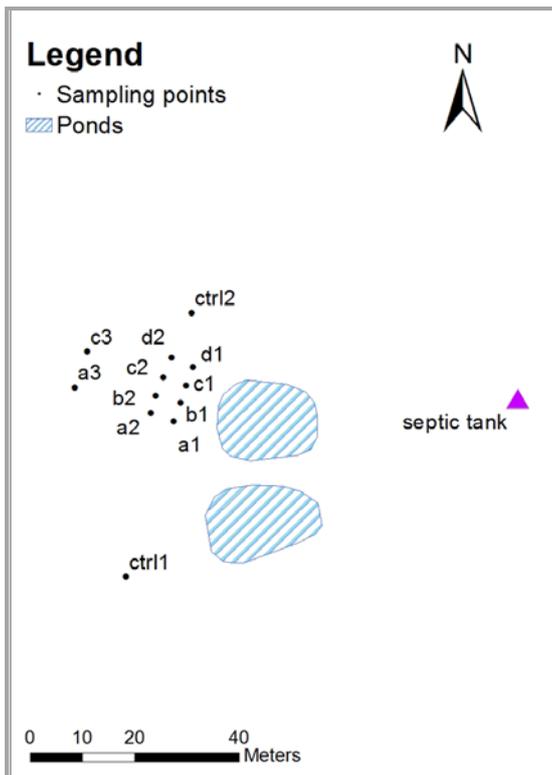
**Figure 8** Distribution of sampling points at site OXON1

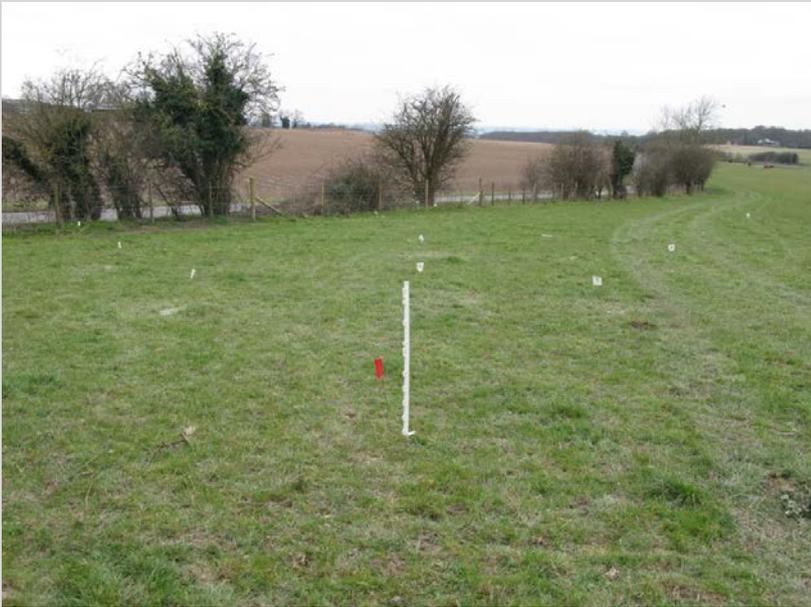
**Plate 8** Septic tank drainage field at the OXON2 site

The septic tank at this site was of unknown construction and believed to be about 9 years old. It was shared with neighbouring properties. The tank was readily accessible for sampling and discharged to a soil soakway that was downslope (6%) of the property (Plate 8).

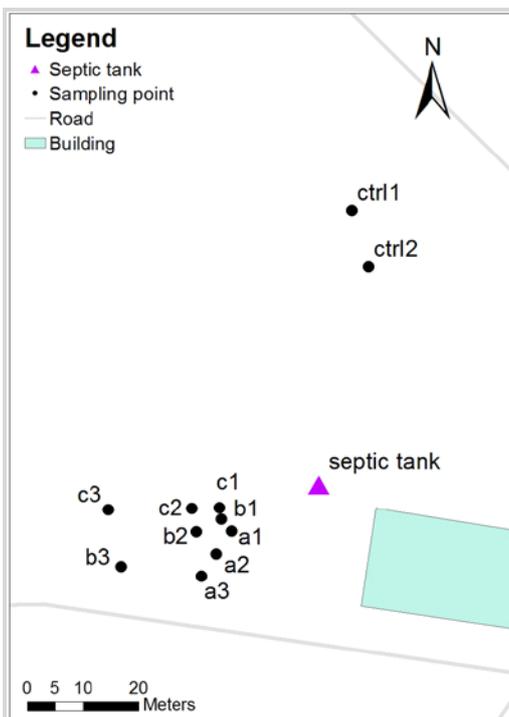
**Figure 9** Distribution of sampling points at site OXON2

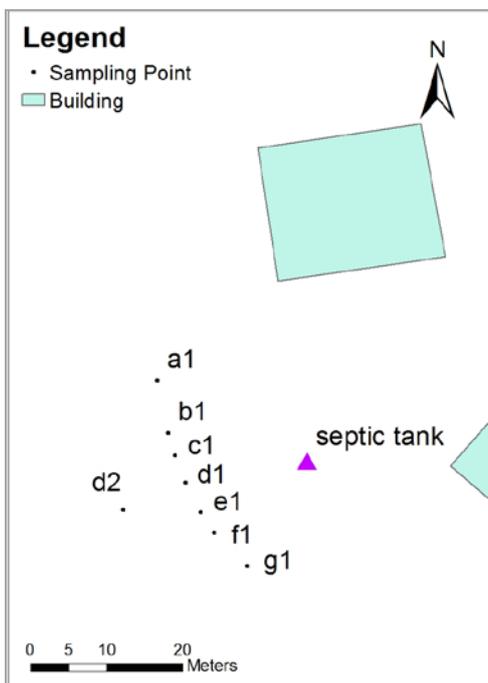
**Figure 10** Distribution of sampling points at site OXON3

OXON3 was at an isolated dwelling on the top of a hill, and was surrounded by farm buildings. The septic tank was behind a wall and a pipe carried the effluent under the wall to the finger drains and main seepage area, the location of which was known by the farmer. The ground sloped gradually (6%) away from the finger drains. The position of the effluent distribuion pipes were relatively well known by the farmer, who helped with the positioning of the soil sampling points. The field into which the effluent was discharged was under crops (wheat) at the time of sampling and, therefore, it was not possible to sample using the usual site distribution pattern.

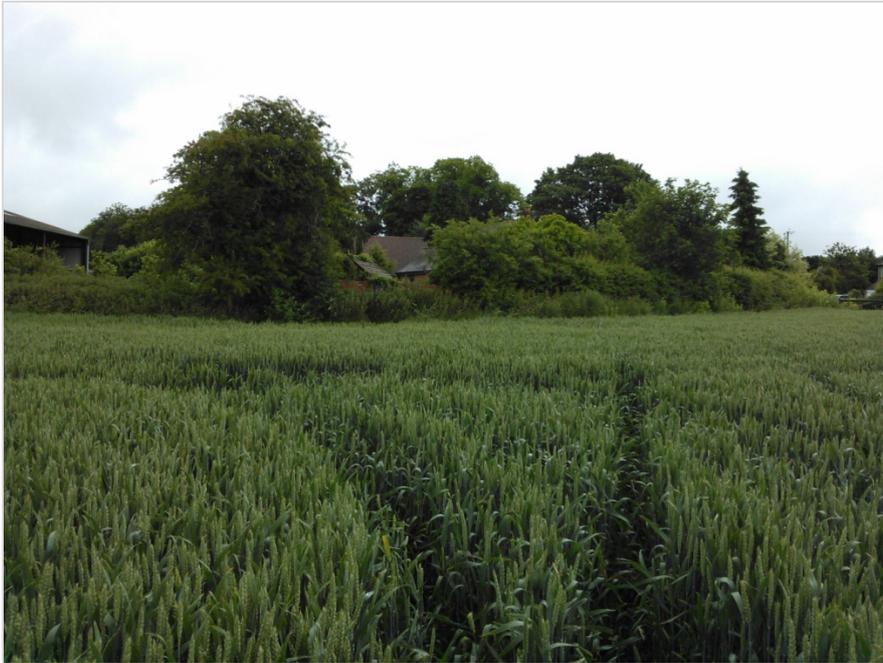
**Plate 9** Septic tank drainage field at the OXON3 site

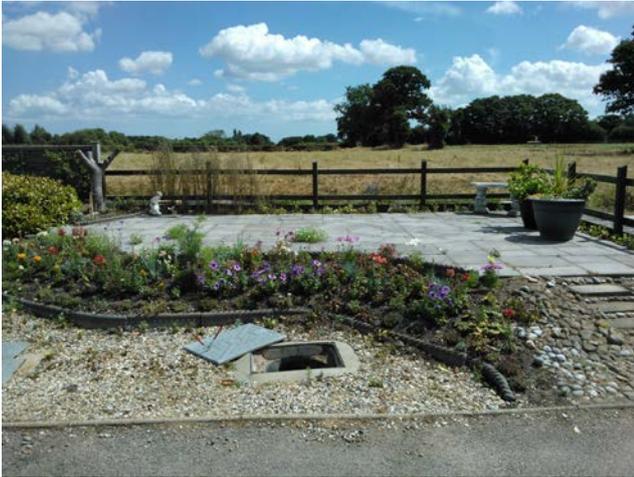
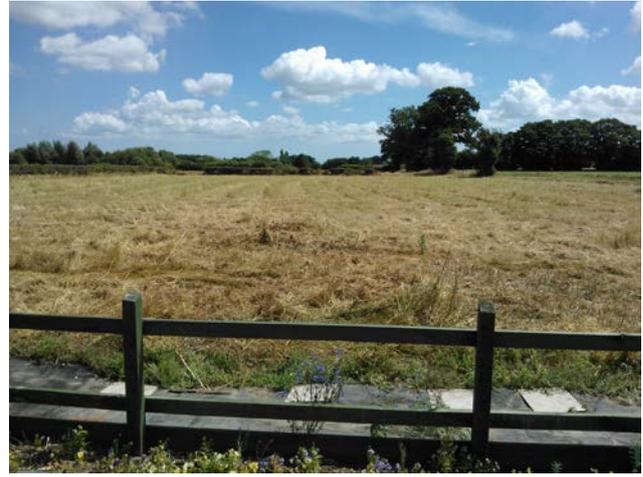
**Plate 10** Septic tank (left) and drainage field (right) at BROADS1

The tank itself was accessible for sampling (Plate 10: left) and the owner believed that the seepage area (Plate 10: right) could be identified by the patches of nettles growing nearby. It was possible to position the sampling directly over the perceived seepage area. There was no obvious slope to the ground in this area; the elevation data collected suggested that the slope was about 2%.

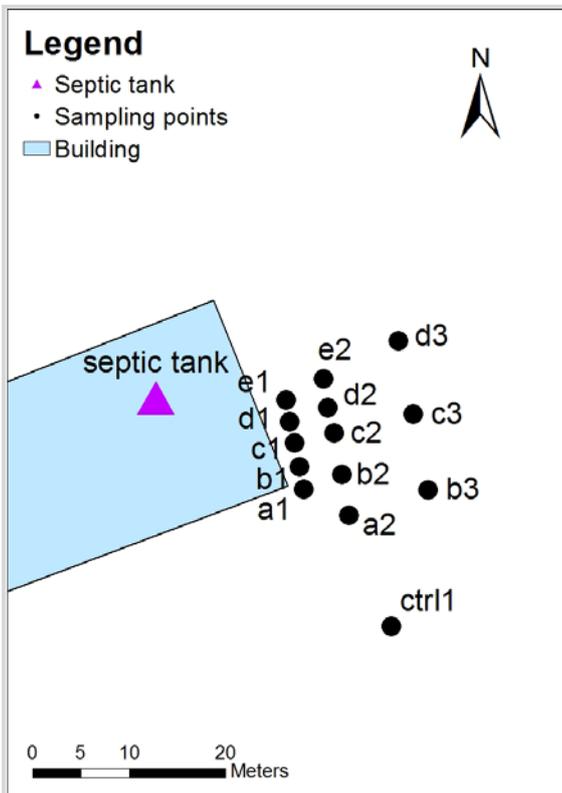
**Figure 11** Distribution of sampling points at site BROADS1

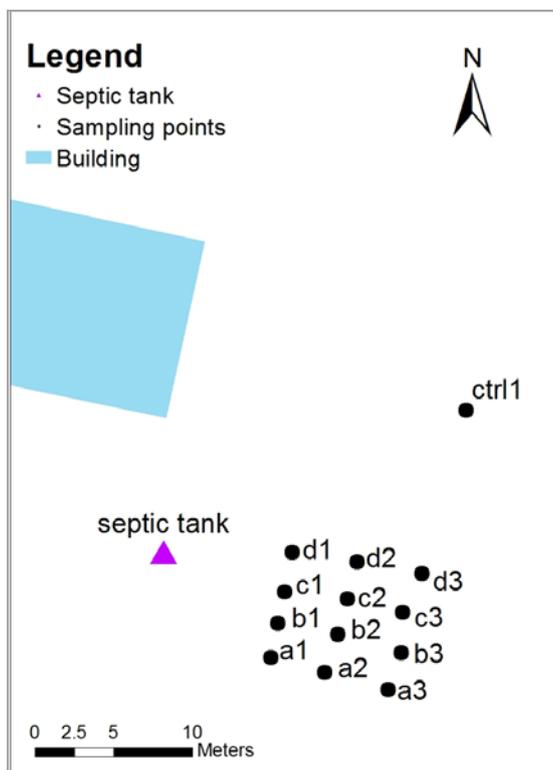
**Figure 12** Distribution of sampling points at site BROADS2

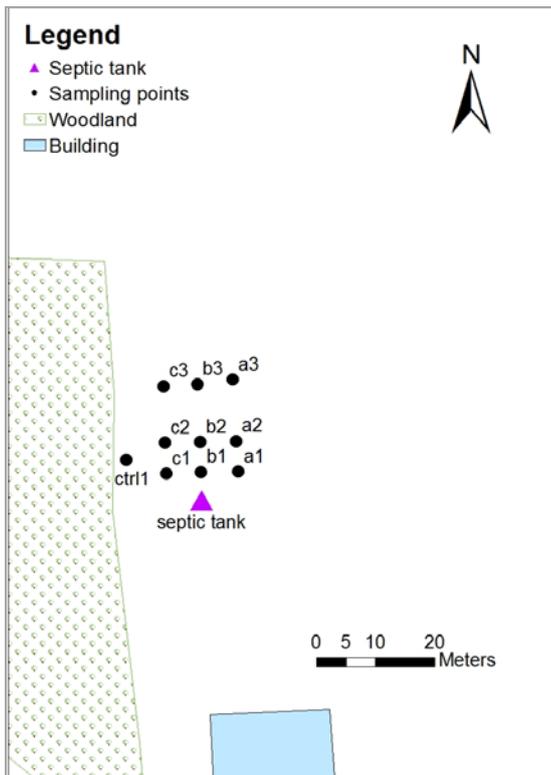
**Figure 13** Distribution of sampling points at site BROADS3

There was no clearly identifiable area for seepage, making positioning of sampling points very difficult. The area was also bound by a road on one side, and influenced by a hedge line leading into a field of sugar beet on the other (Plate 11). There was a slope (estimated to be about 3%) away from the tank and sampling points were located along this slope.

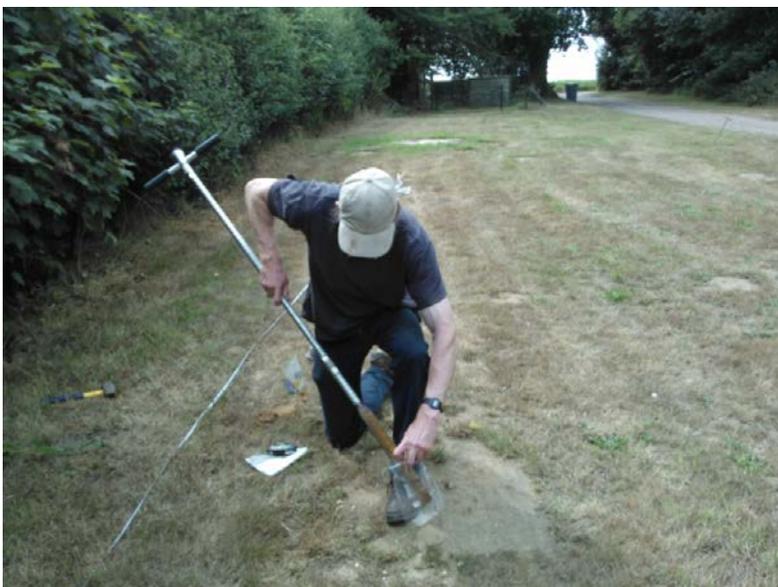
**Plate 11** Sampling the septic tank drainage field at BROADS3

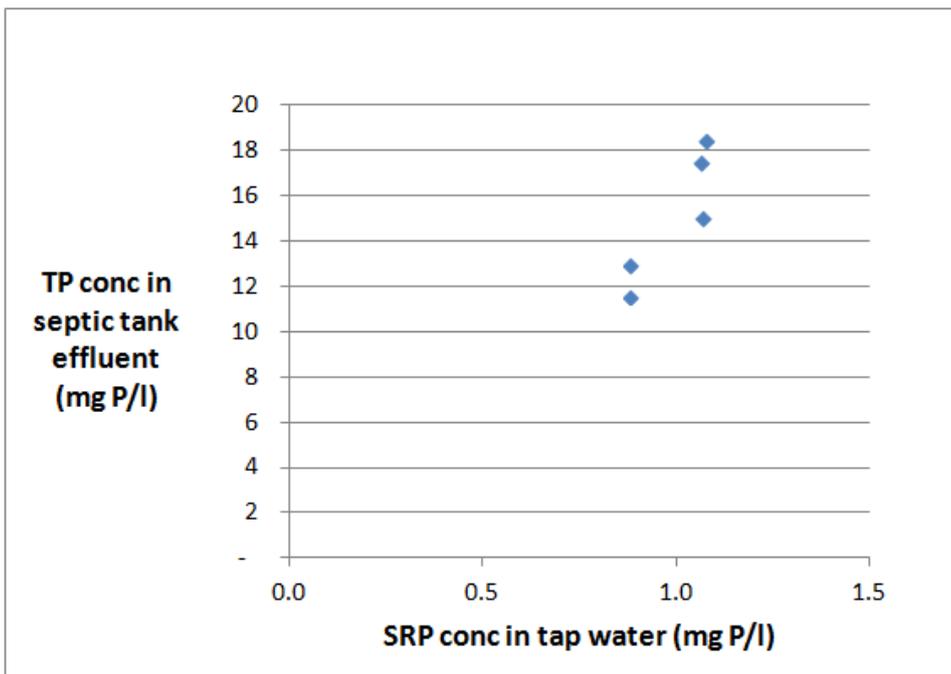
**Figure 14** Relationship between soluble reactive phosphorus (SRP) concentrations in tap water and total phosphorus (TP) concentrations in septic tank effluent in areas where orthophosphate is added to tap water

The relationship between tap water P concentrations and effluent P concentrations was explored. Although the number of samples was small, there was a tendency for higher P concentrations in tap water to be associated with higher P concentrations in corresponding effluents at sites where tap water P concentrations were high (Figure 14). Although tap water samples were not available at BROADS3 and OXON1, values for these sites were estimated to be the average of BROADS1 and BROADS2 for BROADS3 and the value of OXON2 for OXON1.

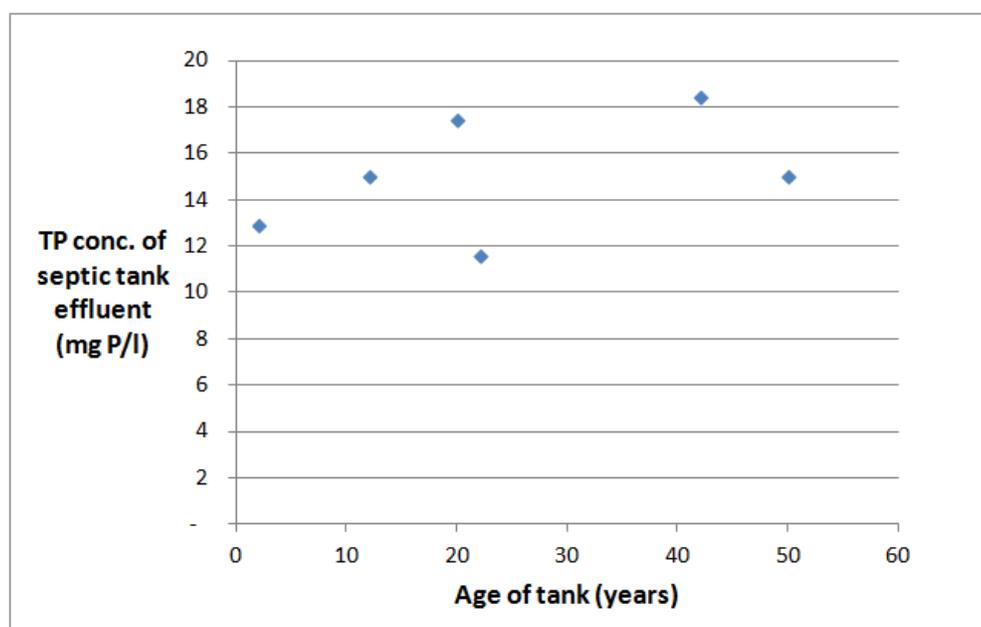
**Figure 15** Relationship between total phosphorus (TP) concentrations in tank effluent and estimated age of tank

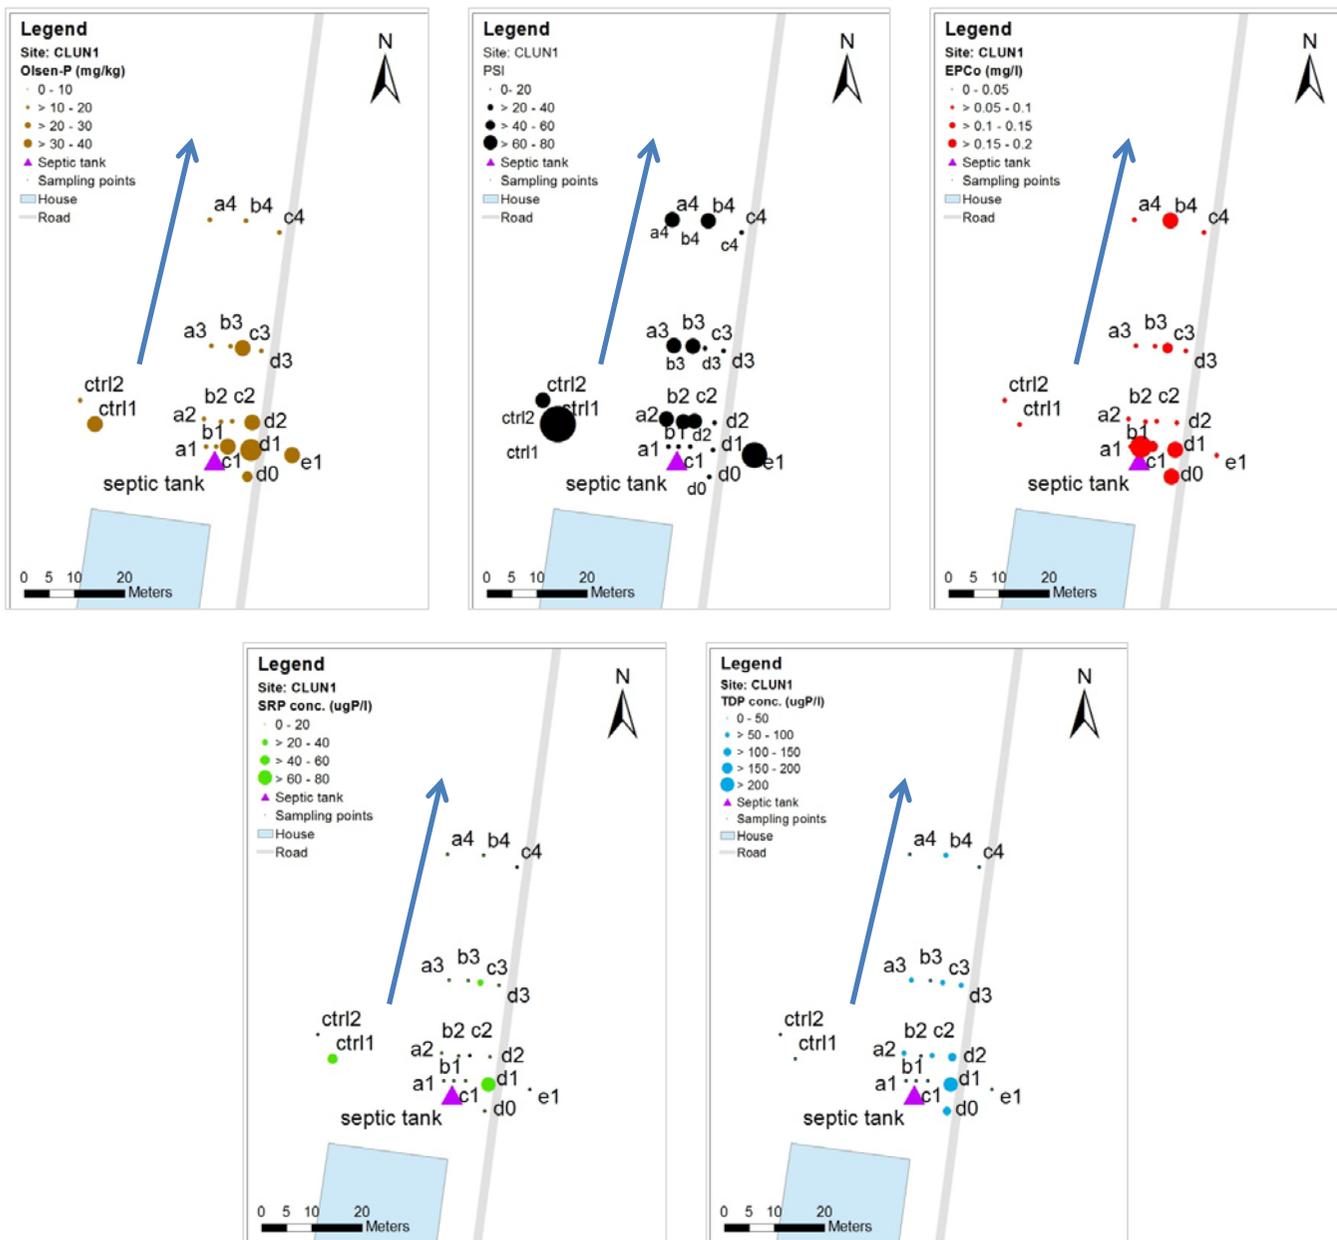
**Figure 16** Spatial distribution of maximum soil (upper panel) and porewater (lower panel) P values across the drainage area at the CLUN1 site. Blue arrow indicates likely direction of plume development. Contains Ordnance Survey data © Crown copyright and database right 2013

PSI values ranged from 15 to 38, with lower values tending to be measured at sites with higher Olsen-P values along the likely path of the plume (Figure 16: upper panel, centre). Values recorded for  $EPC_0$  varied between 0 and 0.15 mg/l and tended to be highest around the septic tank and immediately surrounding drainage area (Figure 16: upper panel, right). Overall, the data suggest that STS effluent was probably causing P contamination of the surrounding soils over a distance of about 20 m from the tank at this site.

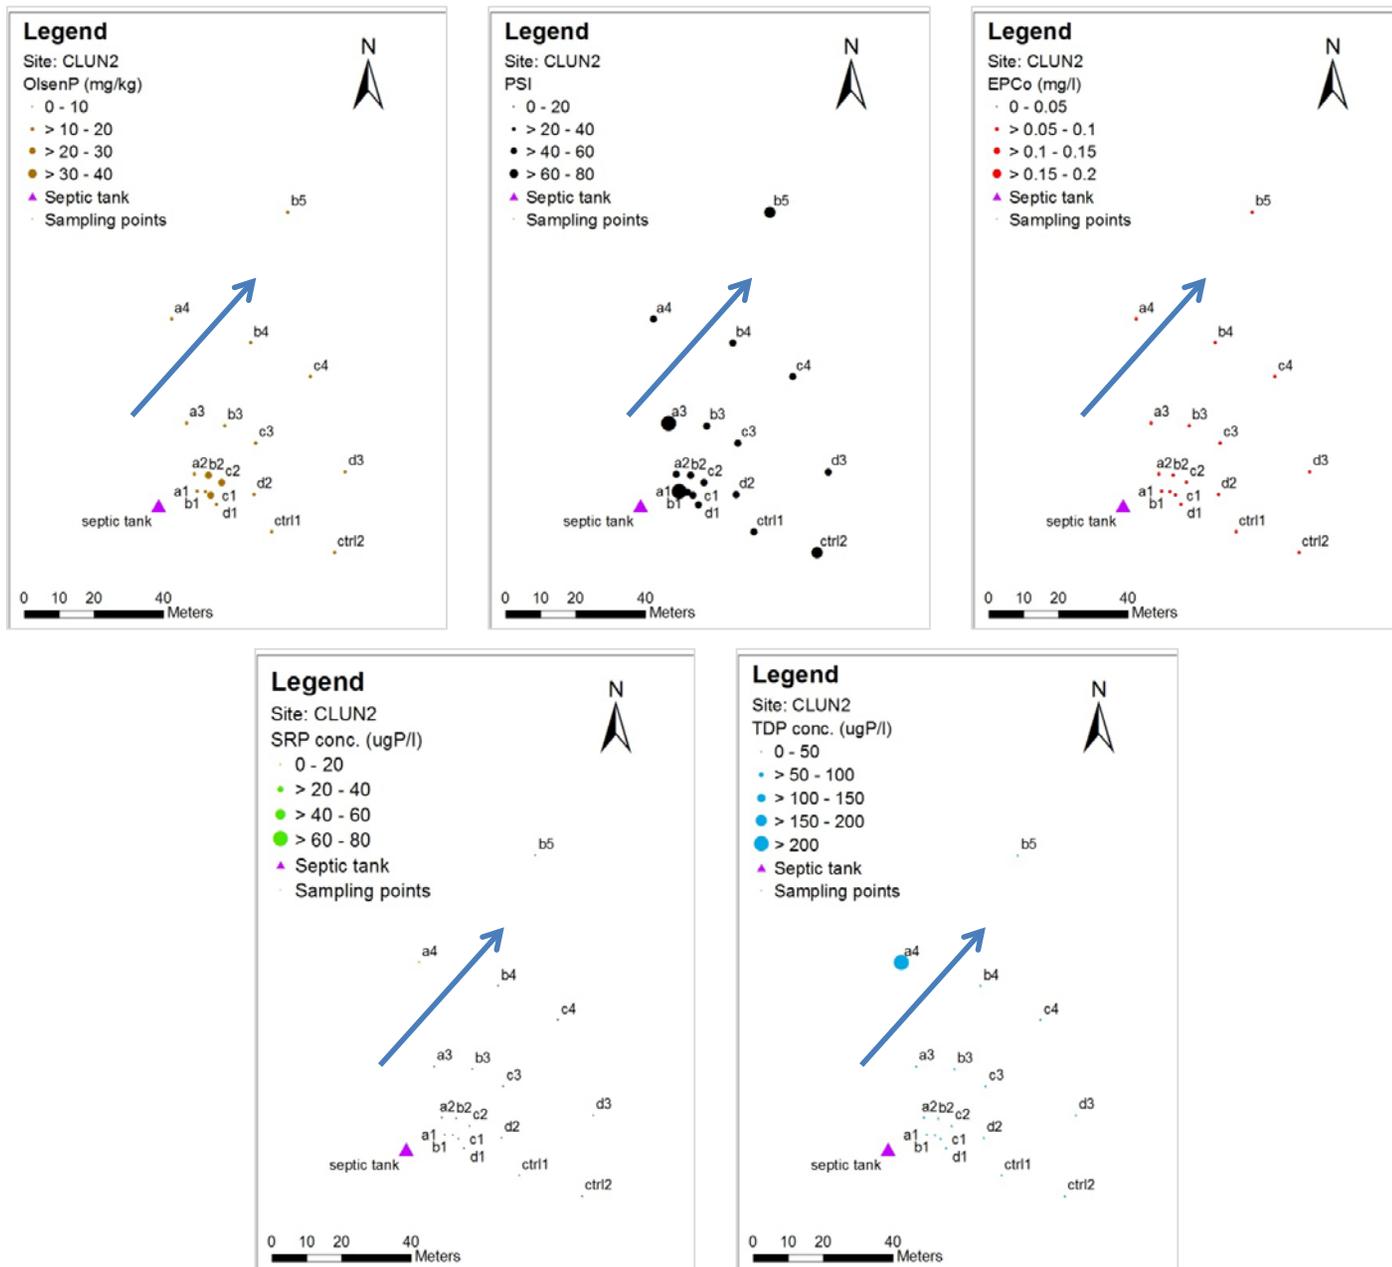
**Figure 17** Spatial distribution of maximum soil (upper panel) and porewater (lower panel) P values across the drainage area at the CLUN2 site. Blue arrow indicates likely direction of plume development. Contains Ordnance Survey data © Crown copyright and database right 2013

Overall, the data suggest a very slight eutrophication of the soils along the likely path of the effluent plume for a distance of up to 20 m. The level of eutrophication recorded was very low, probably reflecting the fact that this tank is relatively new ( $< 7$  years old) and serves a holiday rental property that is not in constant use and, therefore, likely to discharge only small amounts of P. Because the pattern of usage is likely to be different from a normally occupied house, for example holidaymakers may wash less laundry than other house occupants, the source apportionment of P in the influent waste may also be different.

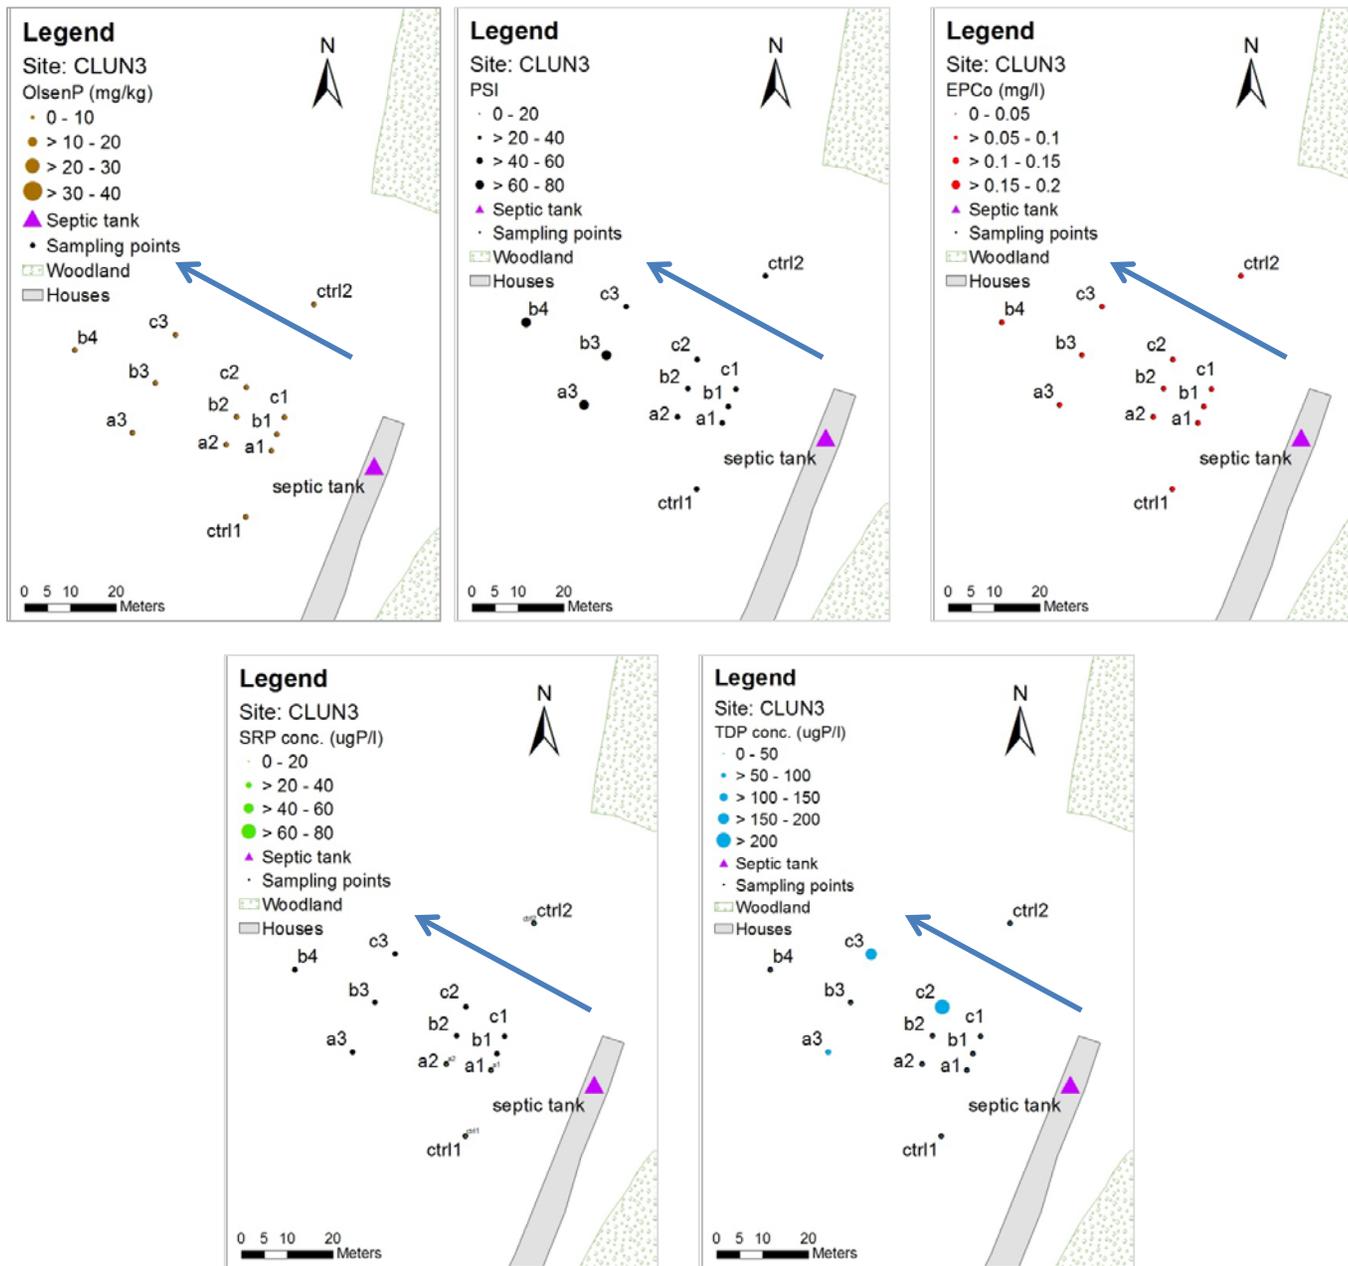
**Figure 18** Spatial distribution of maximum soil (upper panel) and porewater (lower panel) P values across the drainage area at the CLUN3 site. Blue arrow indicates likely direction of plume development. Contains Ordnance Survey data © Crown copyright and database right 2013
