# Development of a risk assessment tool to assess the significance of septic tanks around freshwater SSSIs

Phase 1 – Understanding better the retention of phosphorus in the drainage field

First published 03 February 2015

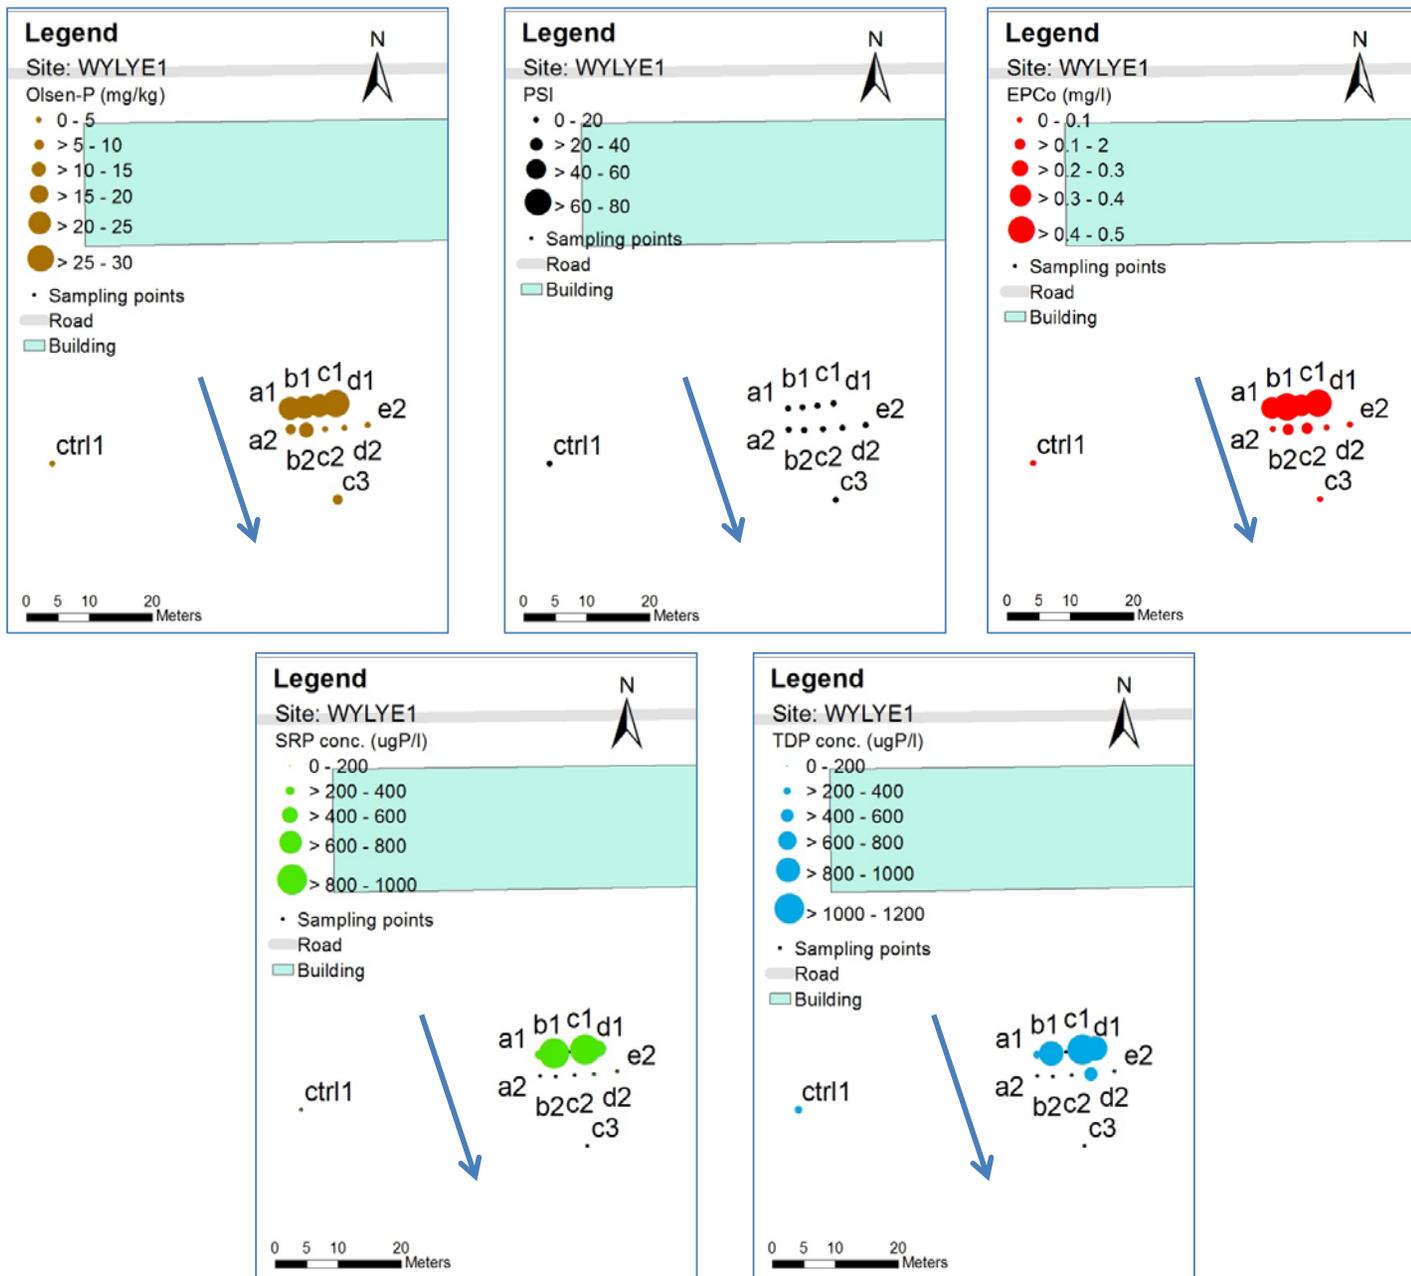
**Figure 19** Spatial distribution of maximum soil (upper panel) and porewater (lower panel) P values across the drainage area at the WYLYE1 site. Blue arrow indicates likely direction of plume development. Contains Ordnance Survey data © Crown copyright and database right 2013

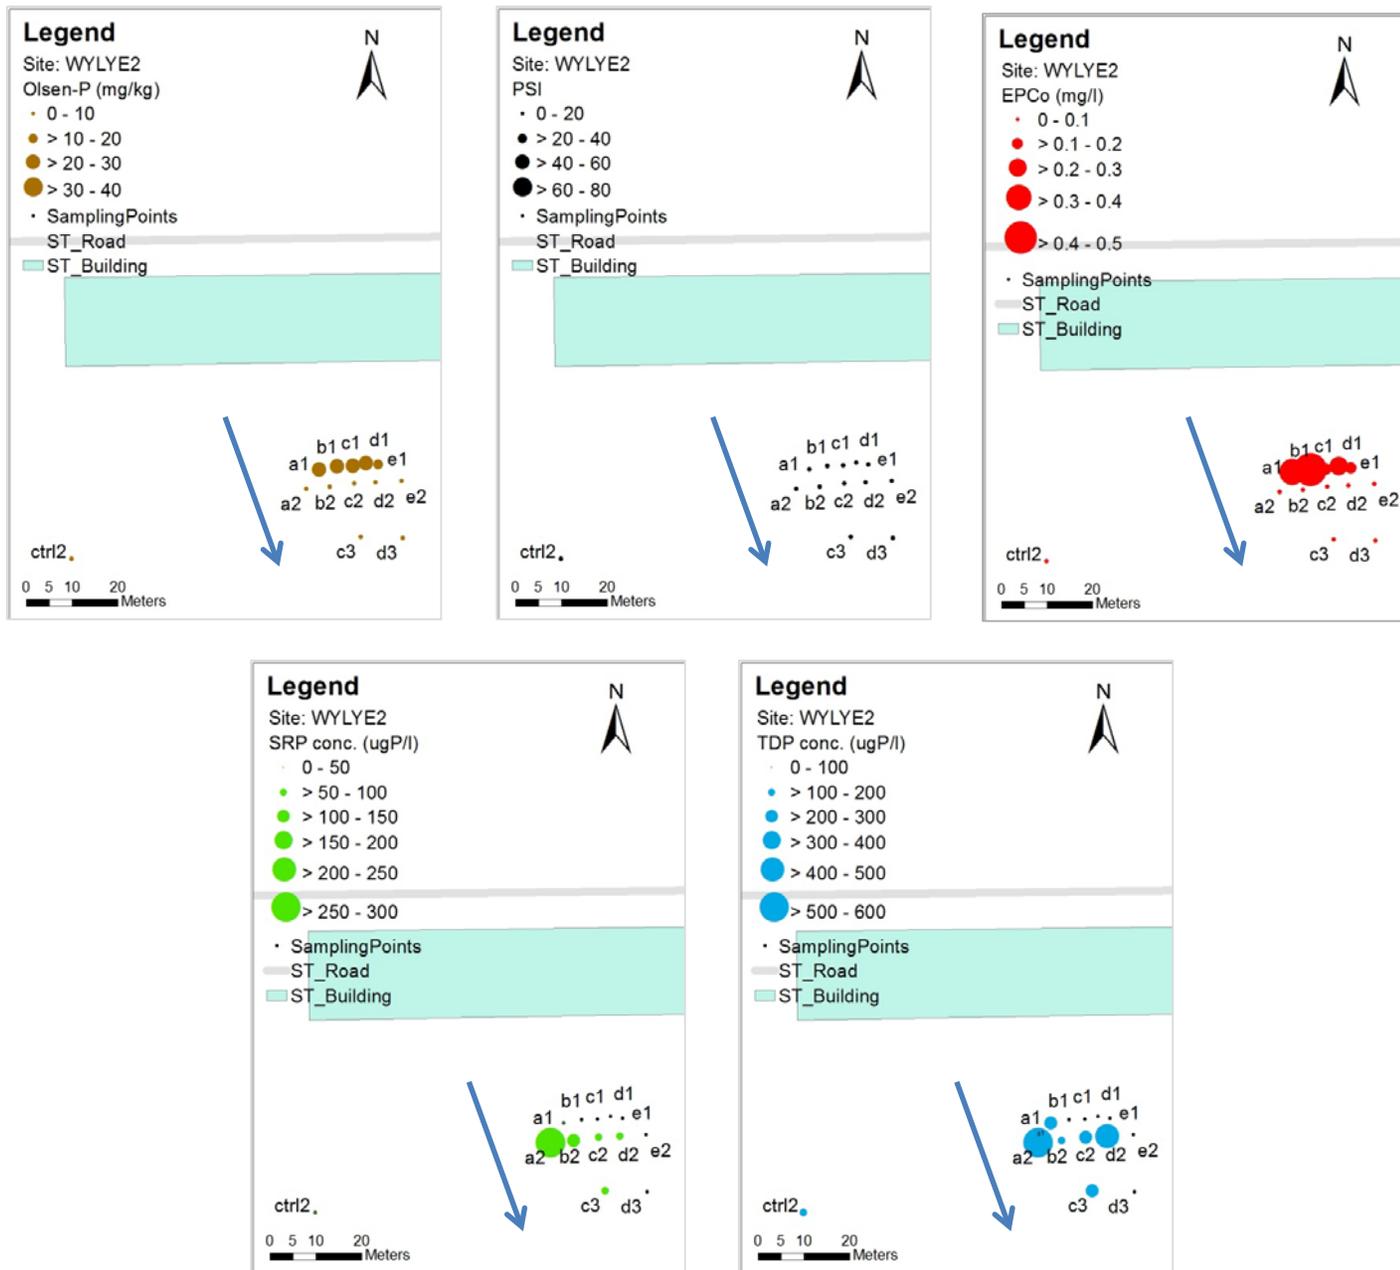
**Figure 20** Spatial distribution of maximum soil (upper panel) and porewater (lower panel) P values across the drainage area at the WYLYE2 site. Blue arrow indicates likely direction of plume development. Contains Ordnance Survey data © Crown copyright and database right 2013

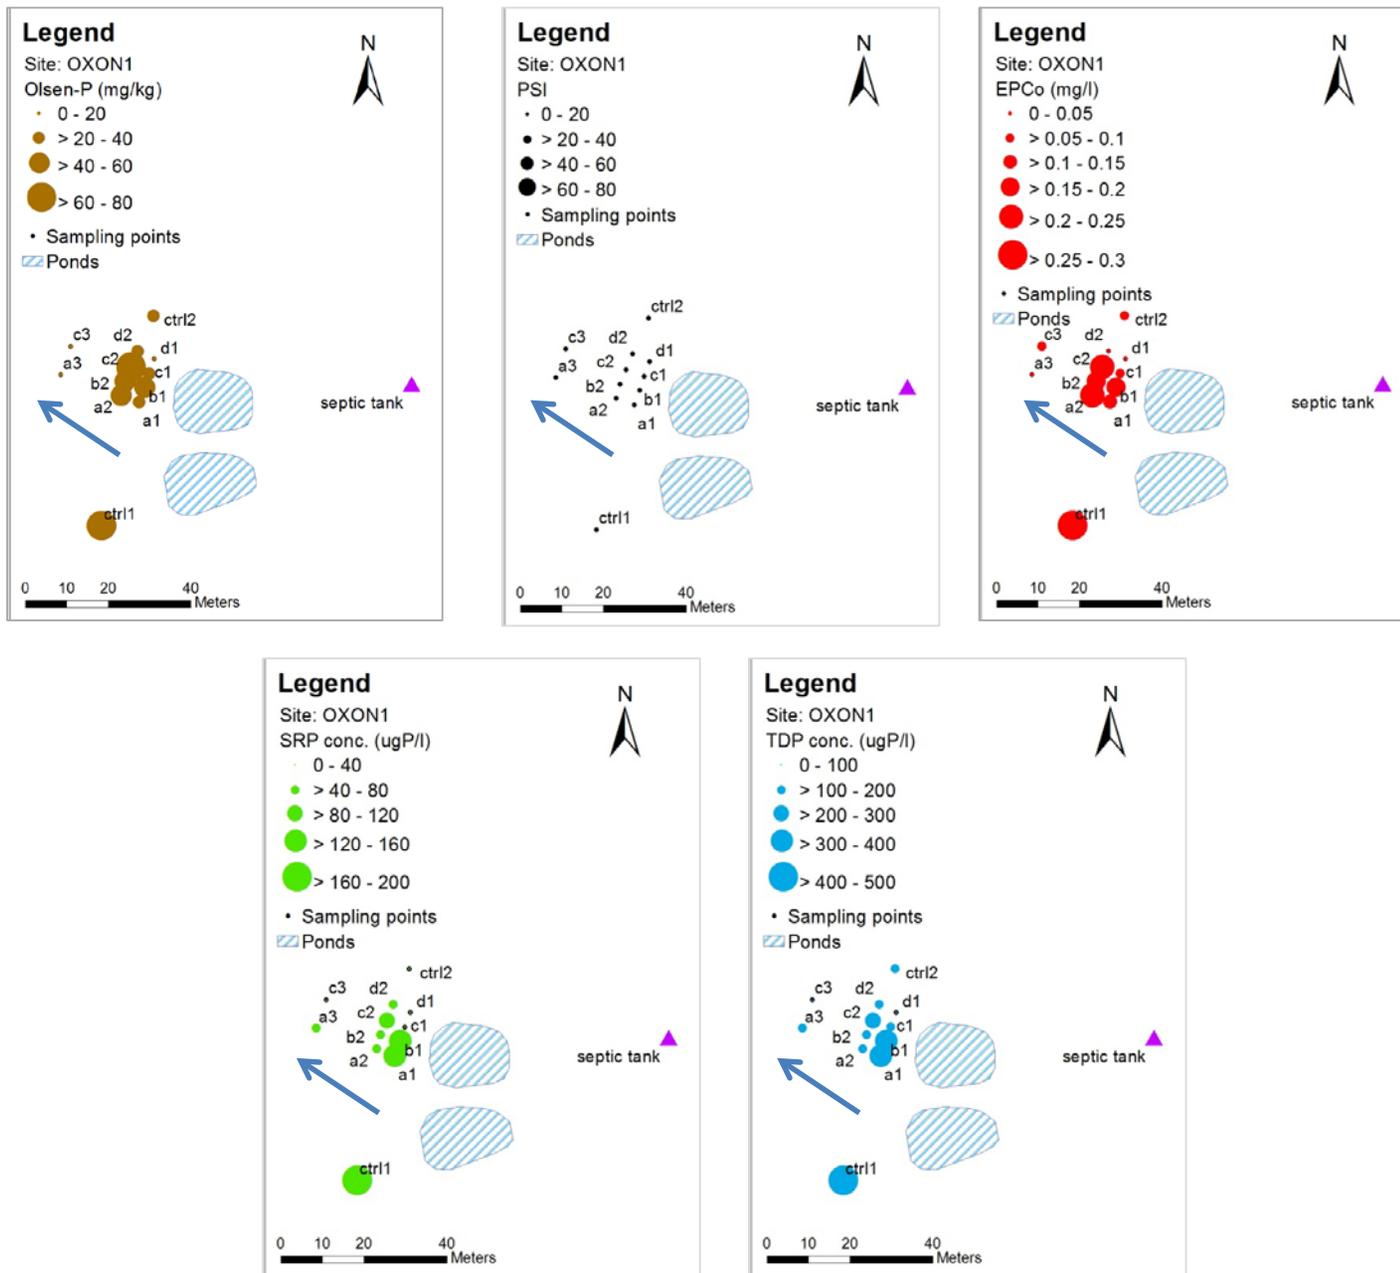
**Figure 21** Spatial distribution of maximum soil (upper panel) and porewater (lower panel) P values across the drainage area at the OXON1 site. Blue arrow indicates likely direction of plume development. Contains Ordnance Survey data © Crown copyright and database right 2013

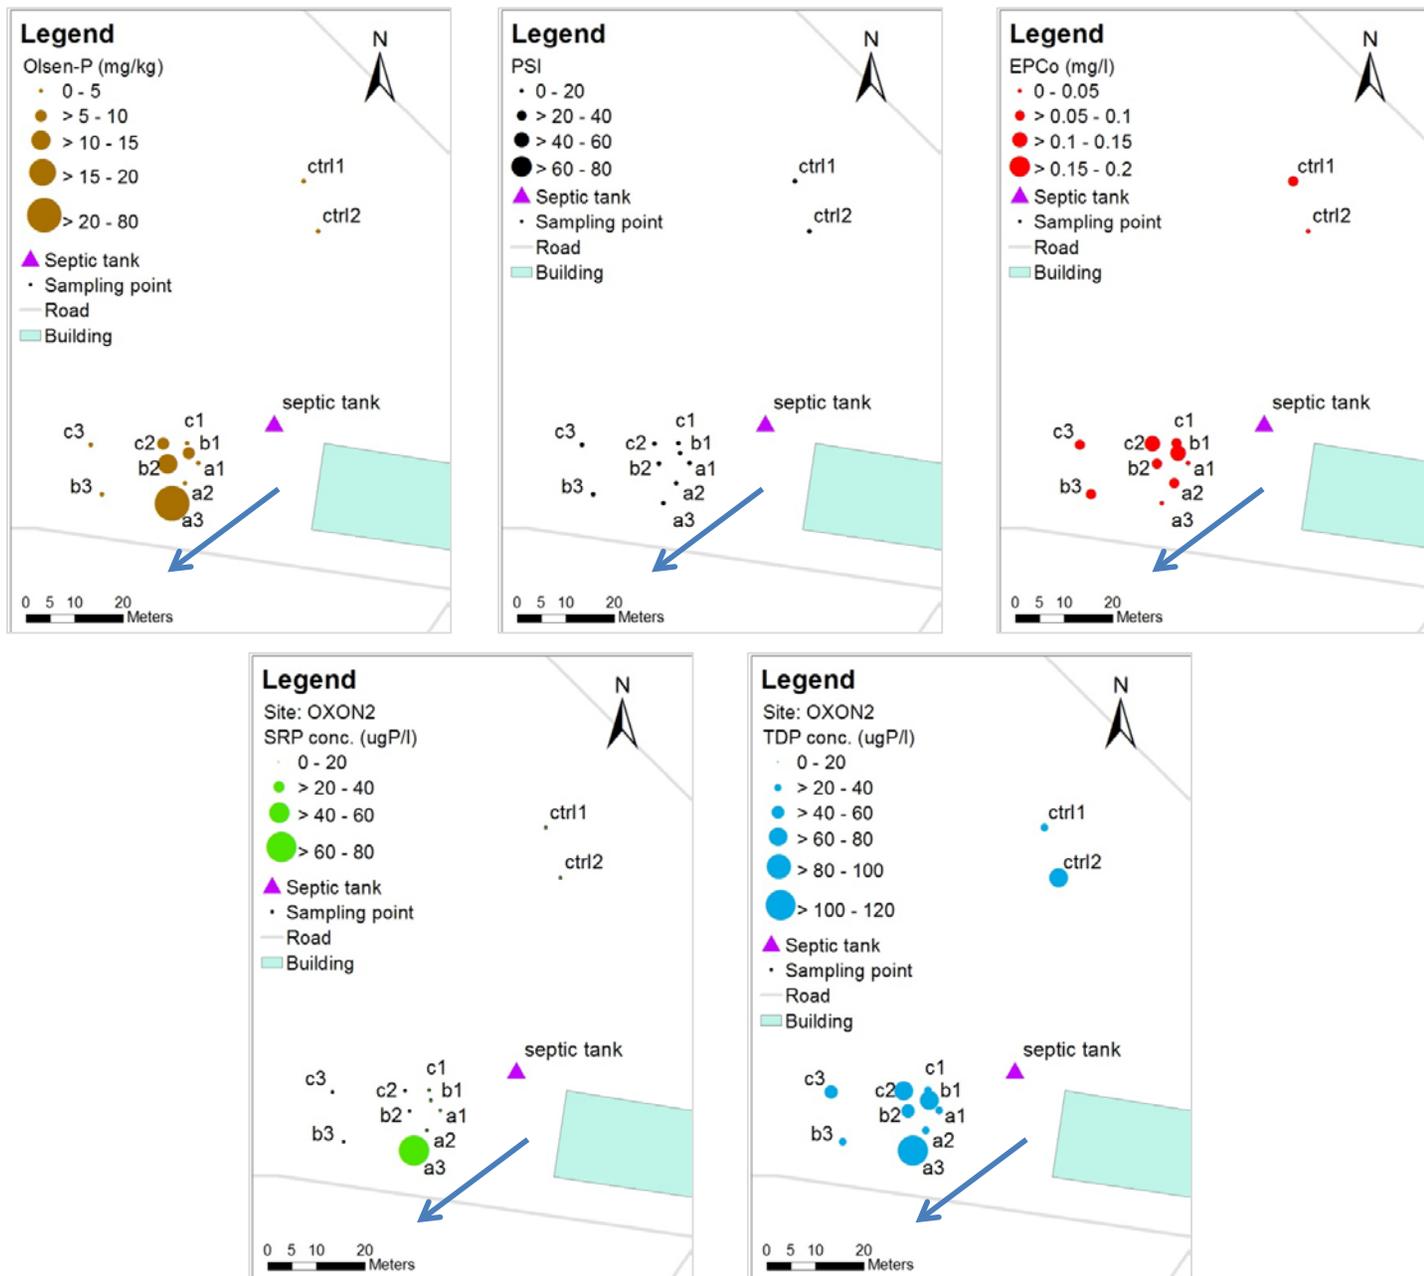
**Figure 22** Spatial distribution of maximum soil (upper panel) and porewater (lower panel) P values across the drainage area at the OXON2 site. Blue arrow indicates likely direction of plume development. Contains Ordnance Survey data © Crown copyright and database right 2013

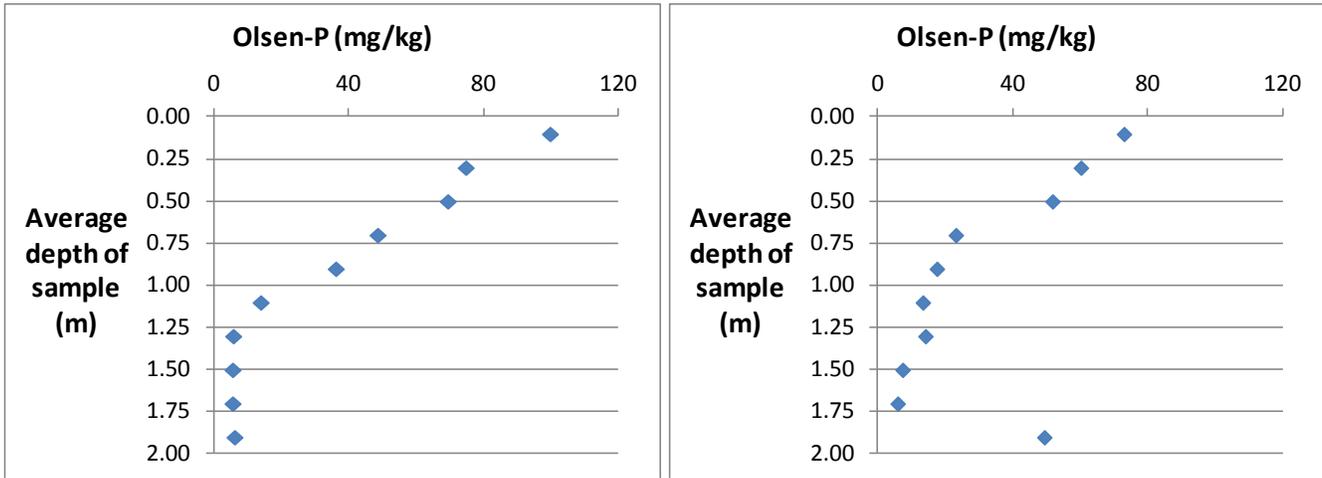
**Figure 23** Change in Olsen-P values with depth at two borehole sites situated among the effluent distribution pipes at OXON3

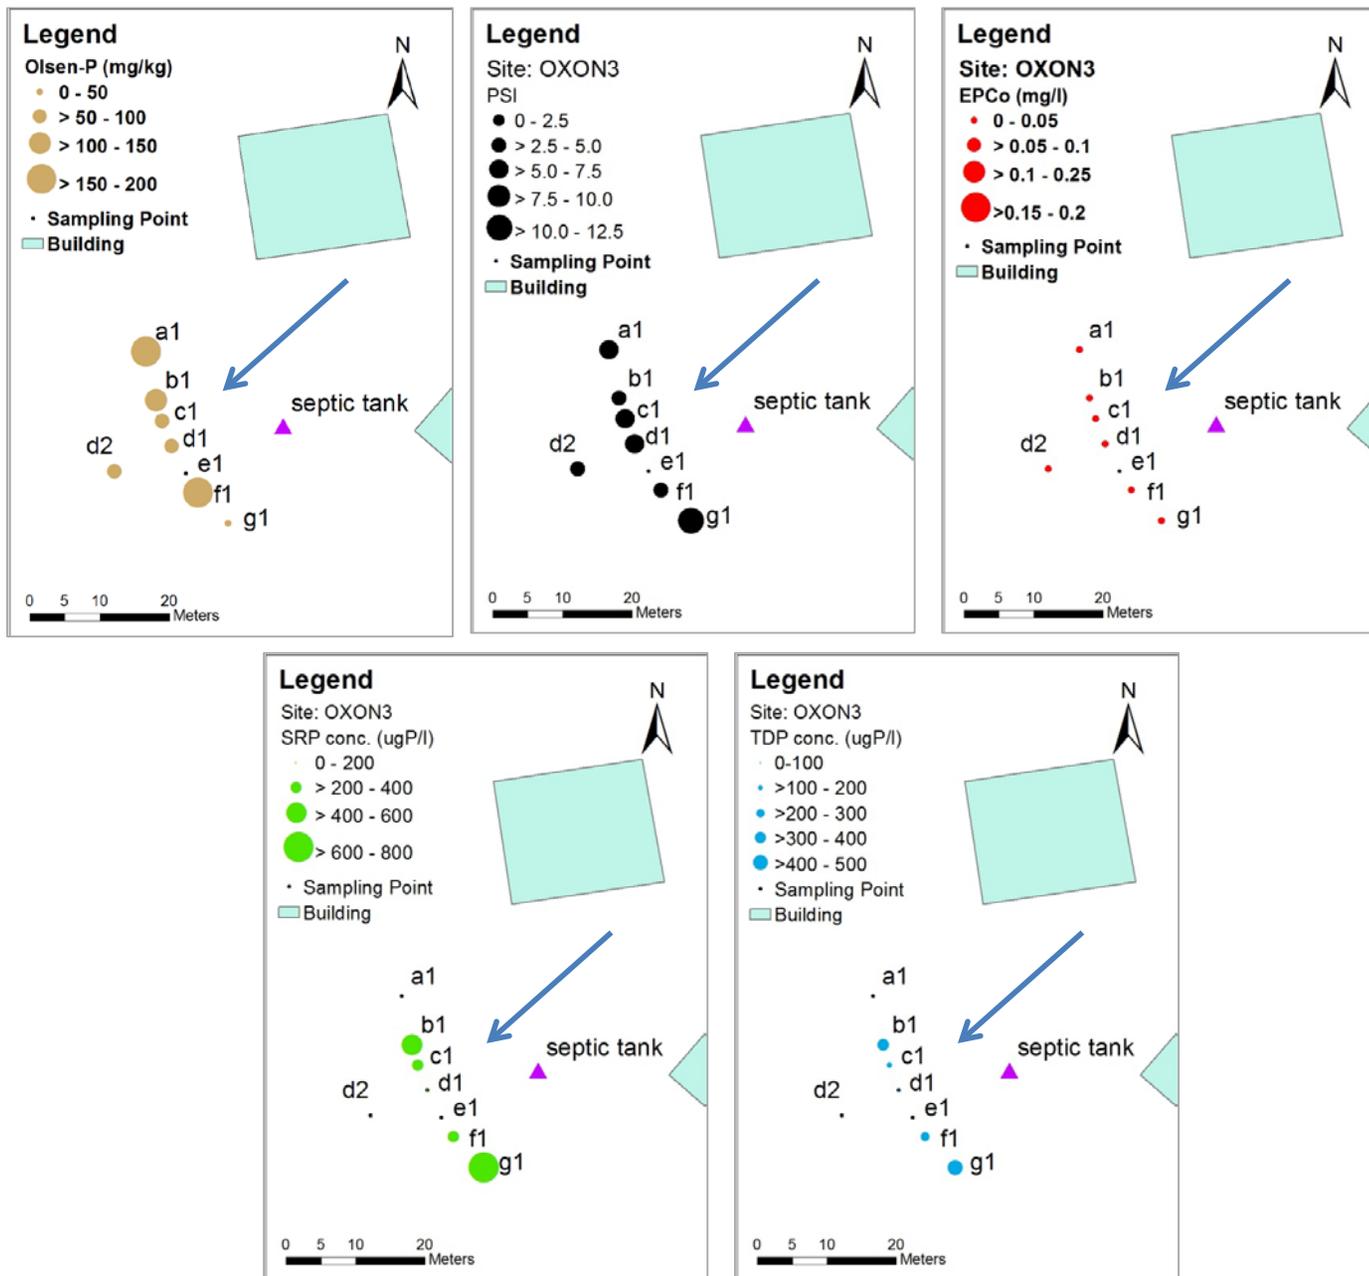
**Figure 24** Spatial distribution of maximum soil (upper panel) and porewater (lower panel) P values across the drainage area at the OXON3 site. Blue arrow indicates likely direction of plume development. Contains Ordnance Survey data © Crown copyright and database right 2013

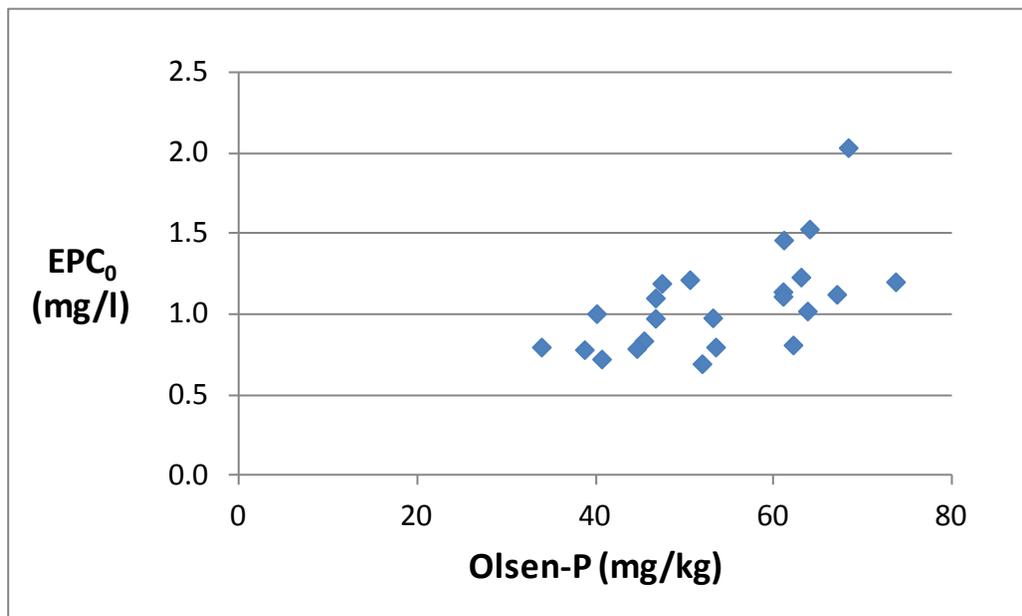
**Figure 25** Relationship between EPC<sub>0</sub> and Olsen-P values at BROADS1

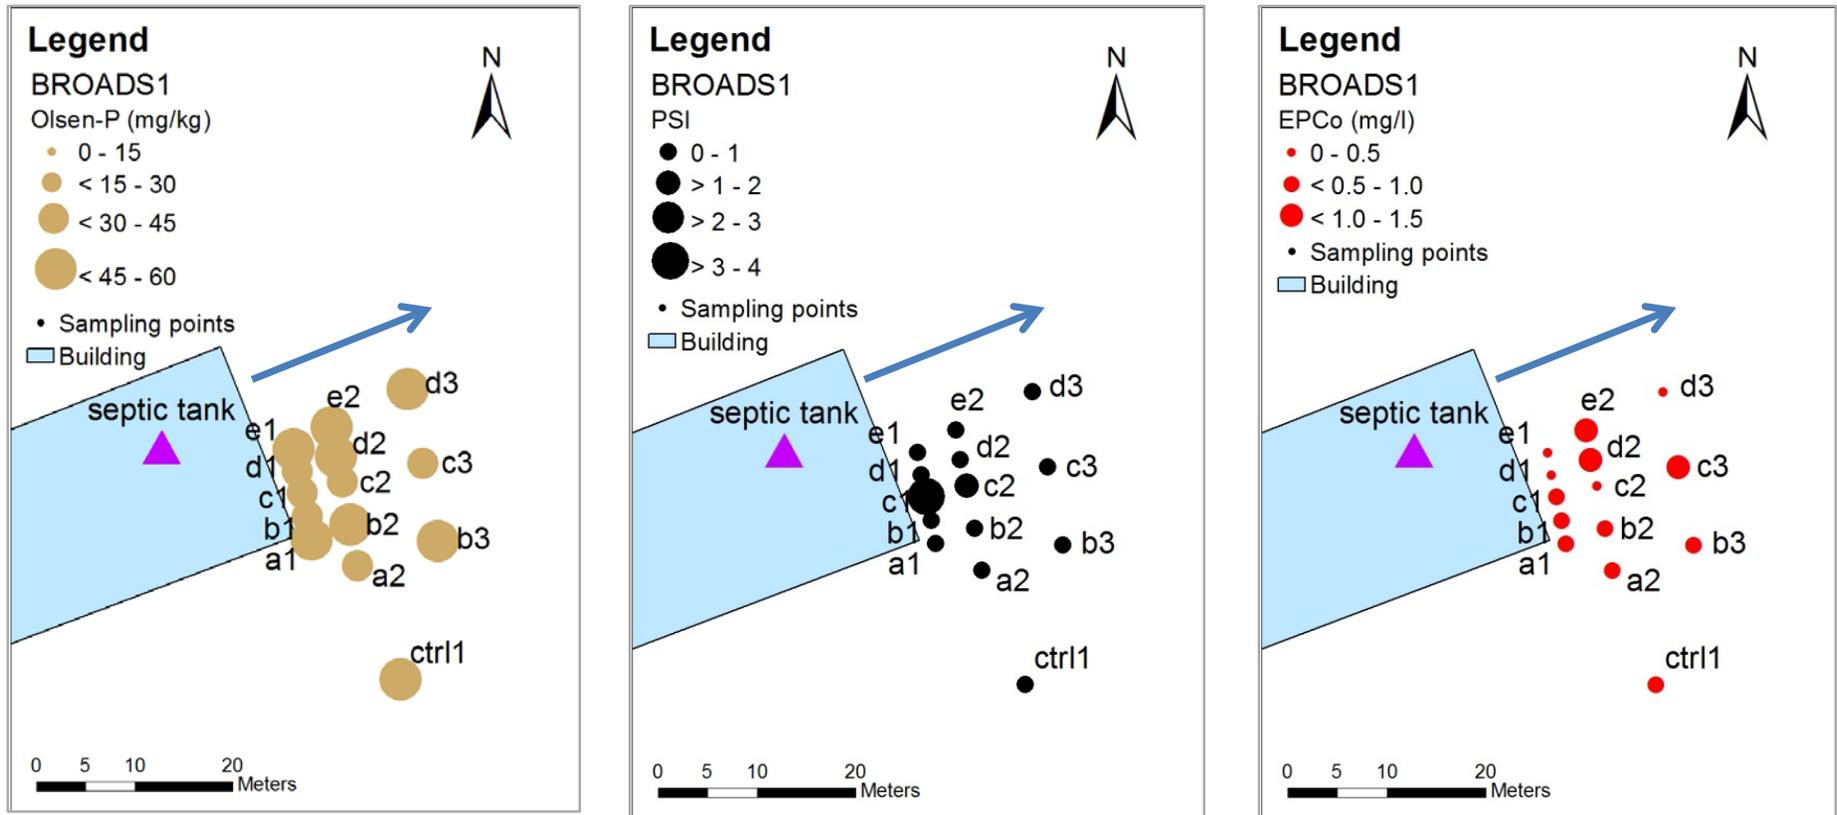
**Figure 26** Spatial distribution of maximum soil P values across the drainage area at the BROADS1 site; the soils were too dry for porewater values to be determined. Blue arrow indicates likely direction of plume development. Contains Ordnance Survey data © Crown copyright and database right 2013.

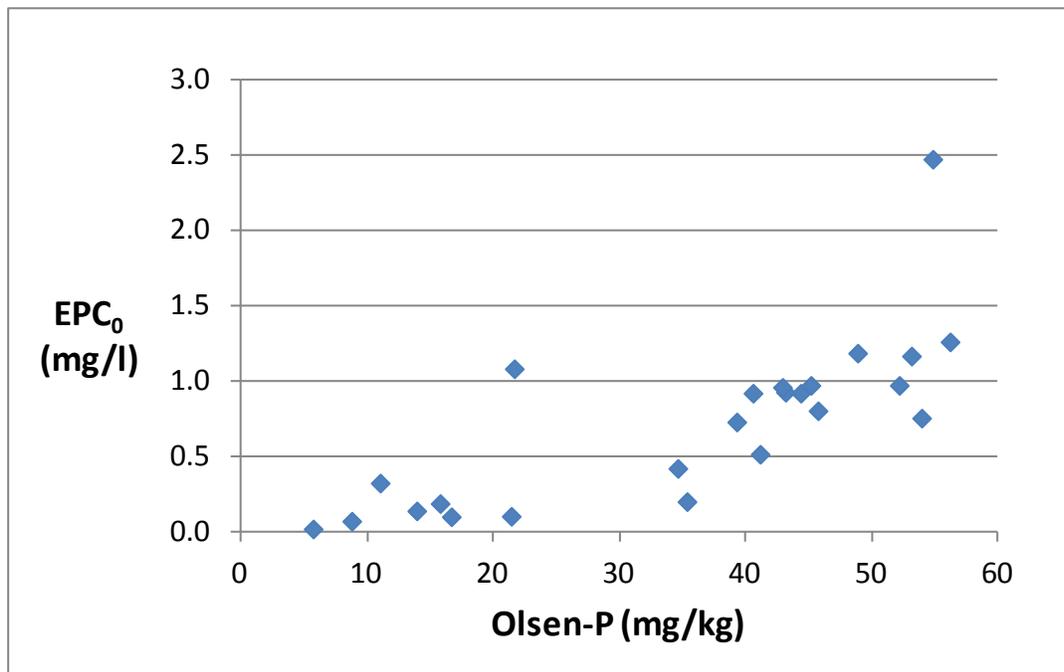
**Figure 27** Relationship between  $EPC_0$  and Olsen-P values at BROADS2

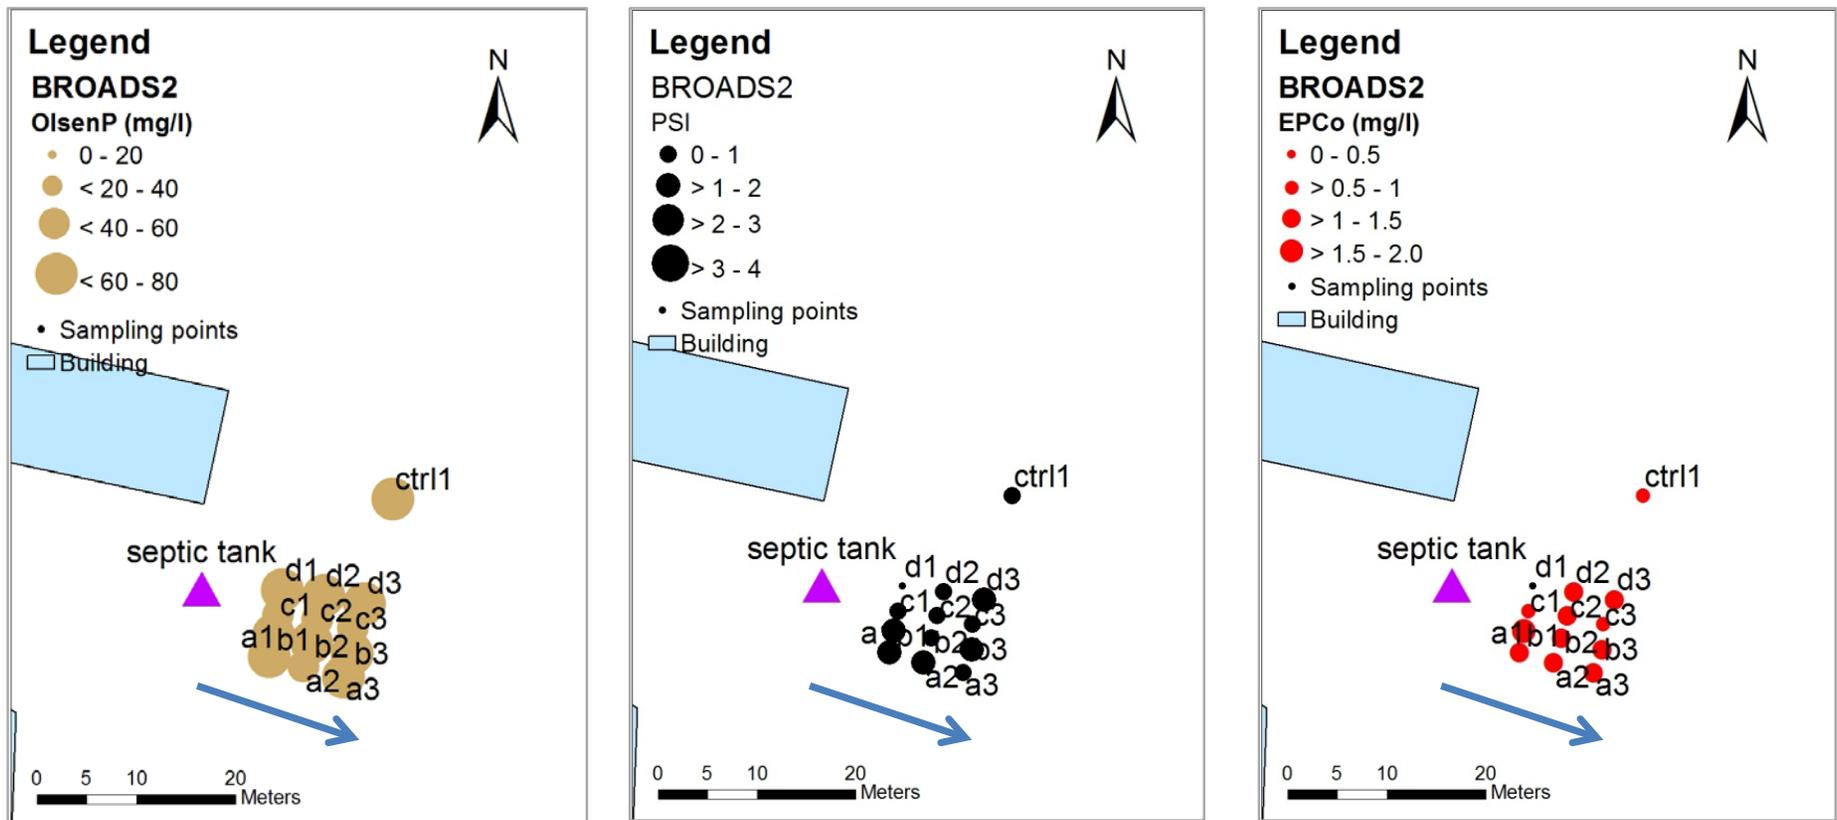
**Figure 28** Spatial distribution of maximum soil P values across the drainage area at the BROADS2 site; the soils were too dry for porewater values to be determined. Blue arrow indicates likely direction of plume development. Contains Ordnance Survey data © Crown copyright and database right 2013.

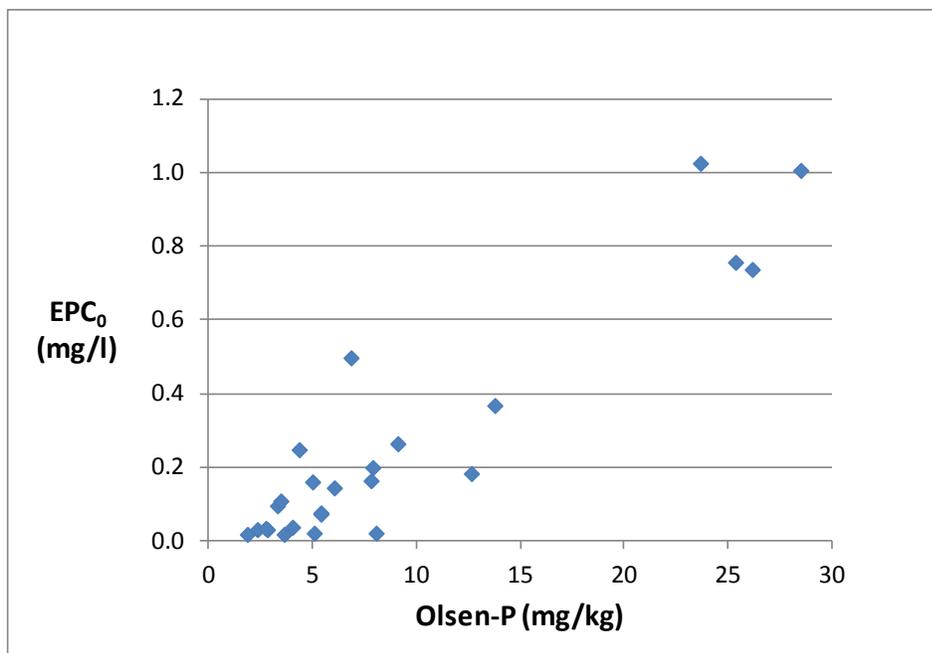
**Figure 29** Relationship between  $EPC_0$  and Olsen-P values at BROADS3

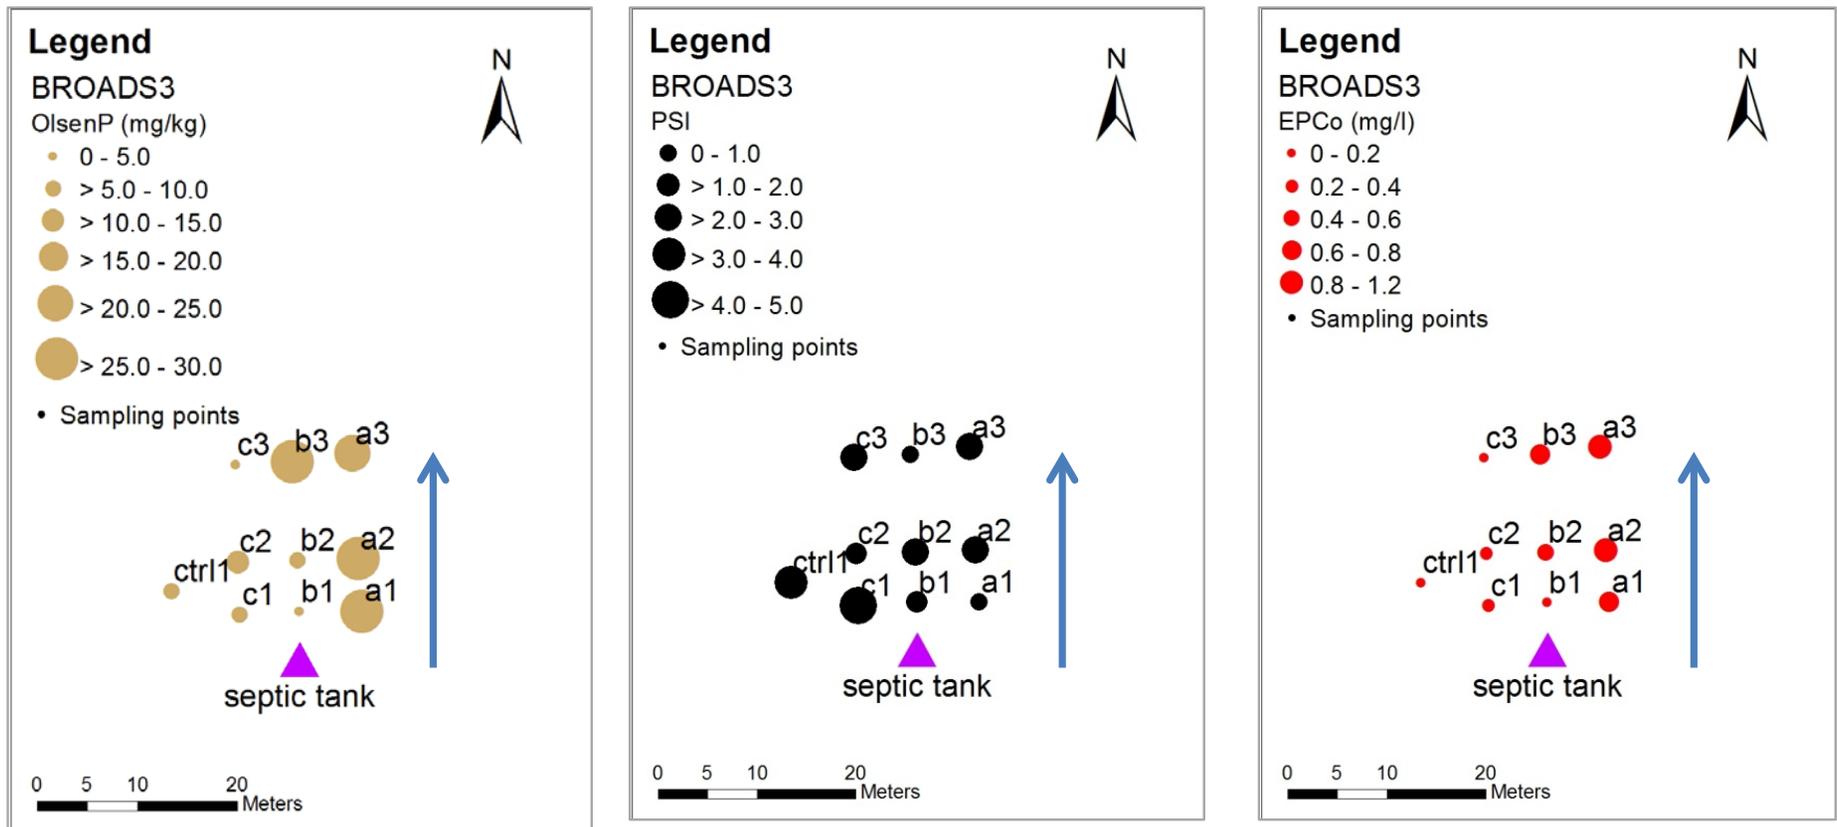
**Figure 30** Spatial distribution of maximum soil P values across the drainage area at the BROADS3 site; the soils were too dry for porewater values to be determined. Blue arrow indicates likely direction of plume development. Contains Ordnance Survey data © Crown copyright and database right 2013

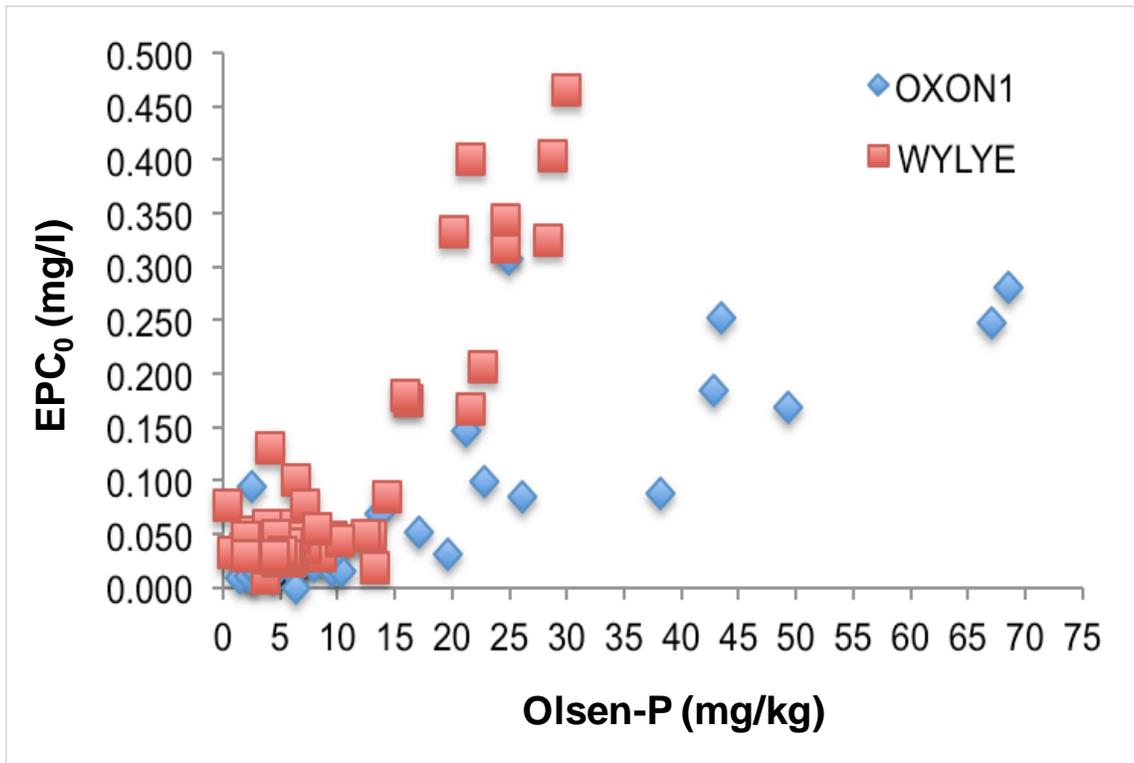
**Figure 31** The relationship between equilibrium P concentrations in the soil solution ( $EPC_0$ ) and soil available P (Olsen-P) at sites at WYLYE and OXON1

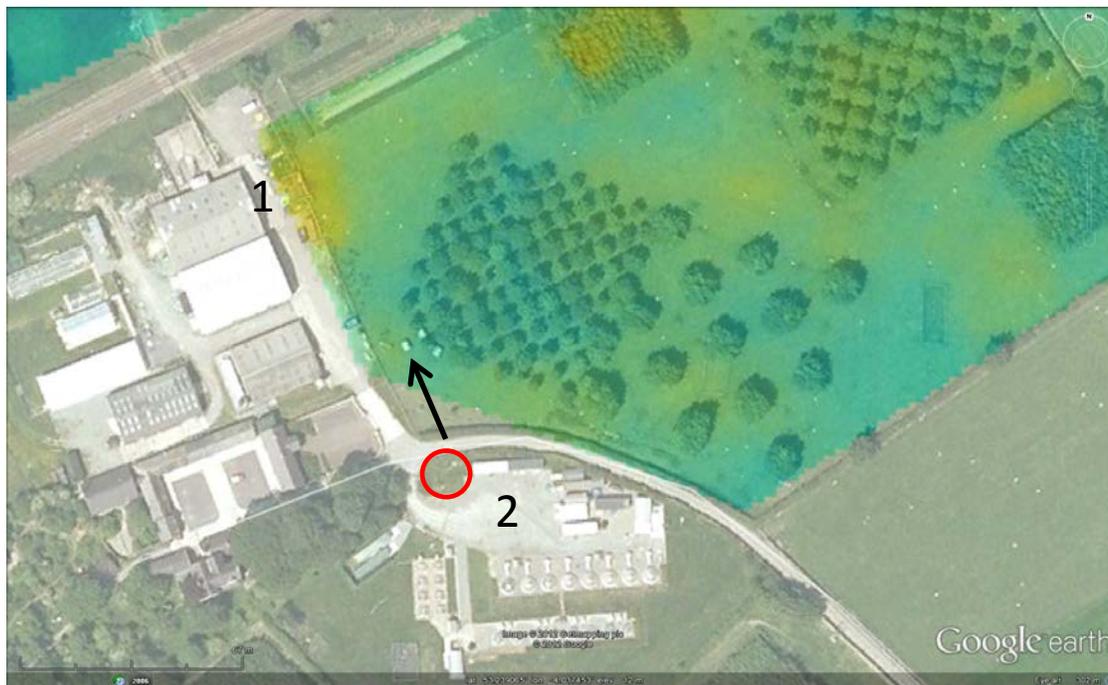
**Figure A** Areas of high electrical conductivity (yellow shading), probably effluent plumes, identified using EMI tracing on a farm in Wales; the position of the septic tank (red circle) and the likely path of the effluent plume (arrow) are indicated

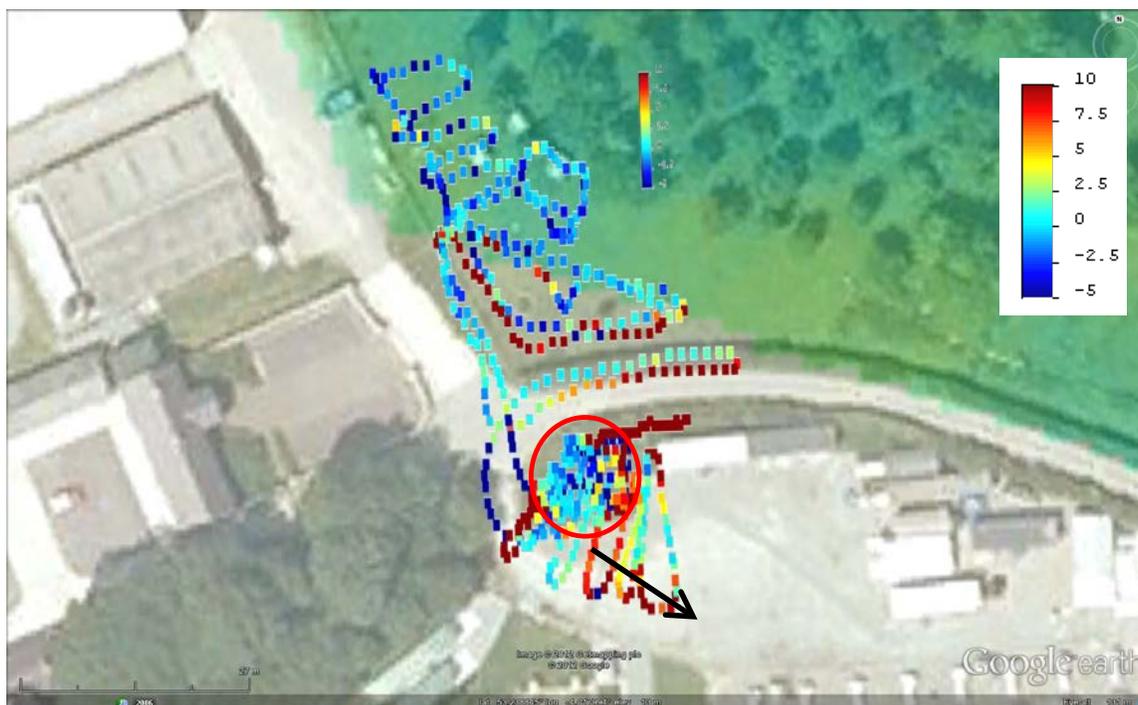
**Figure B** More detailed data from a re-survey of the farm site in Wales showing the position of the septic tank (red circle) and the likely path of the effluent plume (arrow); levels of electrical conductivity (shown in arbitrary units) range from low (blue) to high (red)

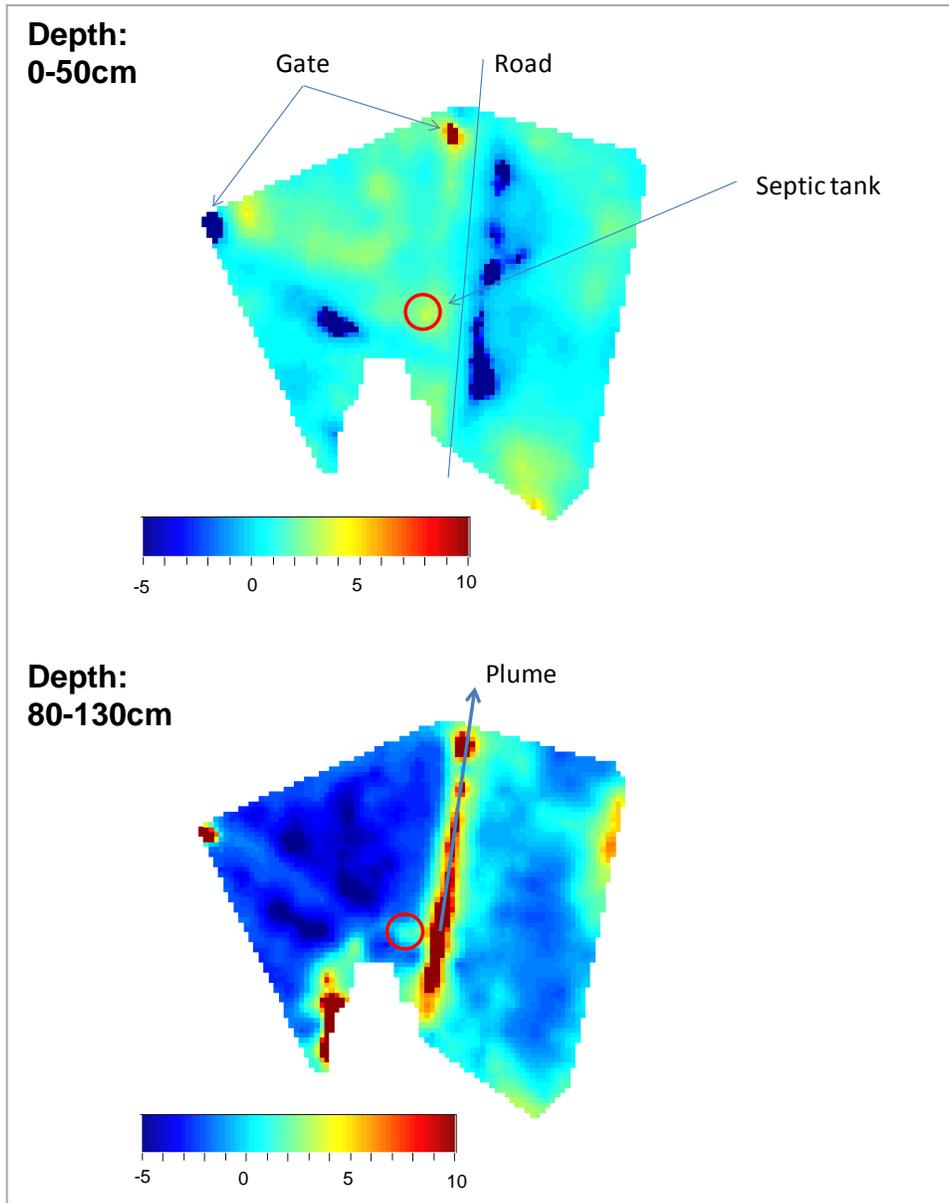
**Figure C** Electromagnetic image (EMI) of the drainage field at Site CLUN1 indicating the possible path of the plume from the septic tank. Levels of electrical conductivity (shown in arbitrary units) range from low (blue) to high (red)

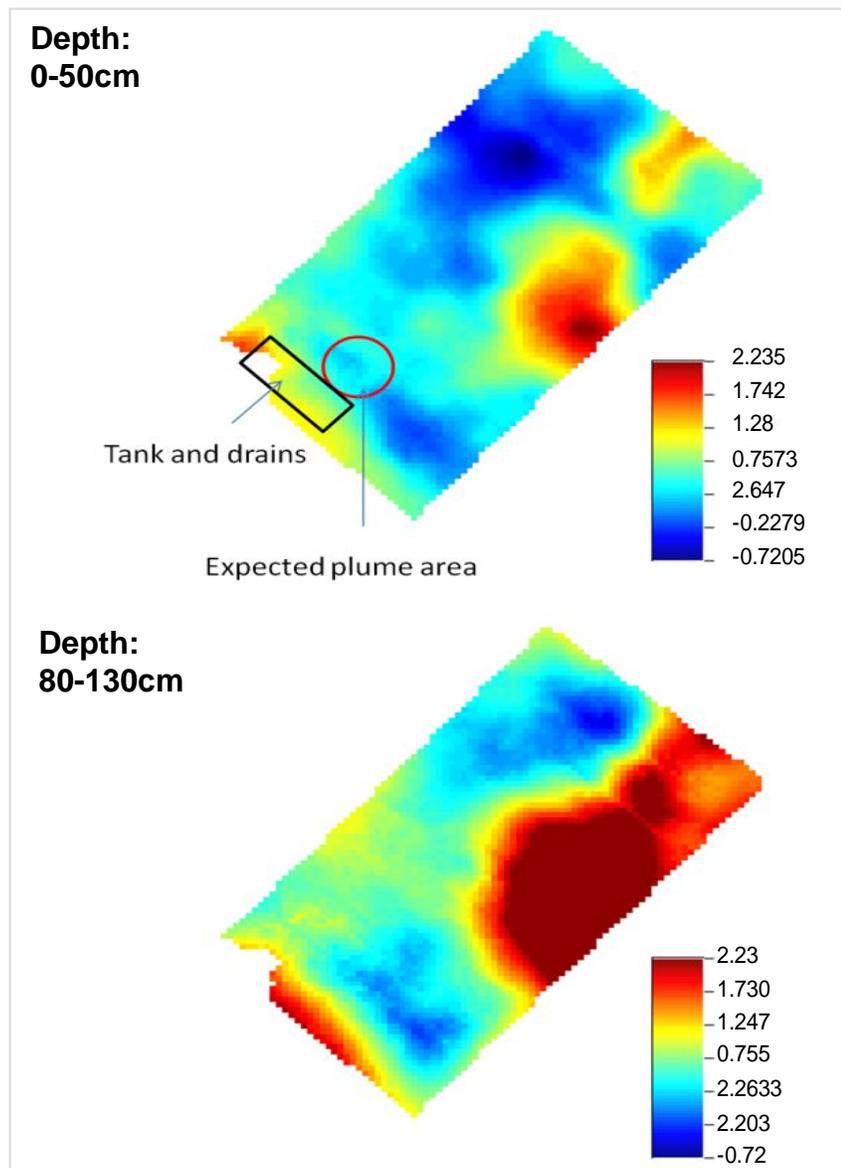
**Figure D** Electromagnetic image (EMI) of the drainage field indicating the possible path of the plume from the septic tank at site CLUN2. Levels of electrical conductivity (shown in arbitrary units) range from low (blue) to high (red)

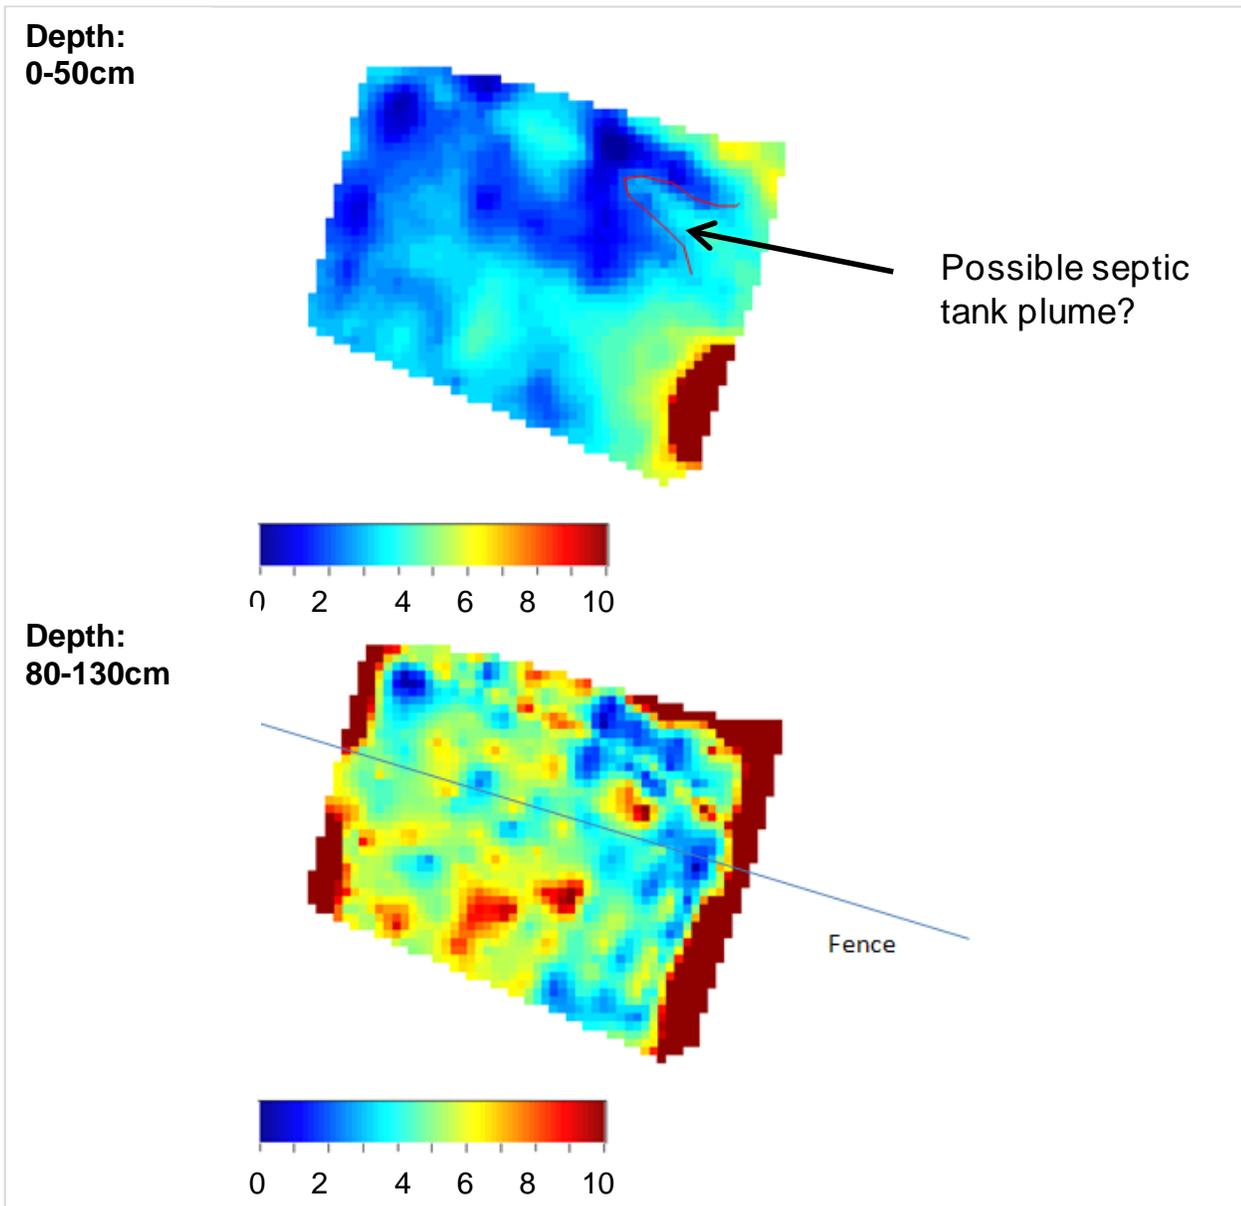
**Figure E** Electromagnetic image of the drainage field indicating the possible path of the plume from the septic tank at site CLUN3. Levels of electrical conductivity (shown in arbitrary units) range from low (blue) to high (red)
