THE ENGINEERING GEOLOGY OF
THE SIDMOUTH DISTRICT
1 : 50 000 GEOLOGICAL SHEET 326/340

TECHNICAL REPORT WN/98/1

A. Forster

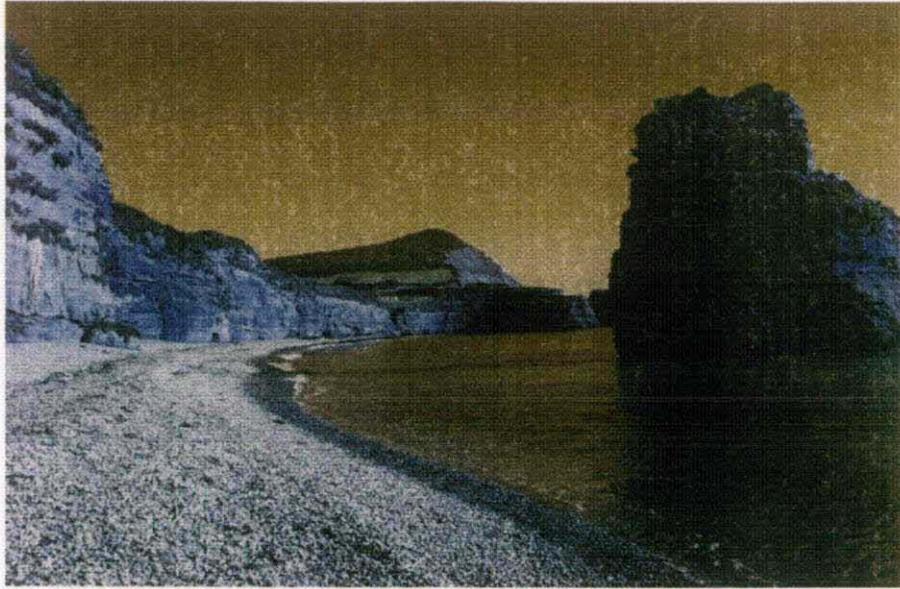
Fig. 33. Cliffs of Otter Sandstone at Ladram Bay.

of up to 45° where they are protected from basal erosion, and stable vertical faces up to 12 m high have been cut by the River Otter. Higher sea cliffs are seen at Ladram Bay [SY 850 095] (Fig.33) and west of Sidmouth by Chit Rocks [SY120 860]. To the east of Sidmouth at the mouth of the river Sid other vertical faces have developed but, where they were subject to marine erosion at their base, active rock falls were present. In the Exeter area road cuttings, up to 15 m deep, have been excavated successfully at angles of 30° to 40°. Older road cuts with near-vertical faces appeared to remain stable up to 3 m high, but where they were between 3 and 8 m high the faces showed isolated instability due to loose blocks and overhangs as a result of weathering and erosion.

Between Budleigh Salterton [SY 290 820] and Hern Point Rock [SY 101 856] the coastal cliffs comprise Otter Sandstone which is generally a medium- to thickly-bedded with widely- to very-widely spaced discontinuities, moderately weak to moderately strong, sandstone which forms near-vertical (70° - 90°) cliffs at Ladram Bay [SY 098 852]. The cliffs show selective erosion of the weaker beds leaving the stronger beds standing proud of the cliff face. During a visit in October 1996 some undercutting of the cliff by basal erosion by the sea was seen, but scars from recent falls were not visible and no debris was present at the base of the cliff (Fig.33).

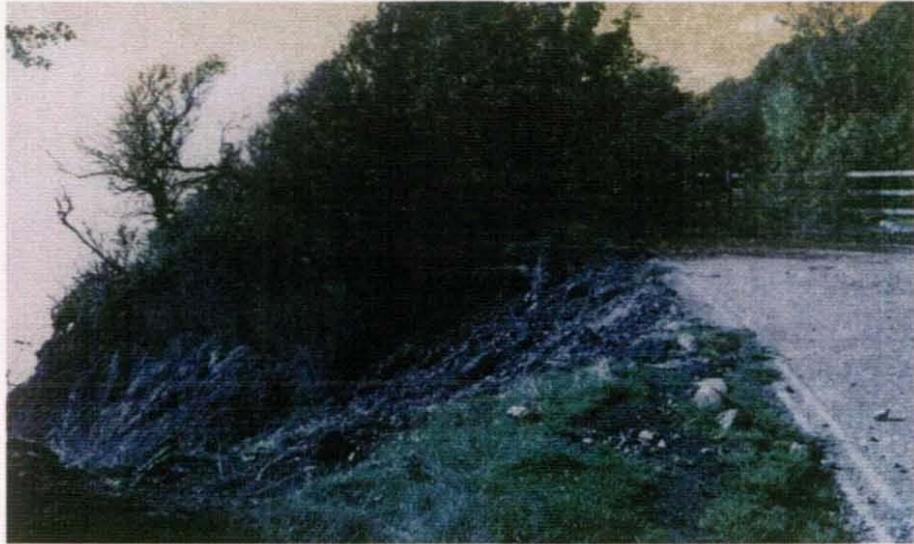
Fig. 35. A recent debris slide has cut back the cliff top west of Sidmouth [SY 1133 8685] to expose a roadside drain at the side of the cliff top road which may have been related to the cause of failure.

- 35 A recent debris slide has cut back the cliff top to expose a roadside drain at the side of the cliff top road, west of Sidmouth [SY 1133 8685], which may have been related to the cause of failure.

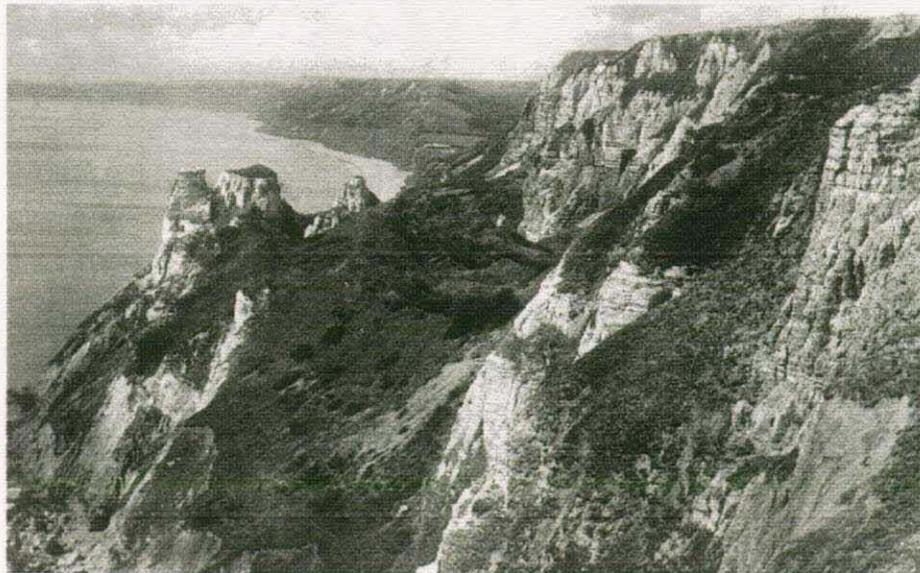
Fig. 39. Hooken Cliff, under Hooken and Pinnacle from the east about 1900 (Rowe, 1903).

Comparison of a photograph of Hooken Cliff (Fig. 39) dating from about 1900 (Rowe, 1903) with Fig. 40 shows that some steepening of the cliff profile in front of the pinnacle had taken place by rock fall since the earlier photograph was taken. However, much of the topography of the area has remained unchanged over a period of 90 years.

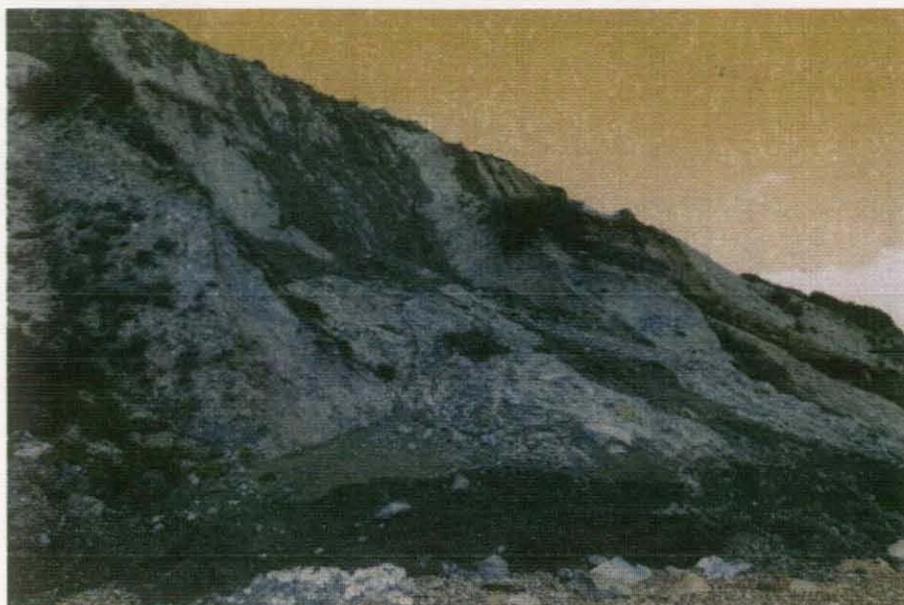
Fig. 42. Sand runs and mudflows from accumulations of Upper Greensand and Gault form debris accumulations at the base of the Mercia Mudstone cliff east of Seaton.

A sand run is a fairly rapid, seasonal, down slope movement of arenaceous debris taking place in the presence of free water. It may be restricted to gullies formed by seepage erosion or it may move on a broader front, as part of the breakdown of rotational slide blocks of Upper Greensand. Heavy rainfall events causing flash floods often result in a very rapid and extensive movement of sand. An example of this was observed during a survey of Black Ven in 1971, when a fifty five minute period of torrential rain mobilised a sand run which moved wooden survey pegs a distance of 40 m (Conway, 1976a).

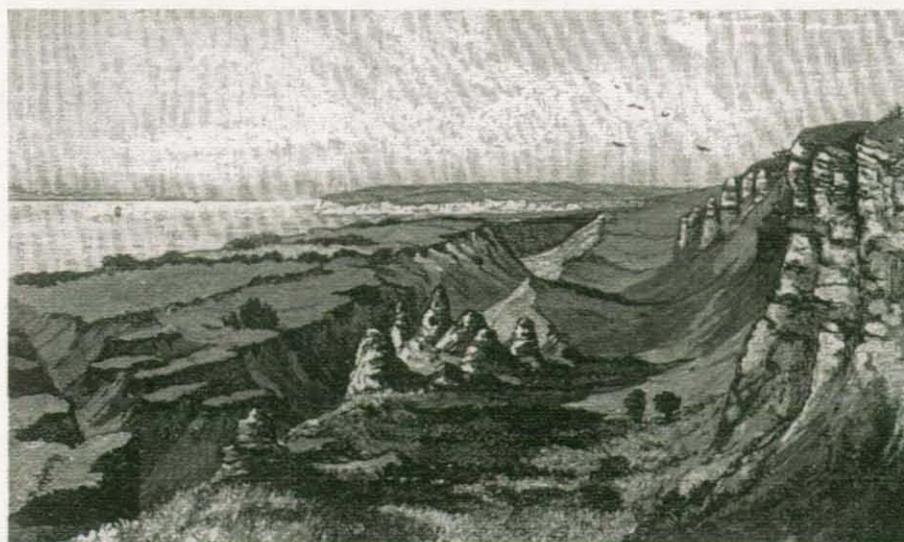
Fig. 43. Bindon landslide around 1885, after a drawing by A Geikie (Woodward and Ussher, 1911).

In the western part of the district where thick Chalk cliffs rest on Gault and Upper Greensand very large scale lateral translational movements of coherent blocks of Chalk have occurred at infrequent intervals, notably at Bindon in 1839/40 and possibly at Hooken Cliff in 1790. The movements appear to be the result of sliding at the base of the Cretaceous strata on the seaward-inclined surface of the Triassic strata on which it rests unconformably. The causes of the movement are the removal of lateral support by the erosion of material by the sea forming an over steepened cliff face and high pore water pressure in the Gault and Upper Greensand at the base of the Cretaceous strata. Rotational failure of the sea cliff reduces lateral support even further and may restrict the drainage of water from the sands at the base causing pore water pressure to increase and large scale lateral spreading to start. Rotational failures into the void created behind the translated block result in the development of graben-like structures on its landward side.
